HADDAM NECK PLANT

LICENSEE EVENT REPORT (LER)

TITLE (4)
Automatic 480 Volt Bus Transfer Failure Due to Circuit Breaker Malfunction

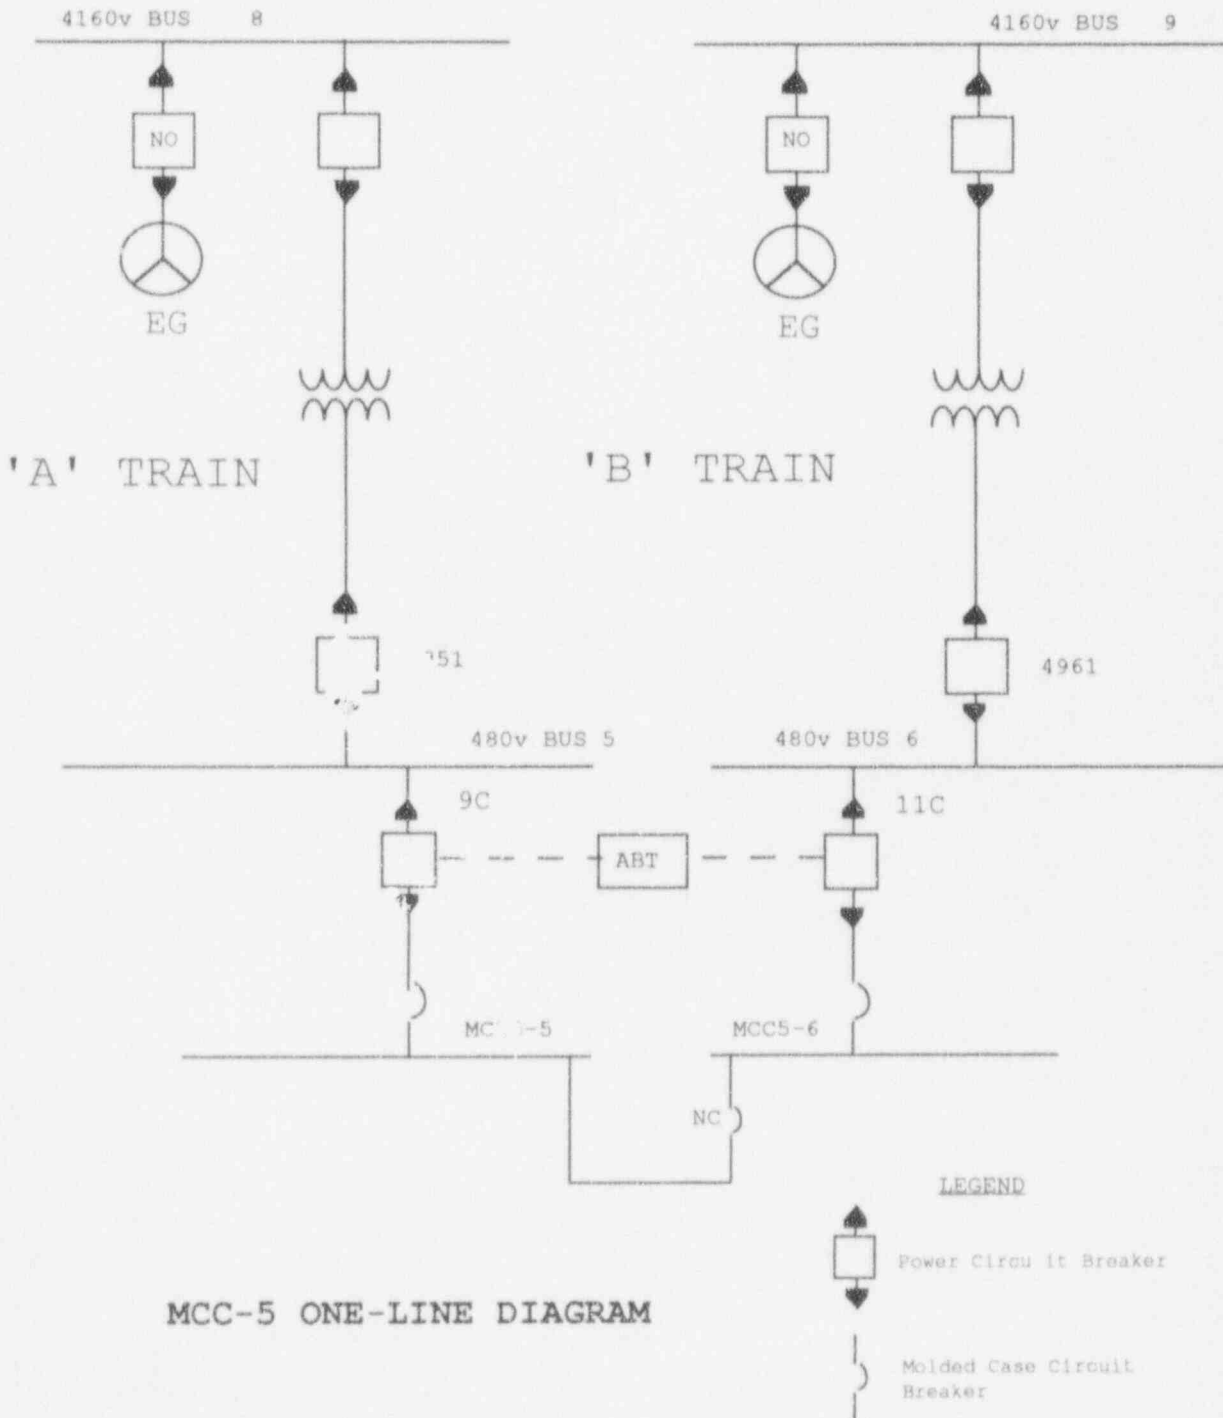
FIGURE 1

The Motor Control Center (MCC) 5 Automatic Bus Transfer (ABT) circuit provides power to MCC-5 from either of two 480 volt AC power sources (EIIS Code: EK) (see Figure 1). MCC-5 is normally aligned so that bus 5 (Train 'A') provides power to MCC-5 via circuit breaker 9C. If for any reason bus 5 becomes de-energized the ABT scheme (see Figure 2) will transfer the feed for MCC-5 to bus 6 (Train 'B') via the 11C breaker. Upon restoration of bus 5 power the ABT scheme will then transfer the feed for MCC-5 back to bus 5 (the preferred supply). During the refueling outage of May to July 1993, an ABT failure was experienced. A root cause investigation performed following that failure was inconclusive yet a component, the 52X relay, common to both ABT circuit breakers (EIIS Code: 52) was determined to be the most suspect. These components were replaced on both the bus 5 9C breaker and bus 6 11C breaker. Connecticut Yankee (CY) committed to perform on-line testing of the 52X relay associated with the ABT. All testing on the bus 5 supply to MCC-5 has been successful since start-up from the 1993 refueling outage in July 1993. CY also committed to perform a functional test of the MCC-5 ABT whenever the plant entered Mode 5 (Cold Shutdown). The current shutdown for service water pipe repairs afforded an opportunity to perform this functional test.
