LICENSEE EVENT REPORT (LER)

FACILITY NAME (1) Millstone Nuclear Power Station Unit 2	DOCKET NUMBER (2) 05000336	PAGE (3) 1 OF 6
--	--------------------------------------	---------------------------

TITLE (4)
"B" Emergency Diesel Generator Deficiencies During 18 Month Inspection

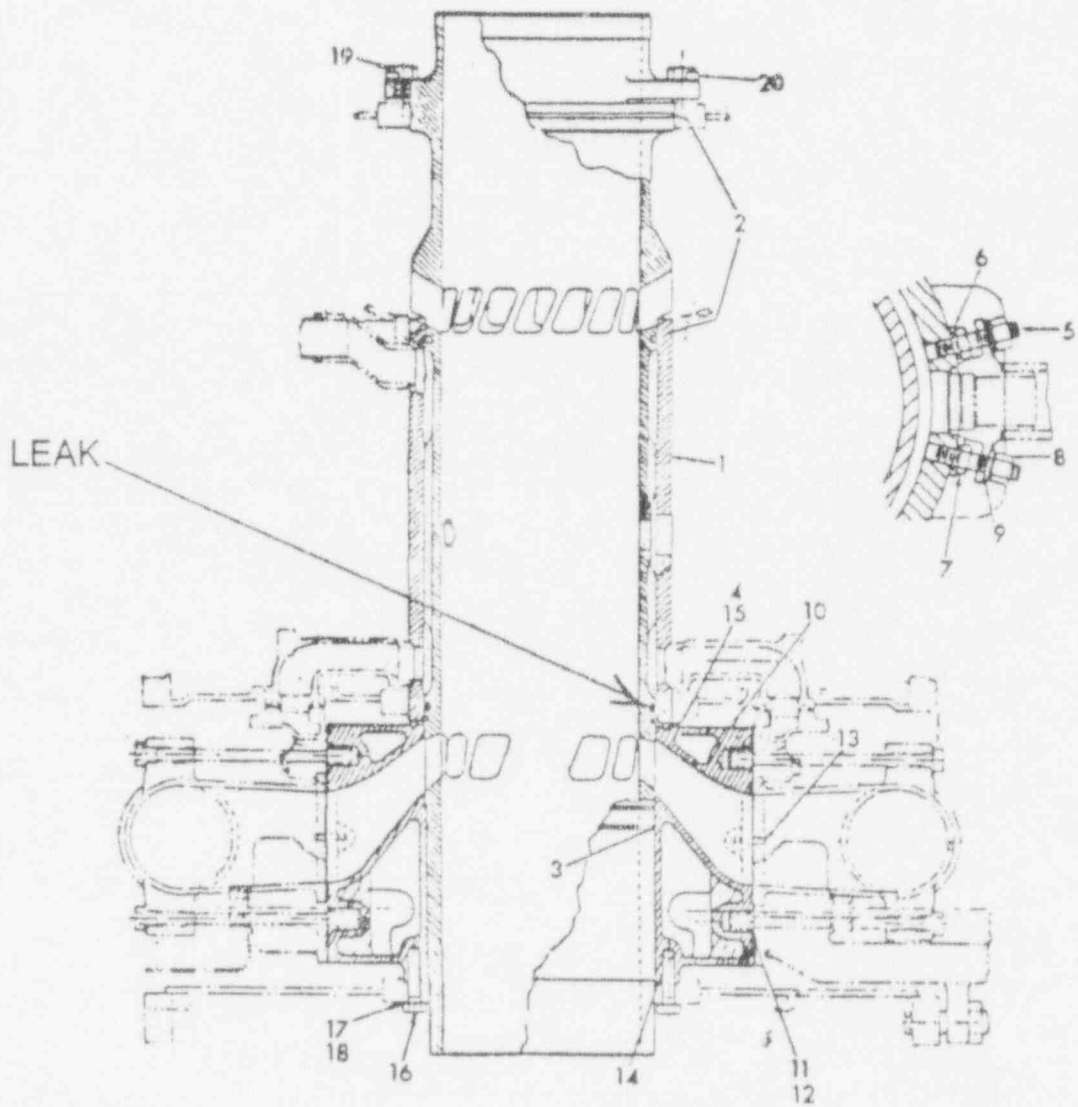
Figure 1
Cylinder Liner Assembly

1) Cylinder Liner Leakage

The root cause of the liner leakage during the water test has been determined to be the natural end of life for the "O" ring joint. The cylinder liners are original equipment and were scheduled for replacement during the end of Cycle 13 refuel outage. The water test performed during this inspection was different than past tests and may have contributed to the earlier than expected leakage. Past water tests were performed at 30 psig for a 24 hour period. The water test performed at this inspection, was performed at 50 psig for a 10 minute period (vendor recommendation). The higher pressure could have contributed to the leakage rate. During engine operation the liner area becomes warmer than during the water test. The warmer temperature may tend to close up the leakage path during loaded engine conditions. The location and amount of leakage would not have hindered the ability of the diesel to perform its safety function. The leakage was from the lower "O" ring joint (see Figure 1) into the exhaust manifold area. Any water leakage would be exhausted through the muffler into the atmosphere. The leakage rate was small enough such that it was within the capability of the make-up system.

- 1) Three cylinder liners were replaced. During a subsequent water test another original liner began leaking. At this time, a decision was made to replace all the cylinder liners. Nine additional liners were procured and installed. A subsequent retest proved satisfactory.

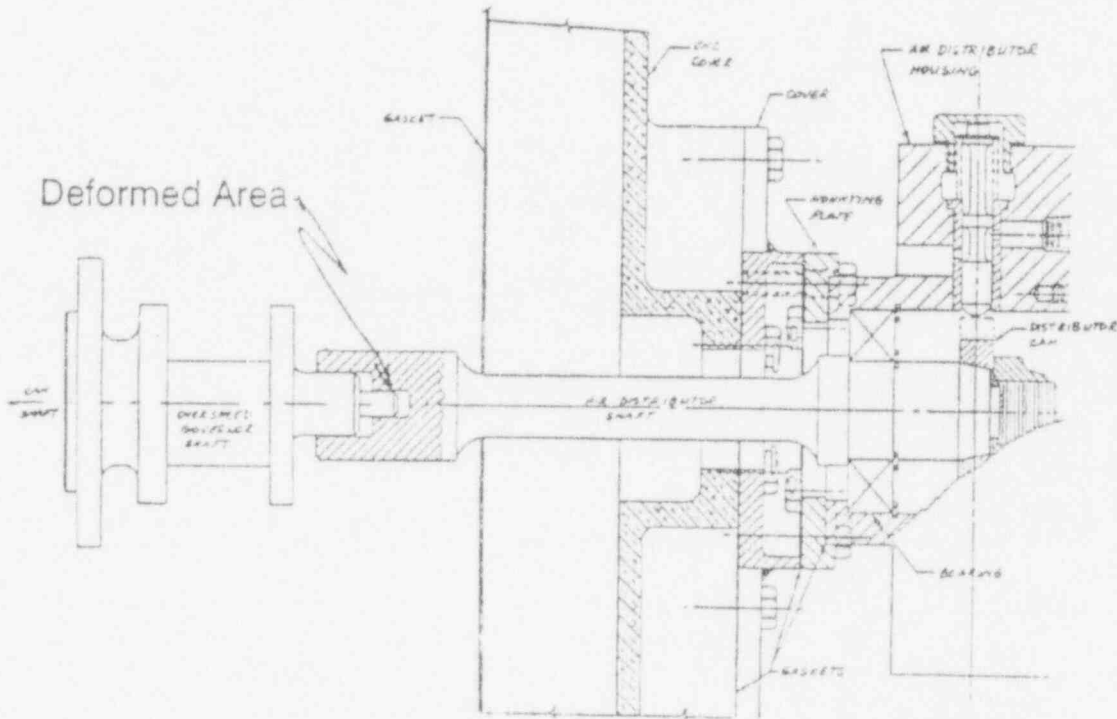
Figure 2
Airstart Distributor Shaft and Overspeed Governor Shaft Deformation

3) Air Start Distributor Drive Shaft and Overspeed Governor Shaft Deformation (See Figure 2)

The cause of the shaft deformation is due to either over-torquing of the air start distributor cam nut during initial installation or a misalignment of the air start distributor drive shaft with the overspeed governor shaft. This misalignment can occur anytime the timing cover is removed from the engine since the air start distributor assembly is mounted to the cover.

- 3) The overspeed governor shaft was replaced and the upper air start distributor was reworked to remove any raised metal from the deformed area and dye penetrant inspected to verify no relevant indications, and accepted for use.
