PHILADELPHIA ELECTRIC COMPANY

March 16, 1983

Docket Nos. 50-277  
50-278

During a meeting held in Bethesda on March 3, 1983, concerning the failure, during environmental qualification testing, of electrical control stations of the type used for the Emergency Core Cooling System (ECCS) room coolers at Peach Bottom, you requested that we provide information and justification for continued operation.

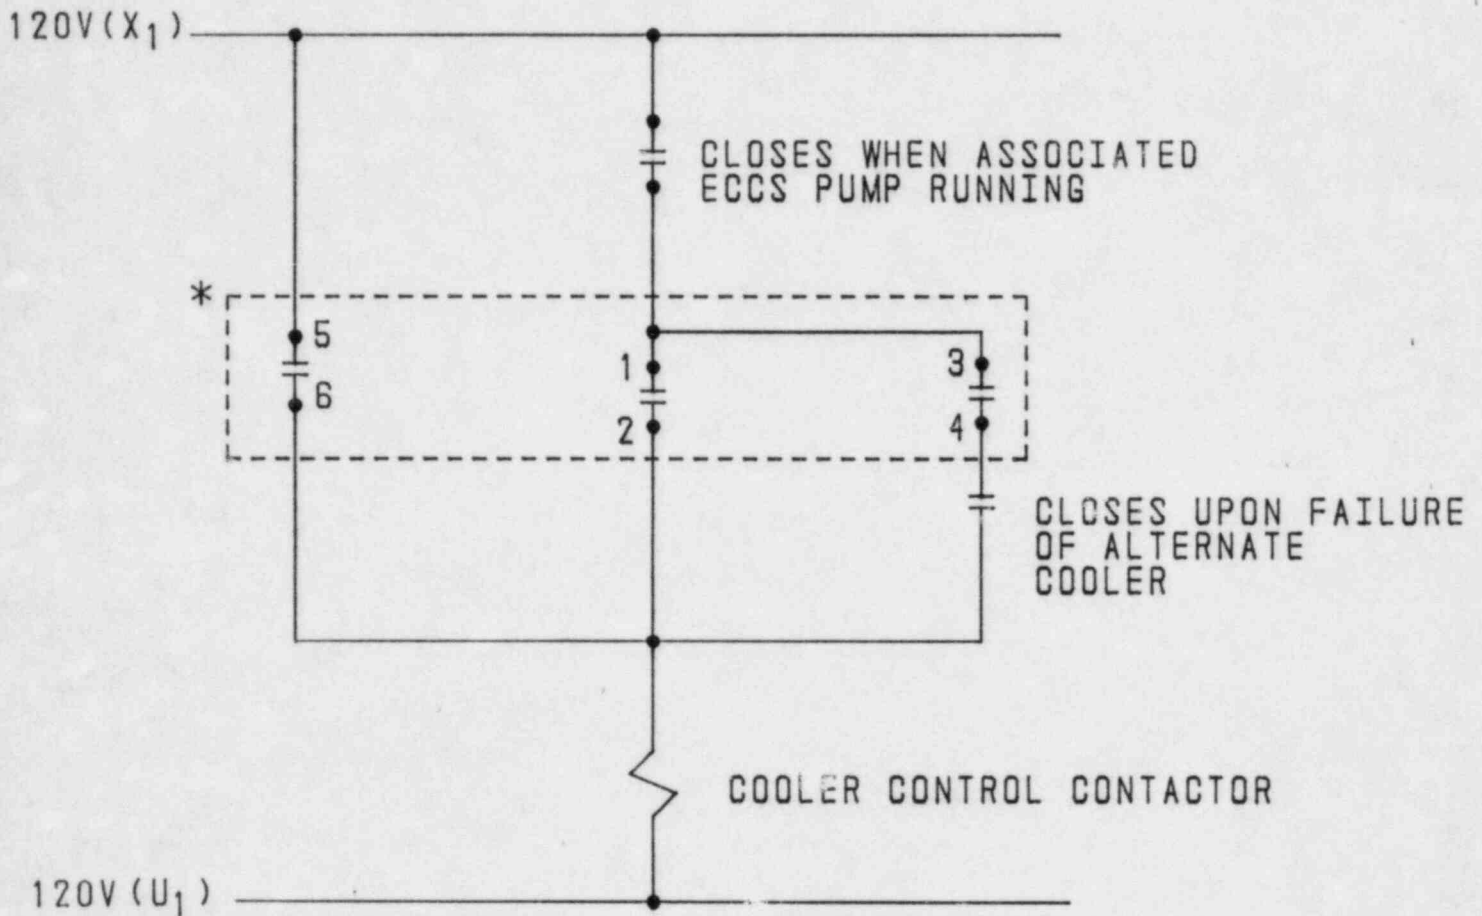
SIMPLIFIED SCHEMATIC  
TYPICAL APPLICATION-ECCS ROOM COOLER SWITCH  
(ONE SWITCH PER COOLER)

Two failure modes have been postulated for the switch assemblies; however, it is necessary to review the ECCS room cooler arrangement in order to more easily address these scenerios. A simplified schematic of a typical switch installation is included as a reference.

Postulated Failure #1 - In this failure scenerio the cams would disintegrate such that neither cooler would operate. Without room cooling the associated ECCS pump motor is assumed to fail and therefore there would be a loss of long term cooling capability.

Postulated Failure #2 - This scenerio sees the cams failing such that the "manual" contact closes thus resulting in operation of all of the coolers. This poses difficulties in that operation of all coolers exceeds the capacity of the ESW system such that there may be insufficient heat removal capability for the coolers and other equipment (Diesels) using ESW supply.

\* COOLER CONTROL SWITCH  
CONTACT ARRANGEMENT

1-2	CLOSED IN RUN	OPEN ALL OTHERS
3-4	CLOSED IN AUTO	OPEN ALL OTHERS
5-6	CLOSED IN MANUAL	OPEN ALL OTHERS

As an immediate corrective measure, jumpers were installed on the auto or run contacts and leads were lifted on the normal contacts as follows:

Jumpers installed across the run or auto contacts effectively bypass the switches thus failure of the cam will not preclude cooler operation. Lifting of manual leads on the limited number of coolers precludes inadvertent operation of these coolers and maintains the ESW flow below the maximum system capacity. The changes do constitute a minor inconvenience to plant operations; however, there is no deleterious effect to plant safety since the coolers will be available as designed for ECCS room heat removal.
