Rio Algom Mining Corp.

May 20, 1994

Re: Lisbon Facility
License SUA-1119, Docket No. 40-8084
Reporting Requirement 10 CFR §40.60 (c)(2)

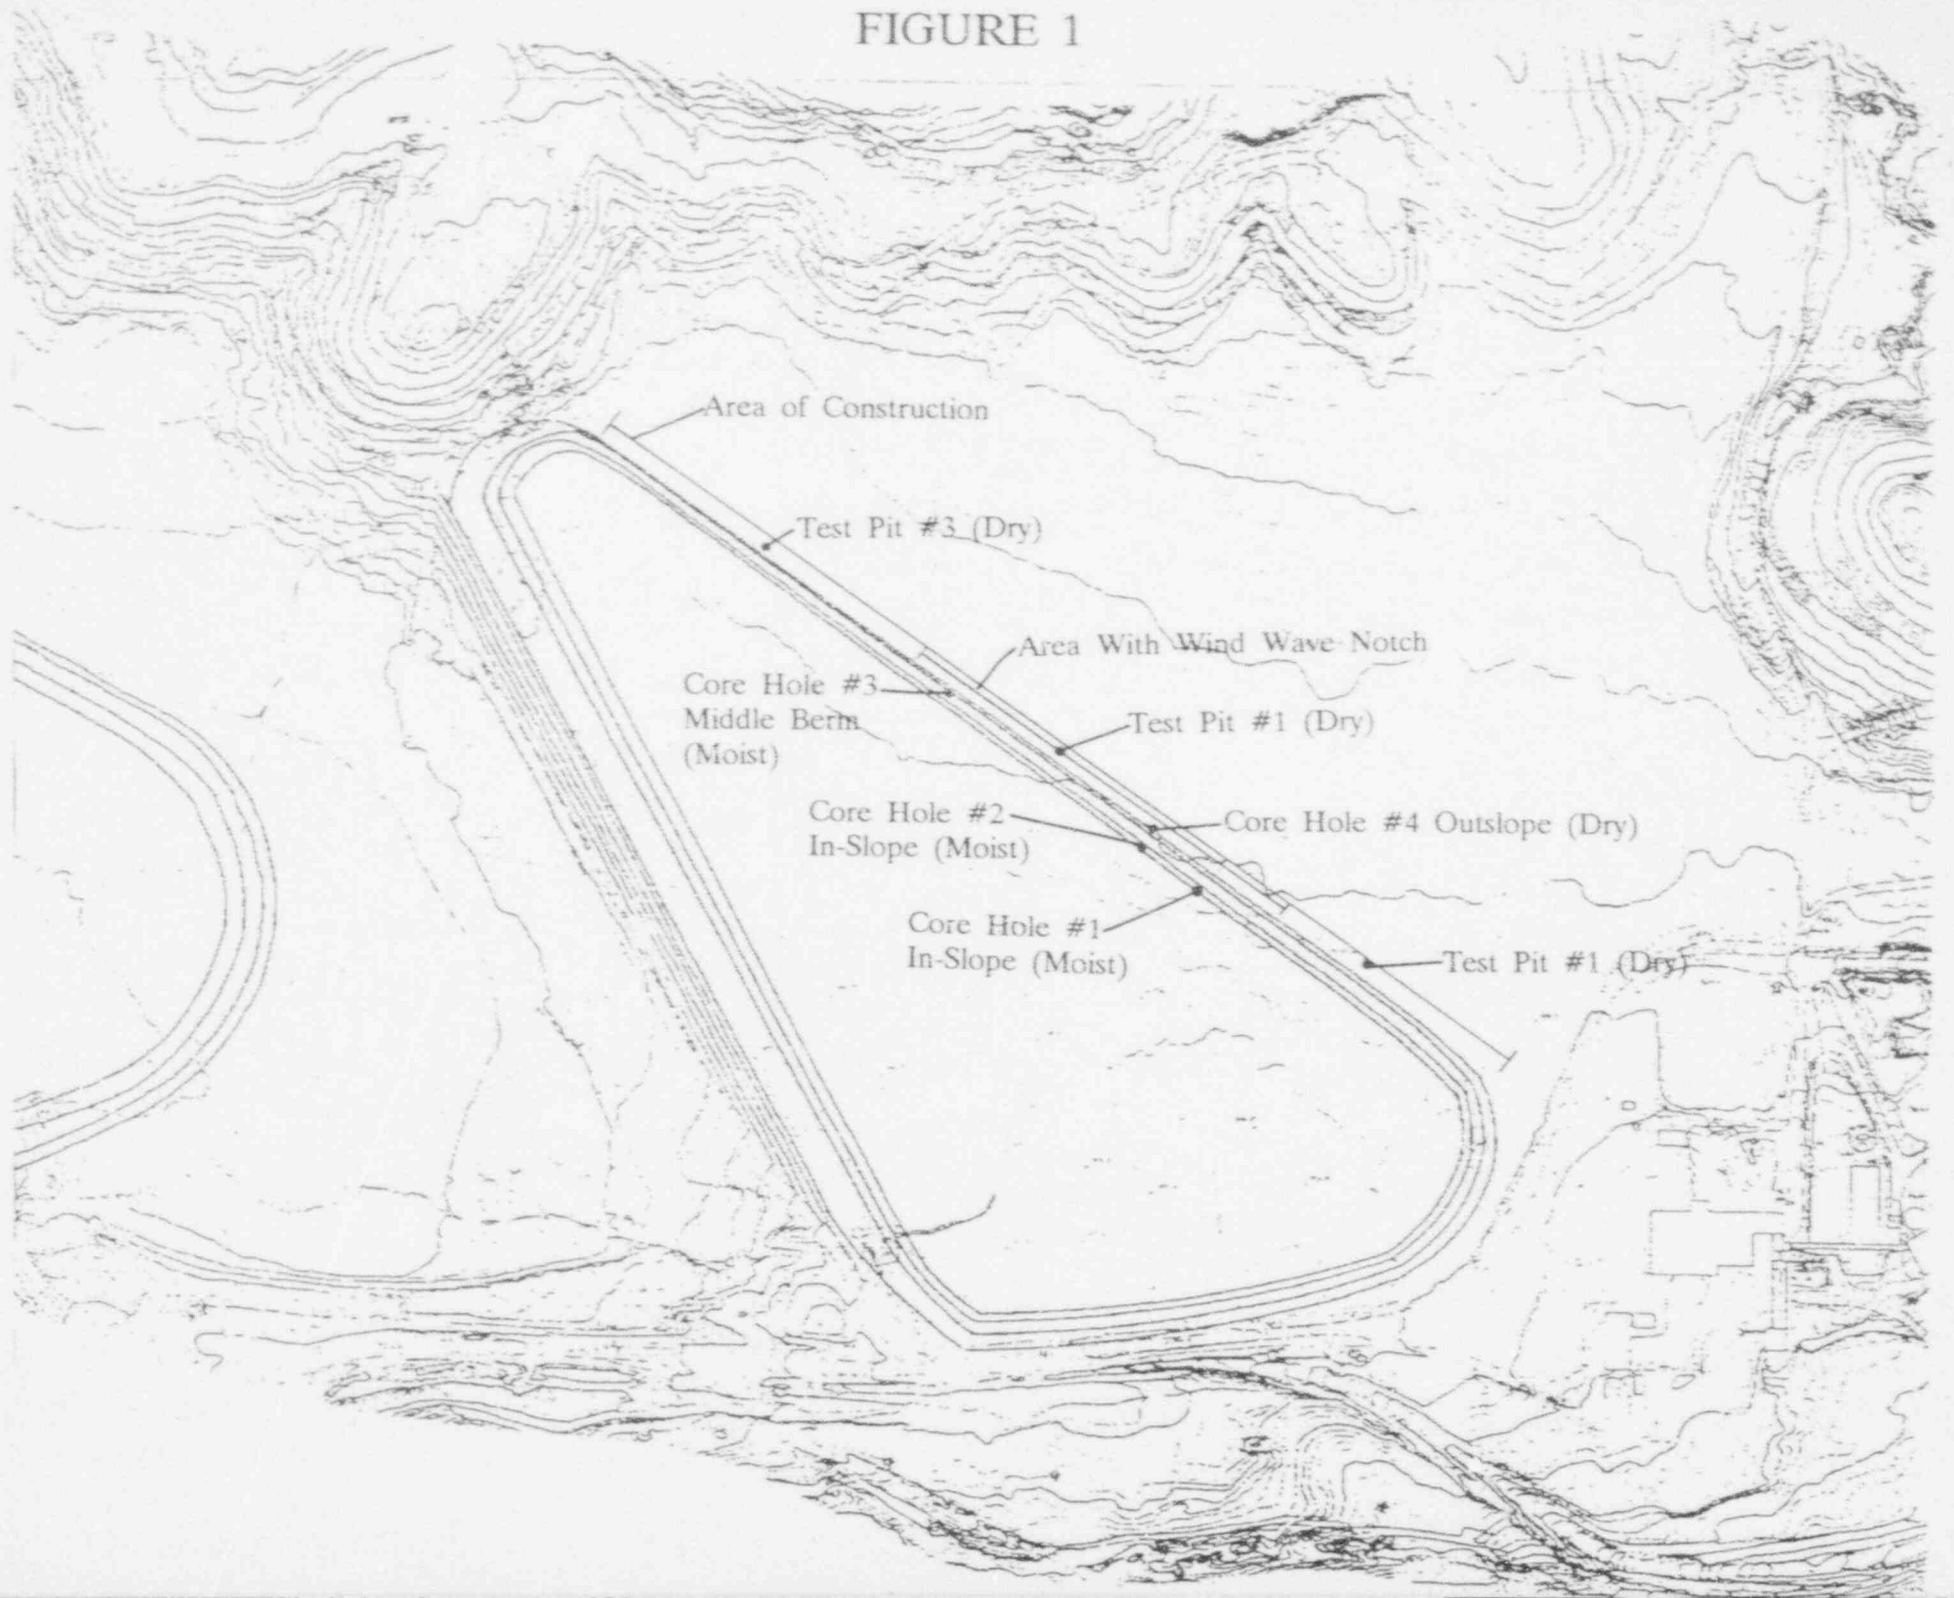
FIGURE 1

As a check to determine the extent of moisture, several core holes were established in the embankment. The core hole locations are shown in Figure 1.

Core holes noted as #1 and #2 were placed on the in-slope of the evaporation cell. Both holes of these core holes indicated the earthen material beneath the clay liner was moist. Core hole #3, was placed near the center of the embankment berm. It also indicate the underlying material was also moist. To help determine the extent of moisture, another core hole that is marked as #4, was placed on the out-slope of evaporation cell. The result indicated the underlying material on the outslope of the embankment was dry.

The moisture associated with the wind wave notching was first noted at approximately the area noted on Figure 1 as core hole location #1.

Upon notification to NRC, plans were implemented to reduce the groundwater solutions in the upper tailings evaporation cell by siphoning to the lower tailings evaporation cell. Two (2) three (3) inch siphon hoses were utilized to removed the groundwater solutions from the upper to lower tailings evaporation cell.

As of May 18, the water level within the upper tailings evaporation cell has been lowered 1.9 feet. Rio Algom plans to continue lowering the solutions so that repairs to the clay liner caused by the wind-wave notching can be implemented. It is presently estimated that approximately 0.5 to 1 feet of additional water may need to be removed from the cell prior to initiation of work to repair the clay liner.

Since the report period, approximately two (2) to six (6) feet of the original berm outslope has been replaced with acceptable silt material. The re-construction of the berm and outslope utilized previous construction parameters approved by NRC to construct the lower tailings evaporation cell dated February 24, 1993, included conducting a compaction test a minimum of every 500 yard³ at 95% standard Proctor. Other construction specifications utilized during the construction included using $\pm 2\%$ optimum moisture and performing; (1) a five point proctor every 5,000 yards³; (2) a one point proctor every 2,500 yards³; (3) an Atterberg Limit Test once per day when a minimum of 150 yards³ is placed and; (4) a soil gradation each 1,000 yards³.

Rio Algom plans to repair the clay in-slope liner upon removal of the necessary groundwater solutions that remain in the upper tailings evaporation cell. The clay will be appropriately protected against future wave-notch action with the potential application of; (1) rip-rap; (2) a synthetic liner covered with earth; (3) other energy dissipation mechanisms; (4) through a gentler in-slope grade or; (5) a combination of these items. Pending final determination of the extent of repair to the clay liner, the most appropriate application will be determined.
