State of Ohio Environmental Protection Agency

RE: SHIELDALLOY METALLURGICAL
GUERNSEY COUNTY
MSL #: 430-1072
DERR CORRESPONDENCE

INVESTIGATION REPORT
Verified Complaint #: 93-DERR-01 - Confidential Memorandum

In the Matter of: Verified Complaint ID#: 93-DERR-01

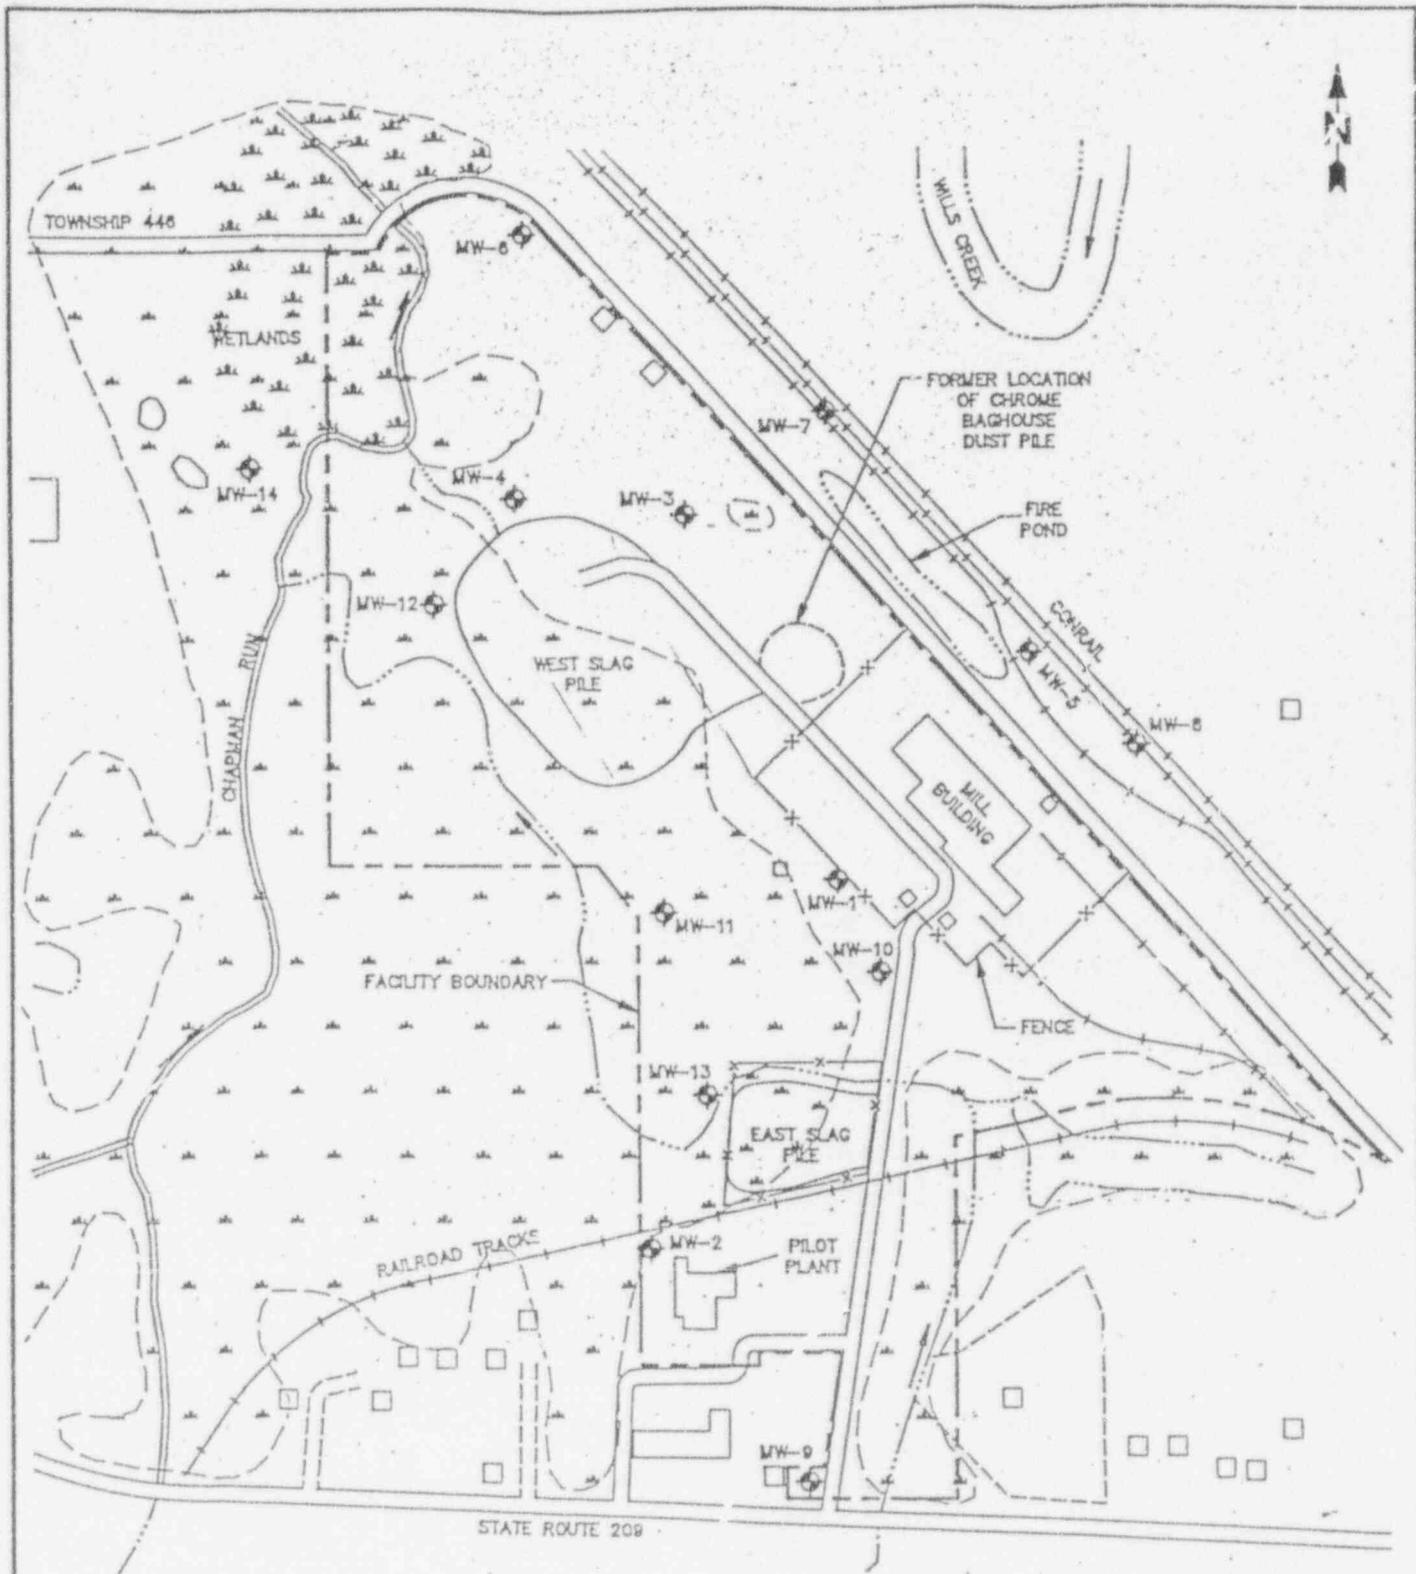
Figure 2 - Detailed map of the SMC site showing the location of the wetlands, the waste piles, the former baghouse dust area, and the existing baghouse dust area.

Two slag piles exist at the site: the west slag pile and the east slag pile (Figure 2). The east slag pile is approximately two to three acres in size. Based on available information the east slag pile is comprised of an estimated 50,000 tons of low level radioactive ferrocolumbium slag, ferroalloy slag and grainal slag material (Attachment 19). The east slag pile has not been

covered, but it is fenced. The slag pile has been sited in wetlands and is on the 100-year floodplain.
