LICENSEE EVENT REPORT

LER 83-02

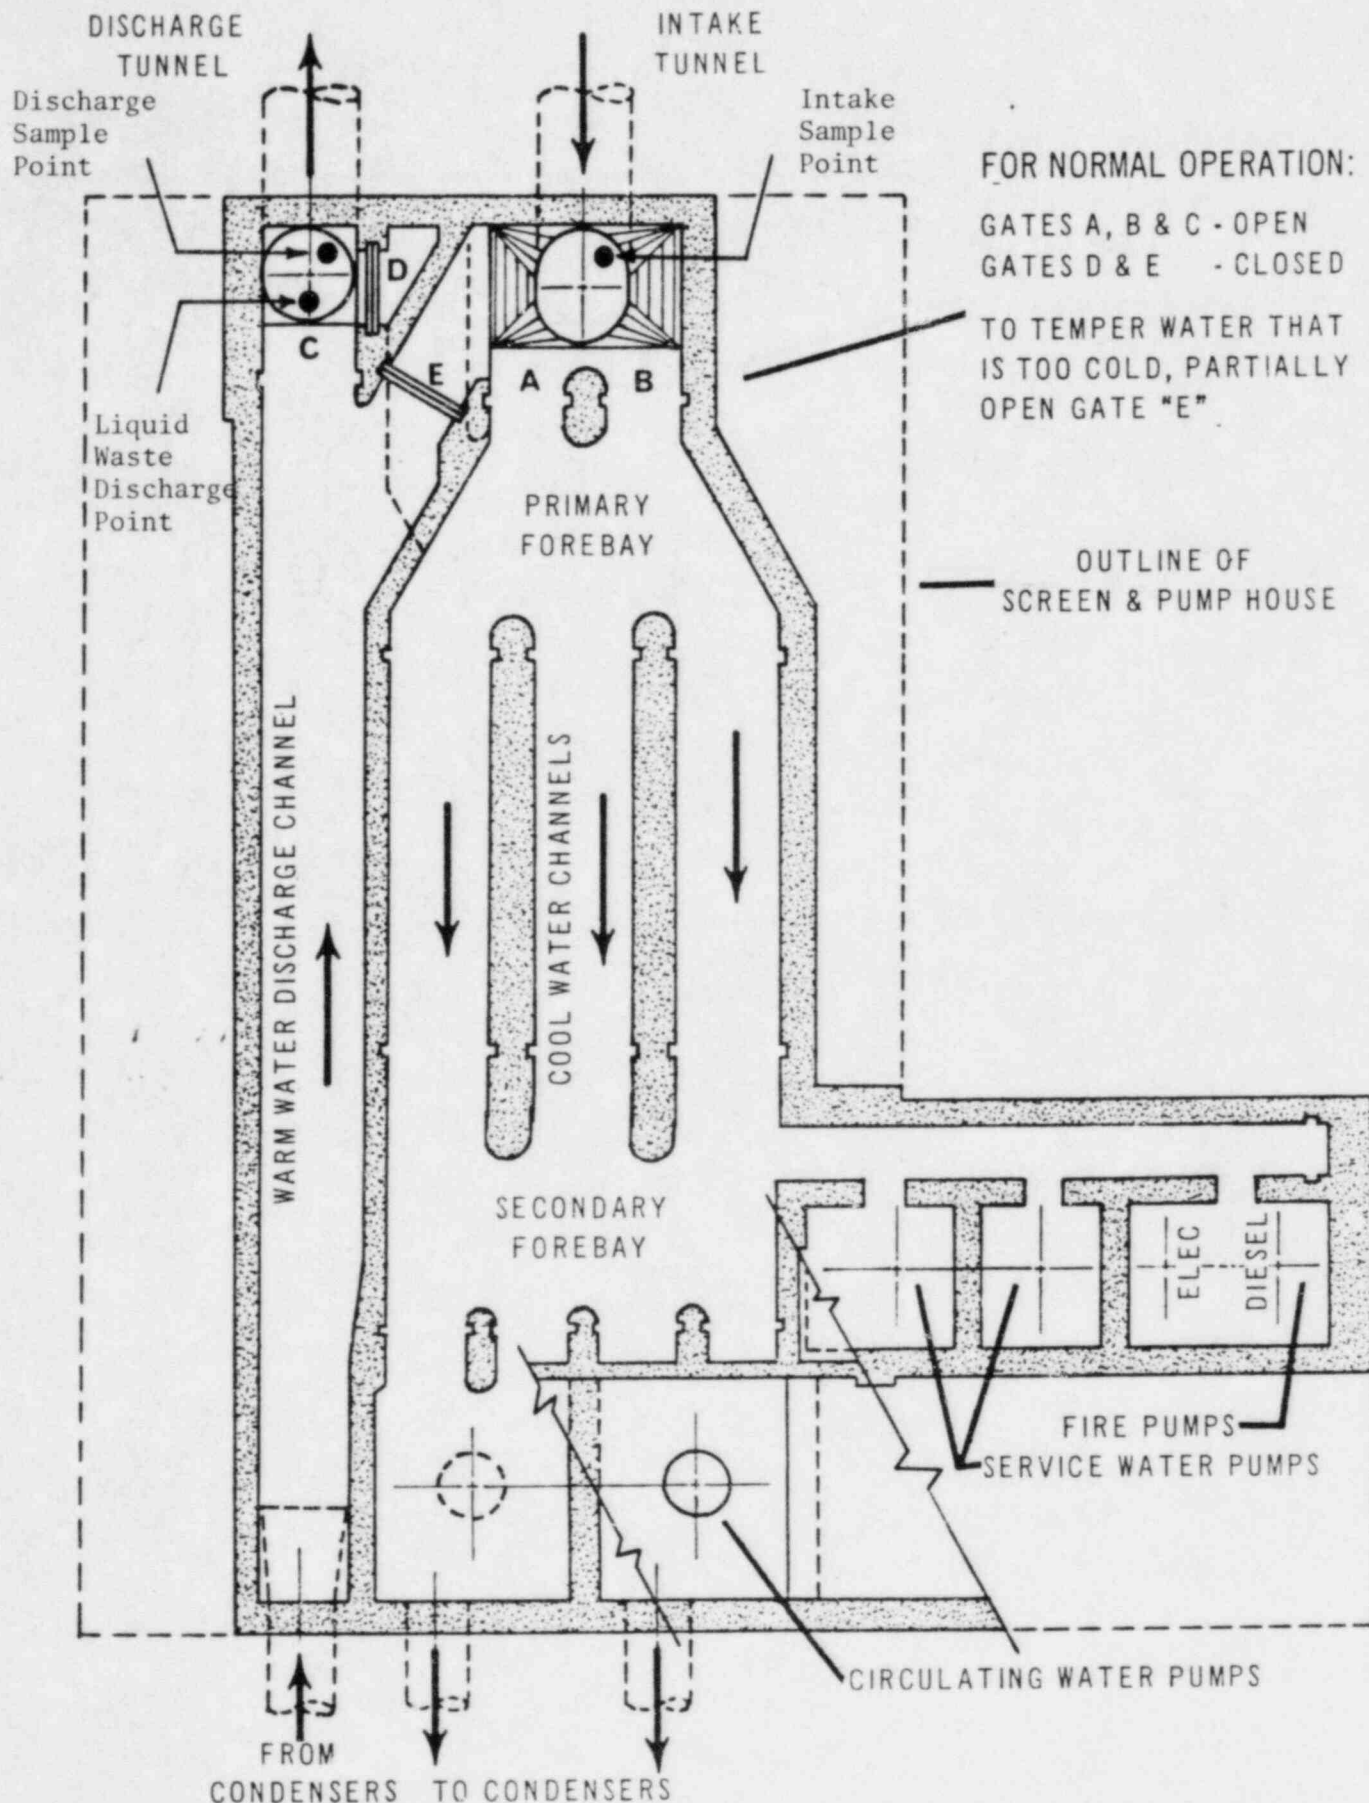
FIGURE III - 16

liquid waste discharge line, which empties into the normal DISCHARGE tunnel, was effectively discharging into the plant inlet due to the reverse flow. Therefore, the INTAKE and DISCHARGE sampling points were downstream of the liquid waste discharge.

Therefore, the tritium, as expected, was from previous, planned, legal discharges in October and does not represent a tritium contamination of Lake Ontario water. Inlet water grab samples taken and analyzed in November and December showed only naturally occurring radionuclides. FSAR figures III-16 and III-17 (attached) show the normal and reverse flow paths.

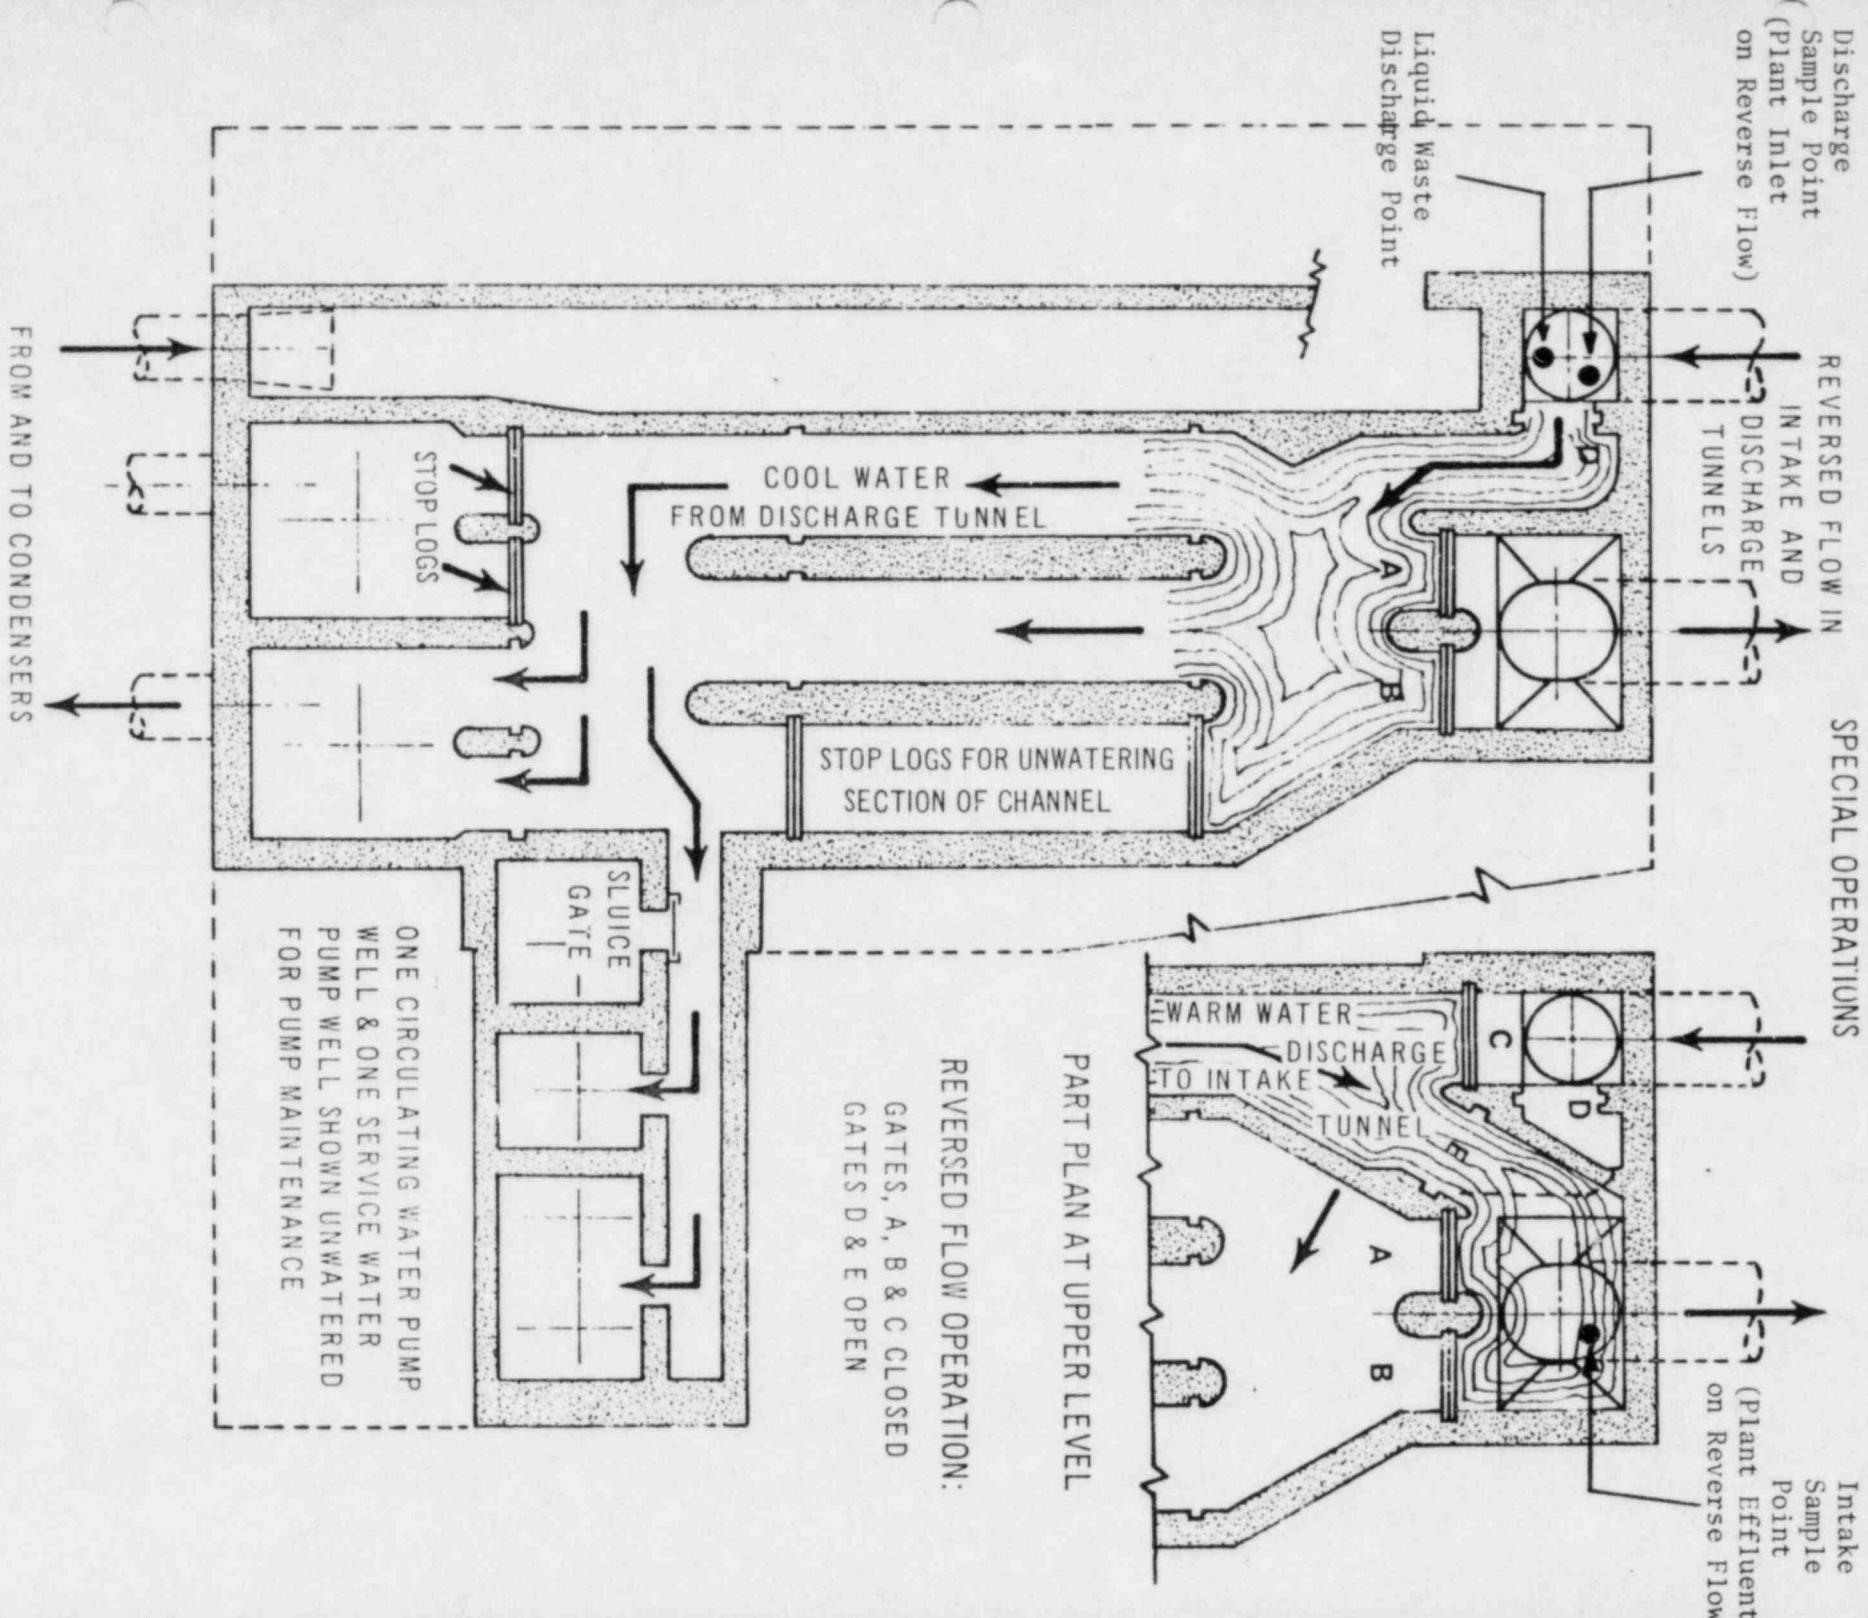
FIGURE III - 17

[1] [0] The plant was shutdown at the time, with the circulating water pumps off, and one [1] [1] service water pump in operation. The normal INTAKE and DISCHARGE tunnels were oper- [1] [2] ating in reverse flow mode due to the installation of a new tempering gate. In this [1] [3] mode, the INTAKE sampling equipment was sampling the service water effluent, and the [1] [4] DISCHARGE equipment was sampling the inlet water flow. In this configuration, the
