Subject Work Order 3900-4000
Washington Public Power Supply System
Supply System Nuclear Project 2
10CFR Potential Reportable Condition 82-08
Responds to: NA

4.16 kV Breaker DG 1.7 & DG 2-8
(82-08)

Description of Potential Defect or Noncompliance

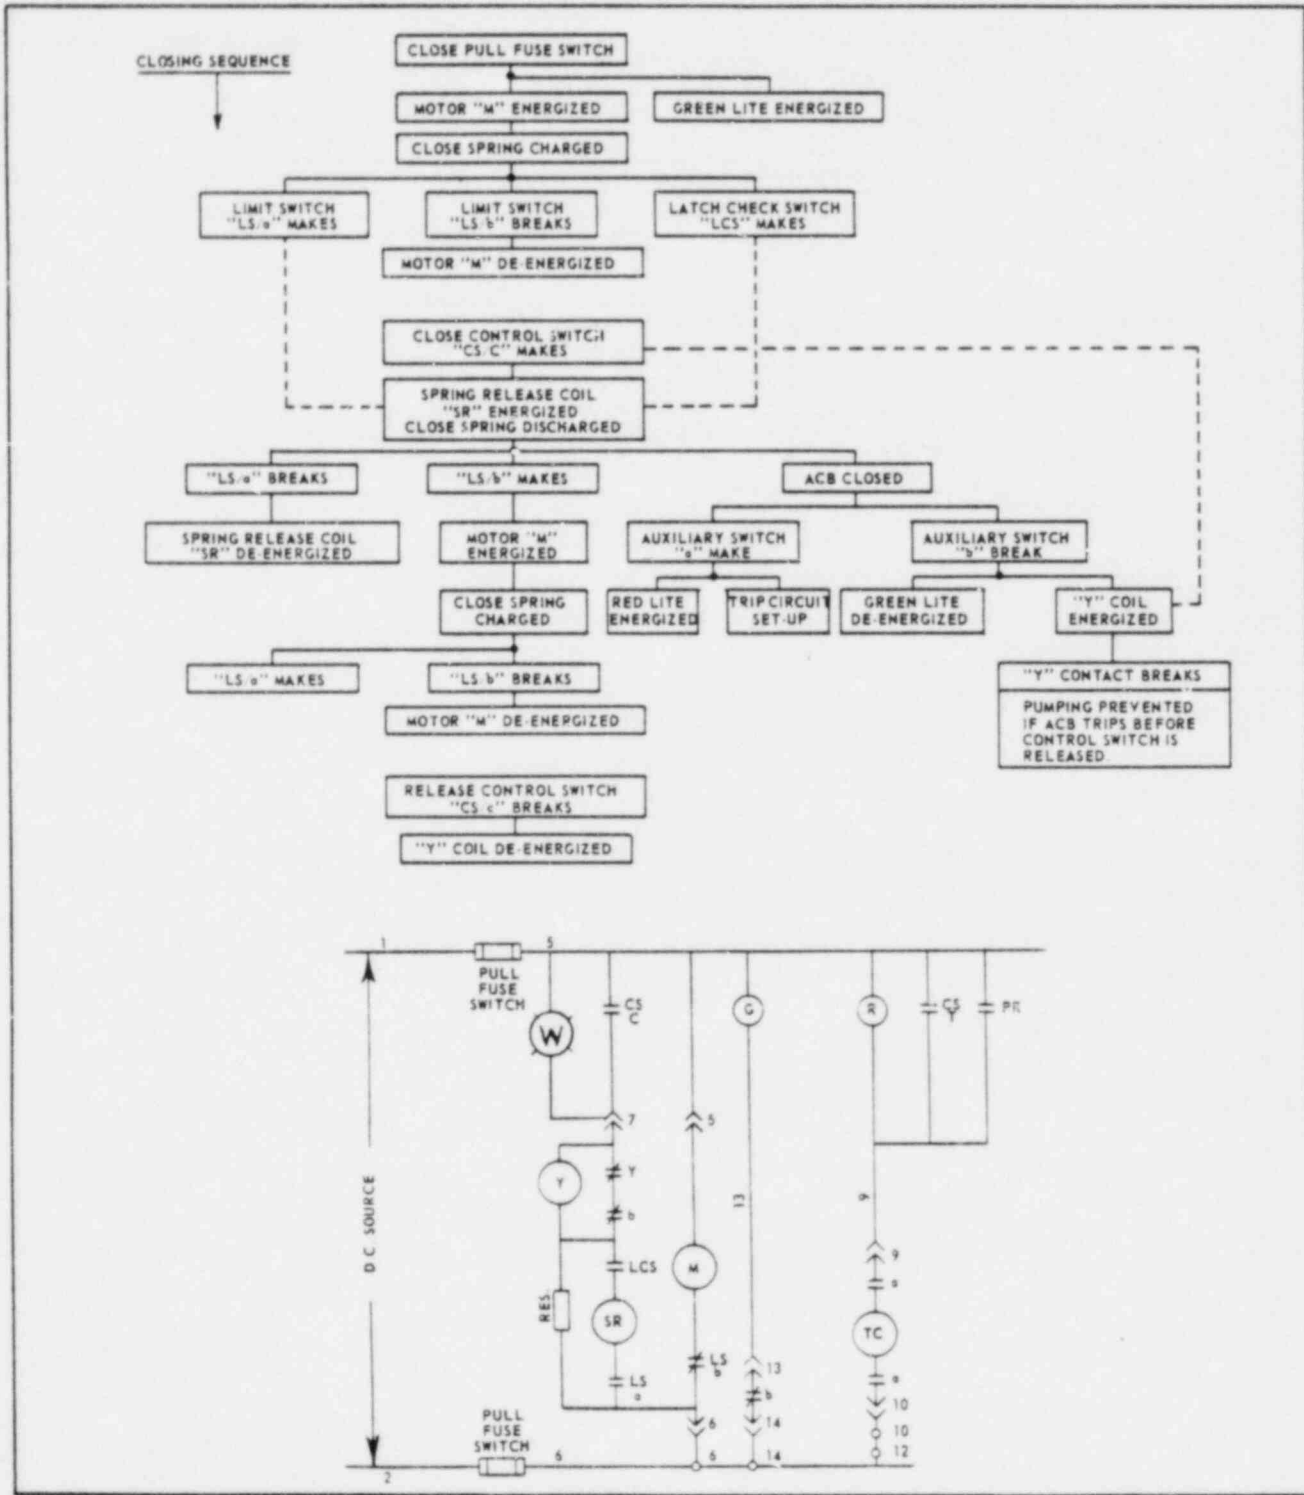
Fig. 44. Stored Energy Breaker with DC Control and DC Shunt Trip

It was discovered that breaker closing circuit availability white indicating lamp provides "seal in" circuit path for the (anti-pump) "Y" relay in the breaker close circuit. This situation prohibits any future closing of the breaker, without removal of the 125V DC control power. (Reference SPR-E-1521.)

Analysis of circuit shows that once the anti-pump relay is energized, it would stay energized through the white light, even though control switch "close contact" is open after breaker close operation. This action opens the permissive in the spring release coil (SR) hence, precludes the breaker closing action unless anti-pump relay is somehow de-energized.

Above scenario leads to the conclusion that once DG1-7/DG2-8 breaker is closed it cannot be reclosed on subsequent fault trip, thereby jeopardizing power availability at Safety busses SM-7 and SM-8.

Circuit configuration for breakers DG1-7 and DG2-8 was changed to utilize a normally closed stationary auxiliary switch contact 52/b in series with breaker availability white indicating light, thereby producing a reset function in the anti-pump relay "Y" coil once breaker is closed. (Reference PED 218-E-A102.)
