DPC SUMMARY REPORT - DESCRIPTION OF WORK TASK TO REDUCE  
FUEL ELEMENT STORAGE WELL LEAKAGE AT LACBWR

C. W. Angle  
Dairyland Power Cooperative

February 10, 1981

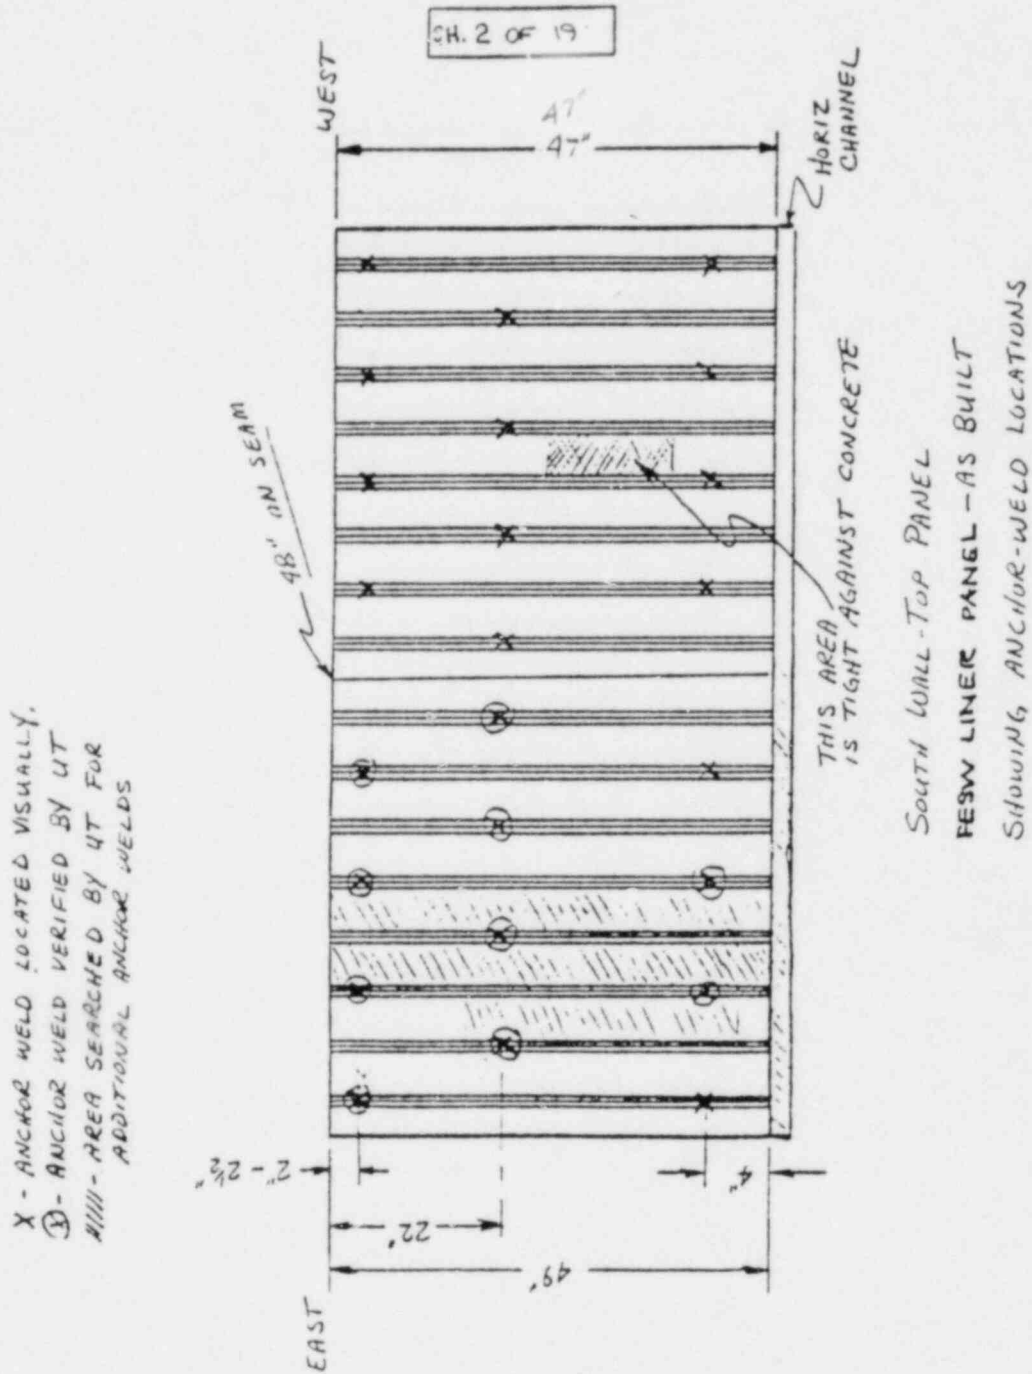
FIGURE 1 - TYPICAL FESW PANEL INSPECTION DATA

The FESW water level was lowered to the 680-foot elevation just below the transfer canal gate. Visual inspection revealed areas of discoloration and occasional dimpling of the liner sheet in the attachment weld locations. These locations were verified using ultrasonics. Additional ultrasonic scans were performed in areas not having visible indications of anchor attachments and no ultrasonic indications were detectable. It was also noted during the inspection that these areas of the liner were slightly buckled inward. Hammering on the liner in these buckled areas verified that the liner was tight against the concrete walls in those areas. This indicates that the buckling took place during the placement of the concrete and did not result from trapped water due to prior liner leakage. The results of this inspection and the anchor layout for all accessible panels is presented in the 19-page "Inspection Report" included in Appendix A to the report of Reference 1. A typical panel is shown in Figure 1, attached.
