INADEQUATE NPSH FOR AUXILIARY FEEDWATER PUMPS
EVENT FOLLOWUP REPORT 90-007
10 CFR 50.72 #16375
AUGUST 16, 1989
PLANT- H.B. ROBINSON
PROJECT MANAGER- R. LO
COGNIZANT ENGINEER- J. THOMPSON

NOTICE OF VIOLATION
AND
PROPOSED IMPOSITION OF CIVIL PENALTY

TITLE (4)
Loss of Safety Injection Pump Autostart Due to Eight Single-Failure Scenarios

EVENT FOLLOWUP REPORT 87-177
50.72 EVENT #10849 DECEMBER 2, 1987
PLANT- H.B.ROBINSON UNIT 2
SUBJECT: UNANALYZED ECCS FAILURE MODE
PROJECT MANAGER-KENNETH ECCLESTON
COGNIZANT ENGINEER-WALTON JENSEN

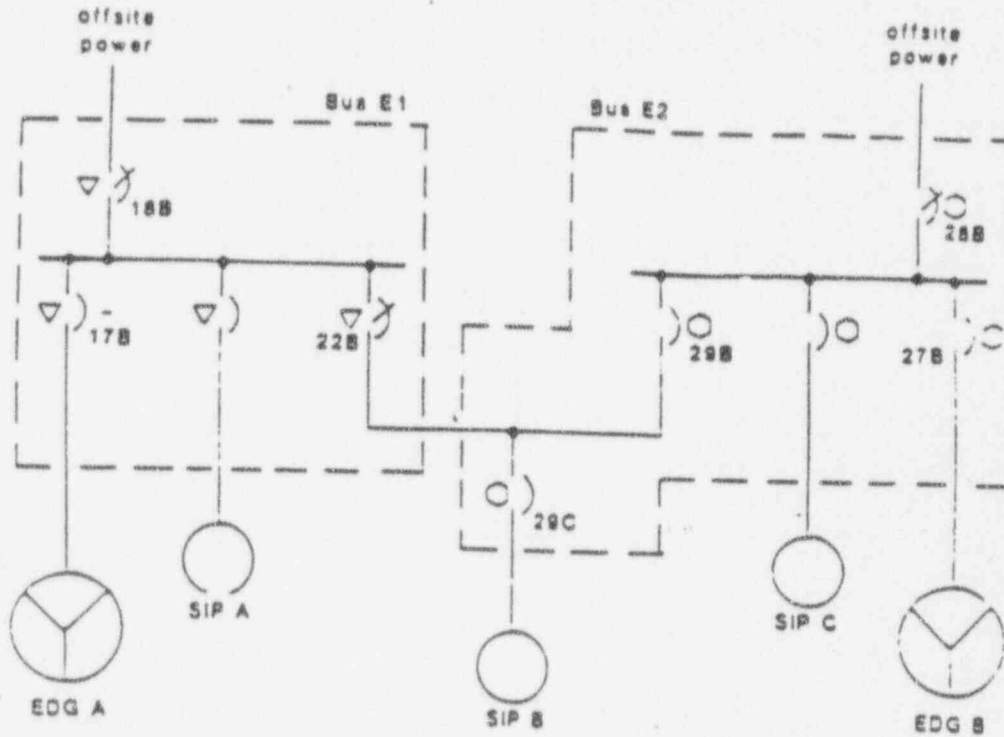
Figure 1
Normal Emergency Bus Lineup
(Before Jan 28, 1988)

During review of Plant documents in response to an NRC Request for Additional Information on the automatic transfer scheme for Safety Injection Pump "B" (SIP-B), the licensee identified a design discrepancy.^{1,2} As originally designed, a single failure of the "B" Battery during a safety injection could result in only one SI pump (SIP-A) being available for automatic start on a Safeguards signal.^{3,4,5} The tie bus between the E-1 and E-2 emergency busses would be energized from the E-1, but there would be no control power to close the breakers for SI pumps "B" and "C".^{6,4} The closing power for the SIP-B breaker comes from the "B" Battery.

The cause of the single-failure susceptibility appears to be inherent in the design of SIP-B and the emergency AC and DC distribution systems in how they provide control power and motor power for SIP-B. Specifically, the SIP-B was designed to be powered automatically from either the "A" or "B" Train (480V emergency power) via a tie bus arrangement (Figure 1). Power would be preferentially supplied by the "A" Train (bus E-1) through a tie breaker. If the "A" Train power was unavailable, the selection logic would sense this tie breaker open and the opposite tie breaker would be closed by the SI sequencer, providing power from the "B" Train (bus E-2). However, control power for SIP-B is provided by only the "B" Train ("B" DC distribution system). It was this configuration (two trains of power, one train of control) and the interrelation of the "A" and "B" Train logics associated with automatic starting of SIP-B that created the various combinations of single-failure scenarios.
