UNIVERSITY OF MISSOURI-COLUMBIA

Research Reactor Facility

Reference: Docket No. 50-186
University of Missouri Research Reactor
License R-103

Subject: Report as required by Technical Specification 6.1.h(2) concerning reactor operation with the regulating blade inoperable for a period of about 10 minutes.

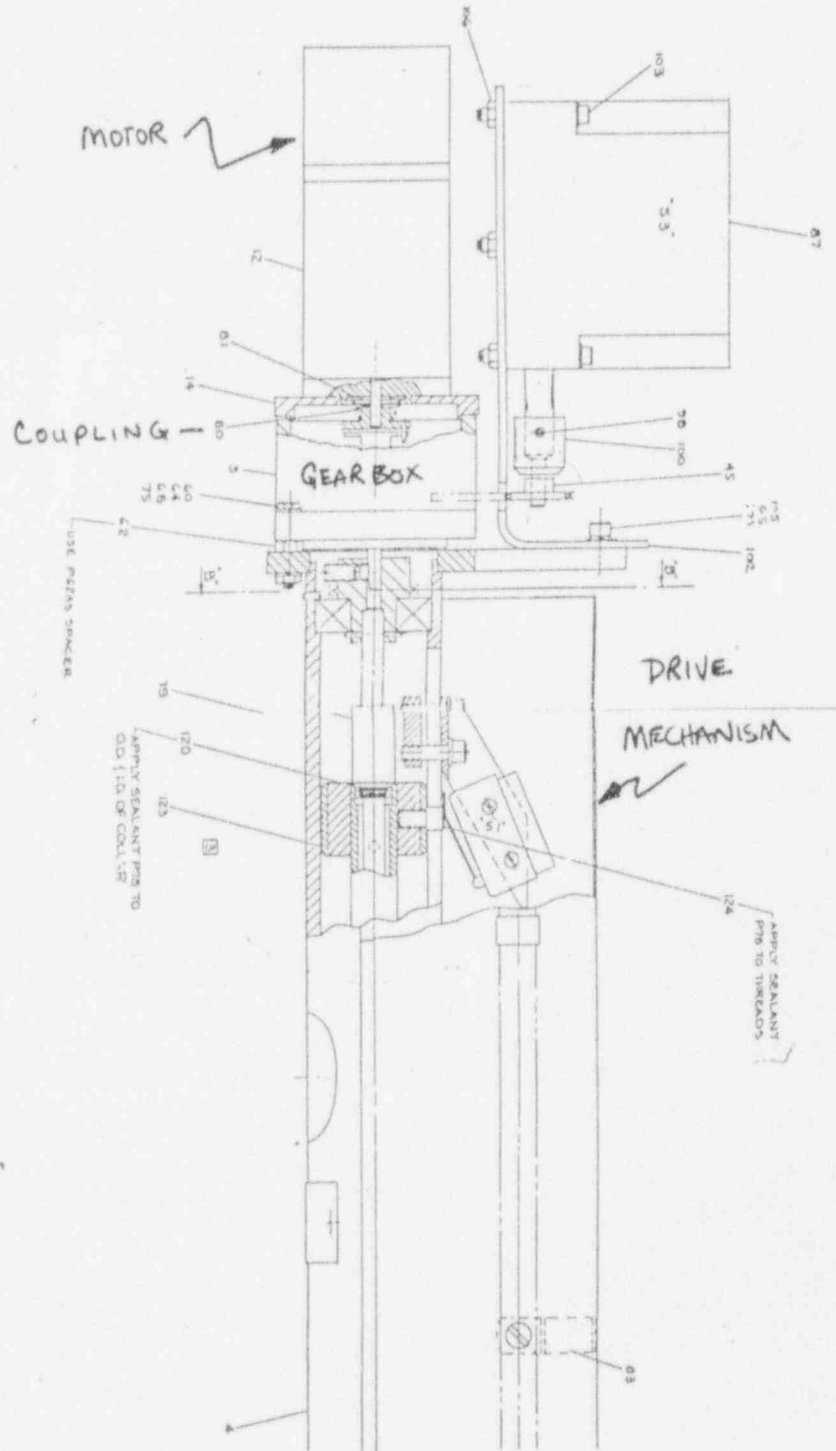
Figure 1

The regulating blade switch was operated while the supervisor going off shift visually inspected the regulating blade drive mechanism. The problem was quickly identified as one loose and one missing set screw in the motor to gearbox coupling. Tightening the loose screw immediately returned the regulating blade mechanism to operability. The missing set screw was replaced with a new one. Regulating blade operability was tested by exercising the mechanism in the manual mode and verifying proper alarm annunciation at the 60% withdrawn position. The reactor was returned to normal operation at 10 MW about ten minutes later. Review of the wide range chart indicated the reactor operated for a total of six to seven minutes with the regulating blade mechanism inoperable. Reactor operation during this time deviates from Technical Specification 3.2.a. and 3.4.c., as stated above.

Part of our evaluation included review of the corrective action taken after the previous similar failure on November 4, 1992, to determine why it had not been more effective. At that time the motor shaft was filed to provide flats for better seating of the set screws. Additionally, Loctite compound was used on the screw threads to reduce the potential for the set screws to come loose. Our review of preventive maintenance performed on the regulating blade since that time indicated that a semi-annual preventive maintenance procedure had been performed on the regulating blade and motor gearbox on two occasions, May 24, 1993, and again on December 6, 1993, as scheduled. The preventive maintenance procedure did not include the use of Loctite compound on the set screws when reassembling the motor and gearbox. We believe the past corrective action would have been effective in preventing the latest failure if it had been implemented into the preventive maintenance procedures.

Immediate corrective action was taken by two shift supervisors who recognized the symptoms as being similar to a previous failure. This immediate action to restore regulating blade operability required tightening of one of two set screws and replacing the second set screw in the motor to gearbox coupling for the regulating blade mechanism.

The preventive maintenance procedures have been revised to specify use of Loctite compound on the set screw threads for regulating blade mechanism maintenance. Additionally, one set screw and the motor shaft have been drilled to accept a pin through the motor shaft to provide a more positive mounting of the coupling to the motor shaft.
