SUBJECT: WAIVER OF CRGR REVIEW OF PROPOSED GENERIC  
LETTER ON SOLENOID-OPERATED VALVE PROBLEMS

SUBJECT: OPERATING EXPERIENCE FEEDBACK REPORT, SOLENOID-OPERATED  
VALVE PROBLEMS AT U.S. REACTORS

This report highlights significant operating events involving observed or potential common-mode failures of solenoid-operated valves (SOVs) in U.S. plants. These events resulted in degradation or malfunction of multiple trains of safety systems as well as of multiple safety systems. On the basis of the evaluation of these events, the Office for Analysis and Evaluation of Operational Data

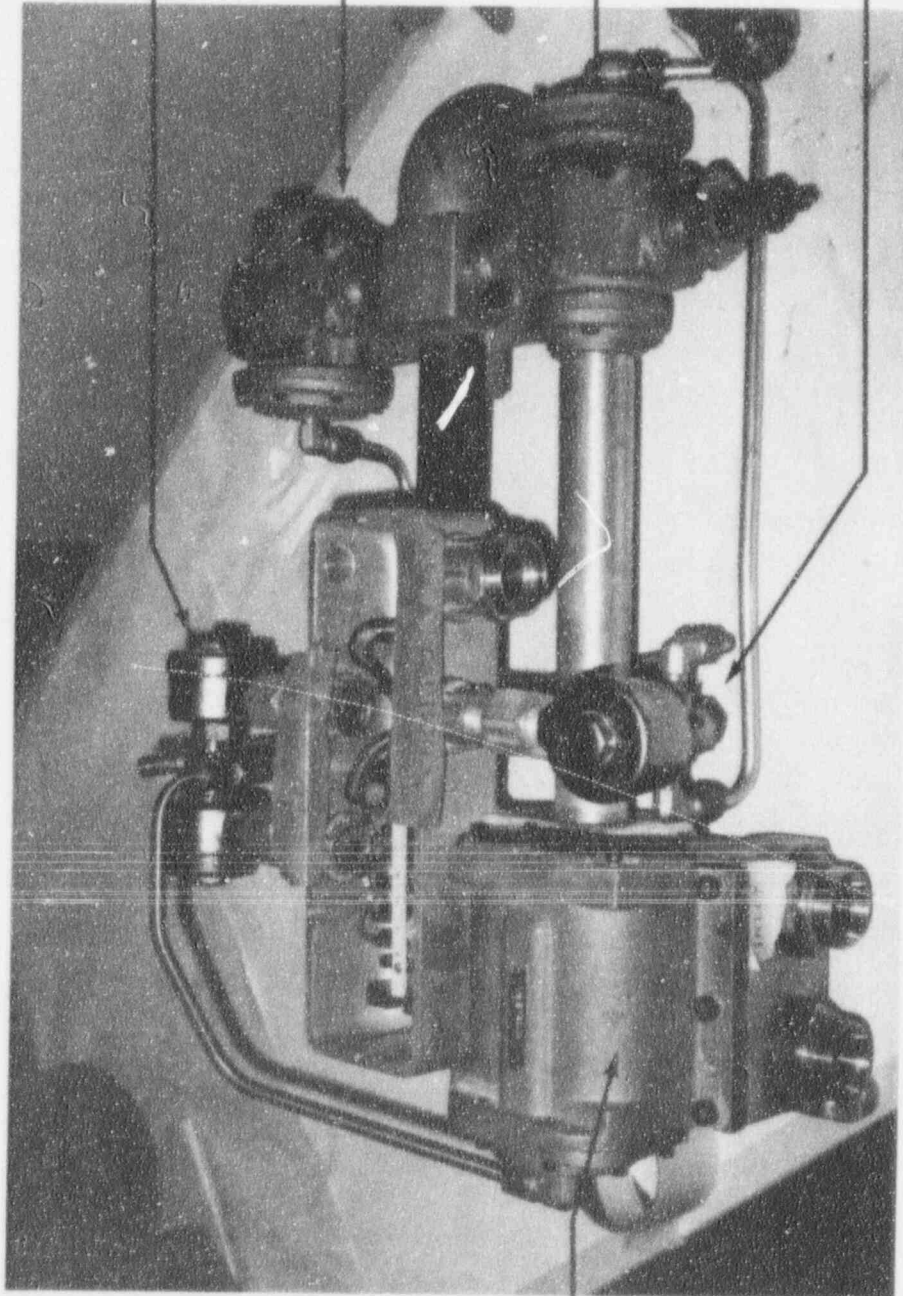
ASCO  
Dual-Coil  
NP8323  
SOV

On August 14, 1989, following a reactor trip, one MSIV (inboard "B" line) failed to close upon demand (Refs. 15, 16, 17). The MSIV did close about 30 minutes later. The failure of the MSIV to close was attributed to the failure of an ASCO dual-coil NP8323 SOV, a piece-part of the MSIV air pack. The licensee's investigation found a piece of EPDM from the SOV's disc on the SOV's outlet port screen. The licensee concluded that the piece had been lodged in the SOV's internals, thereby keeping the SOV from venting control air and hence keeping the MSIV from closing. It is believed that after a piece of the EPDM disc material became dislodged from the internals, the MSIV closed.

Subsequent inspections by the licensee of the eight ASCO dual-coil NP8323 SOVs piloting the MSIVs disclosed that all eight had degraded seats. Initial visual inspection did not reveal the degradations that became apparent under microscopic examination. The EPDM seats of all eight SOVs had cracks. However, on six of them, the raised portion of the seat, formed by the annular impression made by the seat of the exhaust port, was missing. It appeared that six of the eight SOVs had experienced similar sloughing of material from the seat.

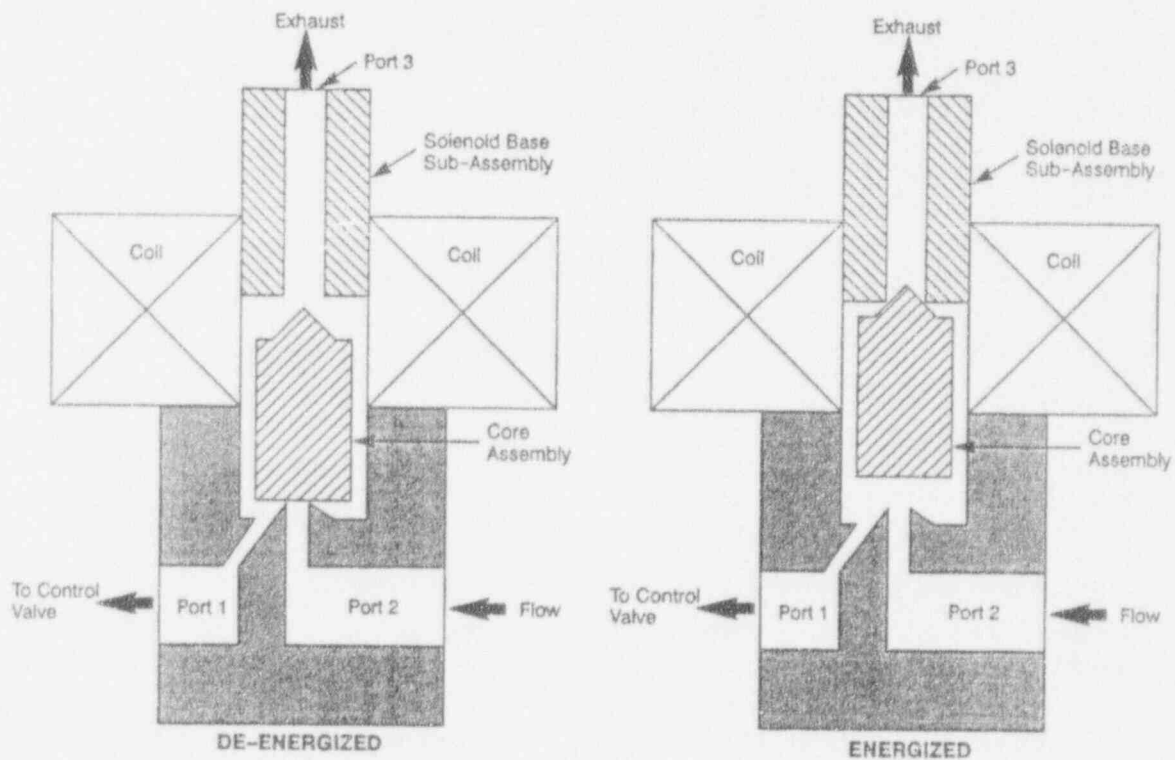
Figure 6 Schematic of a solenoid-operated valve illustrating effect of operating pressure differentials

For many SOVs, the MOPD rating does not appear on the nameplate or in the installation and maintenance instructions. Vendor catalogs need to be consulted to determine the MOPD ratings for the SOVs.

In May 1988, the NRC issued Information Notice 88-24 (Ref. 24), which informed licensees of two SOV failures that were experienced at Kewaunee (Ref. 25) and of the potential for additional failures at Kewaunee and Calvert Cliffs 1 and 2 (Refs. 26-28). Subsequently, several licensees informed the NRC of similar discoveries at their plants, where the potential for overpressurizing SOVs existed, which could prevent the SOVs from performing their safety-related functions. At some plants, the task of verifying the potential for overpressurizing SOVs has been complicated by the fact that documentation is not readily available. For example, Millstone 1 and 2 (Ref. 29) and Crystal River 3 (Ref. 30), have reported that documentation to identify SOVs in containment is not readily available and that containment walkdowns are necessary for their identification.

It is not clear that all licensees have taken appropriate corrective action on the issue of SOV overpressurization as presented in Information Notice 88-24. This concern is predicated on the Crystal River 3 event (Ref. 30) and a followup discussion in which the licensee stated that its review of the potential for SOV overpressurization assumed the proper operation of in-line pressure regulators, it did not address the consequences of pressure regulator failures.\* One of the events described in Information Notice 88-24 involved the discovery at Calvert Cliffs that several safety systems were vulnerable to single failures of pressure regulators in the air supply system.

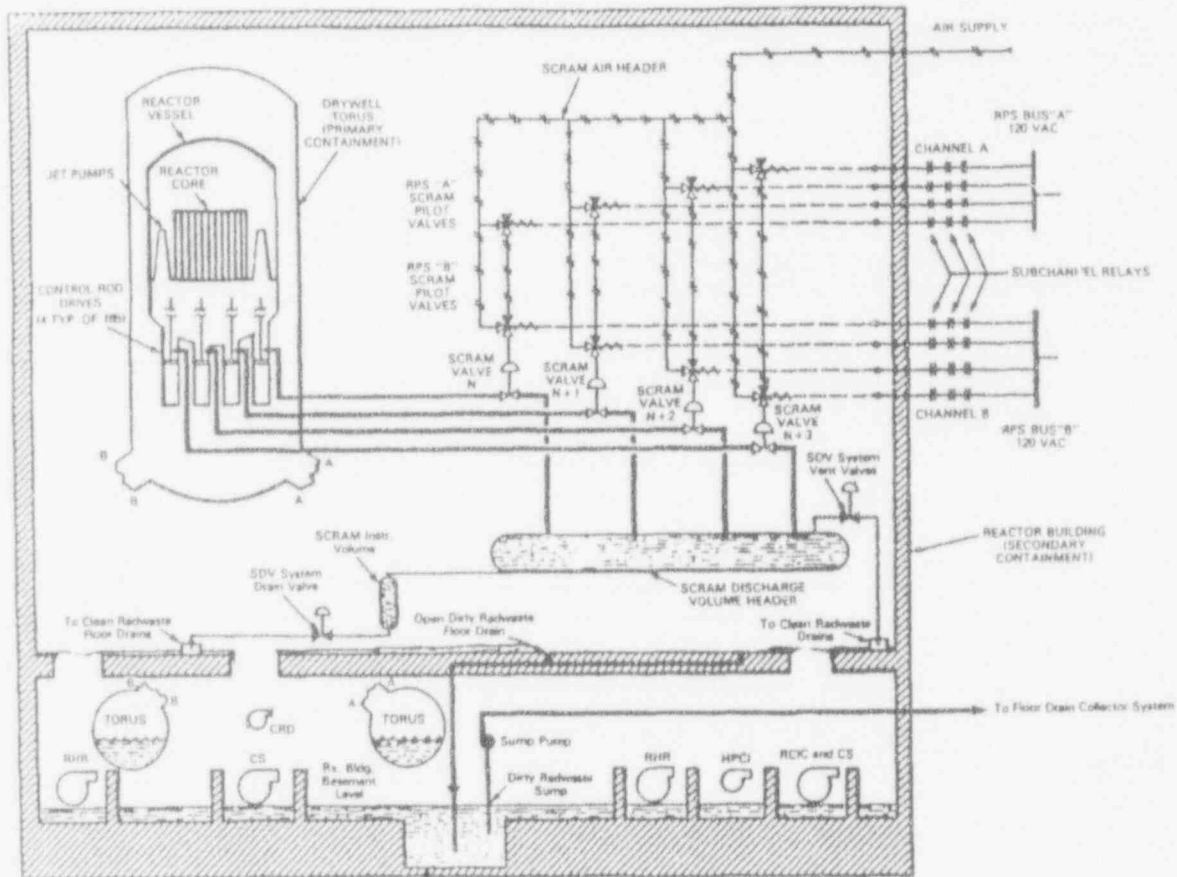
Figure 7 BWR scram system illustrating leakage path outside containment

Discussion with GE has indicated that since Information Notice 85-95 was issued, BWR owners have made improvements in their SDV systems so that there are redundant SDV vent and drain valves at all U.S. BWRs vs. only one vent and one drain valve per SDV header prior to the modification.\* However, it is not certain that all U.S. BWRs have manual handwheel overrides for the SDV vent and drain valves to limit reactor water leakage outside primary containment in the event of a common-mode failure of the SOVs piloting the SDV vent and drain systems.
