Subject: Final Report - DER 82-69  
A 50.55(e) Report Relating to  
Incorrectly Marked Fuses In Control Element Drive Mechanism  
Control System  
File: 83-019-025  
D.4.33.2

FINAL REPORT - DER 82-69  
DEFICIENCY EVALUATION 50.55(e)  
ARIZONA PUBLIC SERVICE COMPANY (APS)  
PVNGS UNIT 1, 2 & 3

Subject: Arizona Nuclear Power Project  
Rochester Instruments Digital  
Isolation Device Assembly  
Manufacturing Deficiency

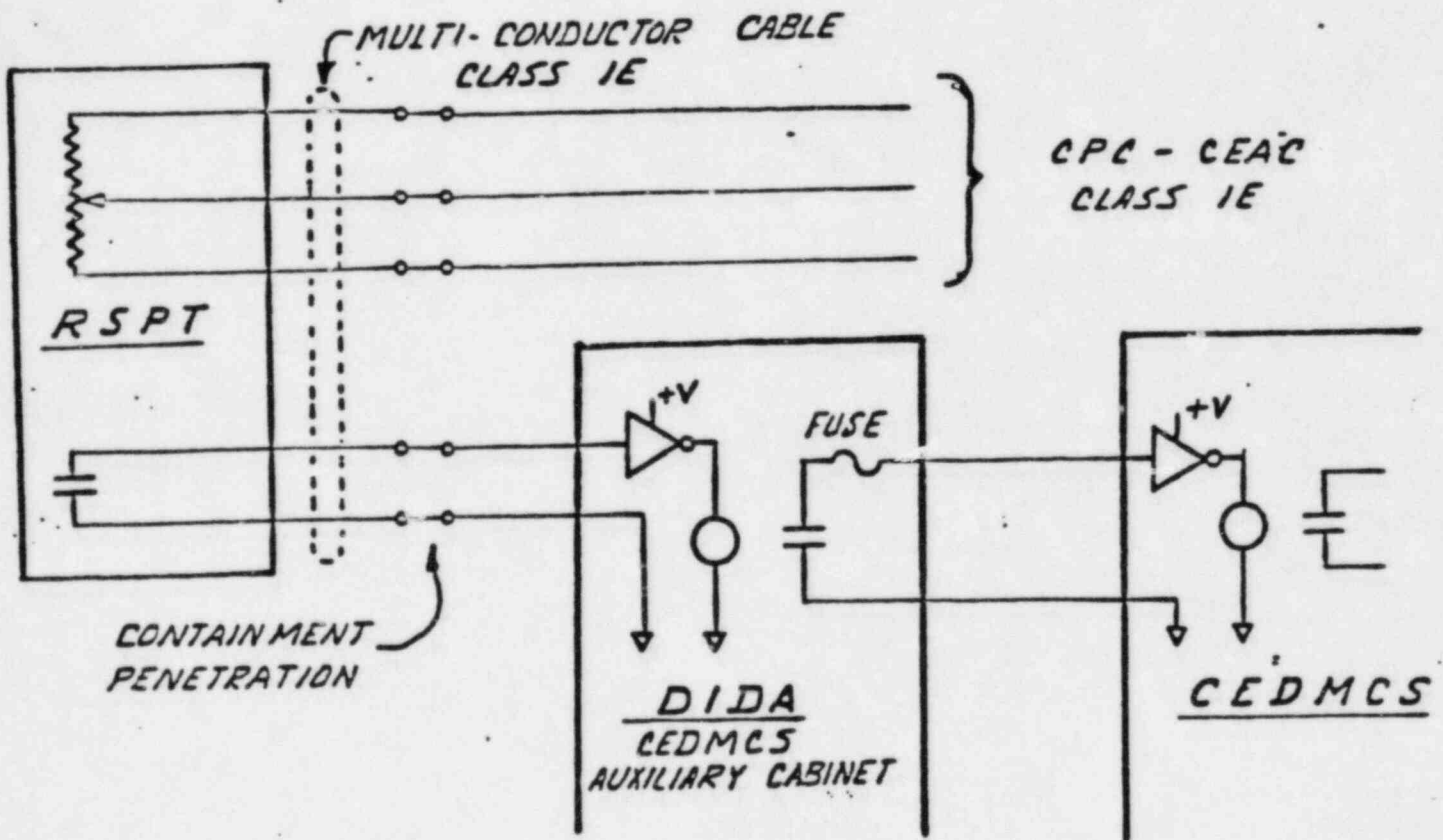
Figure 1

The DIDA provides isolation between the "associated circuits" (RG 1.75 definition) of the Reed Switch Position Transmitters (RSPT) and the non-class 1E Control Element Drive Mechanism Control System. Figure (1) provides a simplified schematic overview of the systems involved and their interconnections.

The DIDA was designed and qualified with one ampere fuses as the fault interruption device. The vendor notified C-E that 7 ampere fuses may have been inadvertently utilized in place of the required 1 ampere fuses through a mis-labeling error by the fuse manufacturer. The DIDA manufacturer (RIS) states that approximately 1-2% of the fuses had been mislabeled.

The 7 ampere fuse would permit a fault current above that for which the DIDA has been analyzed or tested.

Based upon a review of the circuit design, the circuit with the 7 ampere fuse is sufficient to prevent a credible fault from cascading through the DIDA. This judgement is based upon the inherent coil to contact isolation of the relay and upon the fact that sufficient energy would have to be provided to the input side of the relay to breach the isolation of the RSPT contact to the RSPT voltage divider.

The corrective action consists of replacing existing 7 amp fuses in the DIDA with 1 amp fuses.
