**Commonwealth Edison**  
 Dresden Nuclear Power Station  
 6500 North Dresden Road  
 Morris, Illinois 60450  
 Telephone 815/942-2920

Subject: Dresden Nuclear Power Station Unit 1  
 May 8, 1994 1A Cleanup Storage Tank Event  
 NRC Docket Number 50-010

**TITLE (4)**  
50,000 Gallons of Unit 1 Contaminated Demineralized Water Released to Ground Water

Subject: Recommendations from the Contaminated Demineralized  
Water Line Leak in the Unit 1 Radwaste Area

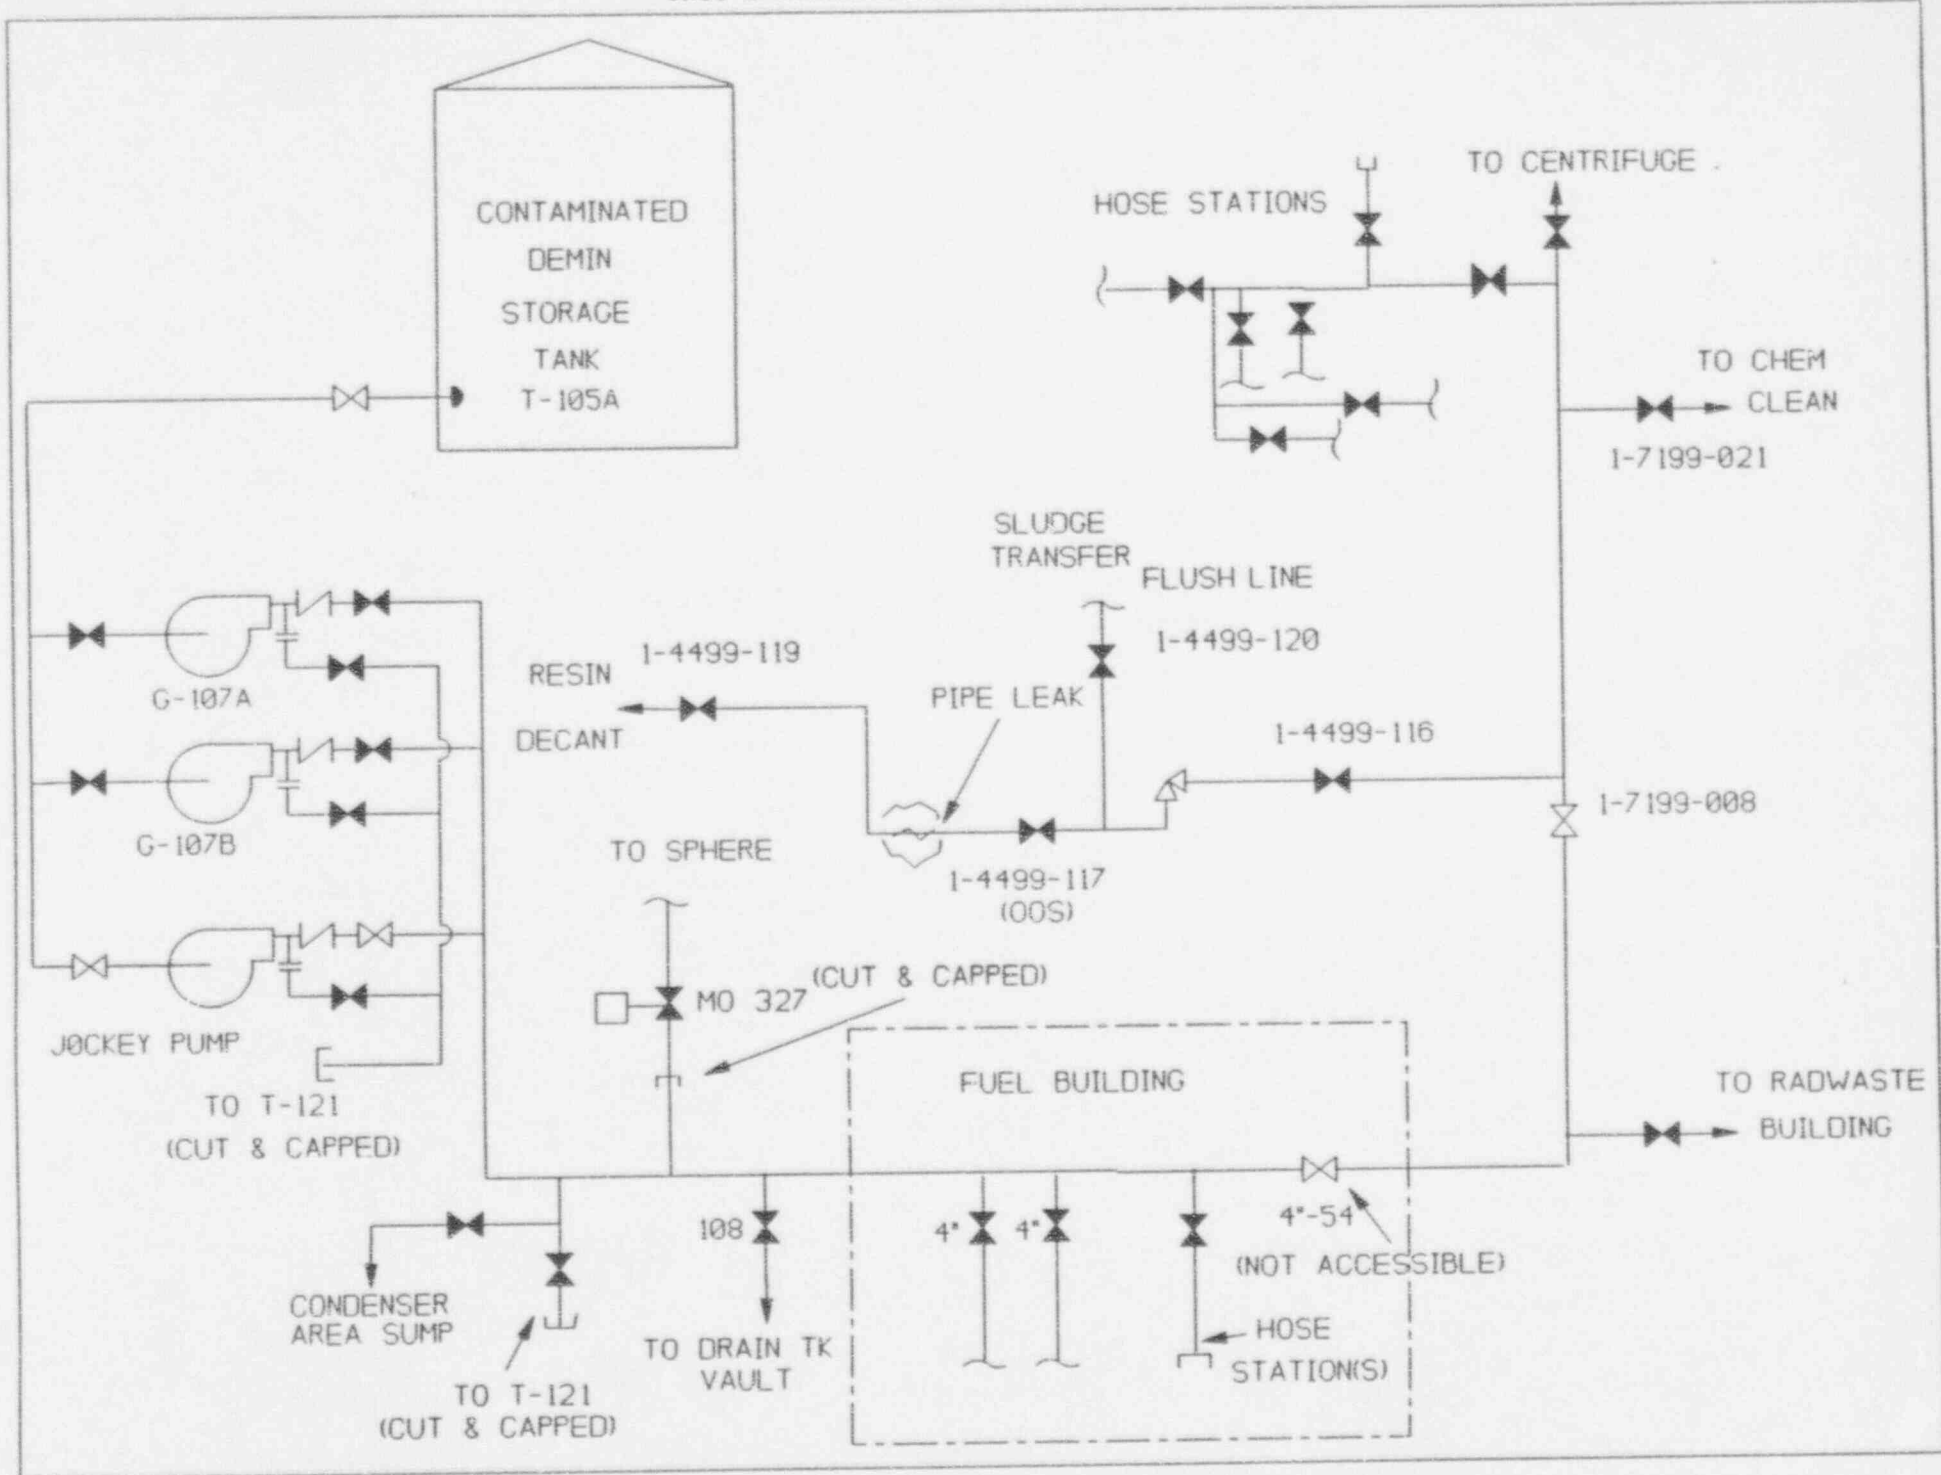
ATTACHMENT A  
EVENT CAUSAL CHART  
ROOT CAUSE ANALYSIS

This report is submitted voluntarily in accordance with 10CFR50.73(a)(1). The root cause of this failure is that the pipe coating failed and exposed the 2 inch schedule 80 carbon steel pipe to ground water and impurities, which lead to localized outside diameter initiated corrosion. Based on the material removed from the soil while digging it is believed that a rock came in contact with the pipe coating and caused this failure.

A root cause of the event was a management deficiency, in that multiple operating crews observed the decrease in CST level without recognizing its significance or taking action.

5. Institutionalize proper backfill requirements and practices. The pipe failure was due to localized corrosion at the two o'clock position on the pipe. It is strongly suspected that this is the result of a localized pipe coating failure as a result of rock/stone in the backfill in contact with the pipe surface. The failure of the coating was the defect which "opened the door" to allow corrosion of the line. It is understood that General Work Specification, K-4080, discusses the requirements for backfilling of underground facilities (section 0223). This event should be used as a lessons learned for construction and maintenance personnel who perform backfill activities (Wheeler/Pape).
