Northeast
Nuclear Energy

LICENSEE EVENT REPORT (LER)

| FACILITY NAME (1) Millstone Nuclear Power Station Unit 3 | DOCKET NUMBER (2) 05000423 | PAGE (3) 1 OF 6 |

TITLE (4)
Westinghouse 7300 Process Control System Surveillance Deficiency Due to Program Failure

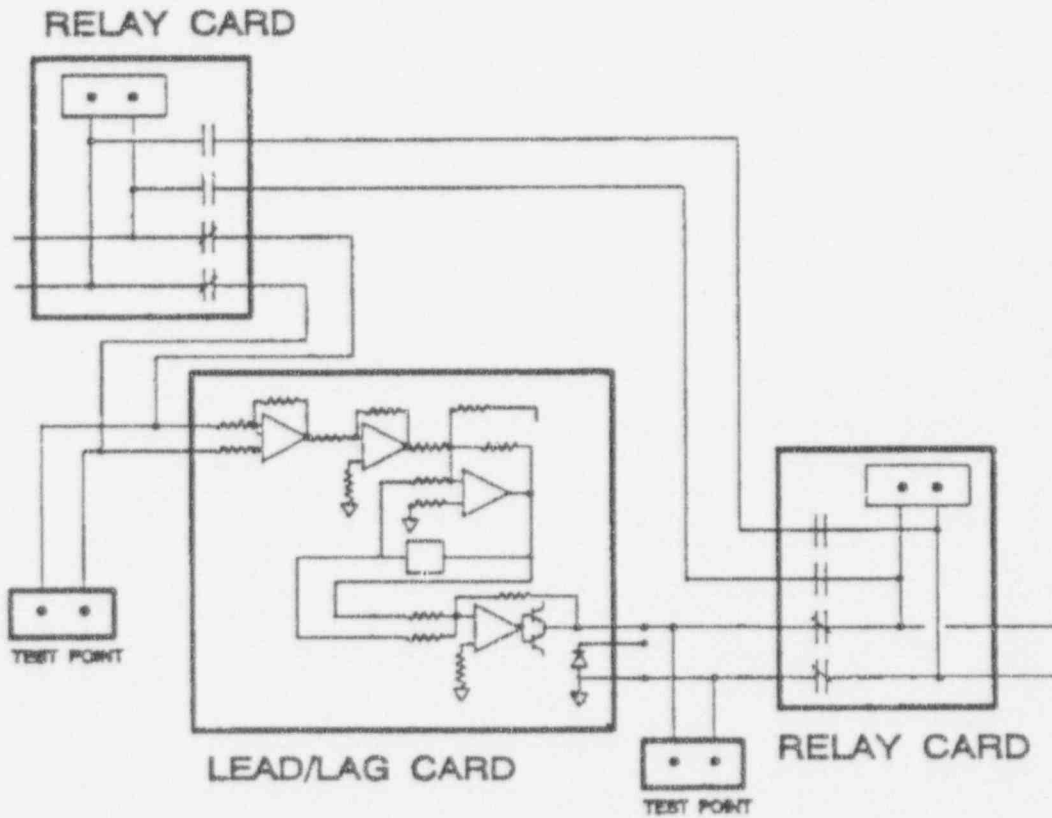
Figure 1
Lead/Lag Modification

During plant construction, I&C personnel recommended a change to the Westinghouse 7300 Process and Controls System test method for lead/lag compensated channels. The Westinghouse approved design provides a bypass of the lead/lag (NLL) cards, using a relay (Westinghouse NRC8 card) on both sides of the NLL card (see attached Figure 1). The design change improved the surveillance testing of the circuits by allowing the I&C technicians to bypass the NLL cards for dynamic testing to allow comparator trip testing. The NRC8 cards are enabled only when the instrument loop test logic is met. This prevents the possibility of inadvertently bypassing an NLL card in an operable instrument loop.

Technical Specification 4.3.2.1 requires that overlap testing be performed as part of a channel calibration at least once every 18 months. The channel calibration procedures did not verify closure of the normally closed relay contacts. These relay contacts are used to restore the bypassed NLL cards in the Westinghouse 7300 Process Protection sets, which provide input to the SSPS (see attached Figure 1).

The root cause of the condition was a program failure which resulted in a procedure deficiency. When the Westinghouse approved design was made during plant construction, emphasis was placed on safely placing a lead/lag compensated circuit into test configuration. The possibility of a normally closed NRC8 contact failure when returning the NLL bypass to the normal alignment was not considered.

To prevent recurrence the surveillance procedures will be modified to verify bypass relay card contact closure. The quarterly analog channel operational test procedures and the 18-month channel calibration procedures will be modified to require continuity verification of the relay card contacts for the involved protection channels.
