Northeast  
Nuclear Energy

Reference: Facility Operating License No. DPR-65  
Docket No. 50-336  
Licensee Event Report 94-002-02

# LICENSEE EVENT REPORT (LER)

TITLE (4)  
Failure to Meet Acceptable Isolation For Class 1E Protection Instrument Channels

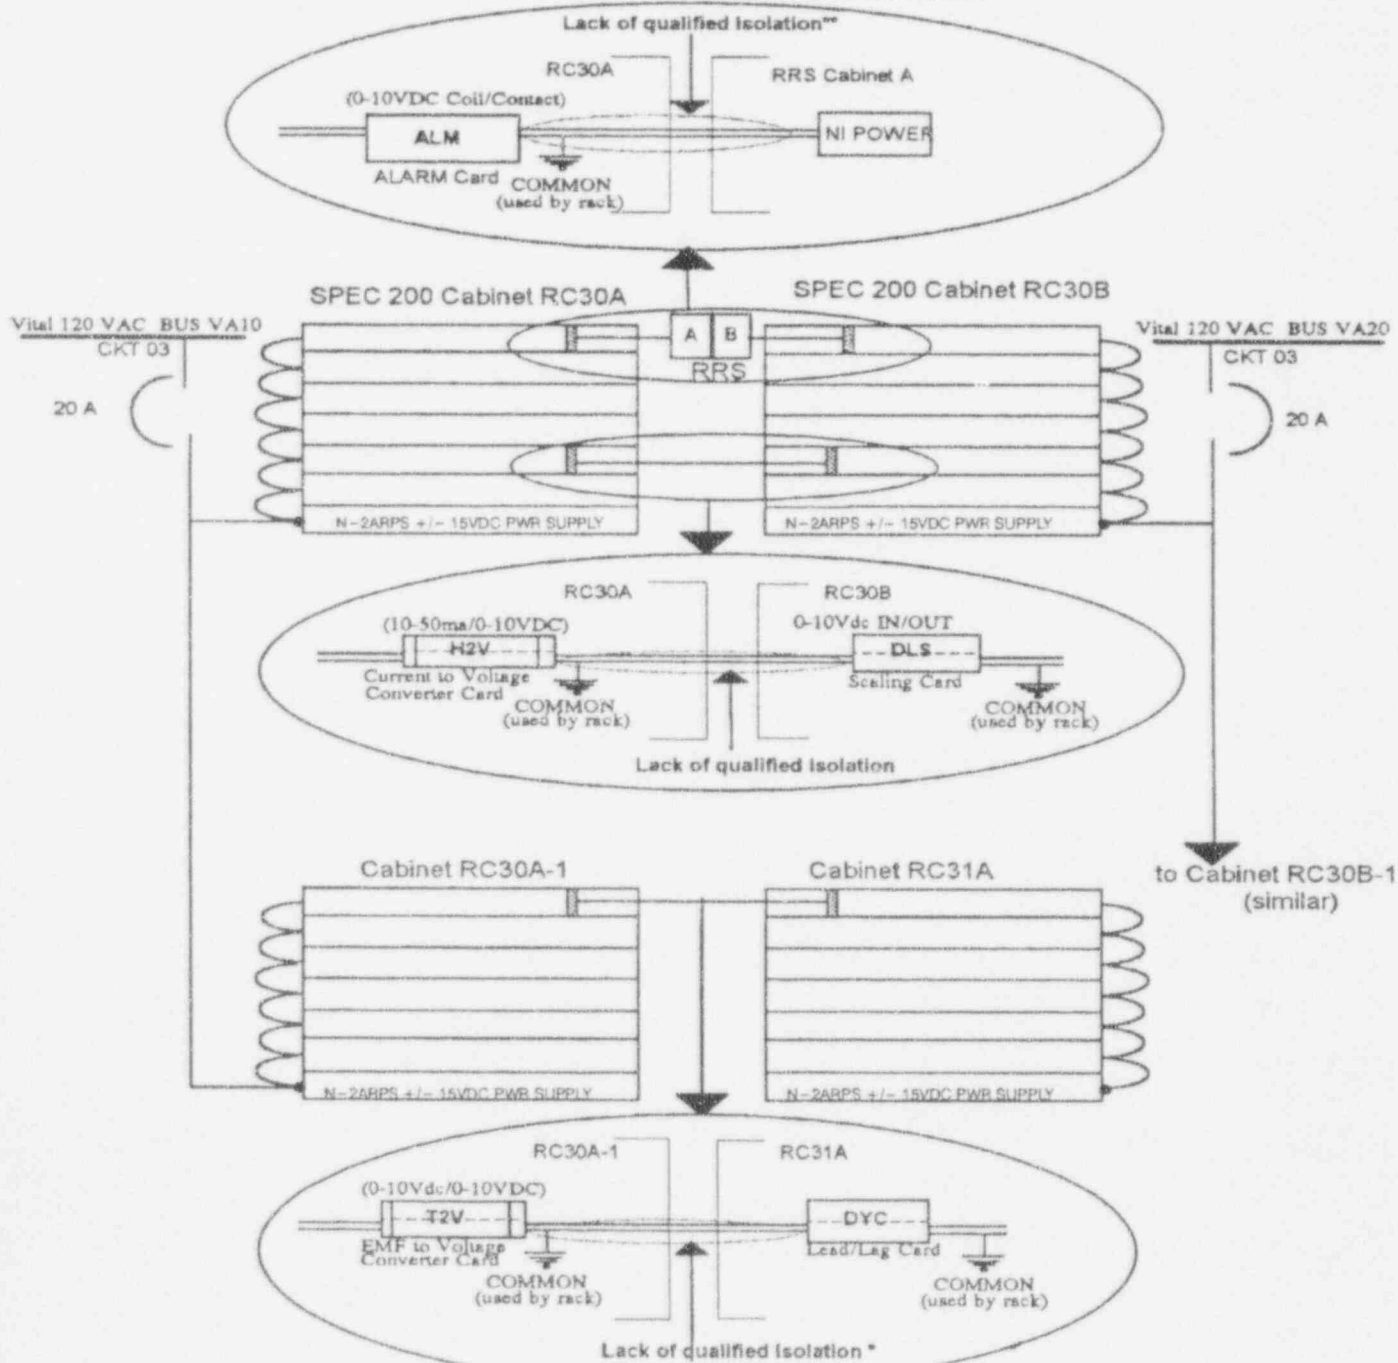
The wiring permits the pressurizer (0-10Vdc) low voltage control signal to pass from cabinet RC30A to RC30B via an isolated current to voltage (H2V) converter card. The common leg of both cabinets became connected due to the wiring configuration of the H2V card (refer to the attached figure). If a catastrophic fault in the form of a voltage surge from the 120VAC feed or +15/-15 Vdc power supply, or a ground fault were to occur, the fault could affect both cabinets. Each cabinet power supply also feeds an independent channel of safety related (Class 1E) reactor protection system (RPS)/Engineered Safety Features Actuation System (ESFAS) instrument loop. Therefore, the wiring deficiency could affect the safety related instrument loops if the fault were to cause failures of the +15/-15 Vdc power supply units in each cabinet.

At approximately 0900 hours on March 10, 1994, during the follow-up instrument channel isolation review, it was determined that inadequate isolation exists between the 1E cold leg temperature (Tcold) inputs into the non-1E feedwater regulating system single element control. The concern is that a fault in the non-safety grade Spec 200 instrument cabinets, RC31A or RC31B, could propagate to, and compromise the safety grade Spec 200 protection instrument cabinets of RC30A-1 or RC30B-1 as a result of the inadequate isolation scheme (refer to the attached figure).

The wiring permits the (0-10Vdc) low voltage Tcold control signal to pass from cabinet RC30A-1 (and RC30B-1) to non-1E cabinet RC31A (and RC31B) via an isolated "EMF to voltage" converter (T2V) card. The common leg of the 1E and non 1E cabinets become connected due to the output wiring of the T2V card (which only provides input wiring isolation).

The wiring permits the low voltage RRS cabinet NI signal for nominal 20% power permissive for AMSAC actuation in the event of a high pressurizer pressure signal to pass to 1E cabinet RC30A (and RC30B) via an alarm relay (ALM) card. The common leg of the 1E and non-1E cabinets become connected due to the wiring of the NI input to the coil side of the ALM card. The coil of the ALM card is powered by the Spec 200 power supply.

\*\*NOTE: Similar for RRS Cabinet NI to RC30B interface

\*NOTE: Similar for RC30B-1 to RC31B interface

As corrective action, design changes have been completed to provide isolation for the two pressurizer pressure channels, Tcold inputs to single element feedwater control, and NI inputs to AMSAC in order to maintain a design basis consistent with the FSAR description.
