Subject: Three Mile Island Nuclear Station, Unit 2 (TMI-2)
Operating License No. DPR-73
Docket No. 50-320
TMI-2 Cork Seam

TMI-2 CORK SEAM MODIFICATIONS

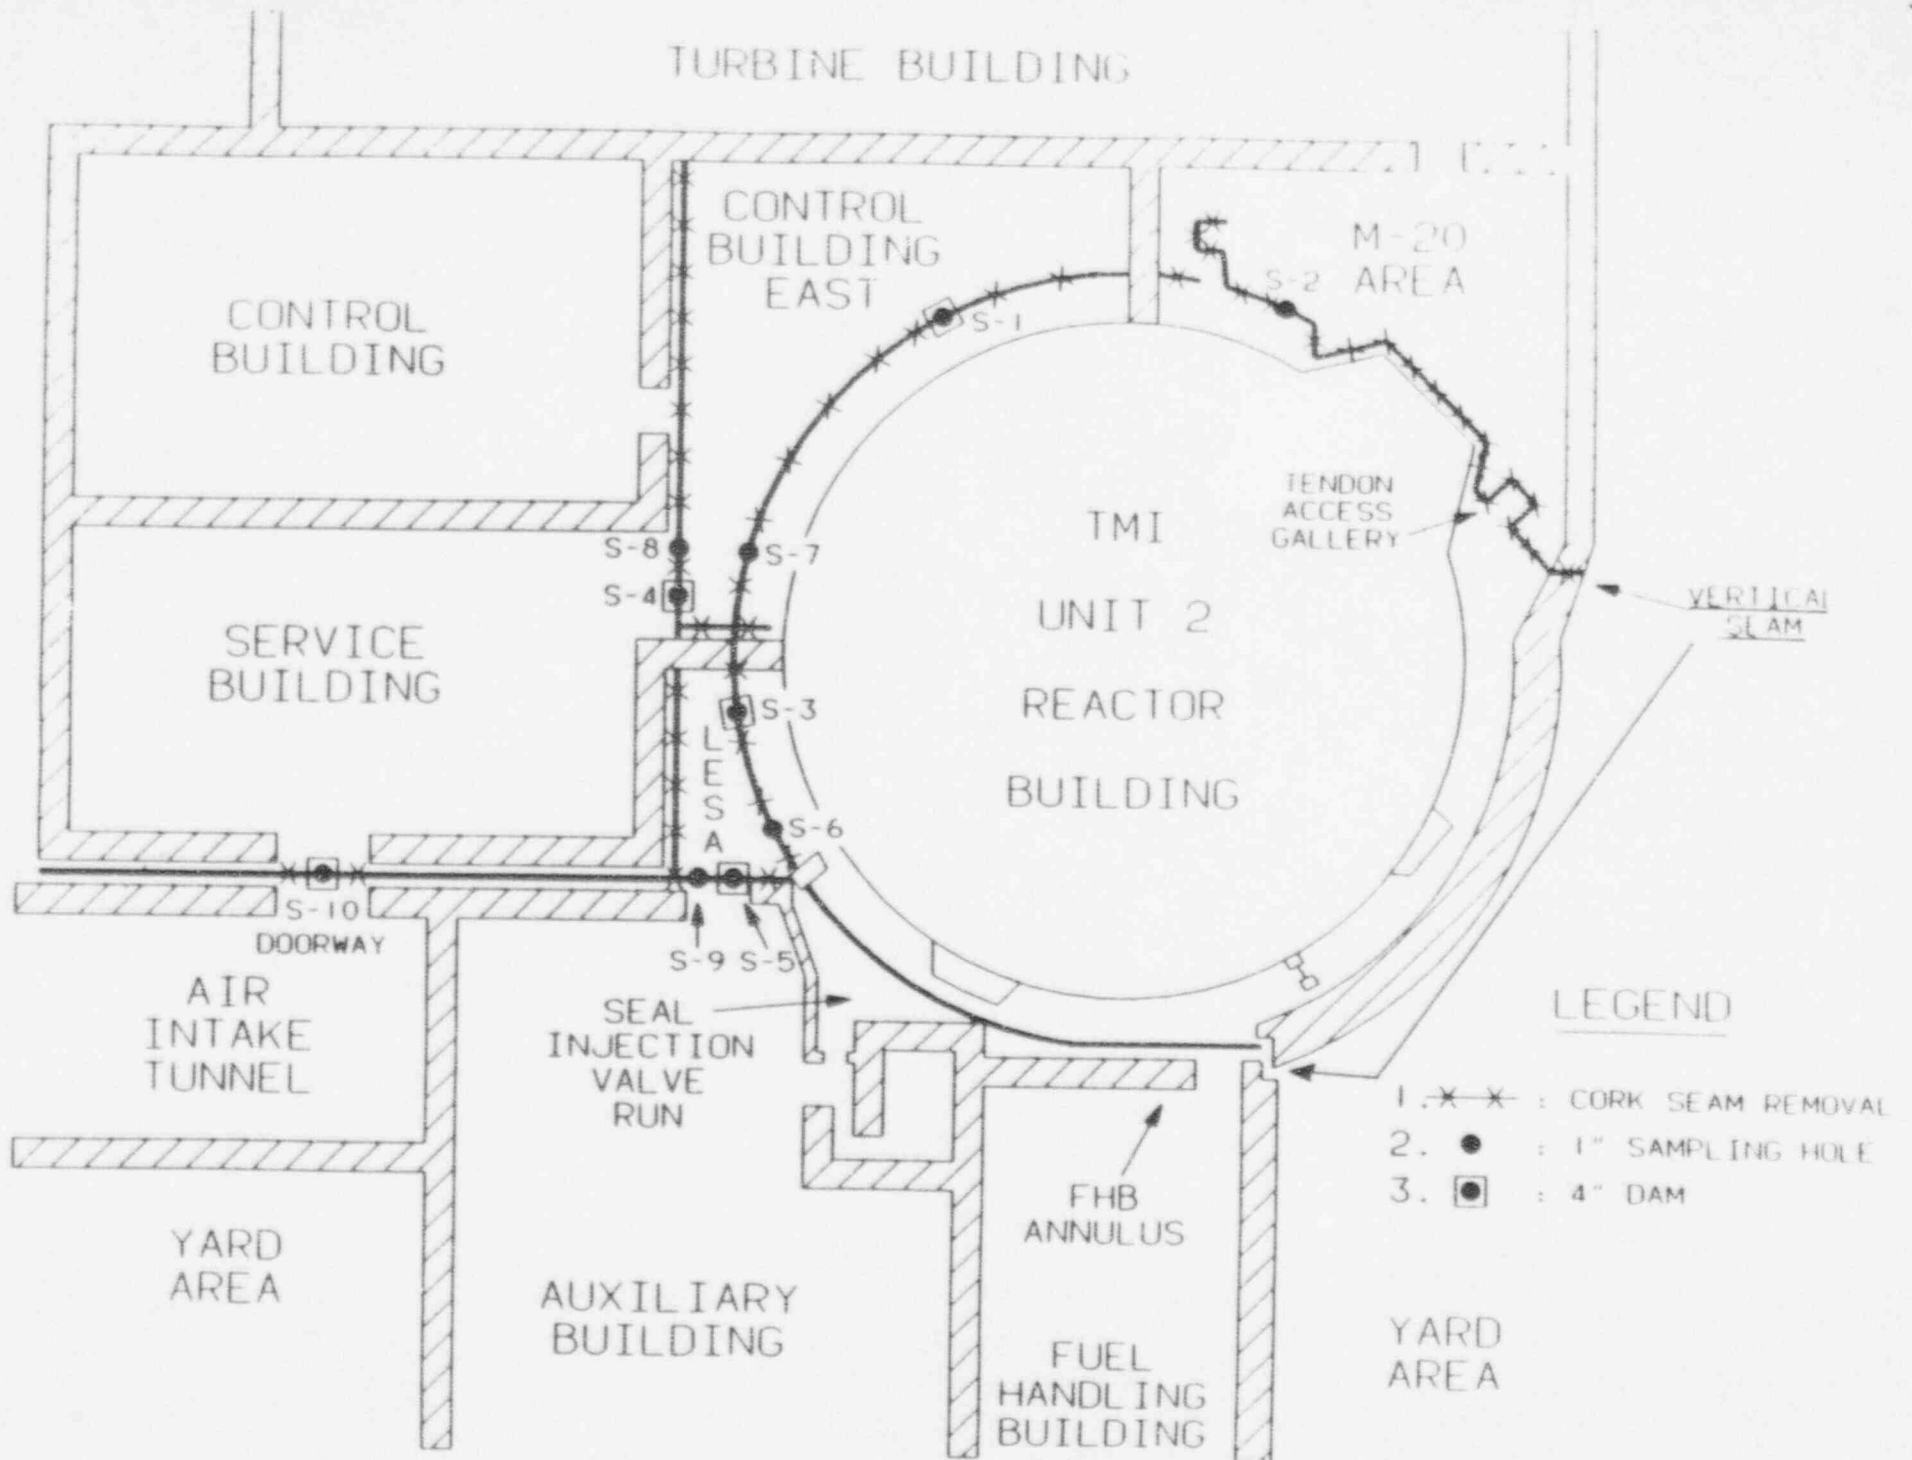
FIG 1: GENERAL ARRANGEMENT OF THE CORK SEAM AREA

The TMI-2 cork seam is a construction joint between the various major facility structures. Its purpose is to allow for differential expansion between the adjoining building structures and to attenuate any vibration or movement that may occur during a seismic event. The seam consists of a 1 to 2 inch space between adjacent concrete floor/base mat slabs. The gap is filled with a sheet cork material that was placed in position during the concrete pour. The bottom of the seam is sealed to prevent groundwater intrusion from below by a PVC plastic water stop that bridges the adjacent slabs at a depth of about 60 inches below the top of the slab (42 inches in some areas). A plan view showing the extent of the cork seam is in the attached Figure 1, and a cross-section showing the details of a typical portion of the cork seam is in Figure 2.

Modifications have been made to the cork seam to allow periodic monitoring of the water levels in the joint, to permit periodic water removal, and to prevent water and contamination migration within the cork filled joint. Figure 1 shows the locations where the cork seam was penetrated and modifications performed. At locations S-2, S-6, S-7, S-8, and S-9, 1 inch diameter holes were drilled into the cork seam to a depth of about 1 inch above the PVC water stop. A perforated tube was inserted into these monitoring holes and acts much like a conventional well-point in providing a means of pumping accumulated water out of the seam in the vicinity. Also, the monitor pipes have been fitted with bubbler devices that allow measuring of the water level in the holes.

At locations S-1, S-3, S-4, S-5, and S-10, a 4 inch diameter hole was core bored to penetrate the cork and the adjacent concrete slab on both sides of the seam. These holes extend down to the surface of the PVC water stop. When these holes were drilled, the bottom was carefully probed with a blunt instrument to verify that the hole had actually reached the water stop and to verify that the water stop had not been breached and the material was still pliable. Where possible, the water stop was visually inspected. The hole was then filled with a moisture activated expandable polyurethane foam material that will bond well with both the concrete and the water stop material. These locations serve as dams that will block water migration within the cork seam.
