U. S. NUCLEAR REGULATORY COMMISSION  
REGION I

Report No. 50-387/83-03  
50-388/83-01  
Docket No. 50-387 (CAT B) 50-388 (CAT A)  
NPF-14  
License No. CPPR-102 Priority -- Category --

Facility Name: Susquehanna Steam Electric Station

Inspection Summary: January 12 - March 8, 1983 (Combined Reports 50-387/83-03, 50-388/83-01).

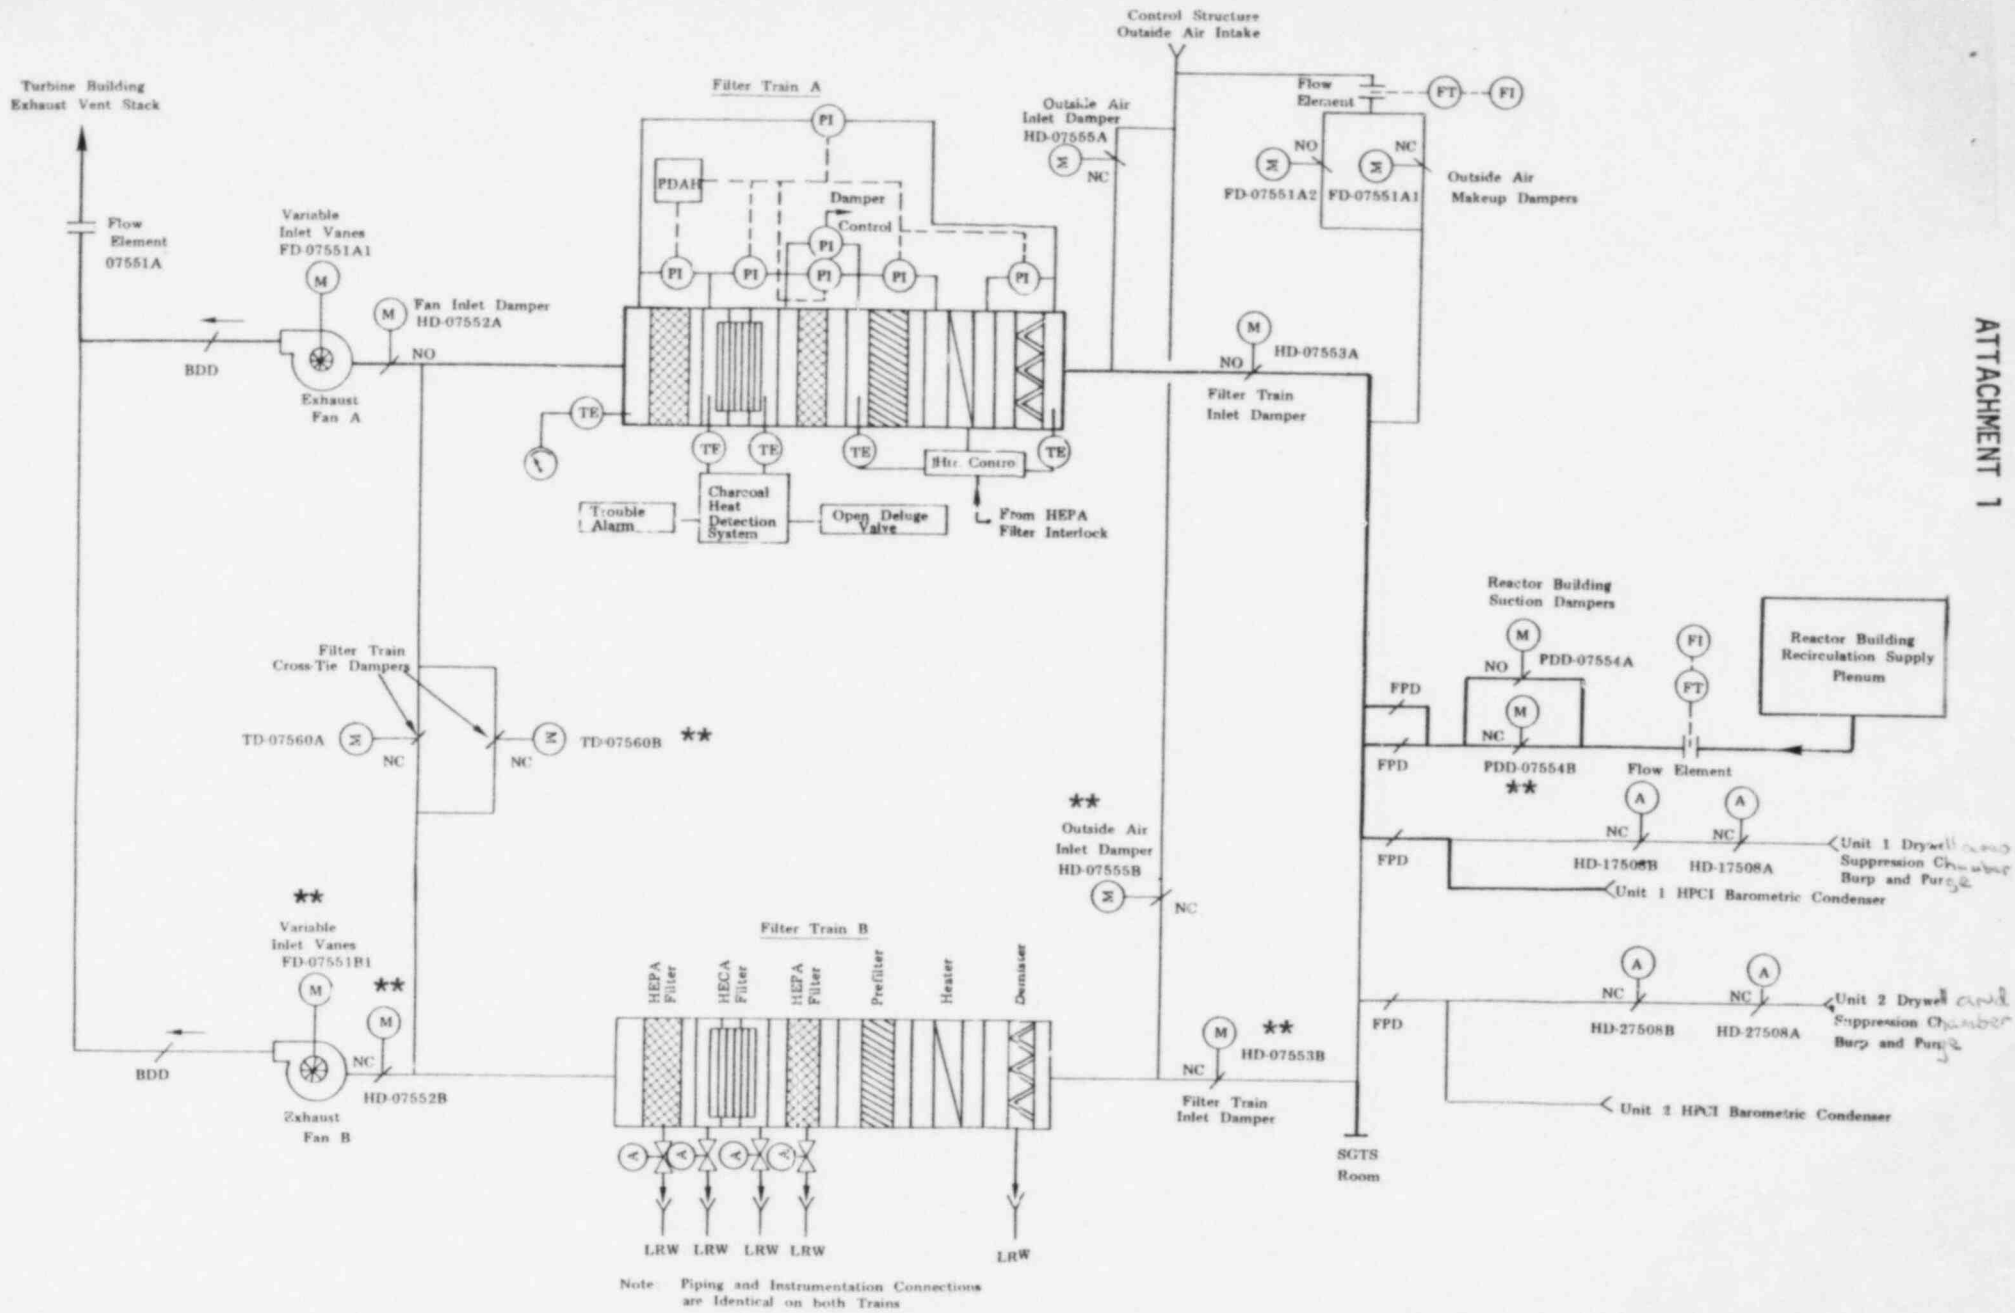
**STANDBY GAS TREATMENT SYSTEM SIMPLIFIED SCHEMATIC**

Contrary to the above, from February 28, 1983 at 11:25 a.m., until March 1, 1983 at 12:10 p.m., with the unit in Operational Condition 1 (Power Operation), both subsystems of the SGTS were inoperable such that the Limiting Condition of Operation 3.6.5.3 and associated Action Statement were not met and no action was taken to place the unit in Operational Condition 4 (Cold Shutdown) as required.

Contrary to Administrative Procedure AD-QA-306, Section 6.4 and Attachment B, the review performed by the Unit Supervisor was inadequate since it did not prevent the removal of both subsystems of the SGTS.

Two factors contributed to the operator's inadequate review of the blocking. First, the design drawings were not intended to facilitate blocking reviews by an operator, and the review process was very complex (generation of a controlled set of electrical load lists is in process but not completed); second, the series of drawings needed for an adequate review were not all available in the Control Room. The inspectors needed the following drawings to determine what loads would be lost when the breakers were opened:

\*\* These "B" train dampers and components receive power through circuit breaker No. 11 on panel 1Y246. "A" train disabled for maintenance.
