A METALLOGRAPHIC INVESTIGATION OF A  
TYPE 304 STAINLESS STEEL SCHEDULE 80 PIPE

POWER AUTHORITY OF THE STATE OF NEW YORK  
JAMES A. FITZPATRICK NUCLEAR POWER PLANT

March 25, 1982

BATTELLE  
Columbus Division  
505 King Avenue  
Columbus, Ohio 43201

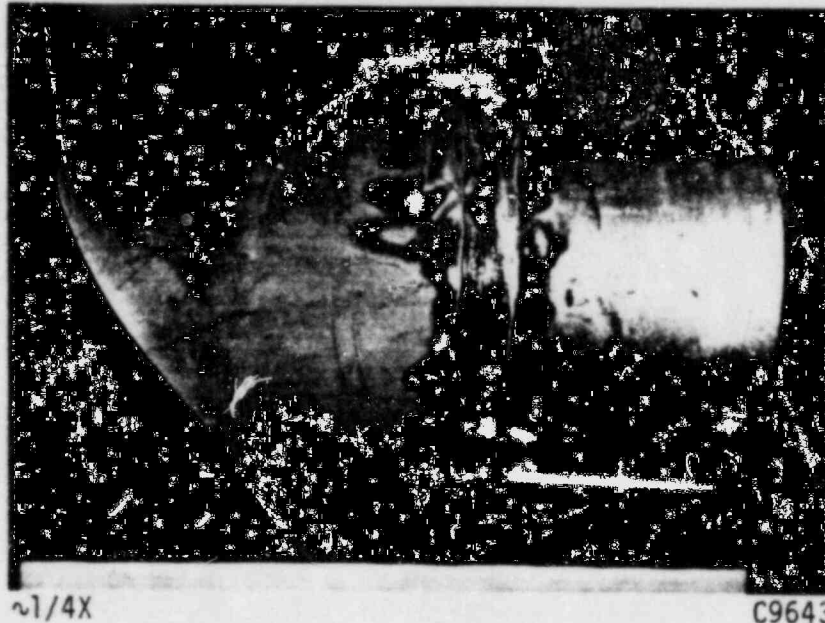
The photograph in Figure 1 shows a portion of the Type 304 stainless steel pipe that contained the linear indication detected by PASNY, that was submitted to BCL for the investigation. That portion of the pipe was approximately 15 inches long; it included about 7 inches of the straight-pipe section and about 7 inches of the elbow section that were joined together by the circumferential weld.

FIGURE 1. PORTION OF THE TYPE 304 STAINLESS STEEL PIPE FROM THE REACTOR CORE-SPRAY SYSTEM THAT CONTAINED THE LINEAR INDICATION DETECTED ULTRASONICALLY

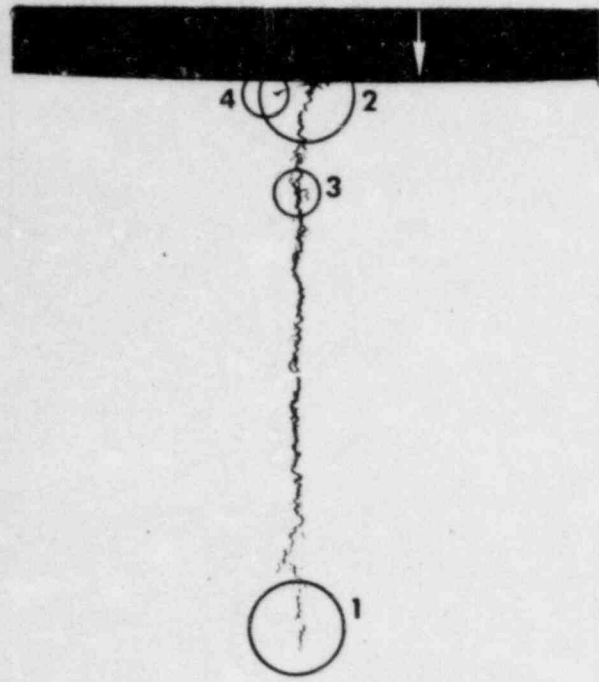
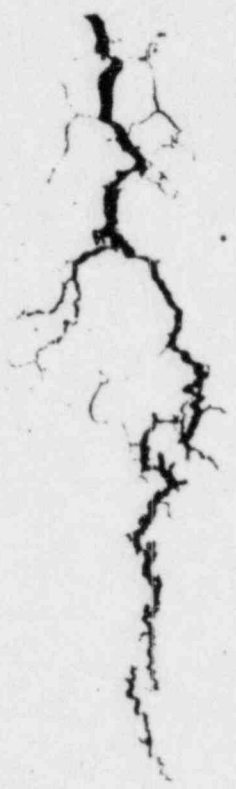
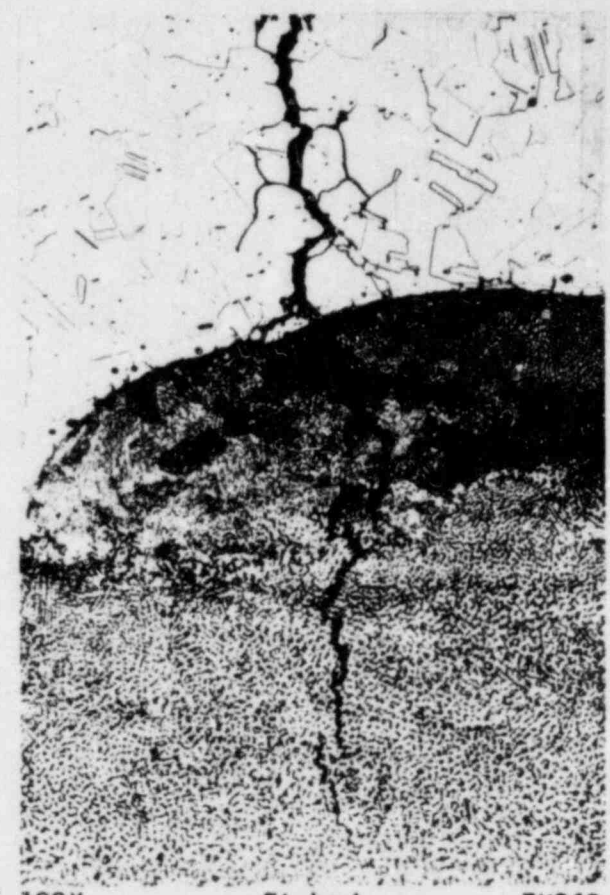
The metallographic cross section of the linear defect is shown in the as-polished condition in Figure 5a. The cross section revealed the presence of a crack that was perpendicular to the surface of the pipe. The crack extended from a location about 0.010 inch below the inside pipe surface for a distance through the pipe wall of about 0.41 inch. The wall thickness of the pipe at that cross section was about 0.53 inch; thus, the crack extended through approximately 77 percent of the pipe wall. As is shown in Figure 5c, the crack propagated into weld metal for a distance of about 0.027 inch and then terminated. In the weld heat-affected zone, crack propagation occurred entirely along the boundaries of equiaxed austenite grains; in the fusion zone, the crack continued to propagate along the austenite grain boundaries of the weld metal. Intergranular branching cracks were numerous along the entire length of the crack, although fewer branching cracks were observed within the weld metal. It appeared as though crack propagation may have been arrested by the weld metal.

FIGURE 5. CRACK OBSERVED IN THE CROSS SECTION THROUGH THE LINEAR SURFACE DEFECT MARKED BY ARROW 1 IN FIGURE 3

occurred. The crack was nearly filled with the corrosion product near, and at the tip (see Figure 5b).

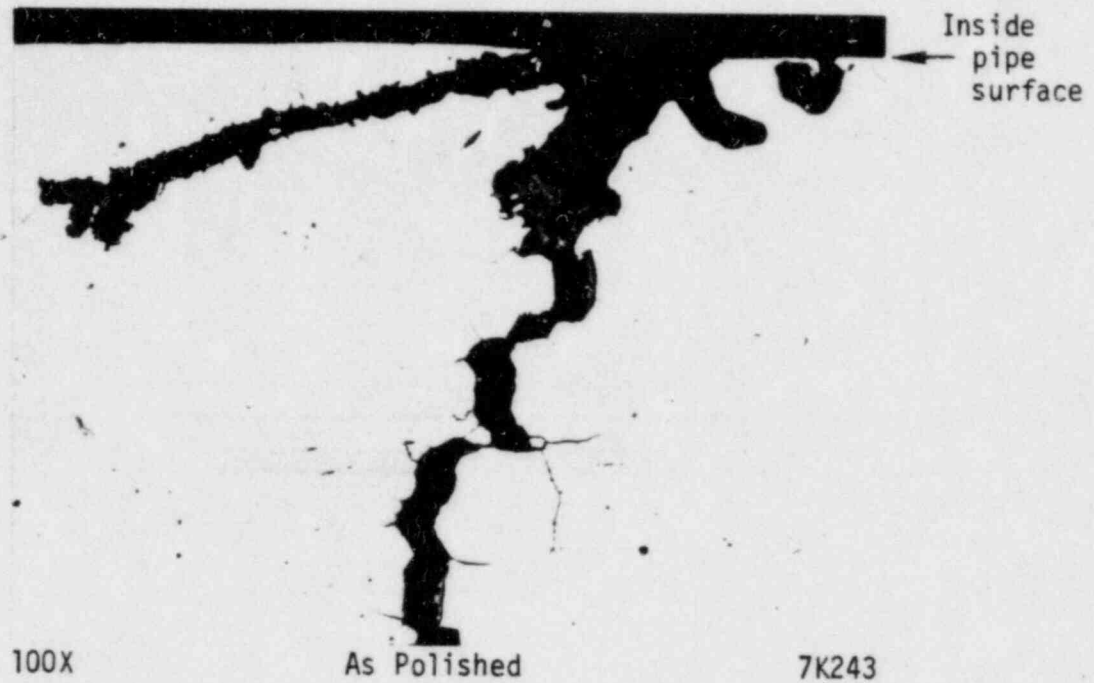
The as-polished appearance of the linear defect in the inside surface of the pipe in this cross section is shown in Figure 6, which is Circled Area 2 in Figure 5a at a higher magnification. The surface defect

FIGURE 6. CROSS SECTION OF THE LINEAR DEFECT  
WITHIN CIRCLED AREA 2 IN FIGURE 5a

at which the crack initiated seemed to extend to a depth of about 0.010 inch below the surface and did not appear to be an intergranular crack. Rather than exhibiting characteristics of an intergranular crack, the defect exhibited characteristics similar to those generally observed for seams or laps in billet surfaces. For example, an apparent overlap, or fold, of surface metal that contained what appears to be oxide at the interface is evident in Figure 6 to the left of the part that showed on the pipe surface. The start of intergranular cracking was apparent only at a depth of about 0.010 inch (the depth of the lap and associated pit) below the surface.

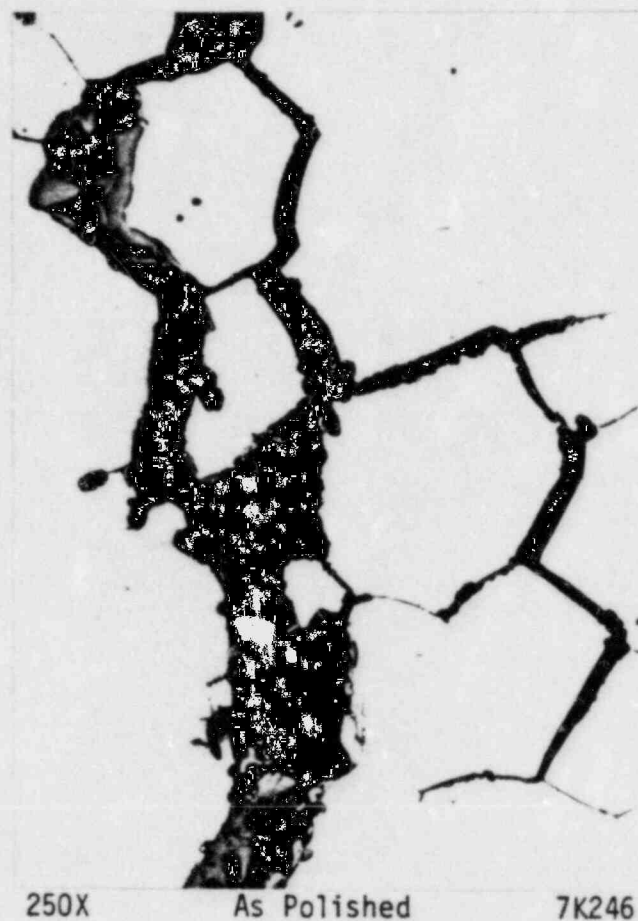
A typical region of the intergranular crack is shown in Figure 7. That region is within Circled Area 3 in Figure 5a. A dense nonmetallic corrosion product that can be seen in Figure 7 was observed on the principal crack surfaces and in adjacent grain boundaries where crack branching

FIGURE 7. TYPICAL REGION OF THE INTERGRANULAR CRACK THAT WAS LOCATED WITHIN CIRCLED AREA 3 IN FIGURE 5a

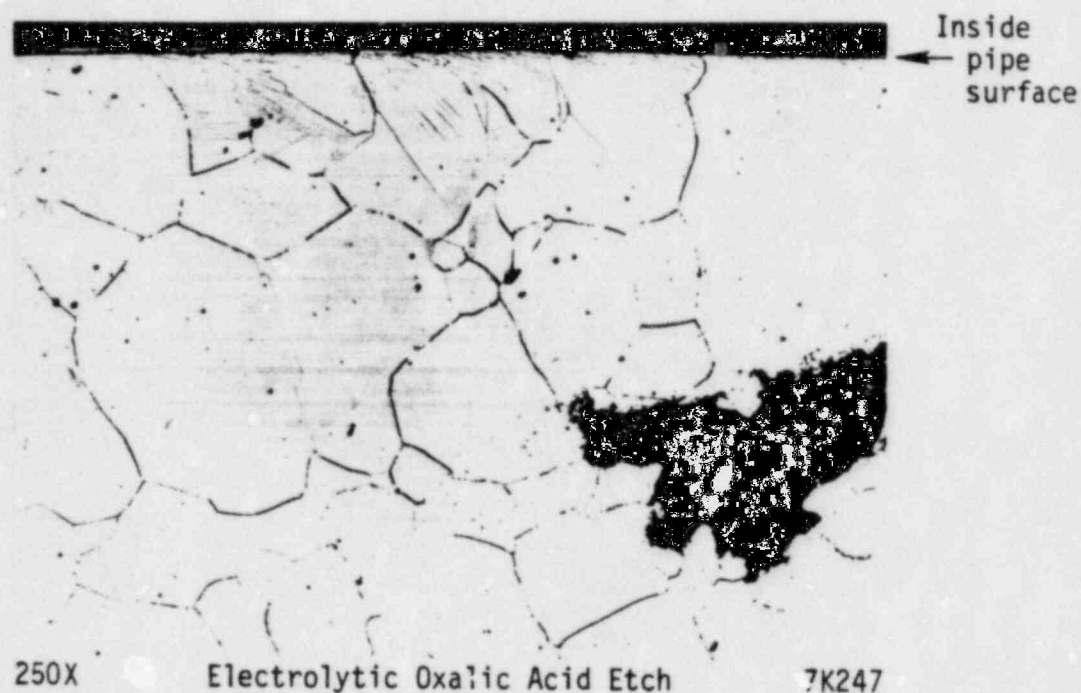
Sensitization was revealed in the cross section through the defect by electrolytic etching using an electrolyte that consisted of 10 percent by weight of oxalic acid in water. (This is an etch commonly used to reveal a sensitized microstructure in stainless steels.) Evidence of sensitization, the presence of fine carbide precipitates in the austenite grain boundaries, is presented in Figure 8. The area shown in Figure 8 was located within Circled Area 4 in Figure 5a. The presence of sensitized material was

FIGURE 8. SENSITIZATION (CARBIDE PRECIPITATE IN THE GRAIN BOUNDARIES) OBSERVED IN THE REGION OF THE LINEAR SURFACE DEFECT

revealed clearly by the etch to a depth of about 0.20 inch below the inside surface of the pipe. Beyond that depth, evidence of sensitization was observed in random grainboundaries.

Figure 8 also shows evidence of some cold working of the metal at the inside pipe surface. Strain lines and deformation that indicated cold working can be seen faintly in Figure 8 in grains at the pipe surface. The cold-worked surface metal was most likely a result of the mechanical surface grinding or abrasion that was evident.

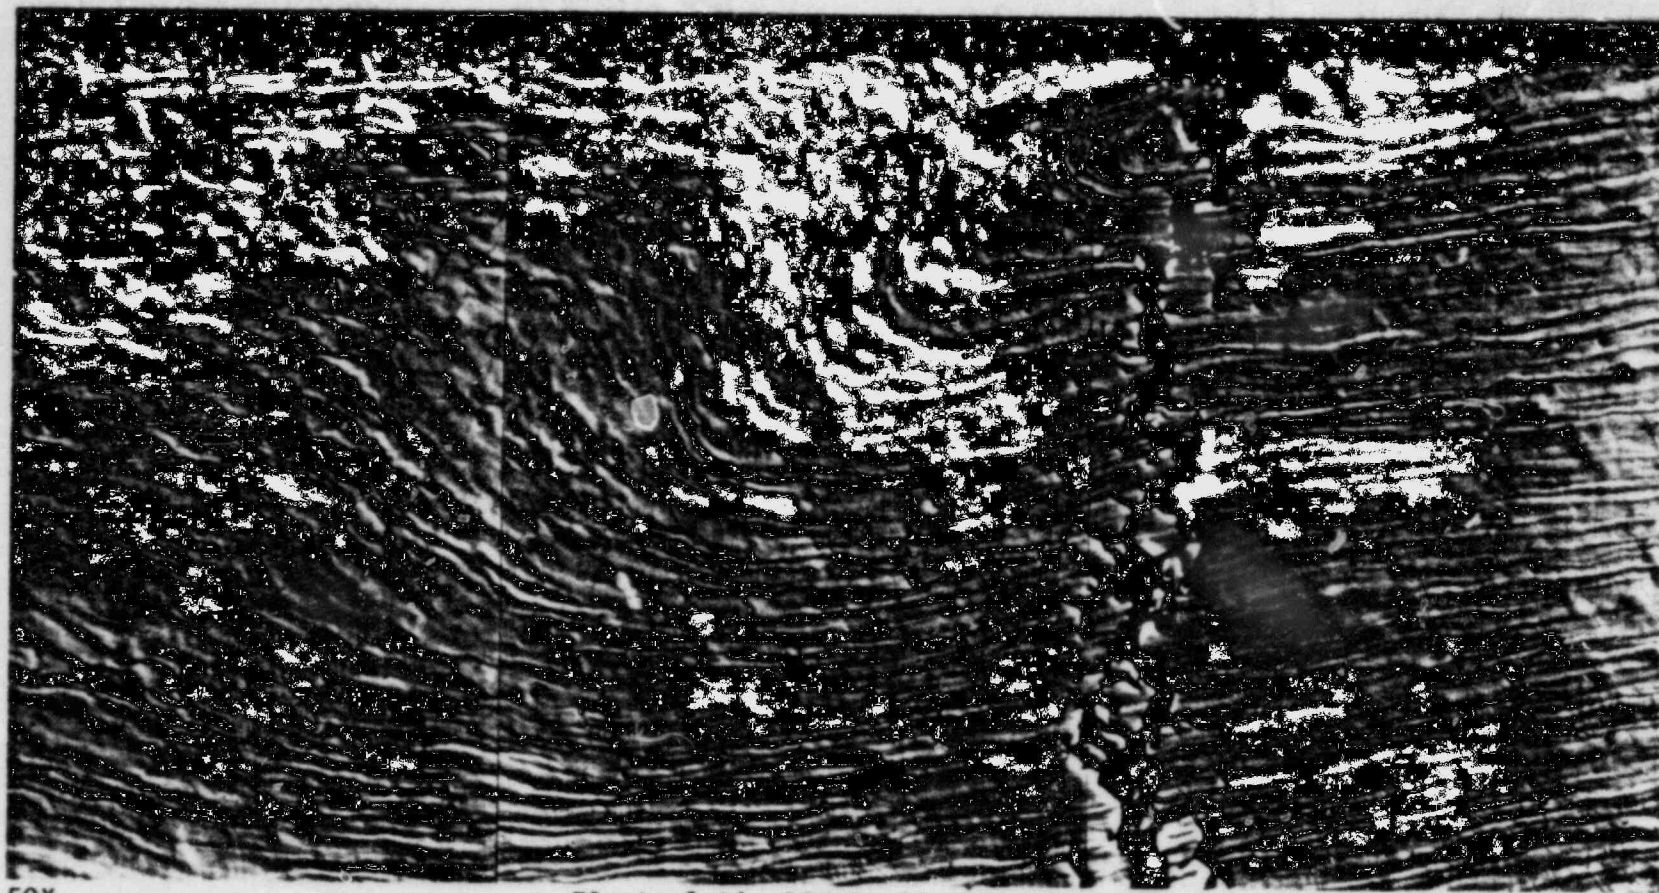
The coring pattern in Figure 9 shows that an interruption of the normal flow of metal occurred around the linear defect in the surface of the pipe during fabrication. The flow pattern around the linear defect was similar to that sometimes observed around seams or laps in billet surfaces. However, inasmuch as the linear defect was on the inside surface of seamless pipe, the origin of the linear defect must have been associated with the piercing or other operation in the process of producing the seamless pipe.

Note in Figure 9 that the cored regions were independent of the grains and the grain boundaries and that the coring had no noticeable effect on the initiation or propagation of the crack.

FIGURE 9. CORING THAT REVEALS THE FLOW PATTERN OF METAL AROUND THE LINEAR SURFACE DEFECT

surface, there was a surface flaw probably introduced during the piercing or other operation in the production of the seamless pipe. The presence of slivers associated with other linear surface defects and the macroscopic appearance of most of the linear defects observed suggest that all of the linear defects were fabrication-induced surface flaws that were similar to laps or seams.
