AN INVESTIGATION OF FLAWS ON THE  
INSIDE SURFACE OF A TYPE 304 STAINLESS  
STEEL SCHEDULE 80 PIPE

POWER AUTHORITY OF THE STATE OF NEW YORK  
JAMES A. FITZPATRICK NUCLEAR POWER PLANT

July 30, 1982

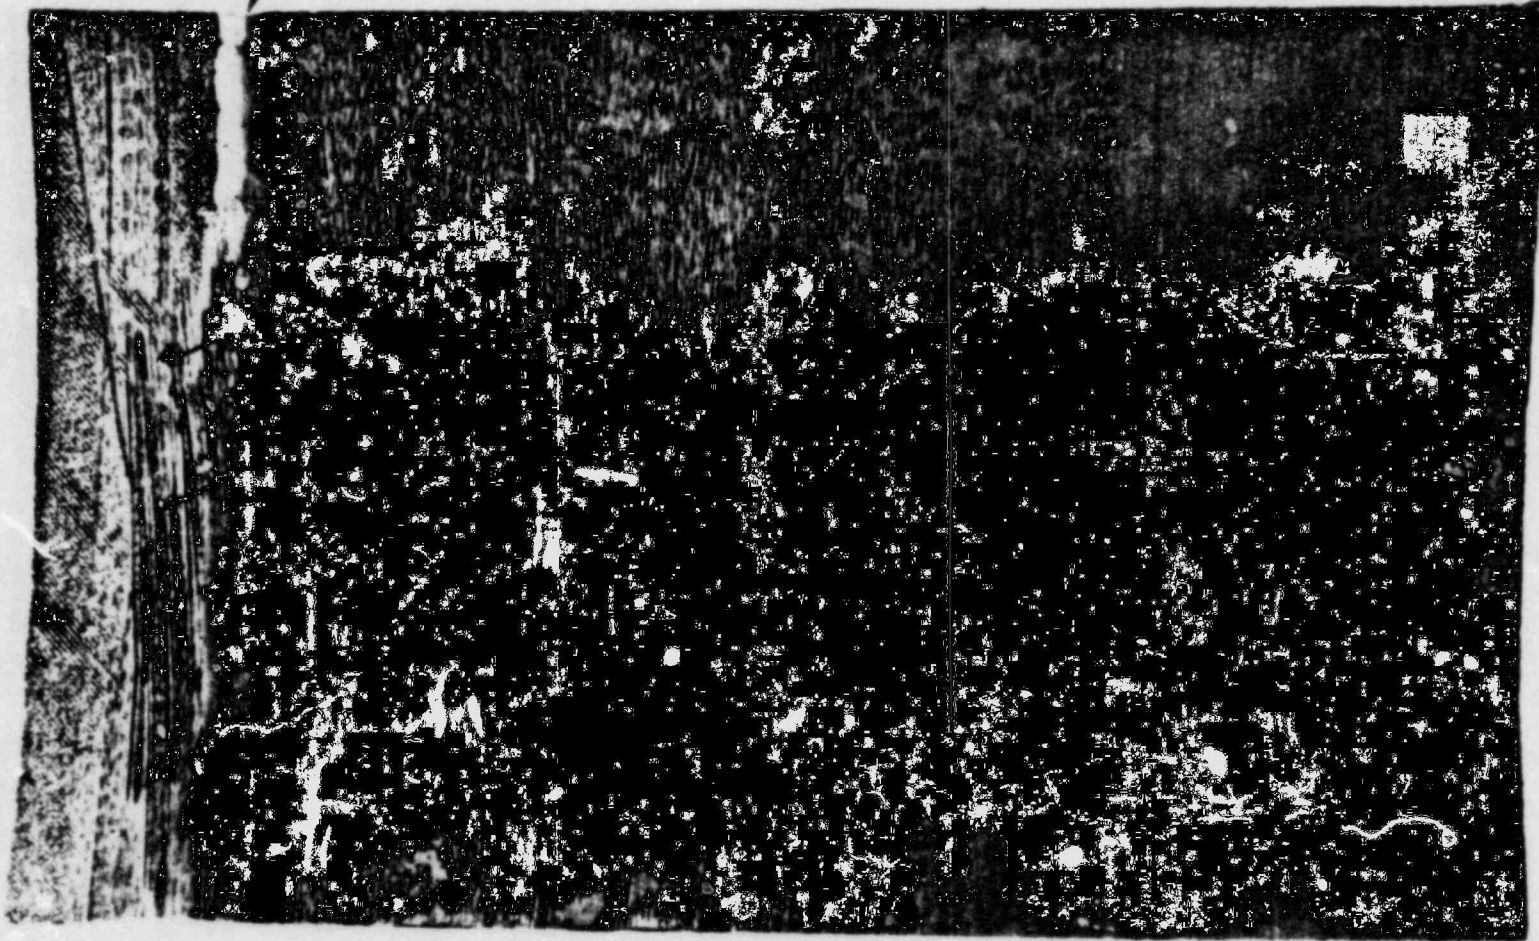
The photograph in Figure 1 shows the portion of the inside surface of the Schedule 80 pipe and the surface flaws that were observed during the previous investigation. (This photograph appeared as Figure 3 in the BCL report of the previous investigation and, also, as Figure 1 in BCL's proposal for this present investigation.) The surface flaws that were selected for further studies are identified in Figure 1 by the arrows numbered 1, 2, 4 and 5. Those flaws, as numbered, conform to the manner in which those flaws were identified in BCL's proposal for this investigation. The feature identified by the arrow that was numbered 3 in that proposal is actually a part of Flaw No. 2 and is now identified as Section R-R of Flaw No. 2 in Figure 1.

FIGURE 1. INSIDE SURFACE OF THE SCHEDULE 80 STAINLESS STEEL PIPE SHOWING SURFACE FLAWS, THE LOCATIONS OF METALLOGRAPHIC AND EPR TEST SPECIMENS, AND THE CIRCUMFERENTIAL WELD

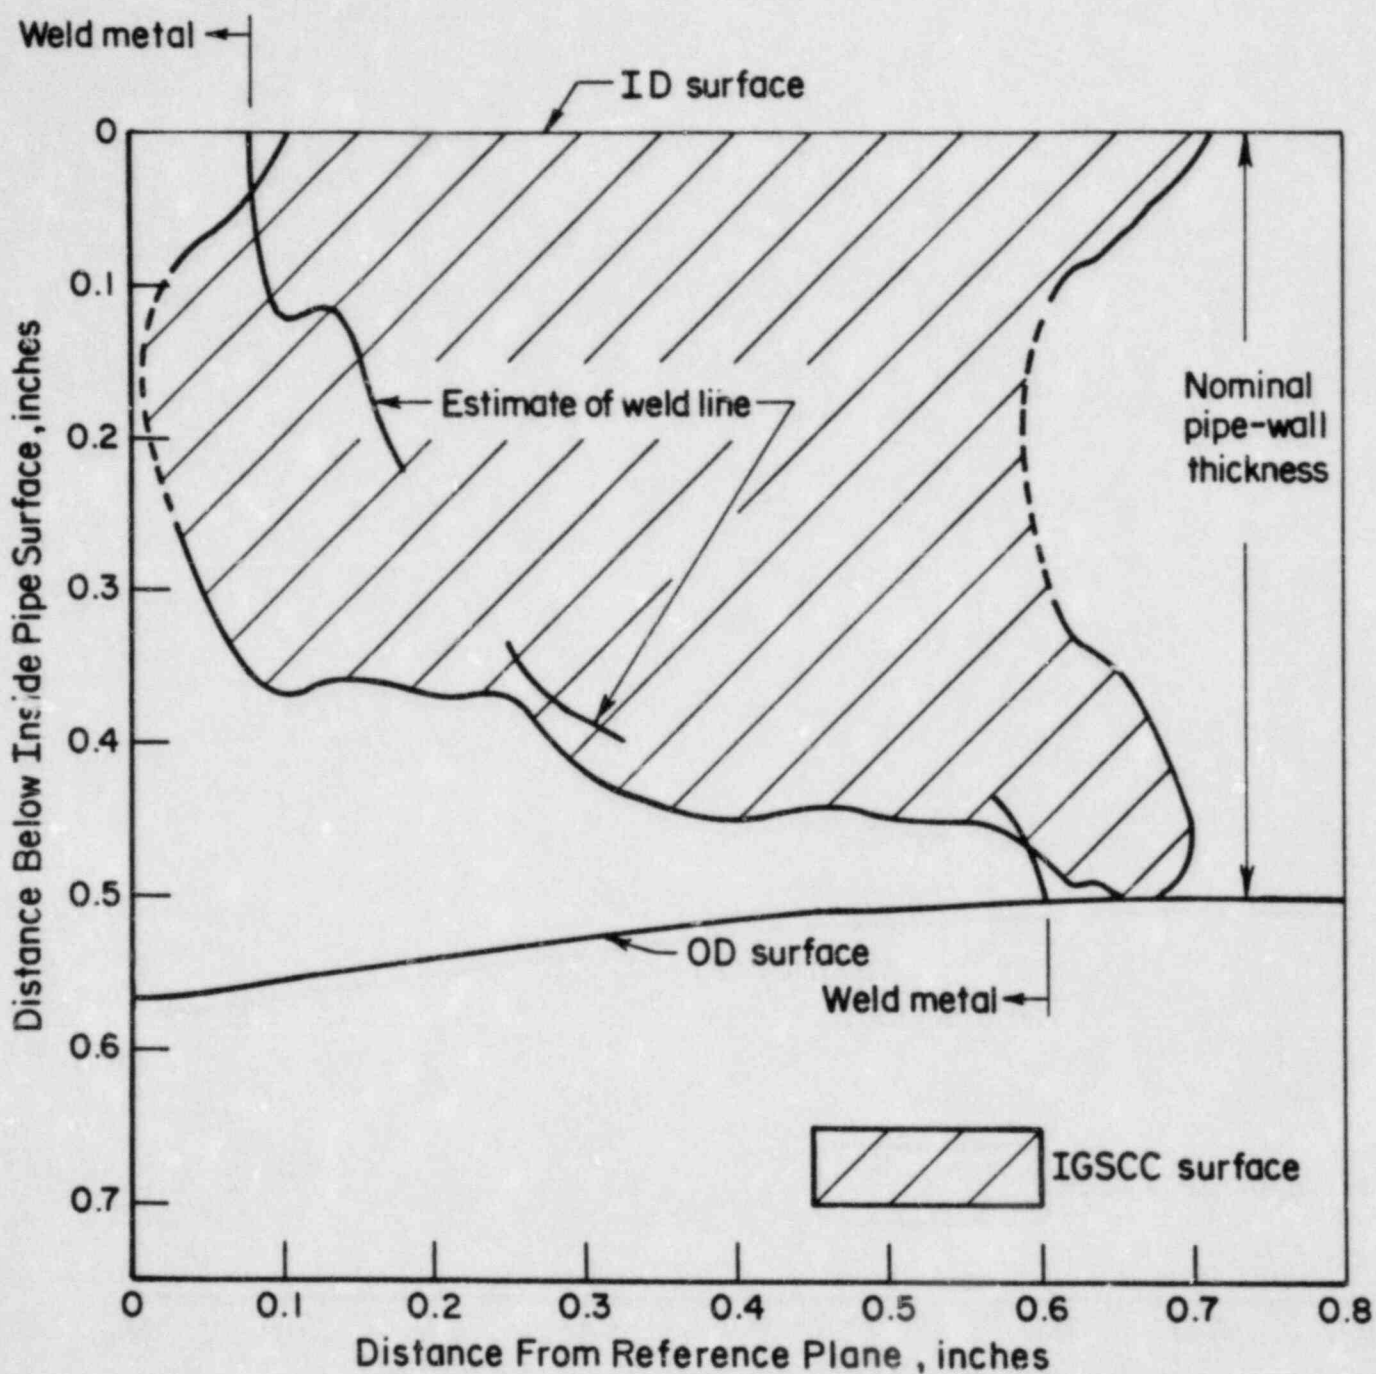
its length was obtained from serial sections of Specimen 1-S-S and Specimen 1-T-T; the profile is revealed in Figure 2 by a plot of the depths of the crack below the inside pipe surface at various intervals of distance along the length of the crack. Zero distance in Figure 2 corresponds to the location (termed a reference plane) where no crack was observed beyond the end of the flaw next to the weld metal; in this case, the reference plane was entirely within the weld metal. The abscissa in Figure 2 extends away from the weld through its heat-affected zone and in a direction along the length of the flaw. The crack-depth and crack-length data that are plotted in Figure 2 are given in Table 2.

The cross-hatched region in Figure 2 represents the extent of the IGSCC surface. Included in Figure 2 are the approximate locations of the inside and outside pipe surfaces and portions of the weld line with respect to the crack. Note that IGSCC penetrated weld metal where crack propagation eventually arrested. However, crack propagation extended a short distance beyond the final pass of weld metal on the outside pipe surface and, in fact, reached the outside surface in one small region. It is interesting to note here that no leakage of the core-spray pipe system was reported.

FIGURE 2. PROFILE OF INTERGRANULAR STRESS-CORROSION CRACK AT FLAW NO. 1

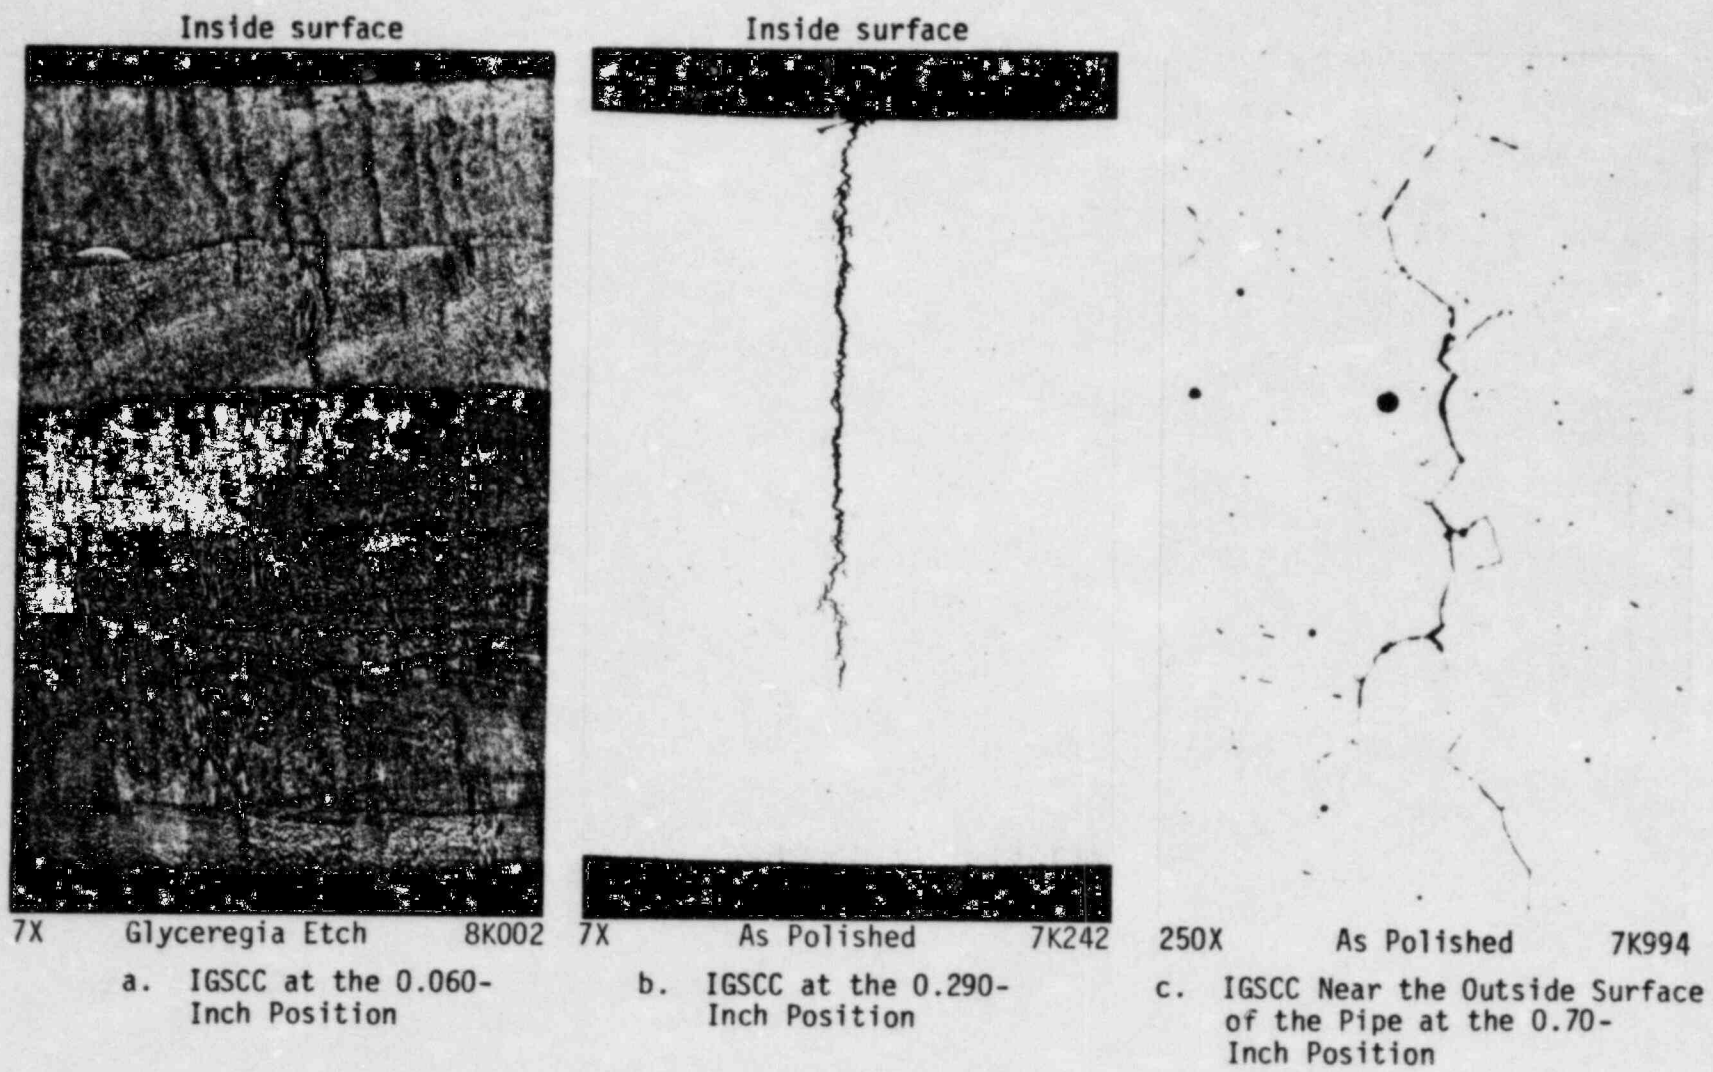
Figure 3 shows the appearance of the IGSCC at a few locations along its length. Figure 3a exhibits the crack at the 0.060-inch position. At that location the crack was subsurface and entirely within weld metal. At the 0.290-inch position, Figure 3b, the crack extended through approximately 77 percent of the pipe wall. Figure 3c exhibits the portion of the crack near the outside surface of the pipe at the 0.702-inch position (at much higher magnification); essentially the entire crack in the through-wall direction is shown.

FIGURE 3. THE IGSCC ASSOCIATED WITH FLAW NO. 1 AT SEVERAL LOCATIONS ALONG THE LENGTH OF THE CRACK

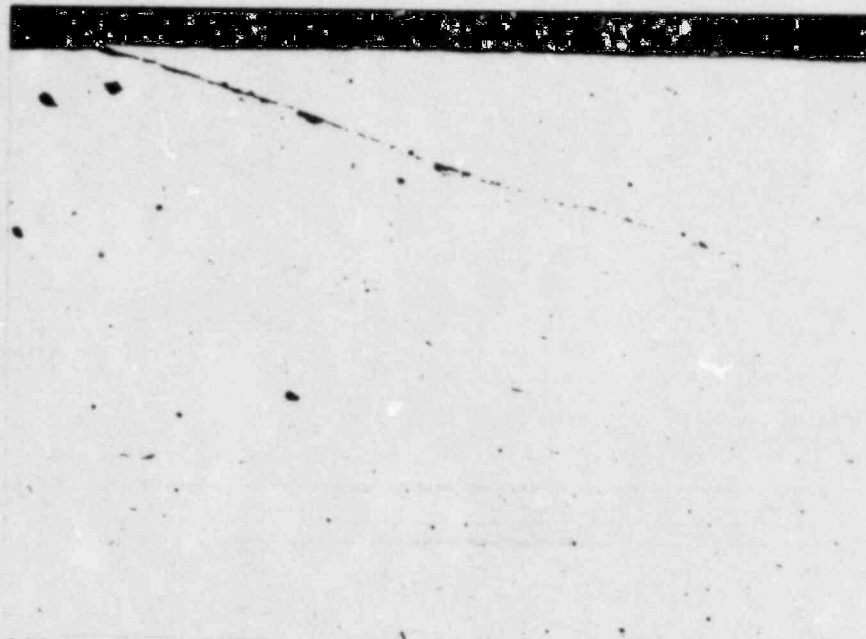
The appearance of the surface flaw at the 0.70-inch position is revealed in Figure 4. The flaw exhibited two surface imperfections that were approximately 0.1 inch apart; those two imperfections are shown in Figures 4a and 4b respectively. A little IGSCC was still evident at the flaw shown in Figure 4b.

a. Surface Imperfection Located About 0.1 Inch from the Imperfection Shown in (b) Below

FIGURE 4. FLAW NO. 1 NEAR THE END OF THE IGSCC FARTHEST FROM THE WELD

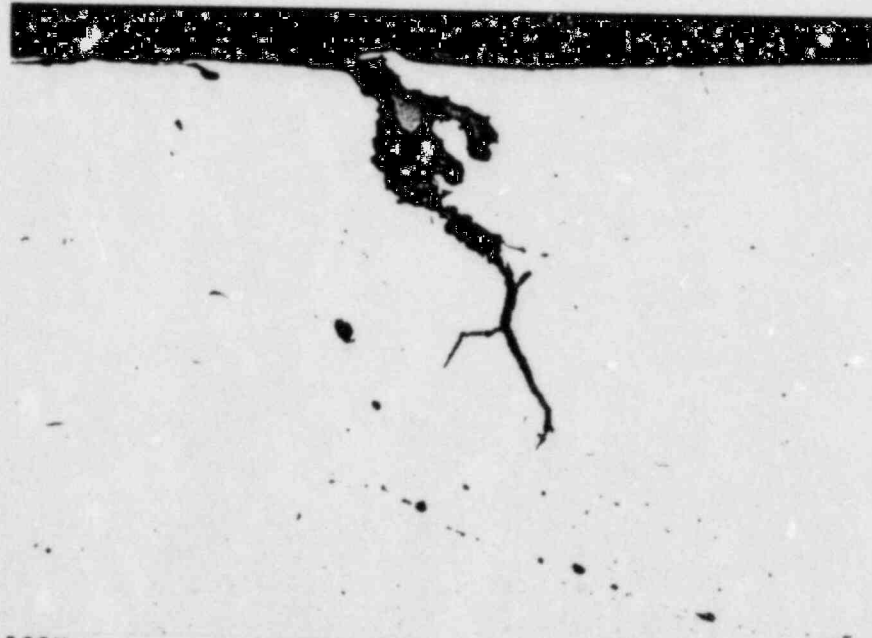
b. Surface Imperfection and Some IGSCC at the 0.70-Inch Position

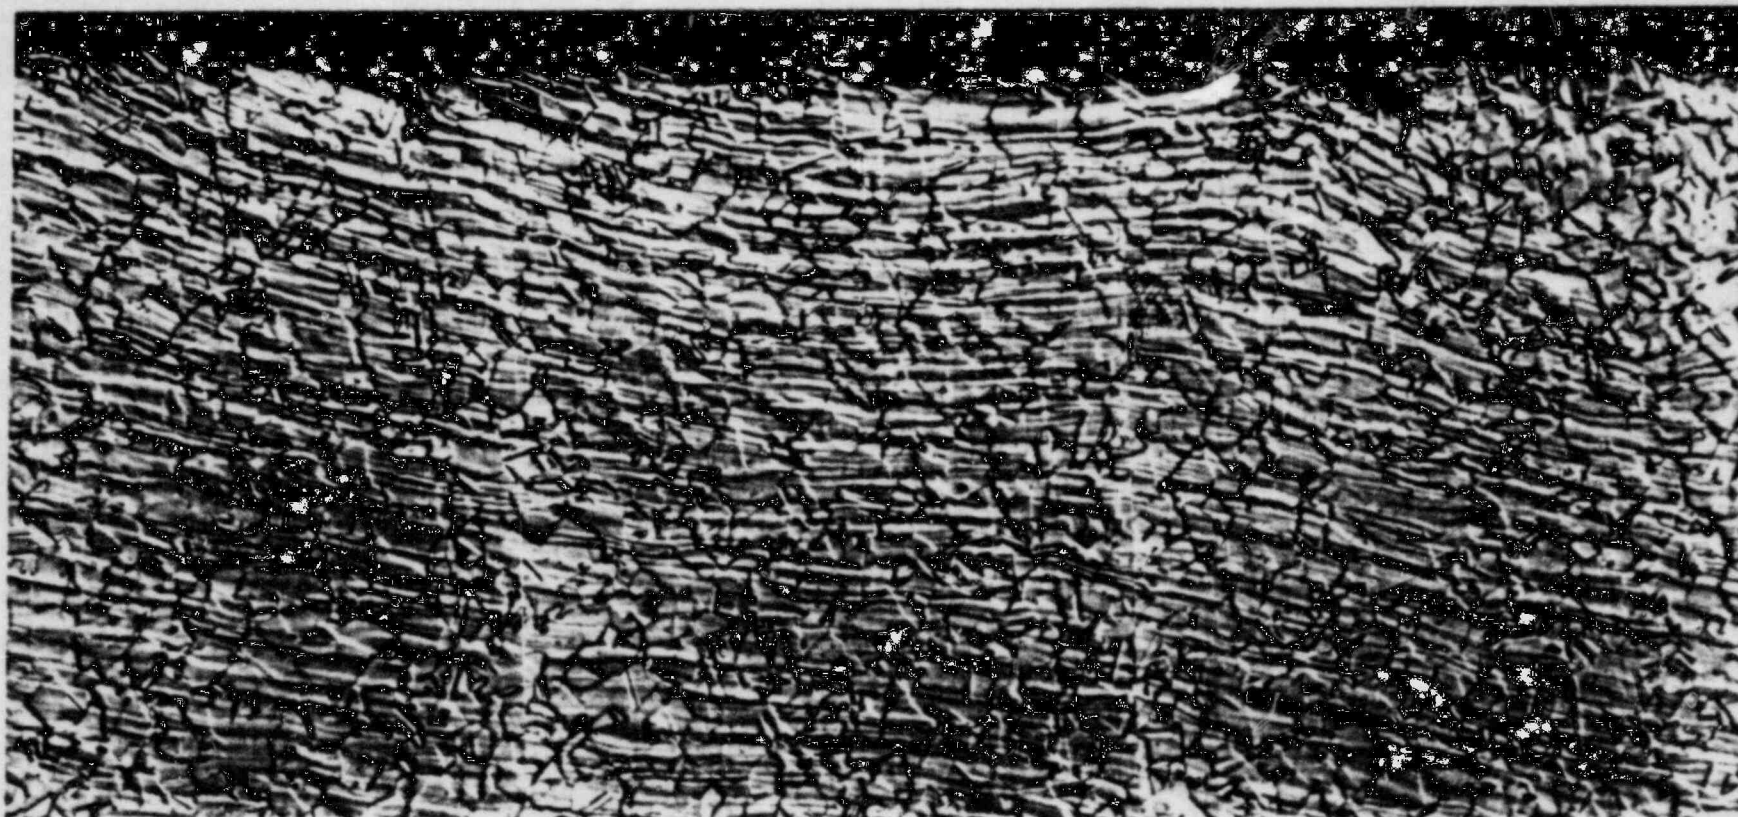
The flow pattern of the metal that developed around the flaw during the fabrication of the pipe was revealed by etching metallographically polished specimens, as is shown in Figure 5 at a magnification of 50X. At

that magnification, the two surface imperfections shown in Figure 4a and 4b are evident. The cross section of the flaw in Figure 5 is located at approximately the 0.72-inch position in Figure 2; that cross section is about 0.02 inch beyond the cross section shown in Figure 4. In Figure 5, the surface imperfection shown in Figure 4a is observed to be slightly larger, and the surface imperfection shown in Figure 4b is observed to be slightly smaller with little or no evidence of IGSCC,

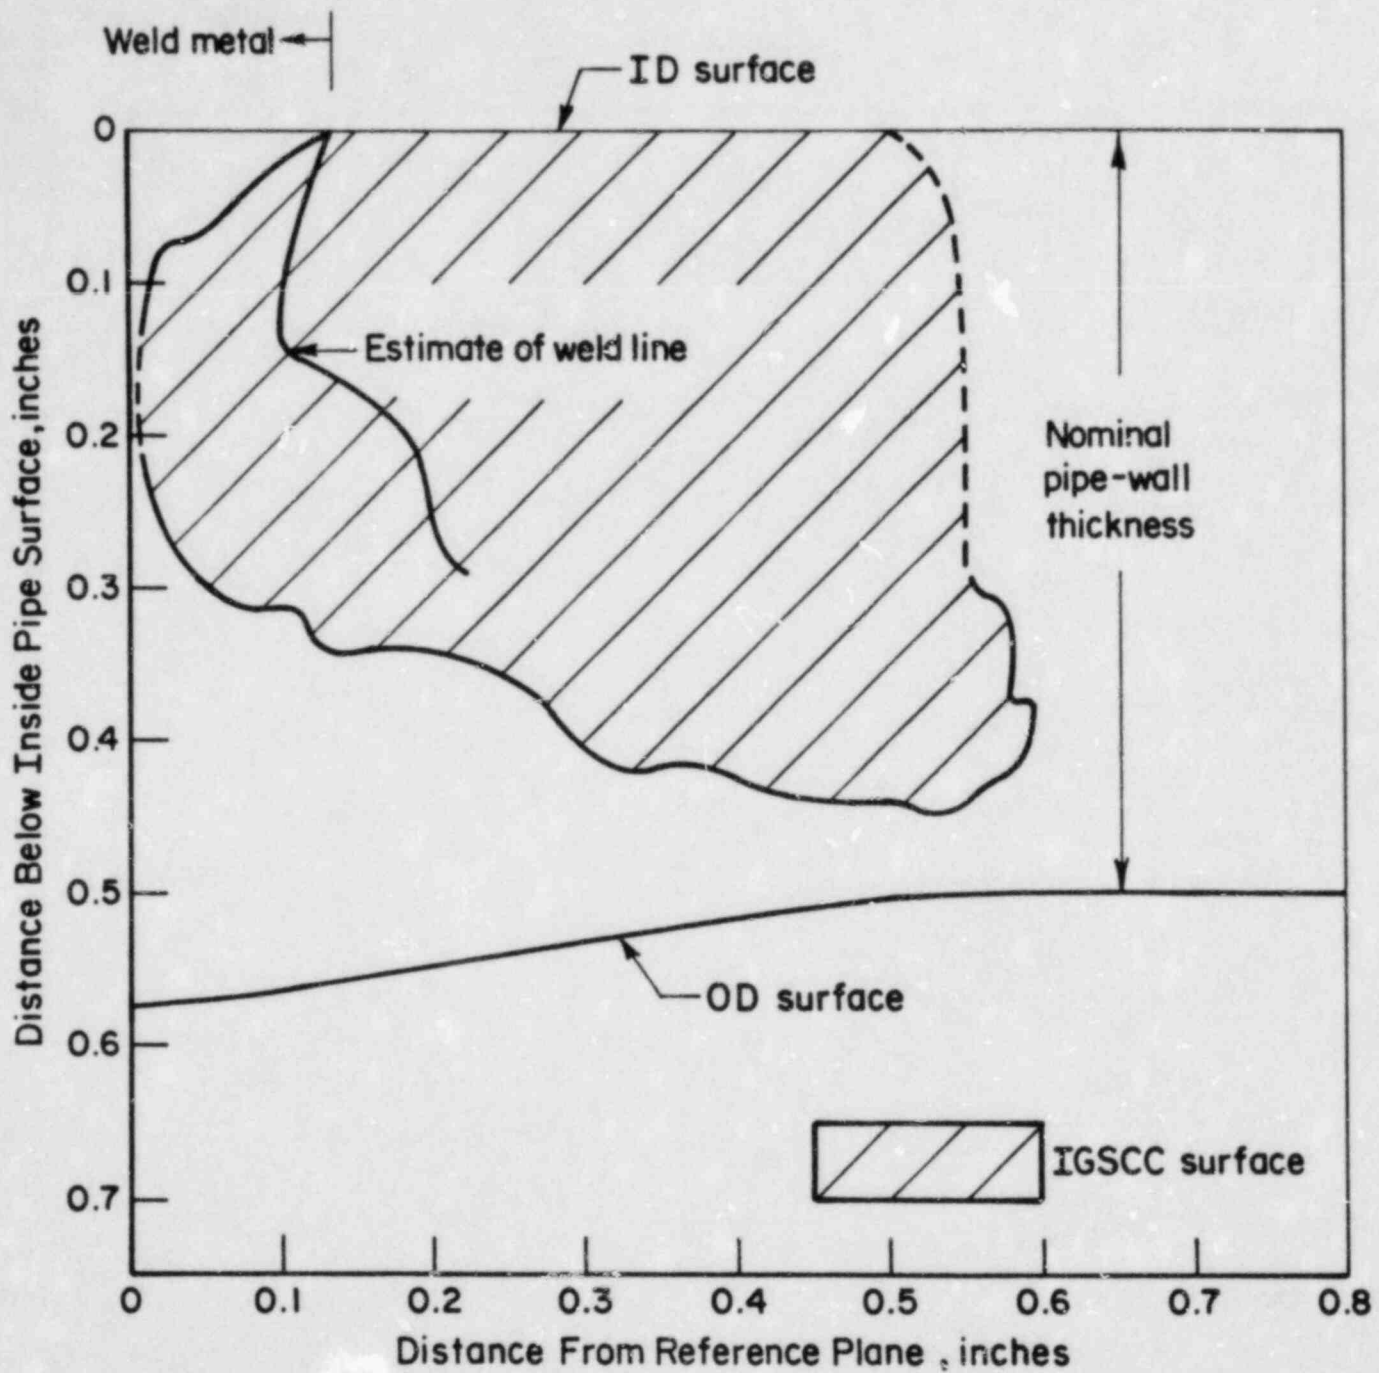
Flaw No. 4, like Flaw No. 1, was located in close proximity to the weld in the region of the weld heat-affected zone. At that location, the propagation of IGSCC from the flaw was suspected and was observed in metallographic cross sections of the flaw. The profile of the crack was obtained from serial sections of Specimen 4-K-K and Specimen 4-L-L. When Specimen 4-K-K was prepared metallographically, it was anticipated that no crack would be present in the initial section, because the section was obtained beyond the end of the flaw that was visible on the surface of the pipe. However, a crack was present; therefore Specimen 4-L-L was prepared in order to determine the extent of the crack in a direction away from the weld. The profile of the IGSCC crack at Flaw No. 4 is revealed in Figure 6 in the same manner as was the crack-profile presented in Figure 2. The data for crack depth and crack length that are plotted in Figure 6 are given in Table 3.

The cross-hatched region in Figure 6 represents the extent of the IGSCC surface. Included in Figure 6 are the approximate locations of the inside and outside pipe surfaces and a portion of the weld line, with respect to the crack. Although the crack-surface area was smaller, the general outline of that area was similar to that of the IGSCC at Flaw No. 1 (compare Figures 2 and 6). Also, arrest of the crack propagation in the through-wall direction again apparently occurred in weld metal.

FIGURE 6. PROFILE OF INTERGRANULAR STRESS-CORROSION CRACK AT FLAW NO. 4

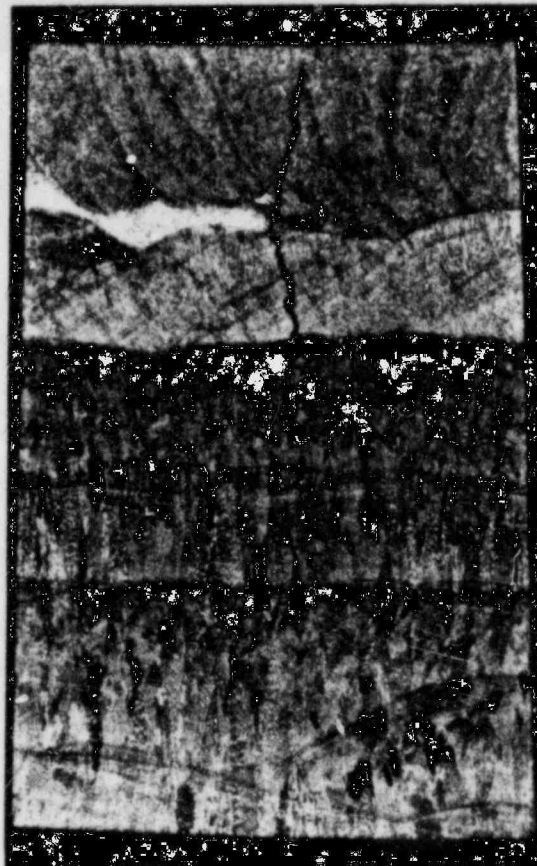
Figure 7 shows the appearance of the IGSCC at a few locations along its length. Figure 7a exhibits the crack at the 0.10-inch position. At that location, the crack was subsurface and was entirely within weld metal except for a very small portion near middepth. At the 0.125-inch position (Figure 7b), the crack was slightly beneath the inside surface of the pipe and had begun to

a. IGSCC at the 0.10-Inch Position

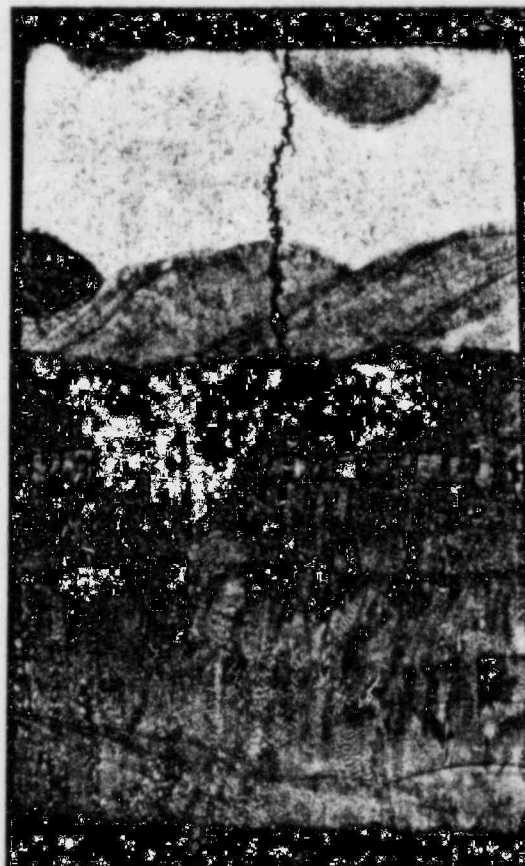
b. IGSCC at the 0.125-Inch Position

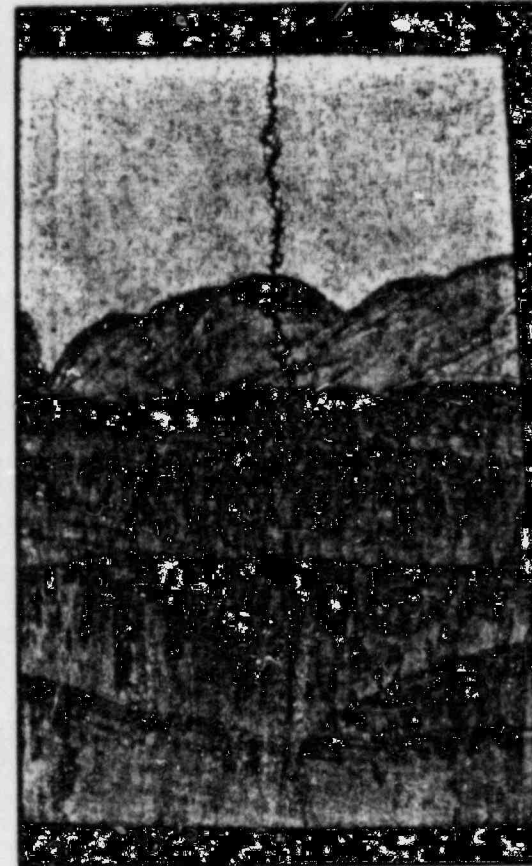
c. IGSCC at the 0.161-Inch Position

penetrate the root pass of the weld. Figure 7c shows the crack at the 0.161-inch position.

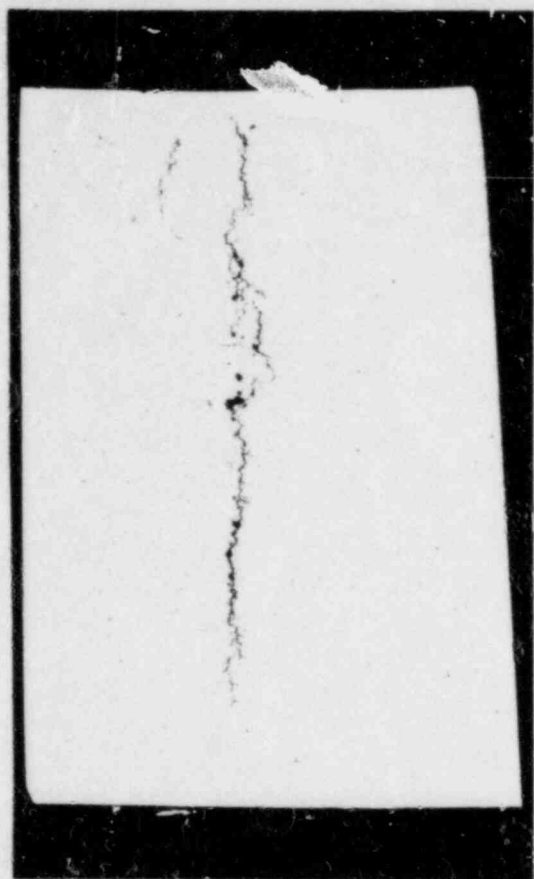
d. IGSCC at the 0.517-Inch Position

The first plane of polish in Specimen 4-K-K revealed the IGSCC as shown in Figure 7d. As was mentioned earlier, the presence of a crack in this plane of polish was not anticipated, because Specimen 4-K-K was beyond the visible end of Flaw No. 4. Not only was the crack present, but the depth of the crack was nearly a maximum and a second, adjacent crack was observed. The second crack is evident in Figure 7d to the left of the primary crack. In this section, both the primary crack and the secondary crack began below the inside surface of the pipe. Neglecting the distance between the pipe surface and the beginning of the crack below the pipe surface, the primary crack extended in depth about 89 percent of the pipe-wall thickness. The secondary crack was not plotted in Figure 6, because its presence was observed only between the 0.49- and 0.52-inch locations and it did not extend beyond a depth below the pipe surface of about 0.12 inch. The secondary crack may have been a branch of the primary crack.

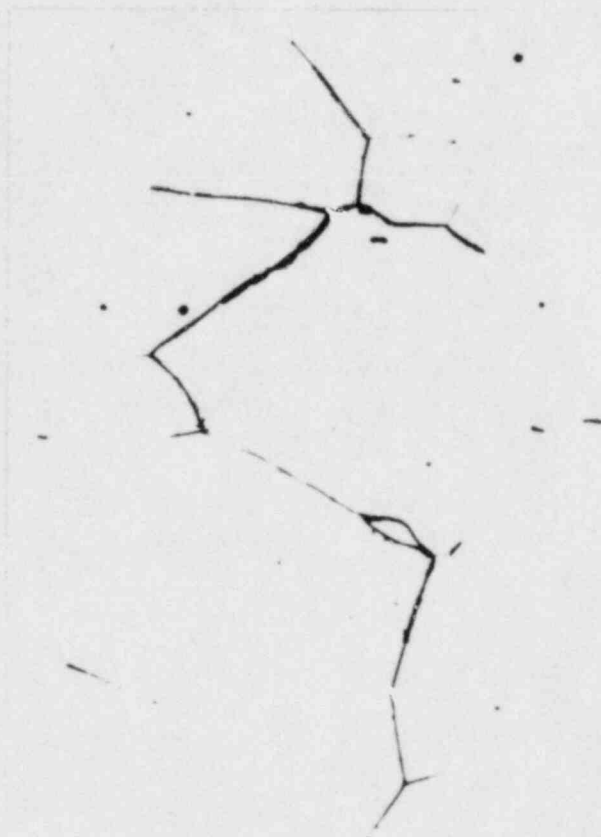
e. IGSCC at the 0.597-Inch Position

Figure 7e exhibits the IGSCC crack near the outside surface of the pipe at about the 0.60-inch position at high magnification; the entire crack in the through-wall direction is shown. No crack was observed in the next serial section beyond 0.60 inch.

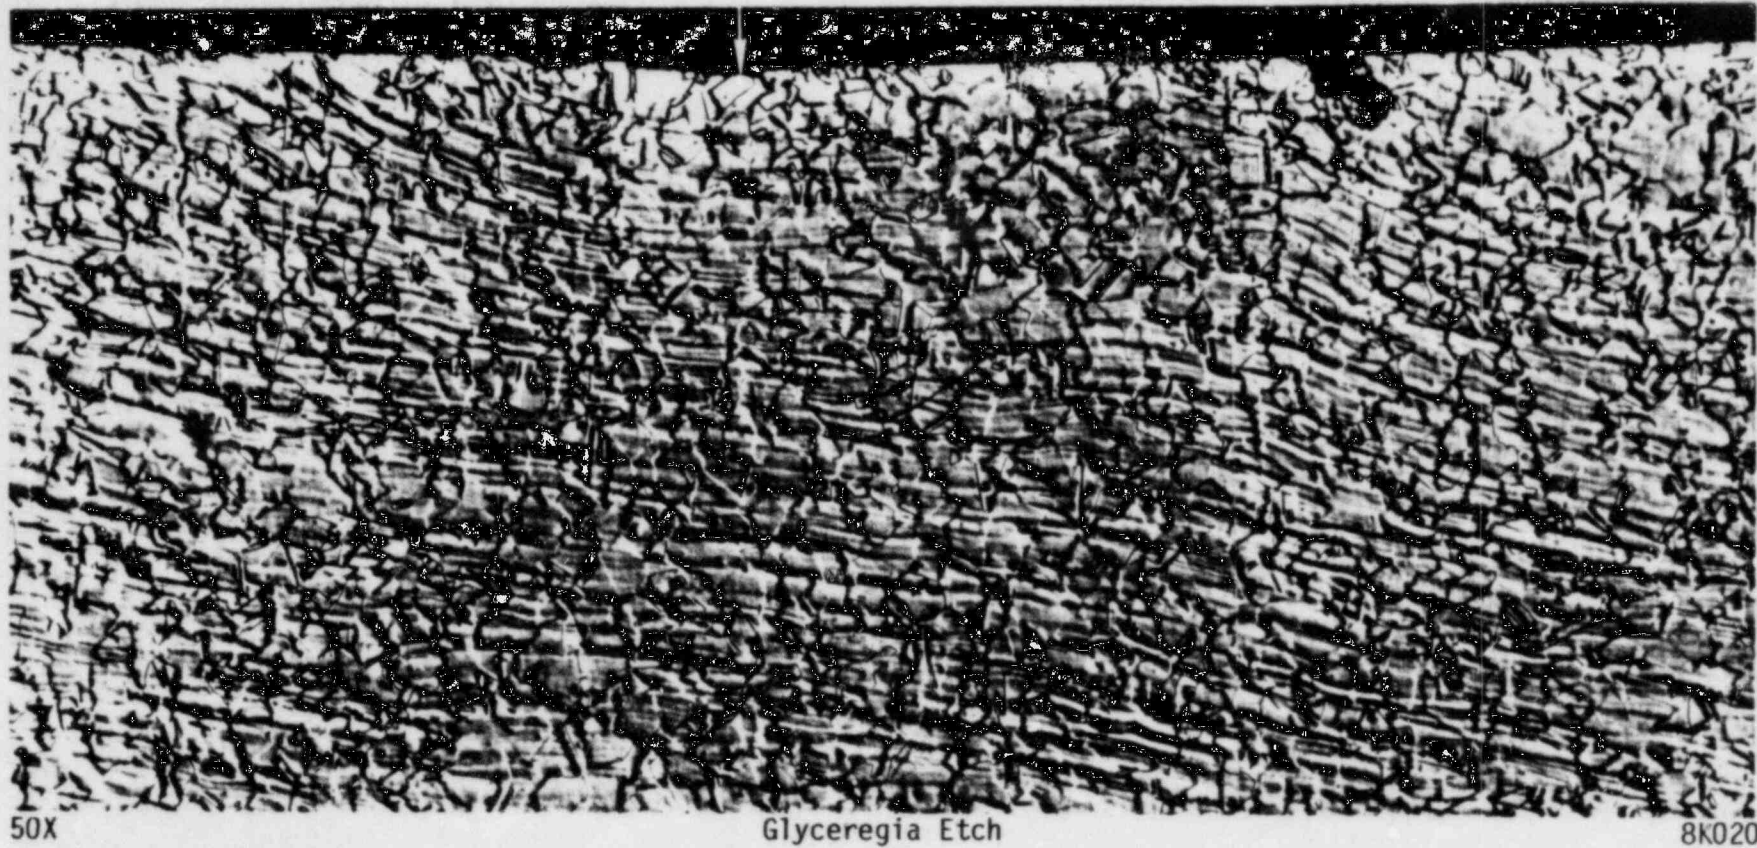
The examinations of cross sections of other surface flaws, namely Specimens 2-P-P, 2-N-N, 2-R-R, and 5-U-U (see Figure 1), did not reveal the presence of IGSCC nor any other mode of failure induced by the surface flaws. All of the surface flaws examined exhibited characteristics similar to those generally observed for seams or laps in billet surfaces. Examples of those characteristics are shown in Figures 8 through 11. The three cross sections of Flaw No. 2 are presented in Figures 8 through 10. In Specimen 2-P-P in Figure 8, the depth of Flaw No. 2 was observed to be relatively shallow. The slight depression in the surface of the pipe, indicated by the arrow in Figure 8, and the curved flow pattern of metal below that depression suggest that a thin, sliver of surface metal may have been present at that location

Possible site of a thin sliver of surface metal

FIGURE 8. THE FLOW PATTERN OF METAL AROUND SURFACE FLAW NO. 2 OBSERVED IN SPECIMEN 2-P-P

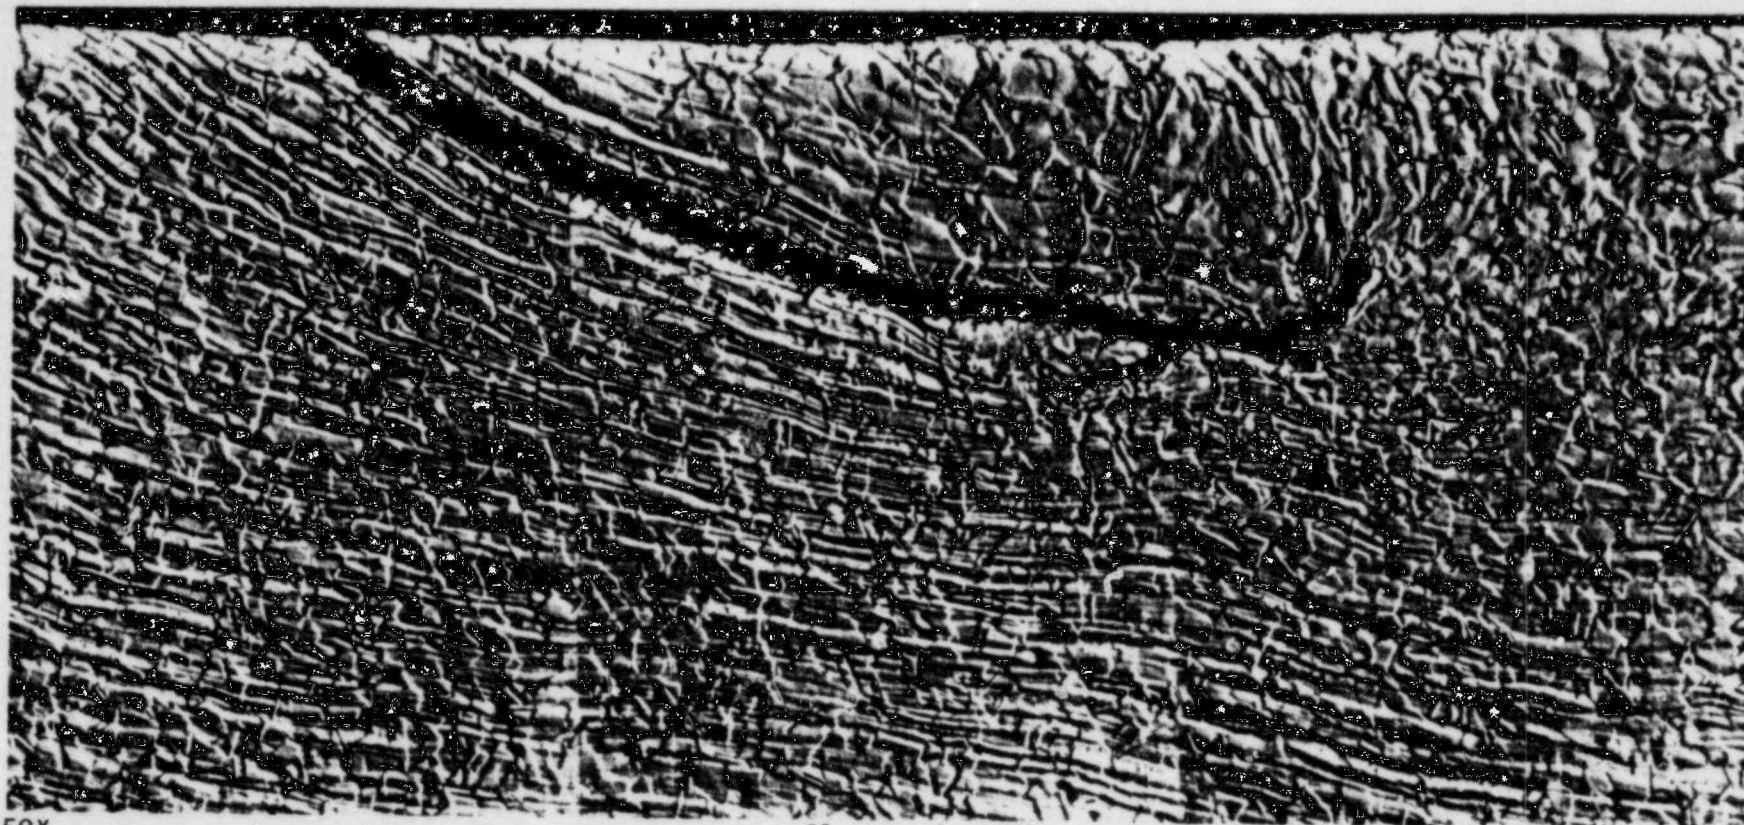
FIGURE 9. THE FLOW PATTERN OF METAL AROUND SURFACE FLAW NO. 2 IN SPECIMEN 2-N-N

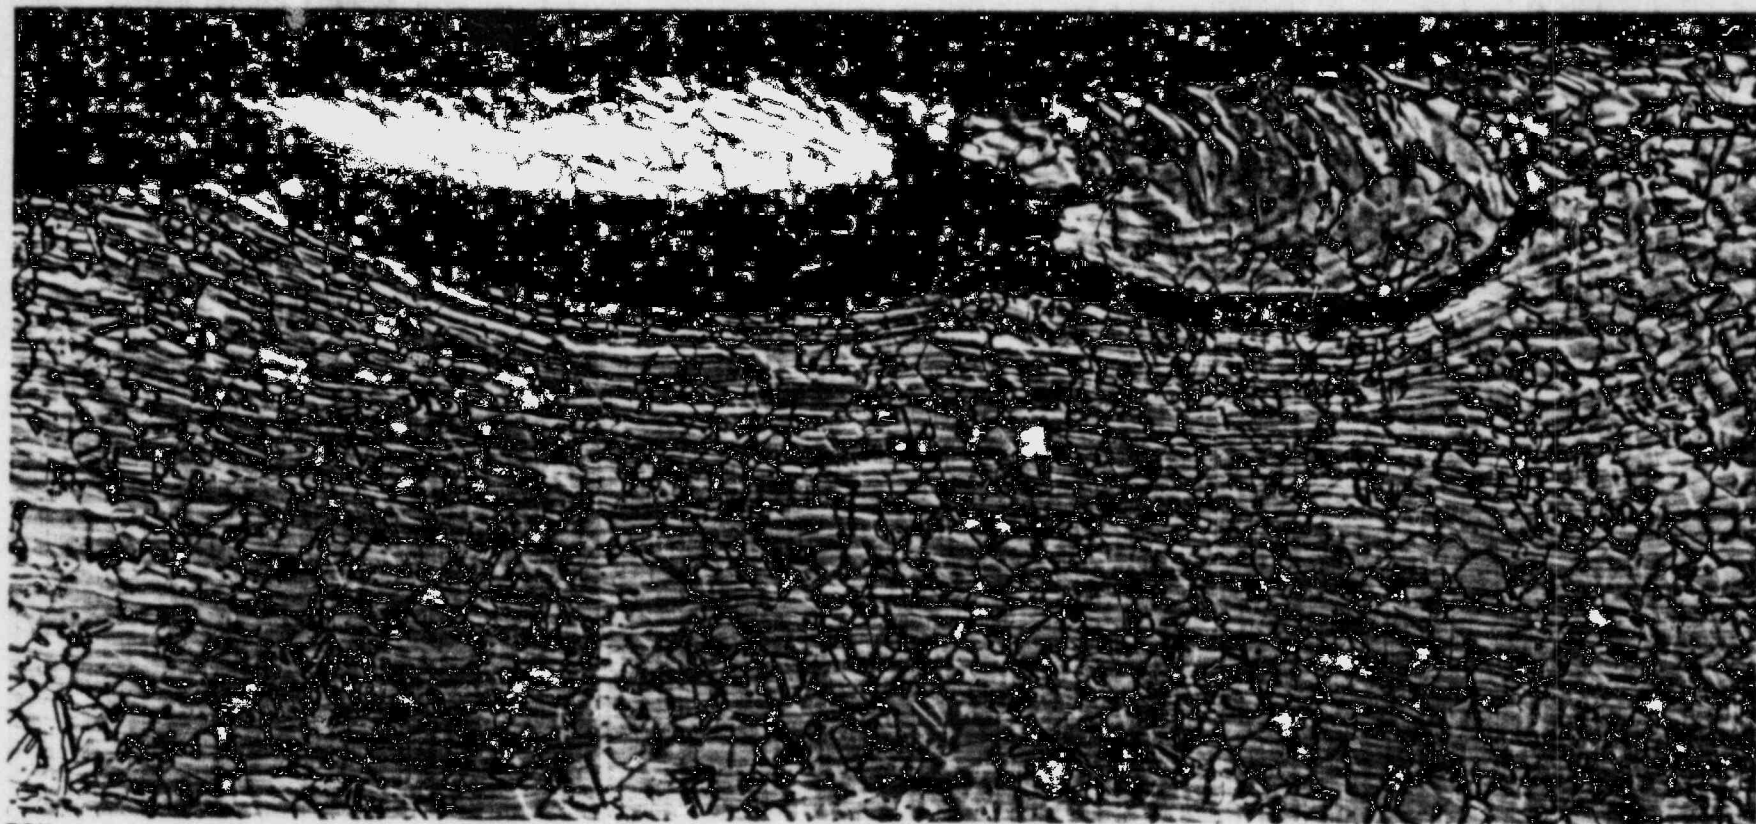
FIGURE 10. THE FLOW PATTERN OF METAL AROUND SURFACE FLAW NO. 2 IN SPECIMEN 2-R-R

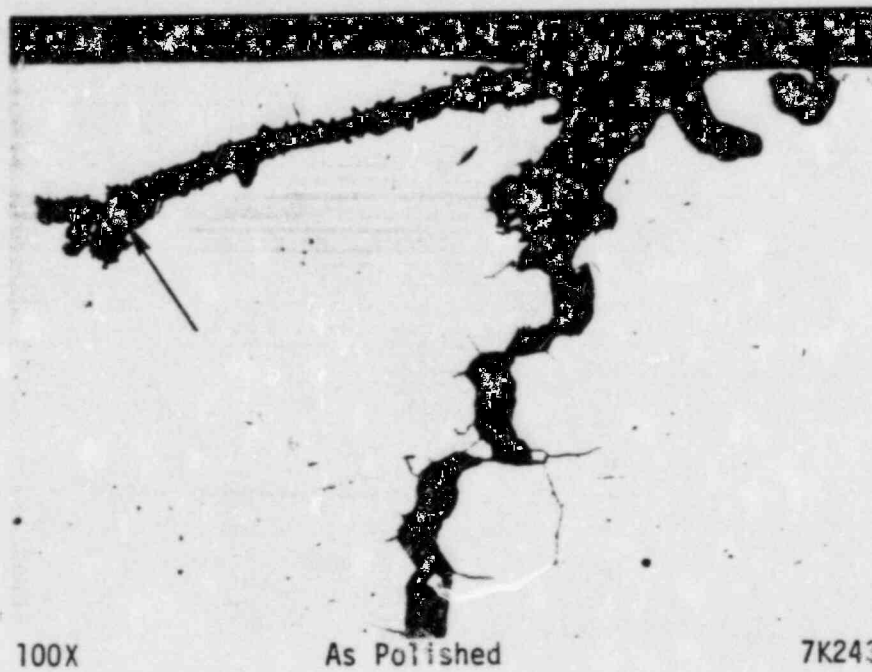
The corrosion products that were analyzed in Flaw No. 1 (Area 3 in Table 4) are identified by the arrow in Figure 13, a cross section of Flaw No. 1 observed in Specimen 1-S-S. The X-ray-energy spectrum for Area 3 is presented in Figure 14. The analysis of the chromium present in the corrosion products indicated that the chromium content was nearly twice the chromium content of the pipe. The increase in the chromium content was accompanied by decreases in the iron and nickel contents.

FIGURE 13. CROSS SECTION OF FLAW NO. 1 IN SECTION 1-S-S  
The arrow identifies the corrosion products  
in Flaw No. 1 (Area 3 in Table 4) that were  
subjected to EDAX analyses.

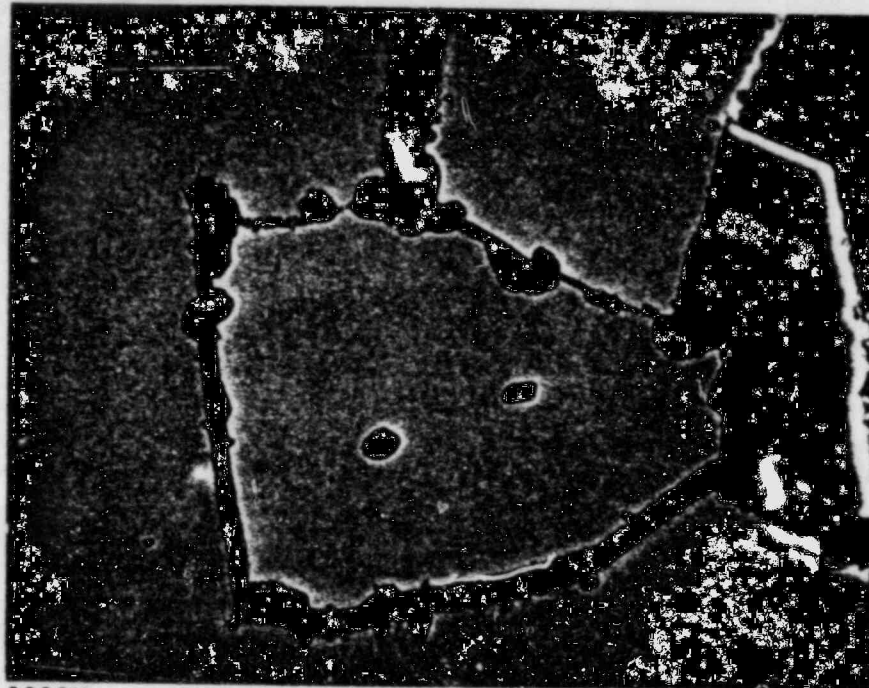
The region represented by Area 4 in Table 4, a region of corrosion products in the IGSCC below Flaw No. 1 near the inside surface of the pipe, is shown in Figure 15a. Those corrosion products contained a relatively low concentration of chromium, as was indicated also by the X-ray-energy spectrum of Area 4 presented in Figure 16. The X-ray distribution map of chromium presented in Figure 15b indicates the low concentration of chromium in the major portion of the corrosion products in the grain boundaries. (A region that exhibits a relatively sparse population of white dots in an X-ray-distribution map of an element indicates that the region contains a lower concentration of the element than do the regions that exhibit more dense populations of white dots.) The major decrease in the chromium content was balanced by a major increase in the iron content.

a. Region of the IGSCC Identified As Area 4 in Table 4 (SEM Micrograph)

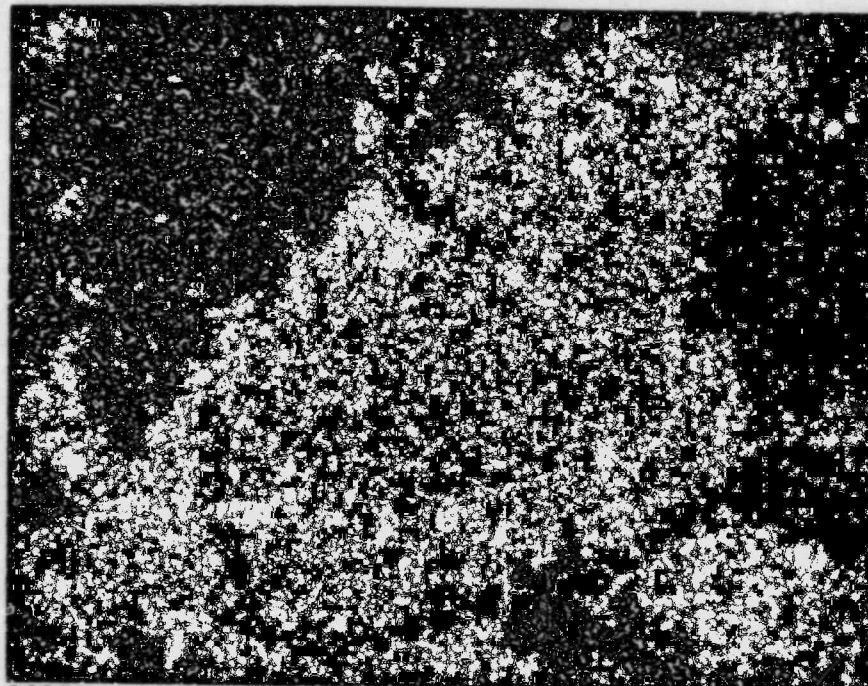
FIGURE 15. CORROSION PRODUCTS IN THE IGSCC NEAR THE INSIDE SURFACE OF THE PIPE

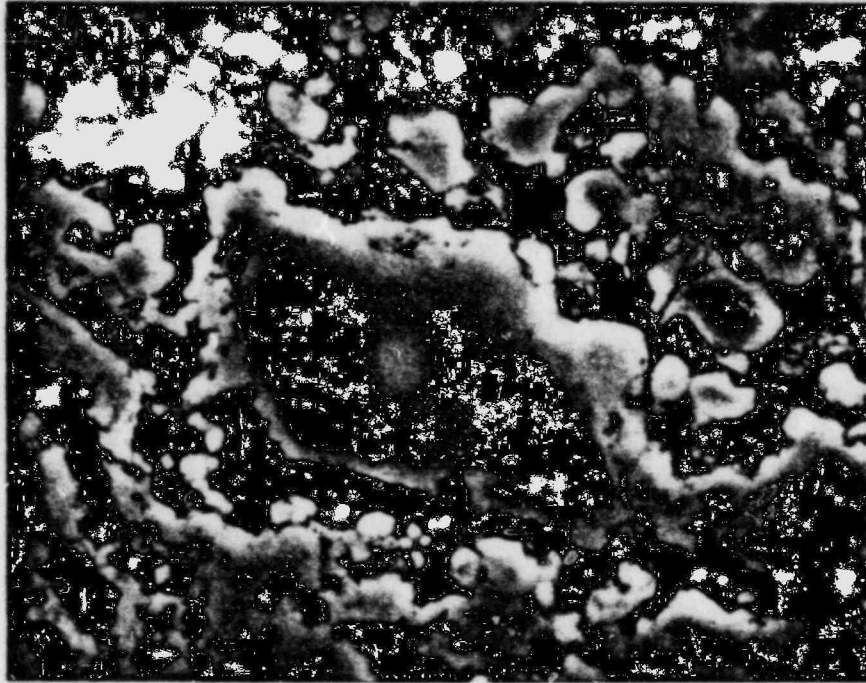
a. Area 1 Reported in Table 5 (SEM Micrograph)

FIGURE 19. CORROSION PRODUCTS IN FLAW NO. 2 THAT WERE  
SUBJECTED TO ELECTRON-MICROPROBE ANALYSES
