AN INVESTIGATION OF FLAWS ON THE  
INSIDE SURFACE OF A TYPE 304 STAINLESS  
STEEL SCHEDULE 80 PIPE

POWER AUTHORITY OF THE STATE OF NEW YORK  
JAMES A. FITZPATRICK NUCLEAR POWER PLANT

July 30, 1982

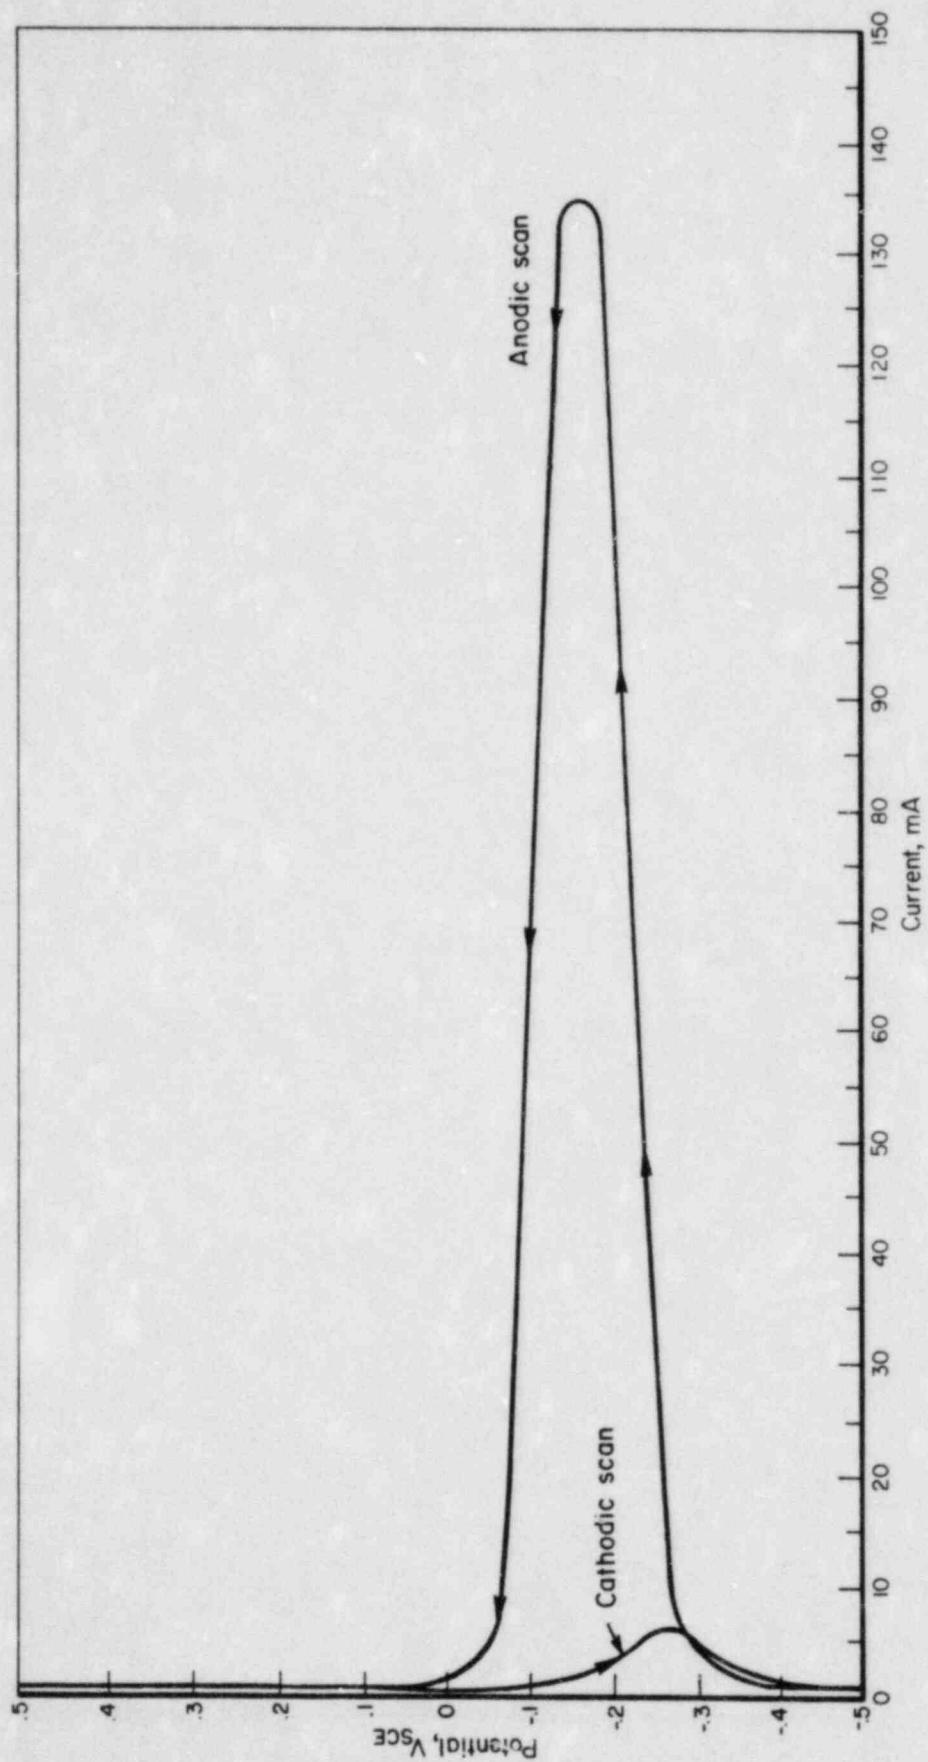
The results of the tests performed in the stronger solution are revealed in Figures 20 and 21 by a plot of current, mA, versus saturated

FIGURE 20. EPR CURVES FOR SAMPLE EPR-2 FROM THE WELD HEAT-AFFECTED ZONE

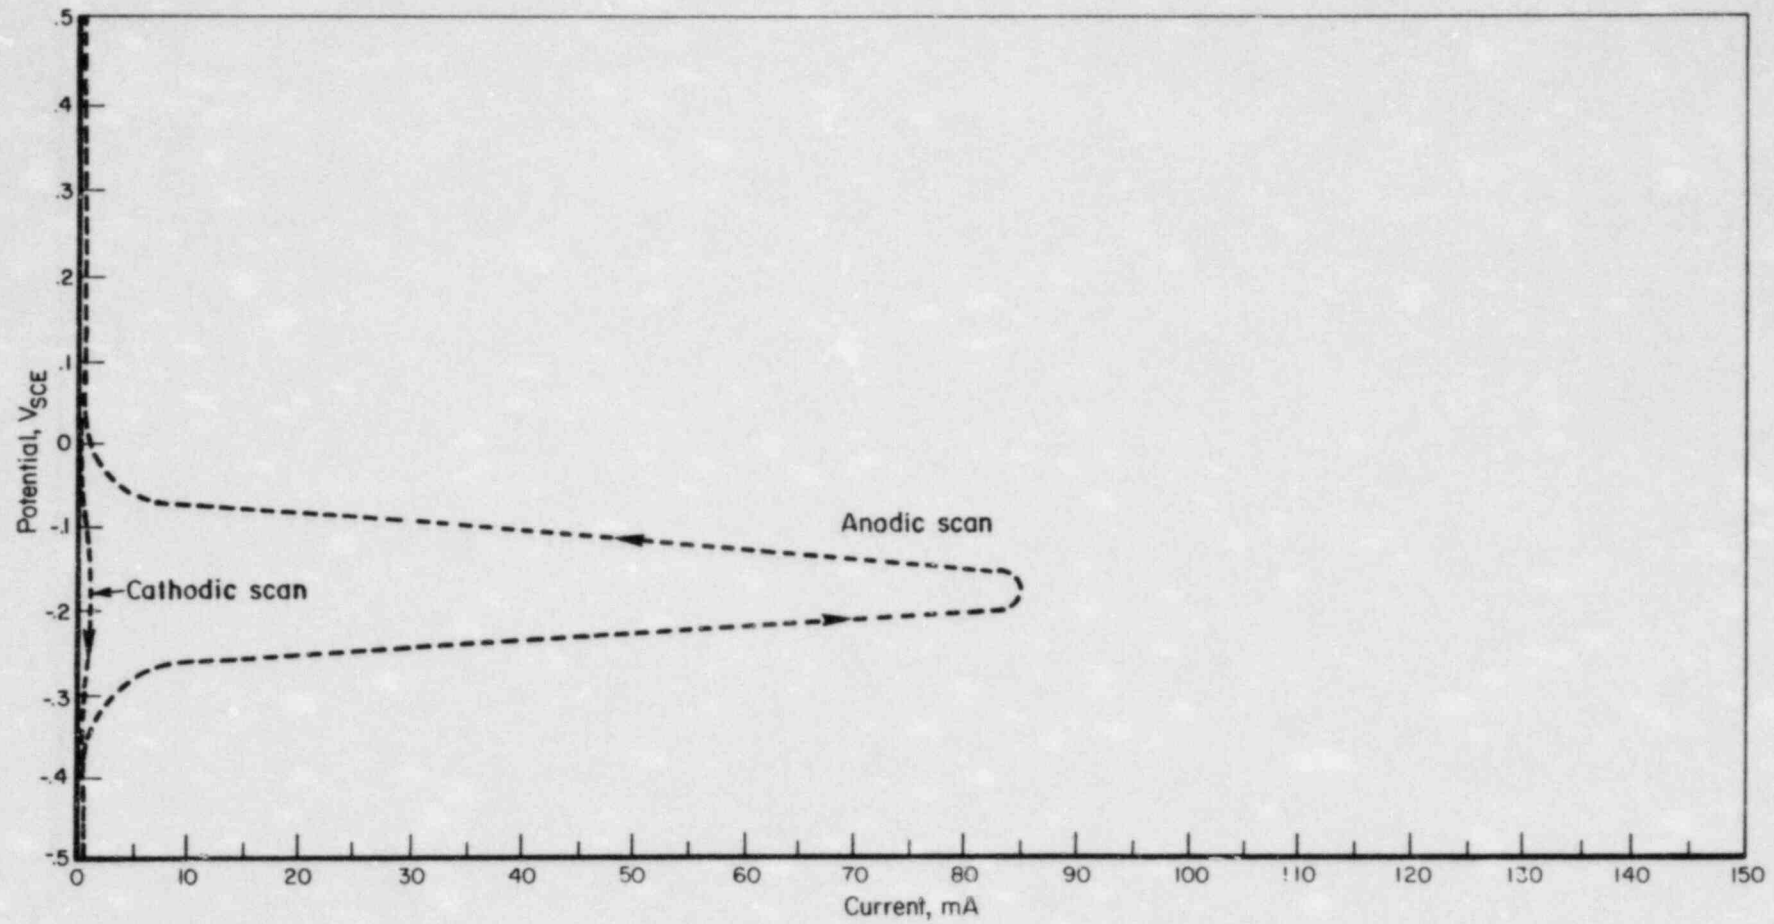
FIGURE 21. EPR CURVES FOR SAMPLES EPR-1 ID AND EPR-1 OD, AISI 304 STAINLESS STEEL PIPE REMOTE FROM THE REGION OF THE WELD

The same curve was obtained for both samples.
