SUBJECT: SALEM RESTART EVALUATION

NRC SAFETY EVALUATION
RELATED TO PLANT RESTART
PUBLIC SERVICE ELECTRIC & GAS COMPANY
SALEM NUCLEAR GENERATION STATION
UNIT NOS. 1 AND 2
DOCKET NOS. 50-272 AND 50-311

EVALUATION OF FAILURE TO TRIP
OF REACTOR TRIP CIRCUIT BREAKERS
ON FEBRUARY 22 AND 25, 1983
SALEM NUCLEAR GENERATING STATION UNIT 1

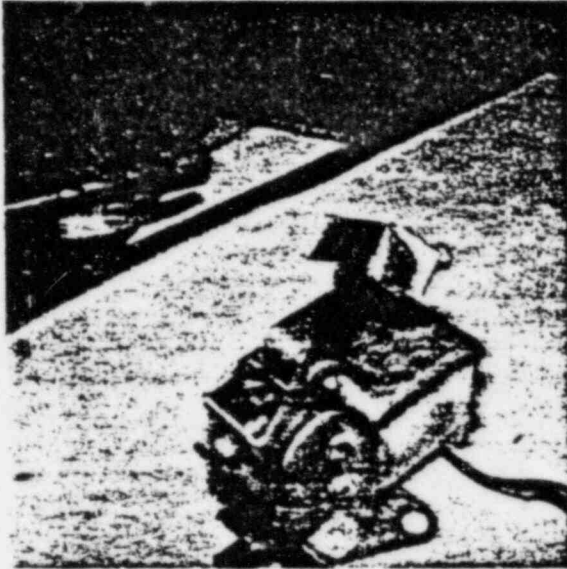
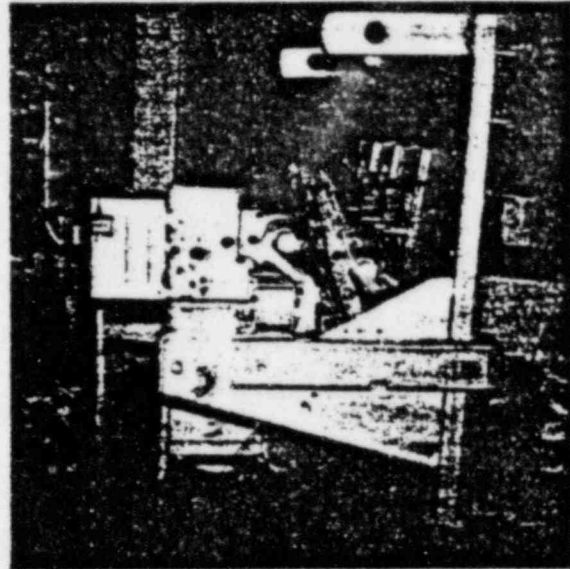
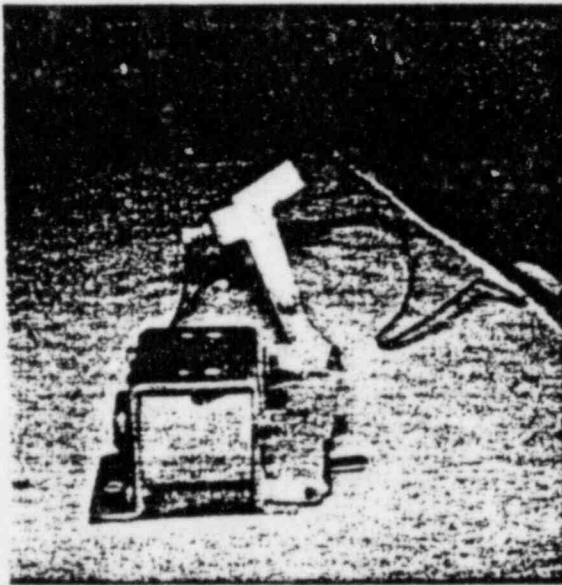
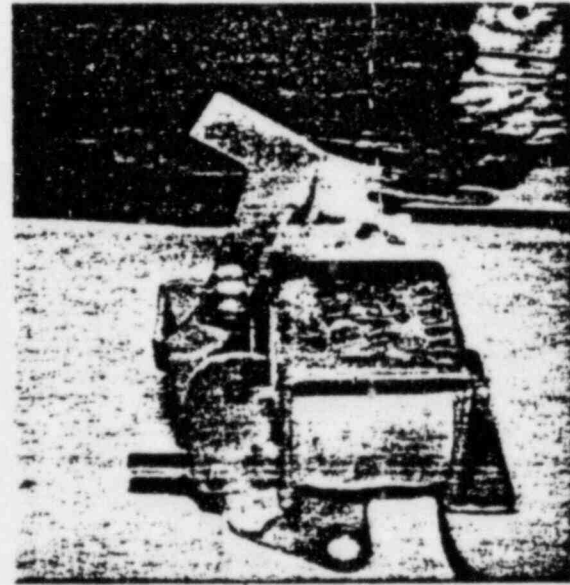
A. Undervoltage Trip Attachment
Top View

B. Undervoltage Trip Attachment
on Circuit Breaker

C. Undervoltage Trip Attachment
Side View

D. Undervoltage Trip Attachment
Side View

Figure 1. Unit 2 "B" Undervoltage Trip Attachment
(A, C, and D are photographs of the as-received condition.)

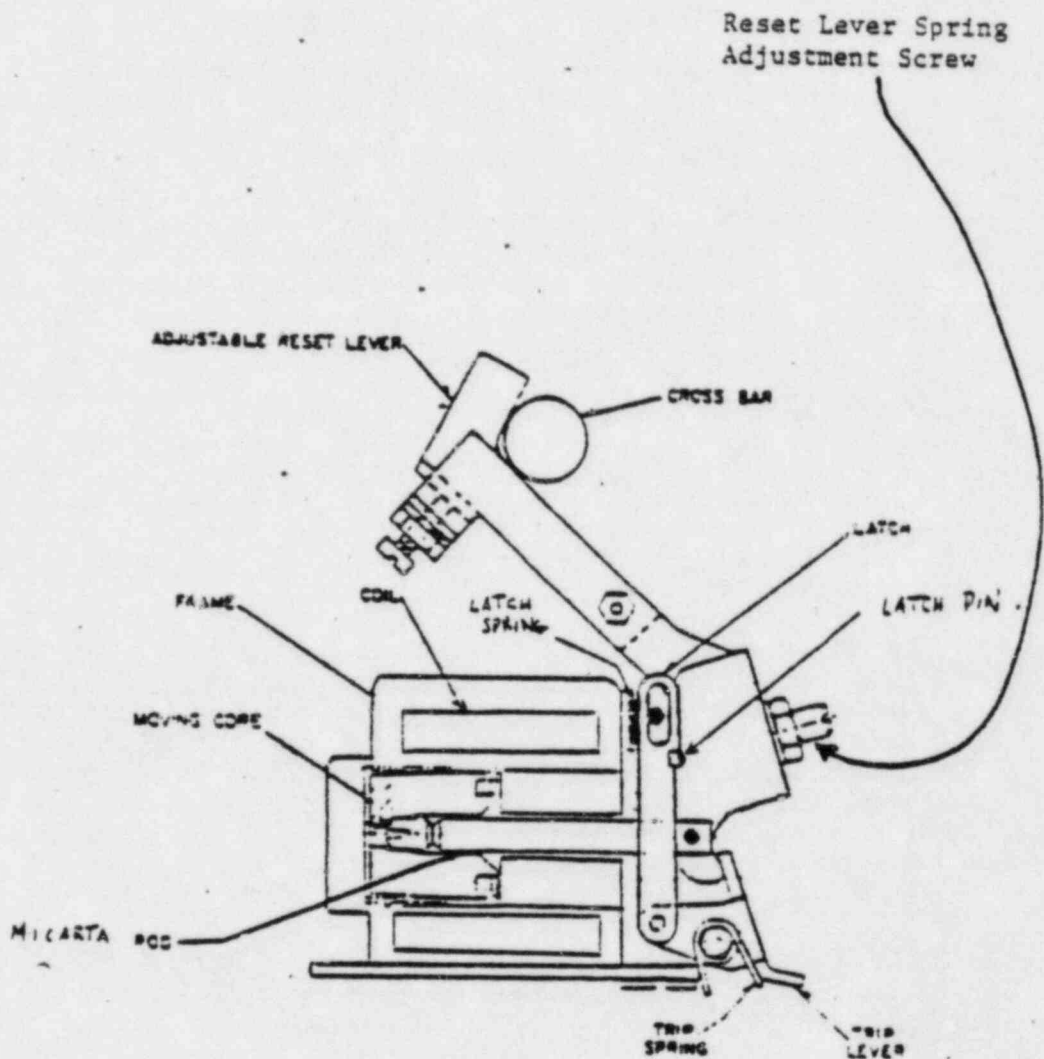
UNDERVOLTAGE TRIP ATTACHMENT

This indicates that the setting of the reset arm spring tension is critical to correct operation and that the as-found position of the adjustment is definitely below the desired level.
