Report No. 50-341/93029 (DRS)

Inspection of: Fermi Unit 2  
Newport, Michigan

FERMI 2 TURBINE GENERATOR FAILURE

DECEMBER 25, 1993

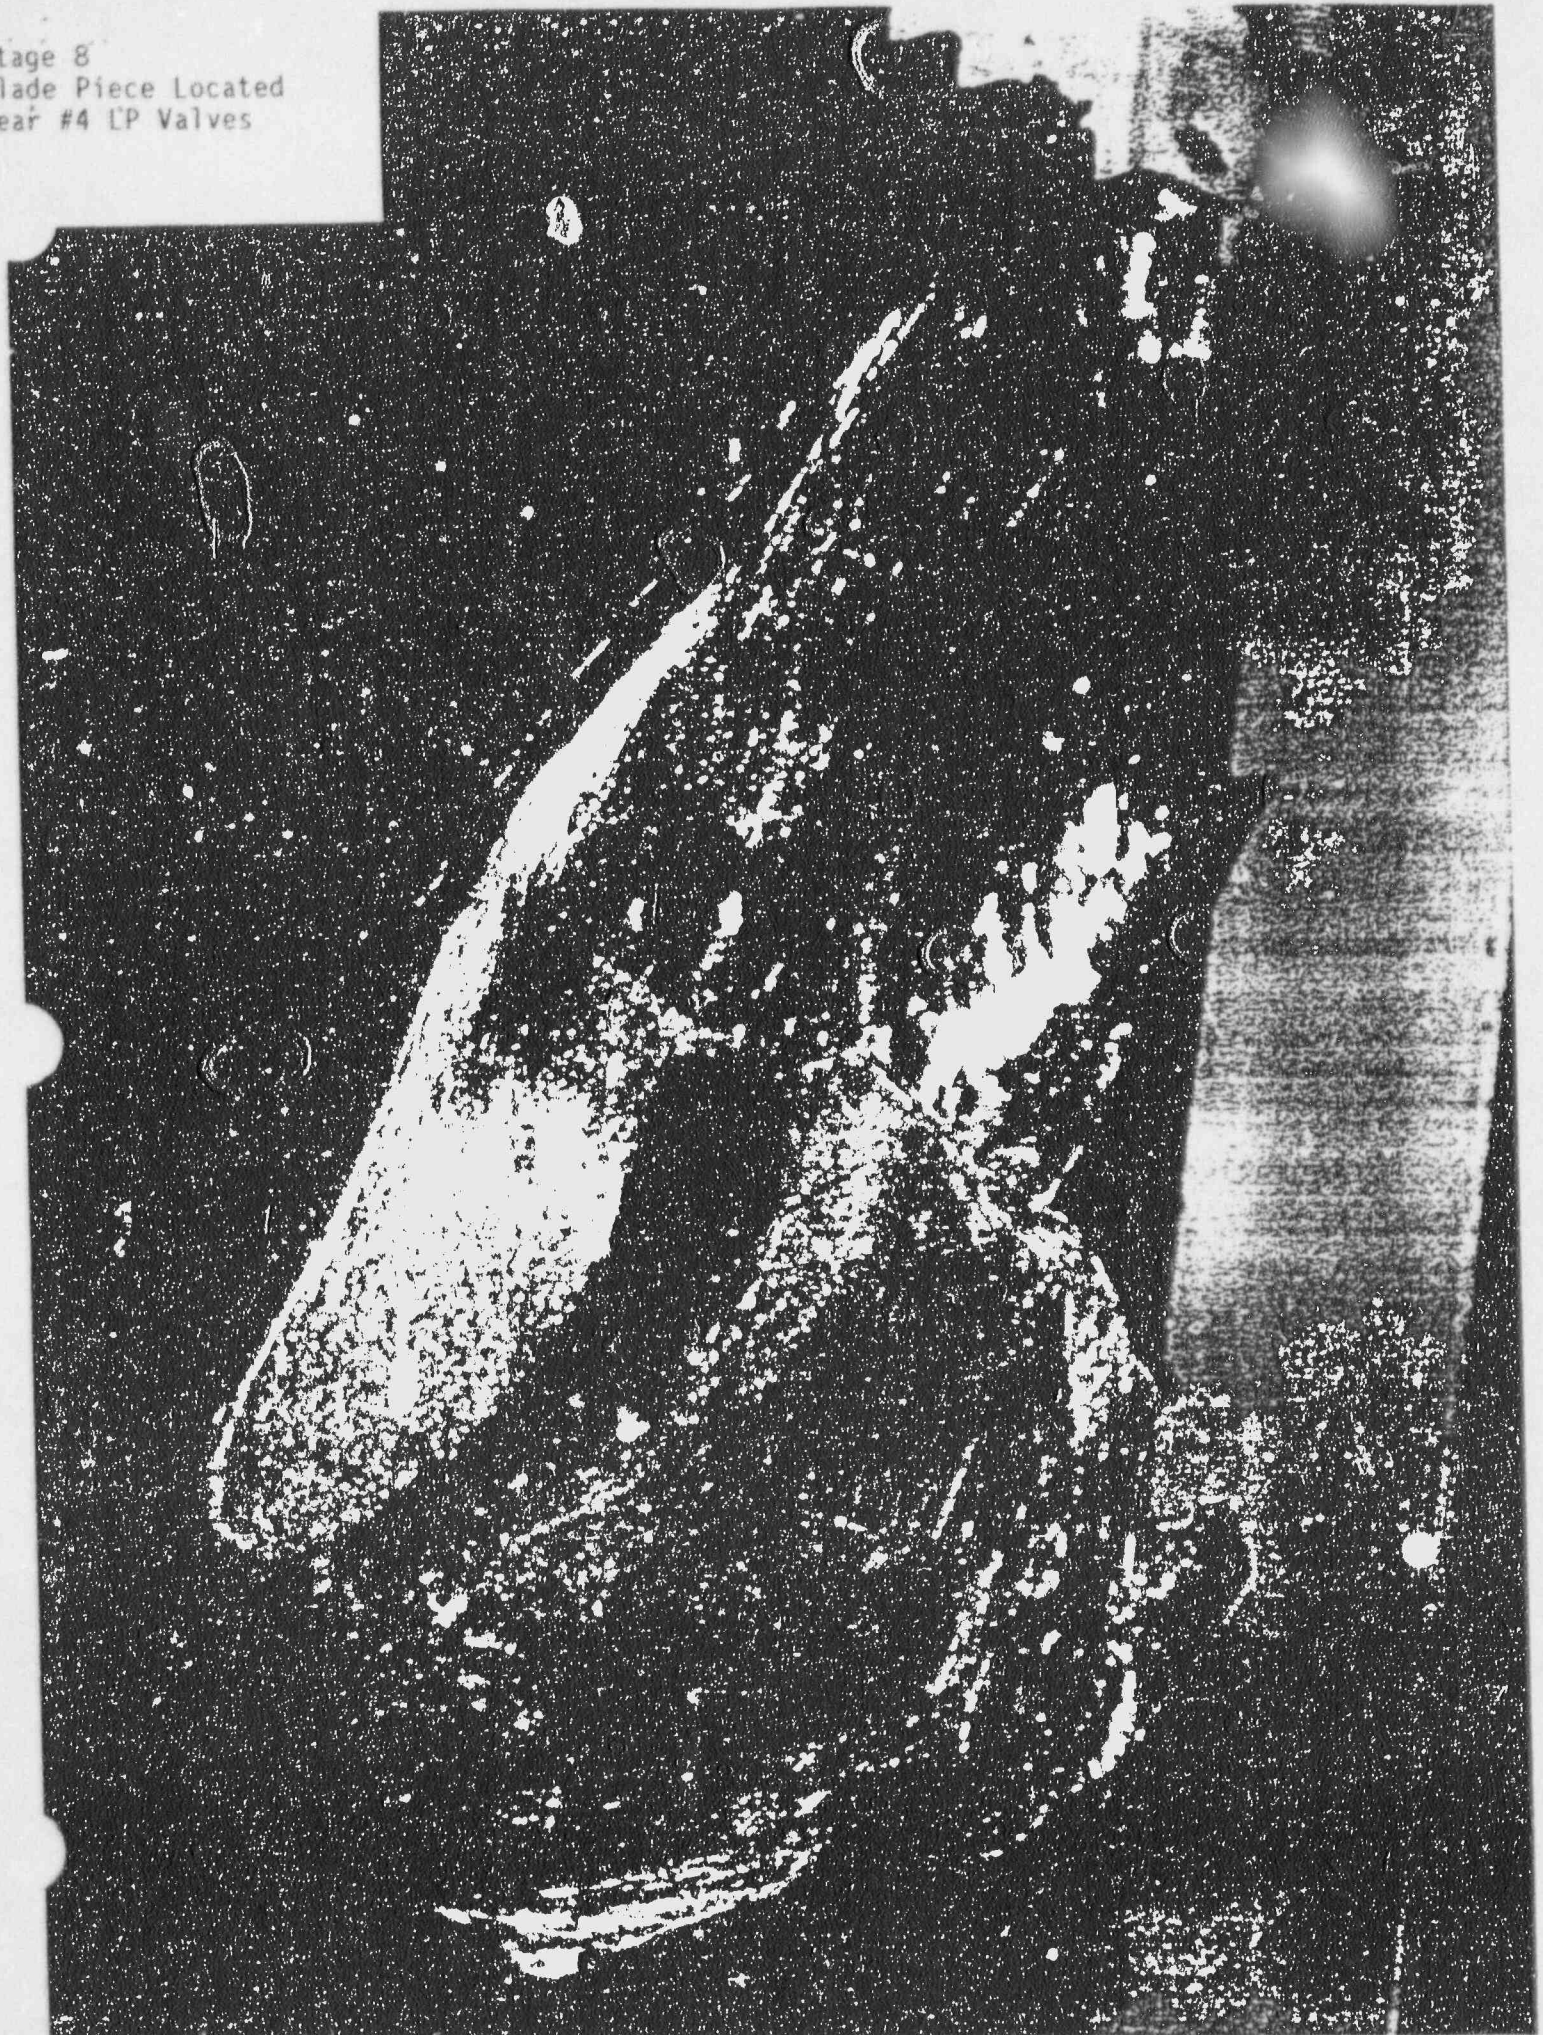
the turbine side Stage 8 wheel. At least 4 blades had broken off from the wheel. Some of the blade fragments fell into the condenser and severed condenser tubes; one blade fragment penetrated the turbine casing, hit a concrete ceiling above a Moisture Separator Reheater and landed on a catwalk. None of the fragments penetrated the turbine building. The fragments and turbine internal components have not been metallurgically examined; therefore, the blade failure mechanism has not been determined. The staff will review the licensee's root cause analysis regarding blade failure when completed.

Stage 8  
Blade Piece Located  
Near #4 LP Valves

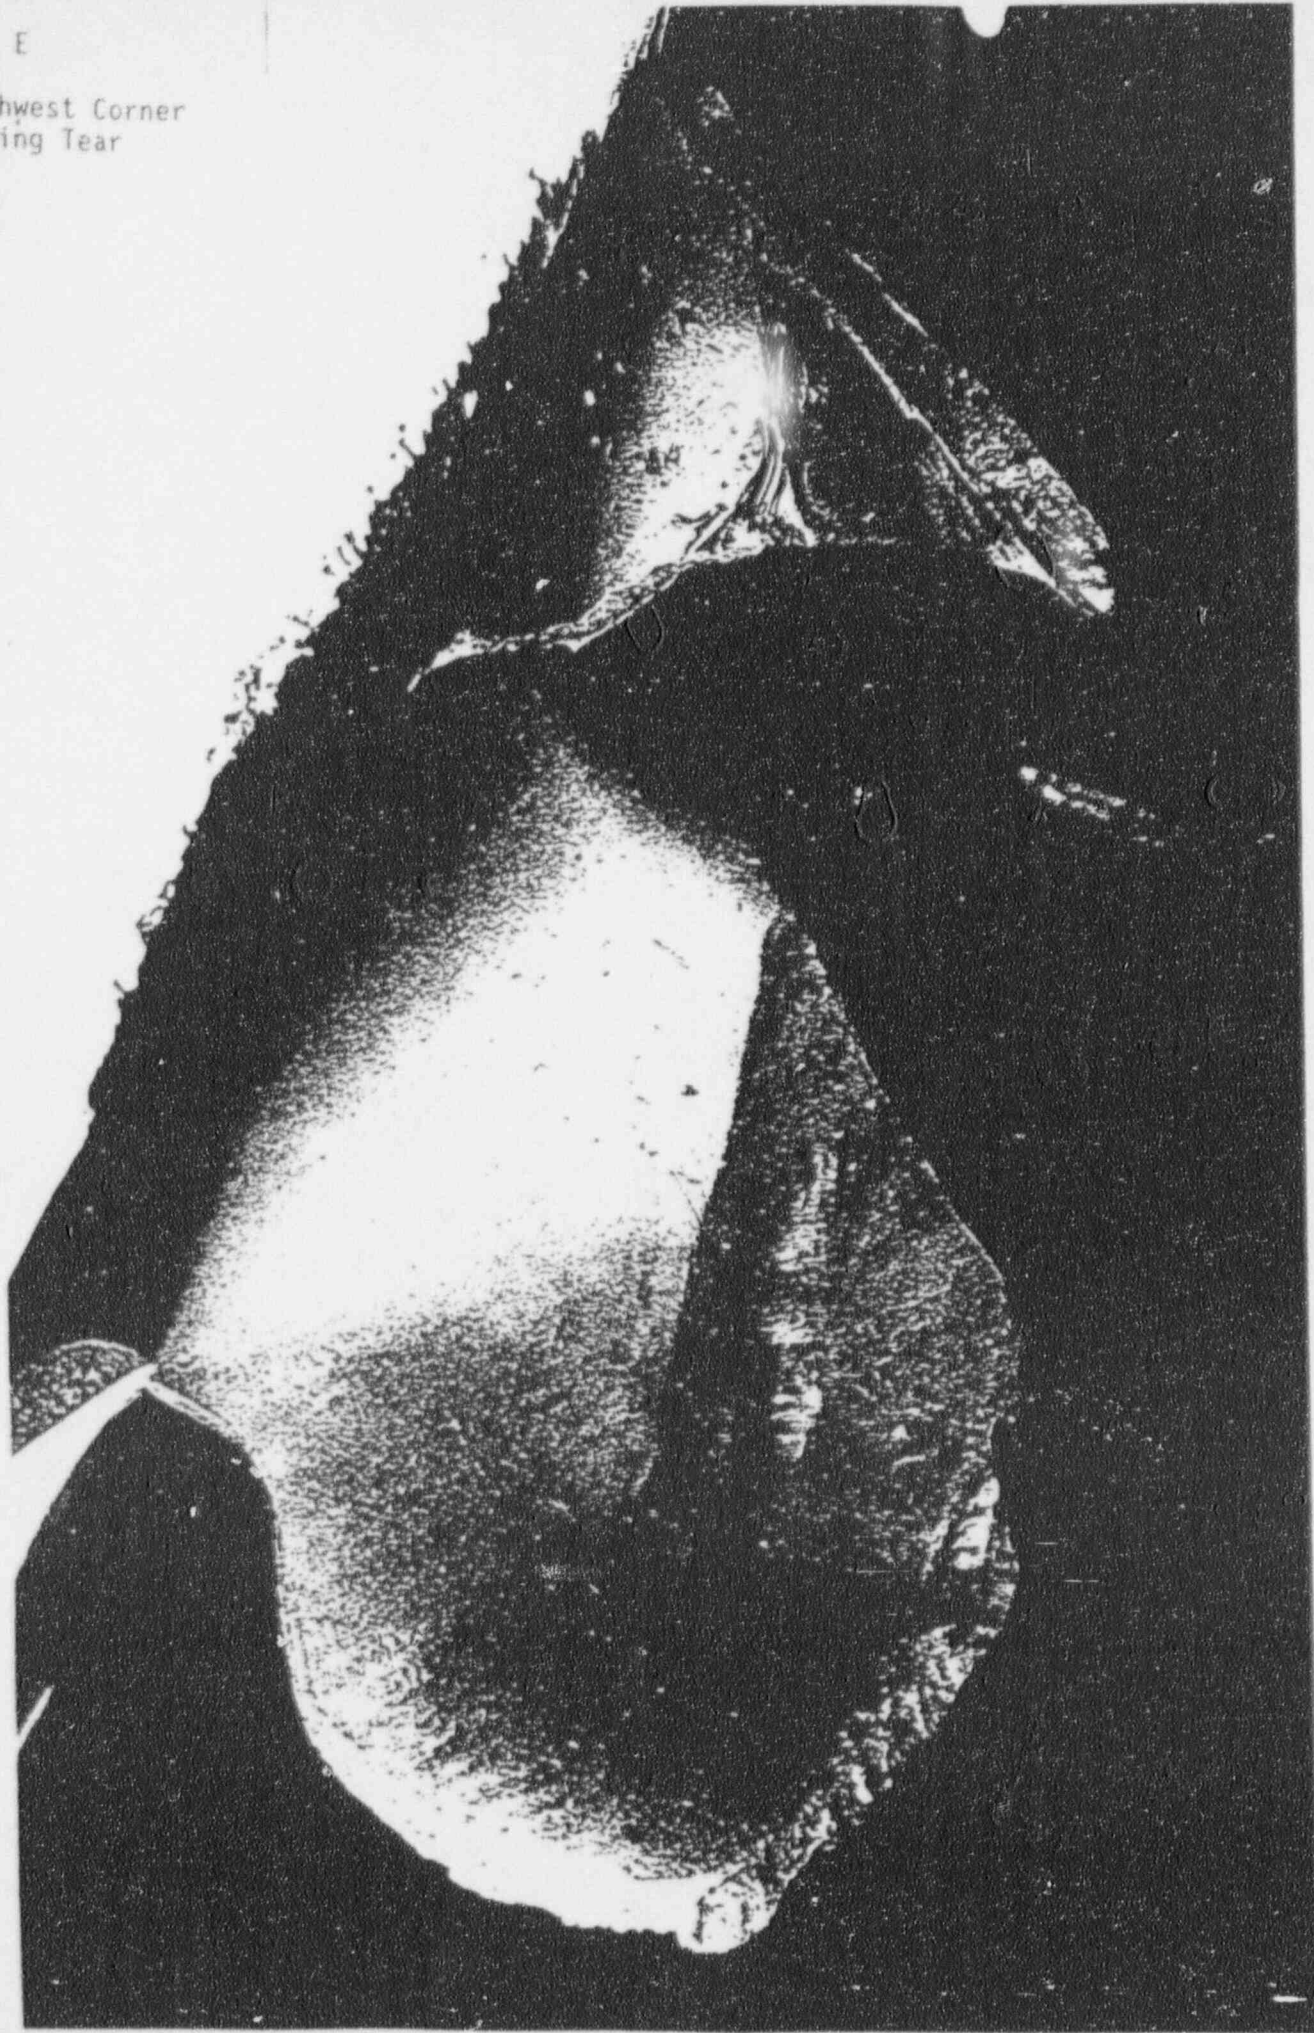
At the time of the AIT exit, the licensee had not removed the turbine casing; therefore, the full extent of damage to the HP and LP turbines was not evident. However, general observations revealed an elliptical perforation about 1 foot by 3 feet on the portion of the LP3 turbine casing that surrounds

LP3 Northwest Corner  
Housing Tear

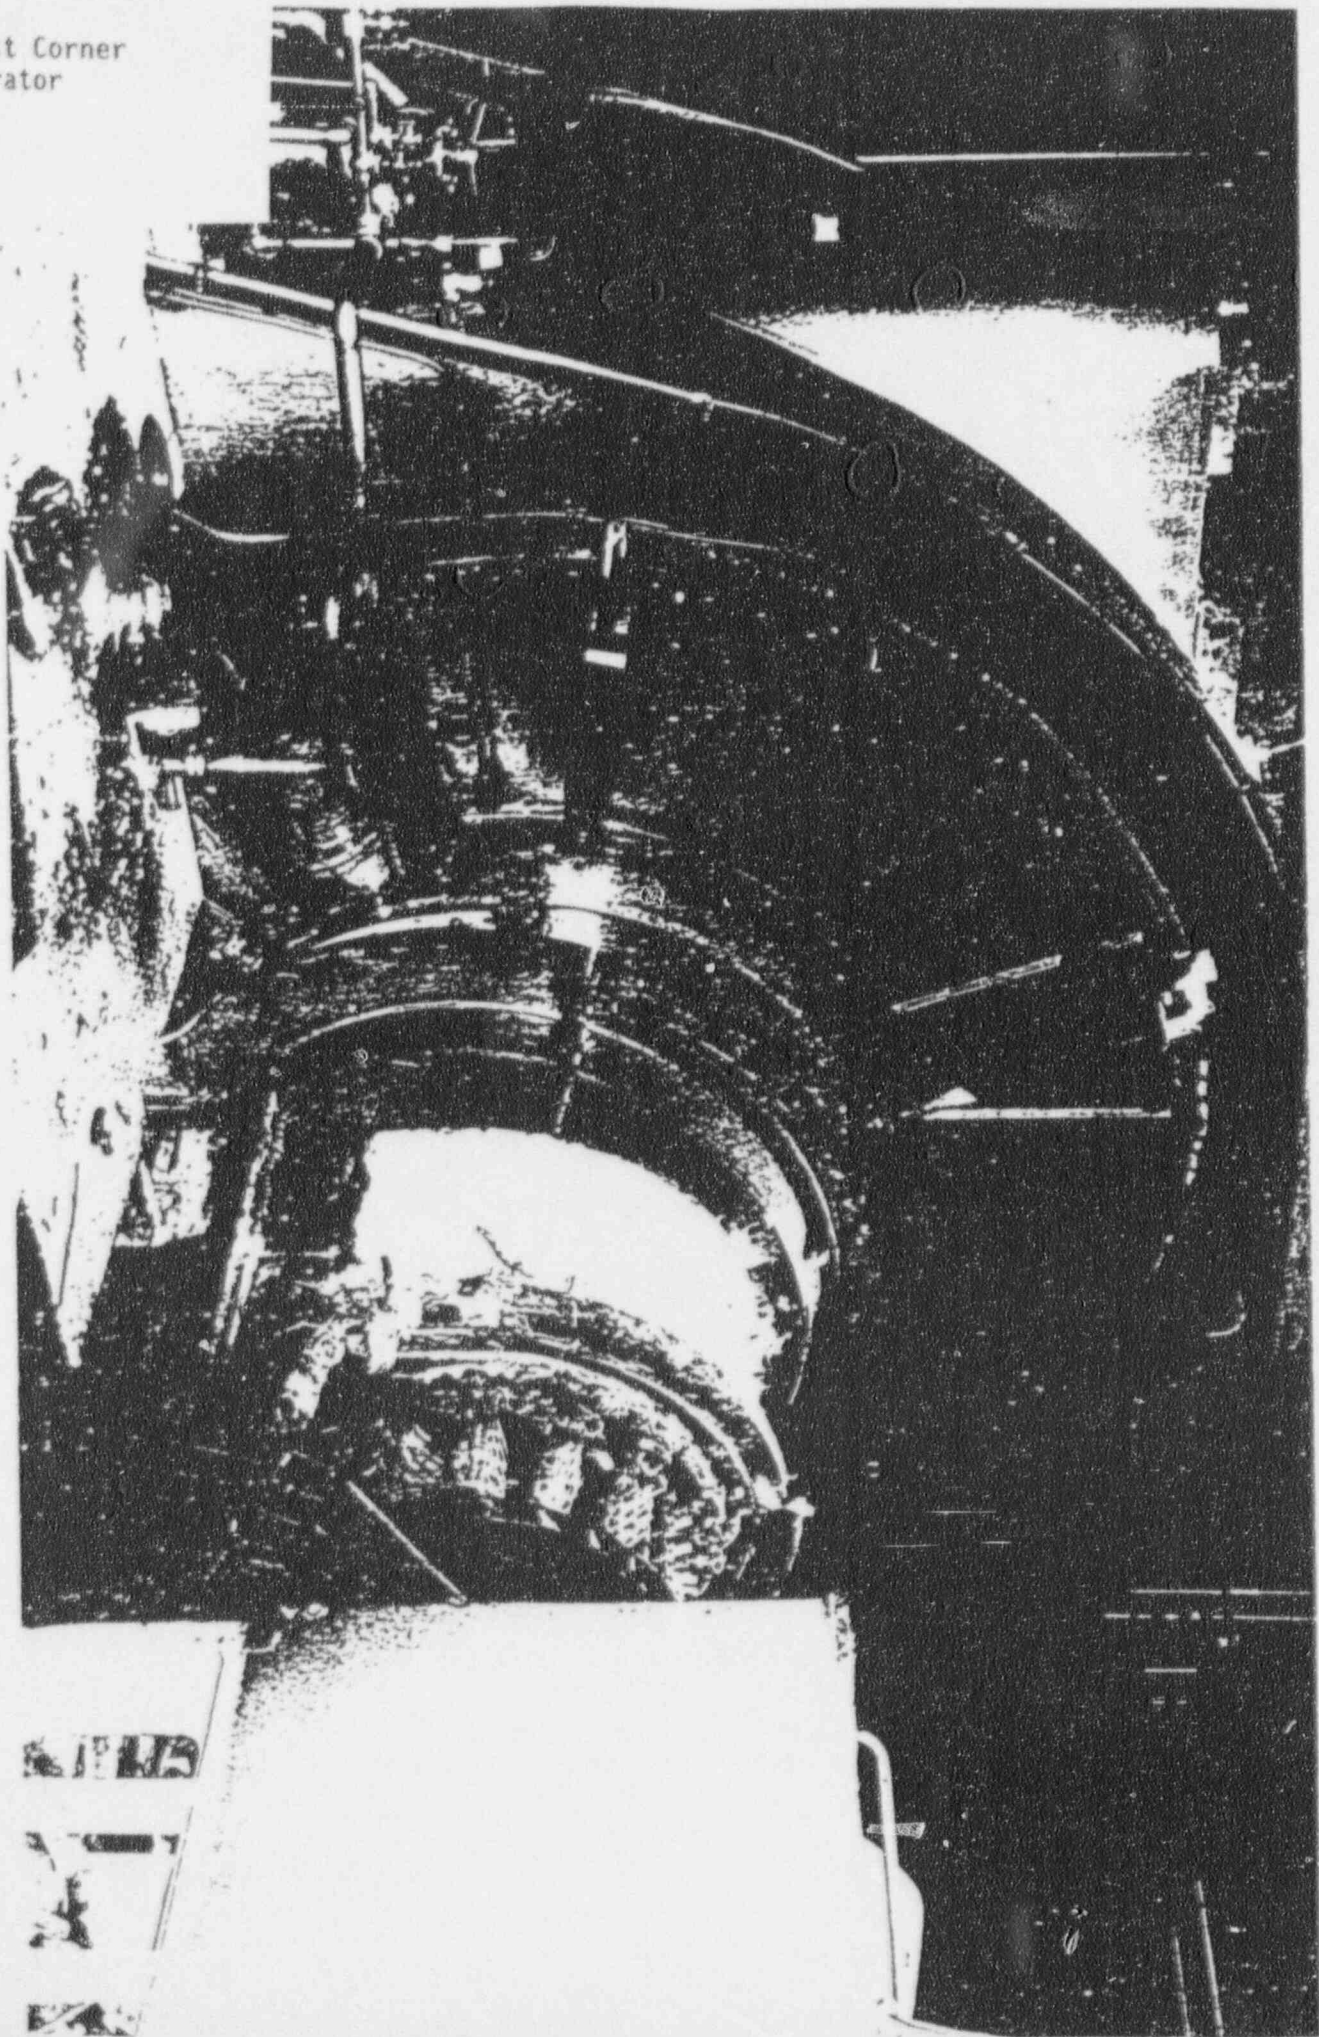
Southwest Corner  
of Generator

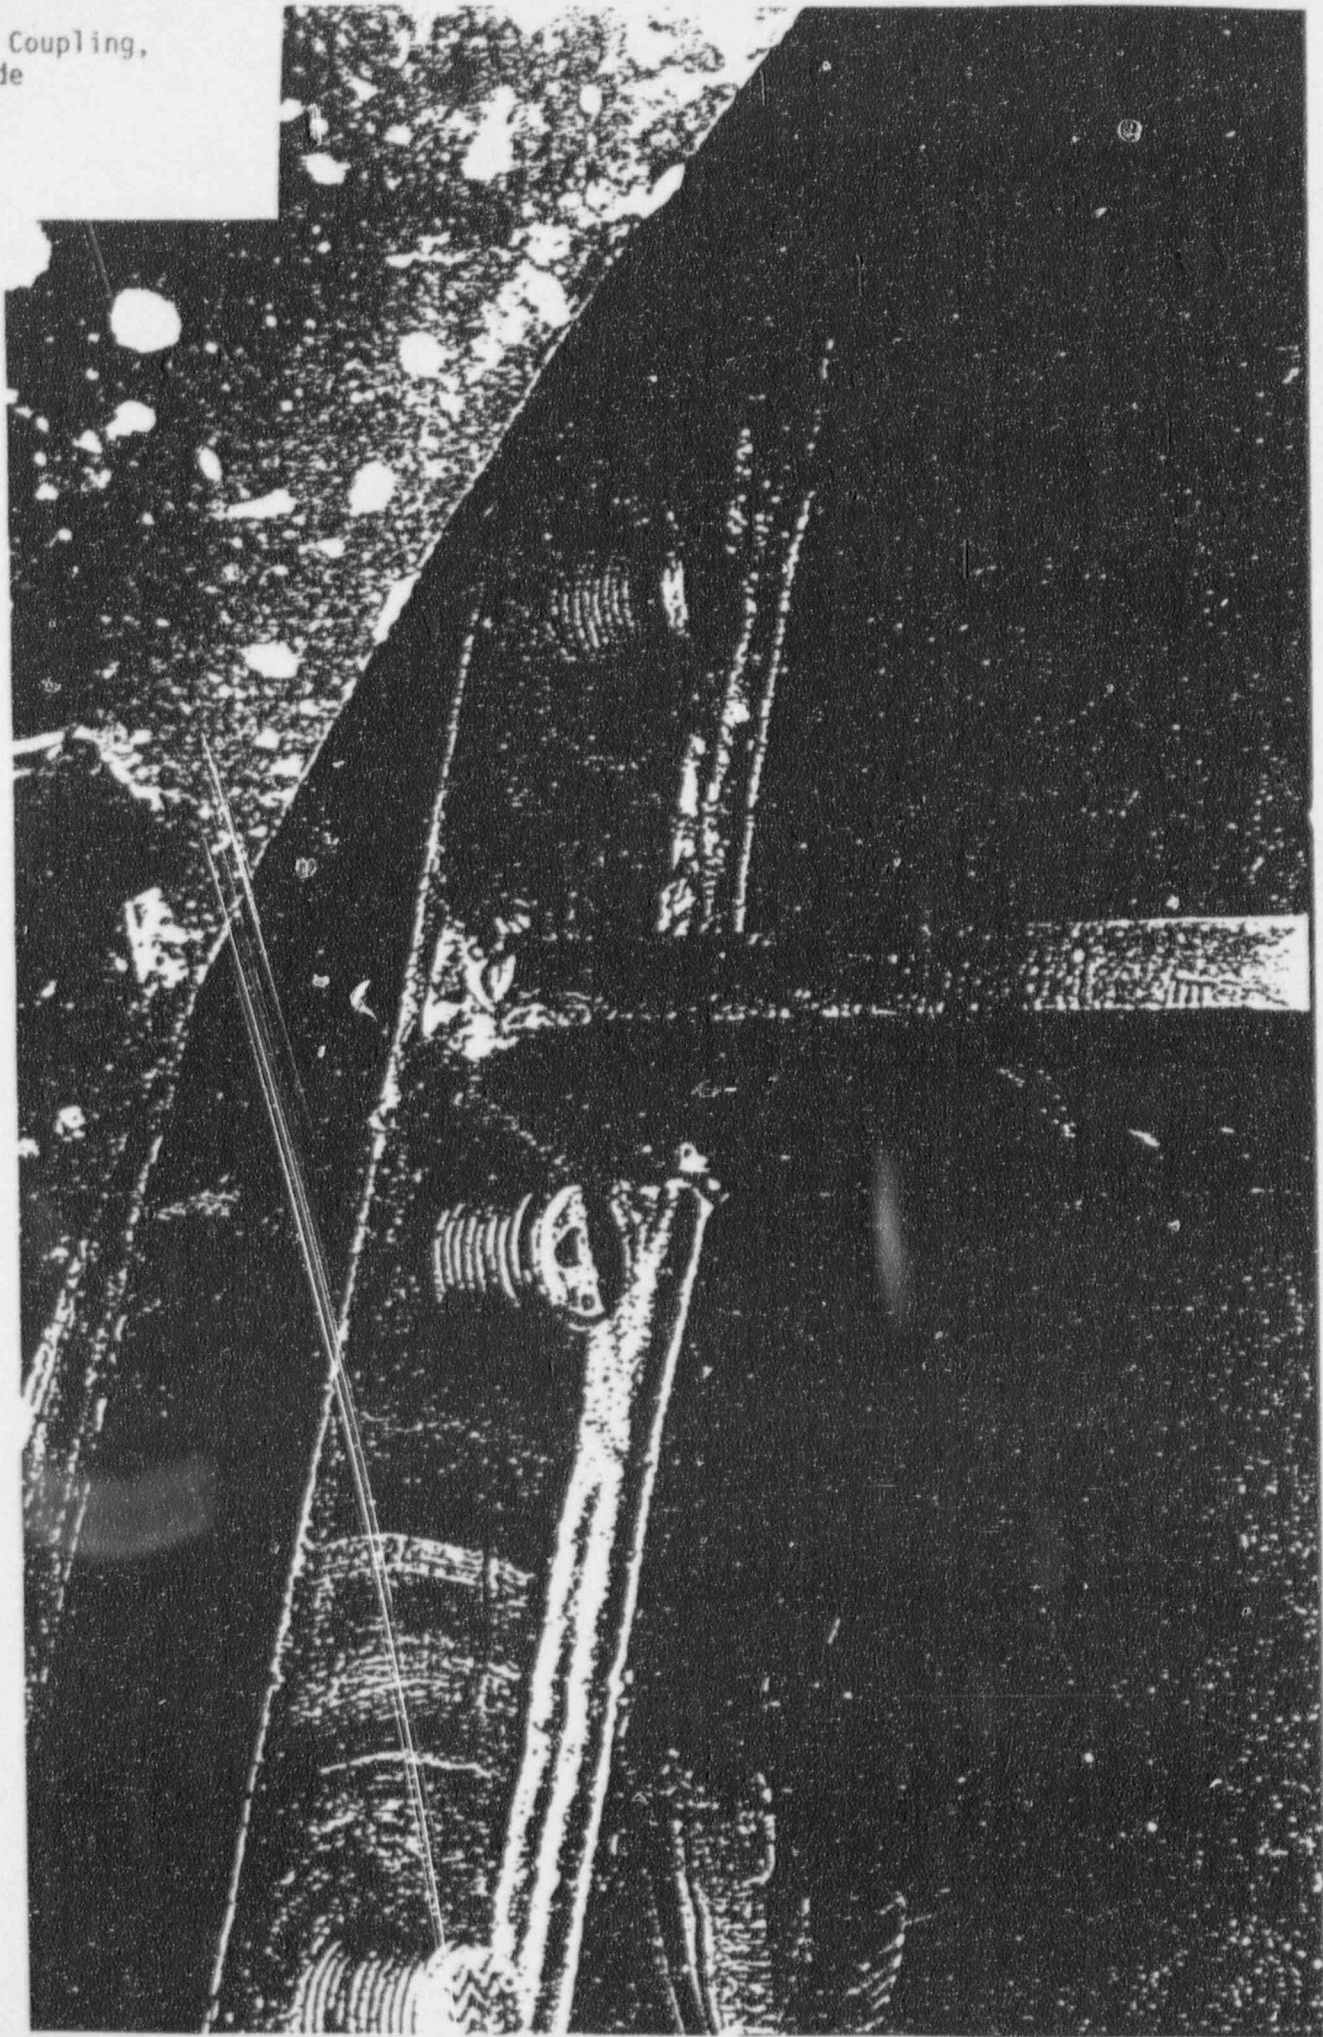
Turbine Coupling,  
East Side

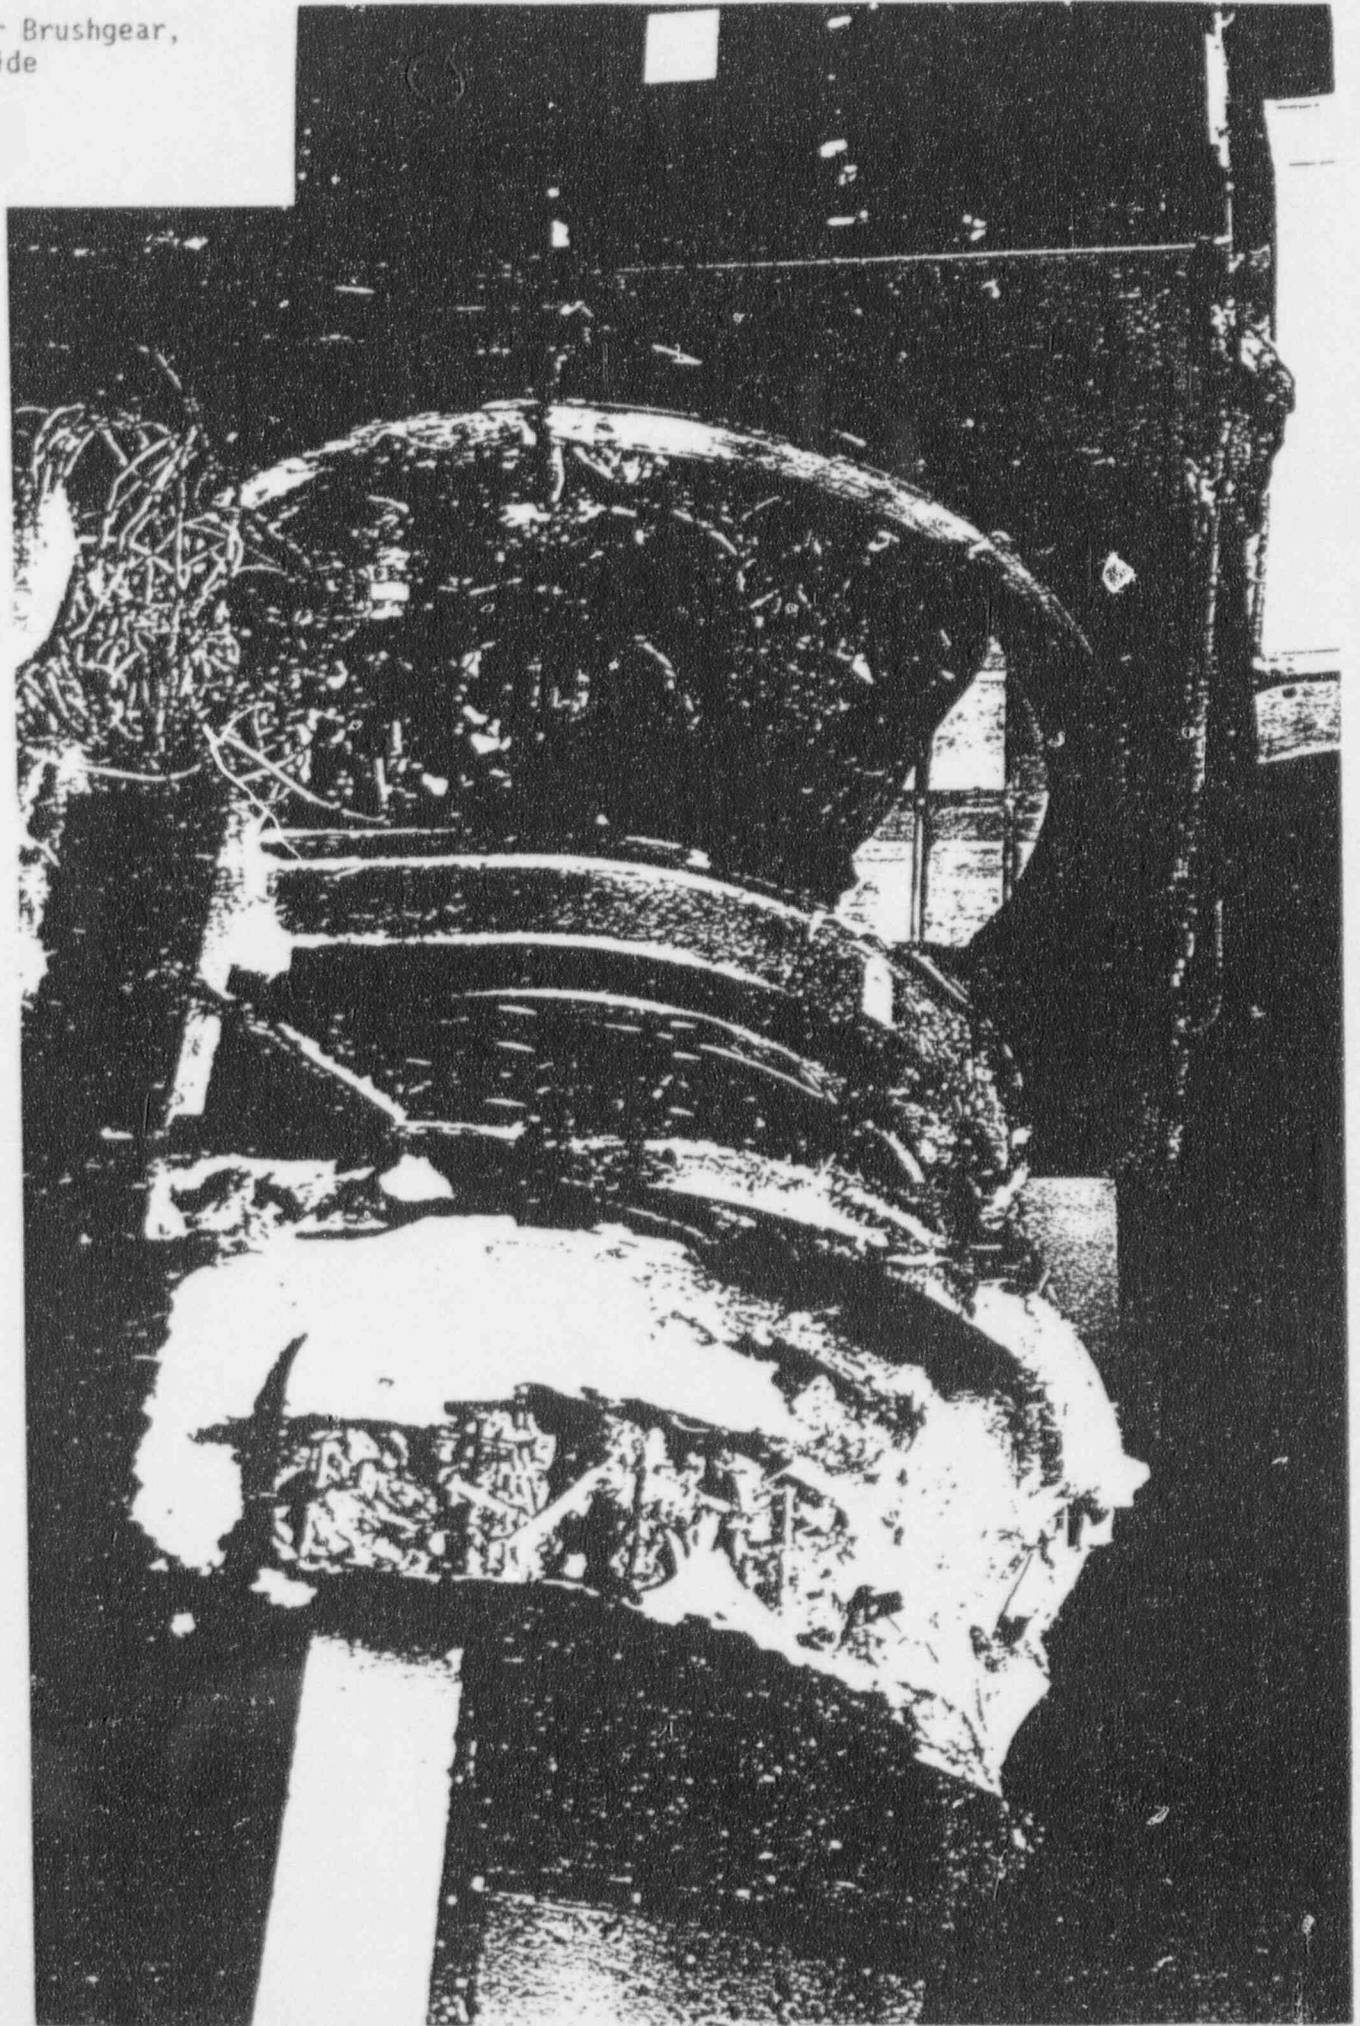
- 1:51 p.m.: the Frenchtown Fire Department was called.
- 1:52 p.m.: an Unusual Event was declared based on a potential fire. The full fire brigade mustered and entered the turbine building. Fire was observed in the exciter brushes and some burning metal pieces were observed that had been expelled from the generator and exciter. The fires were extinguished using a portable CO2 extinguisher (brushes) and by kicking water on the burning metal pieces.

Exciter Brushgear,  
East Side
