Washington Public Power Supply System

Subject: NUCLEAR PROJECT NO. 2
10CFR PART 21 - REPORT ON 3/4" SA-106 GRADE B PIPE
SUPPLIED BY GUYON ALLOYS

WASHINGTON PUBLIC POWER SUPPLY SYSTEM
NUCLEAR PROJECT NO. 2
DOCKET NO. 50-397
LICENSE NO. CPPR-93
10CFR PART 21 REPORT ON 3/4" SA 106 GRADE PIPE
SUPPLIED BY GUYON ALLOYS

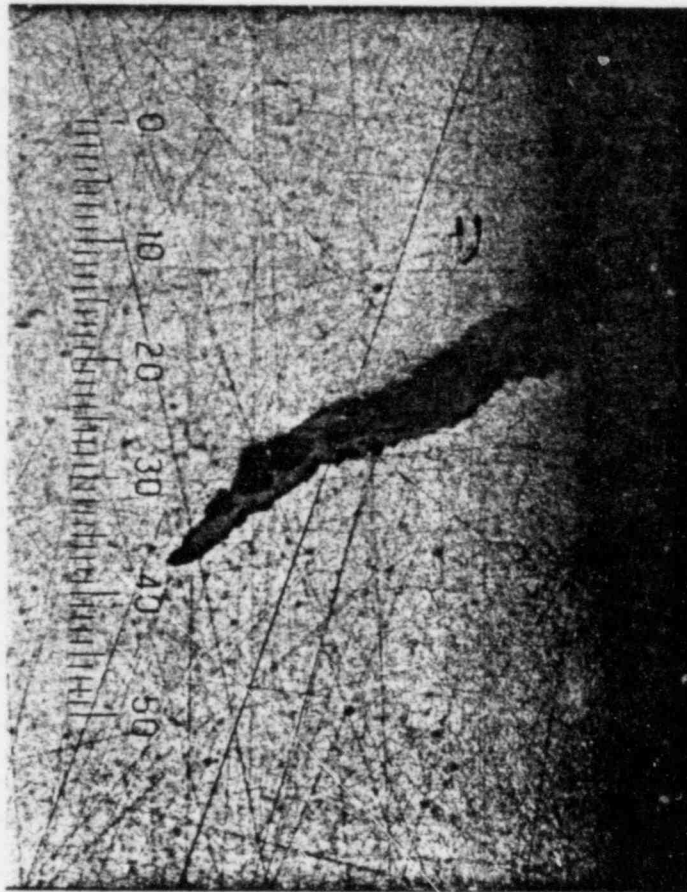
The overfill laps termed "left lap" and "right lap" angle towards each other as would be expected based on the US Steel explanation of overfill laps. Left lap on Sample "A" which becomes Right lap on opposite side Sample "B" appears by use of the photomicrograph scale provided by the laboratory to have a radial depth of 0.032" on Sample "A" reducing to a radial depth of 0.026" on Sample "B". Right lap on Sample "A" which becomes Left lap on opposite side Sample "B" likewise appears to have a radial depth of 0.023" reducing to a radial depth of 0.016".

Mag. 75X - Side B - Right lap

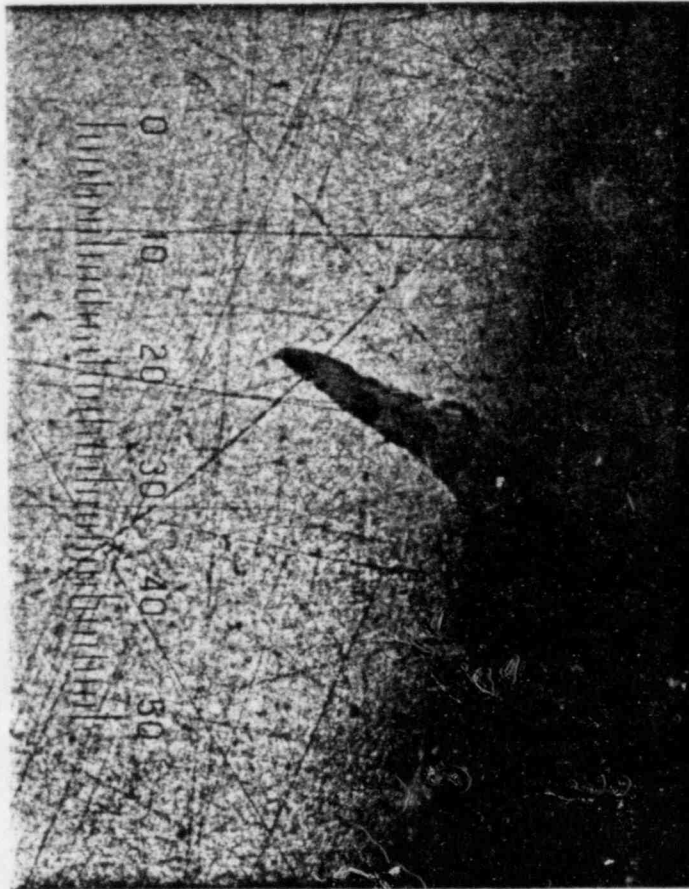
Mag. 75X - Side B - left lap

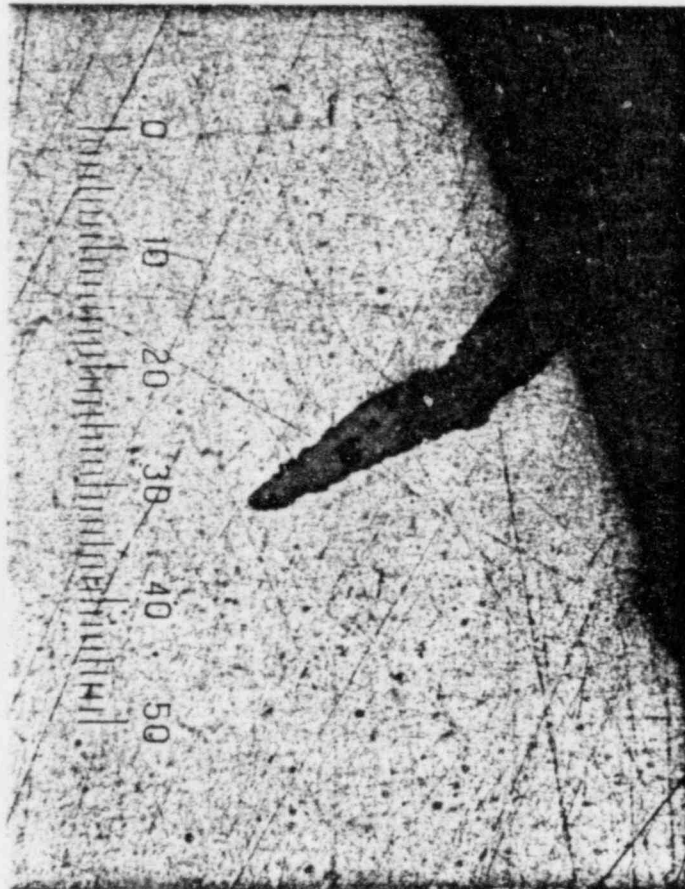
Mag. 75X - Side A - Right lap

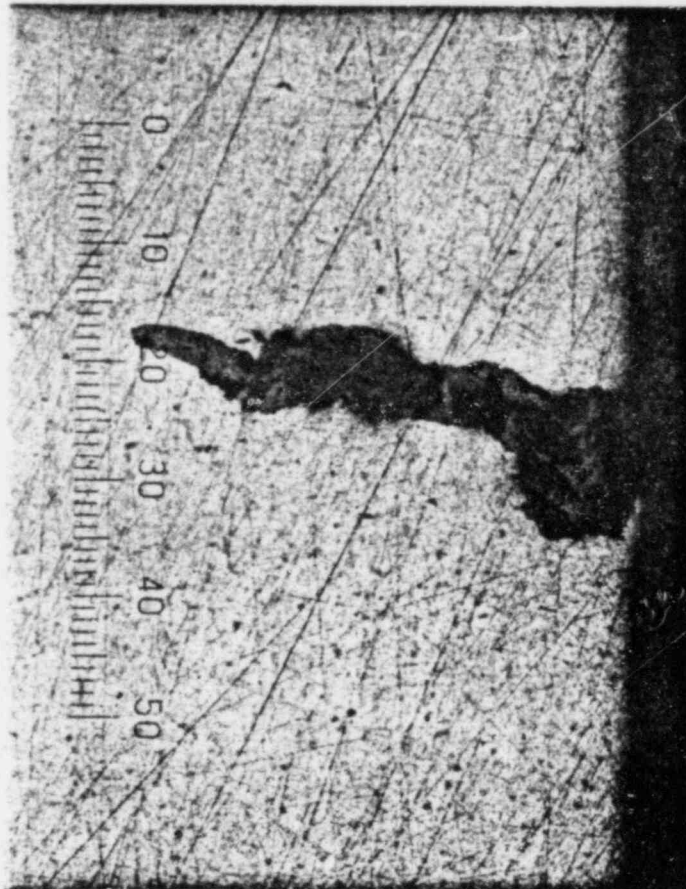
Mag. 75X - Side A - Left lap

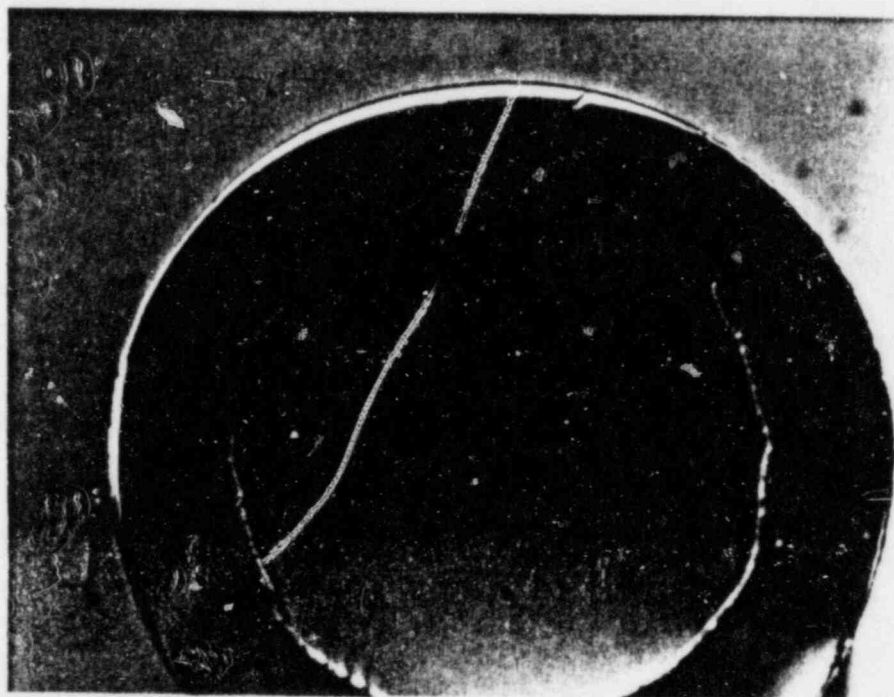
Sample "B"

RESULTS : The submitted sample was polished for macroscopic examination. Macrophotographs, showing approximately 3.5X magnification, shows the relative orientation and depths of the laps.
