Washington Public Power Supply System

Subject: NUCLEAR PROJECT NO. 2
10CFR50.55(e) REPORTABLE CONDITIONS #37, #49, #54, #60,
#64, and #82; DEFICIENCIES IN ELECTRICAL SEPARATION

WASHINGTON PUBLIC POWER SUPPLY SYSTEM
NUCLEAR PROJECT NO. 2
DOCKET NO. 50-397
LICENSE NO. CPPR-93

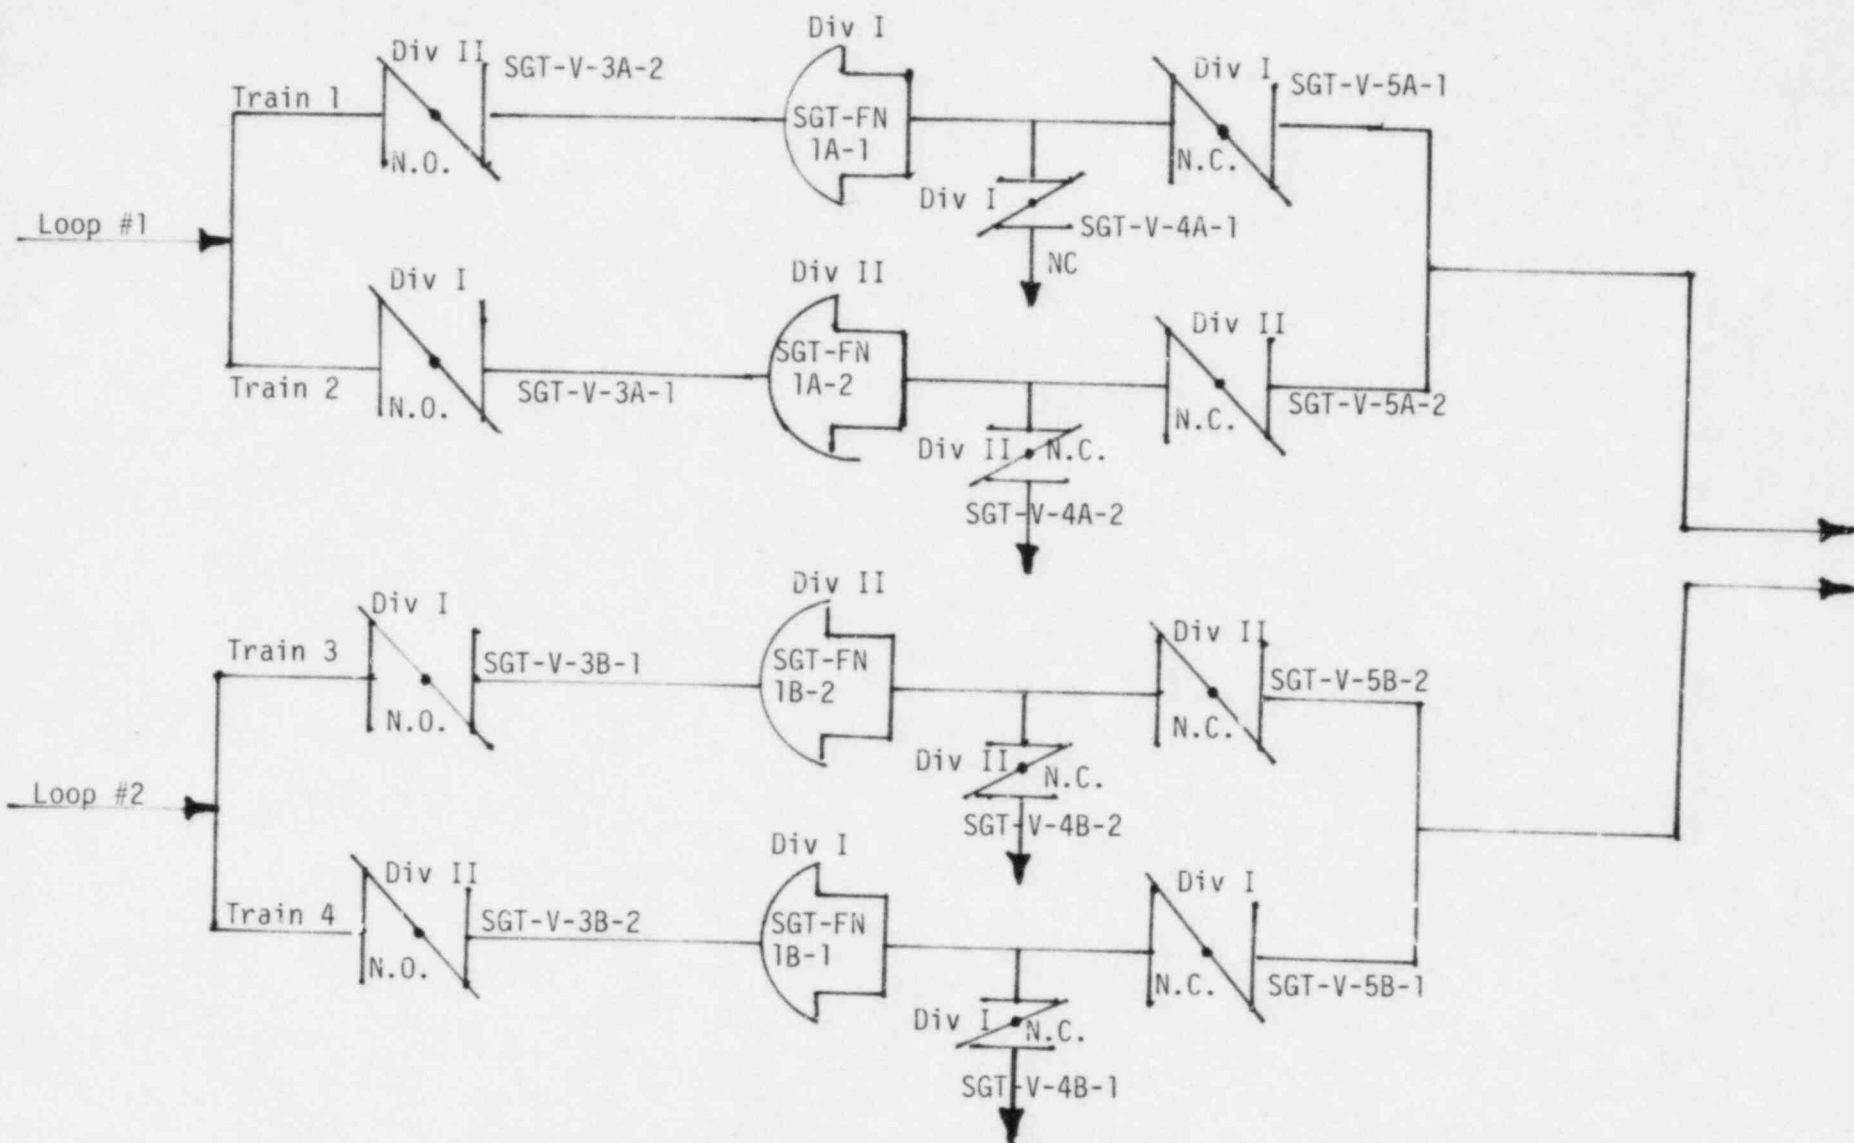
FLOW DIAGRAM

As shown on the attached flow diagram, there exists electrically operated dampers to control the mode of operation of each train (e.g., isolation, recirculation or exhaust). Also depicted on the attached diagram is the source of power for each motor operated damper and fan.

It may be postulated that due to the system design which provides power from two redundant electrical divisions to dampers in each fan train, both Standby Gas Treatment System loops from a single event may be made non-functional.

Since all the damper control circuits in a given division are currently routed in a common enclosure and in common cable trays a fault generated fire could damage adjacent cables and cause spurious signals to be sent to the dampers, causing all the dampers powered from a single division to close and thus cause both SGTS trains to become inoperative (see attached sketch).

The Architect Engineer, Burns and Roe, Inc., will provide a Project Engineering Directive (PED) by April 30, 1983 to re-route the circuits for dampers SGT-V-3A-2 and SGT-V-3B-1 such that a single event, similar to that described above, could not disable the SGTS. This will entail a review of the circuits for the two dampers and re-route of portions located in the same raceways and enclosures with other damper circuits with the disabling capability discussed above.
