Examination of Crystal River Unit #3 Steam Generator Tube Sections

TR-103756

Final Report, January 1994

B&W NUCLEAR TECHNOLOGIES
Special Products & Integrated Services Division
and
THE BABCOCK & WILCOX COMPANY
Nuclear Environmental Services, Inc.

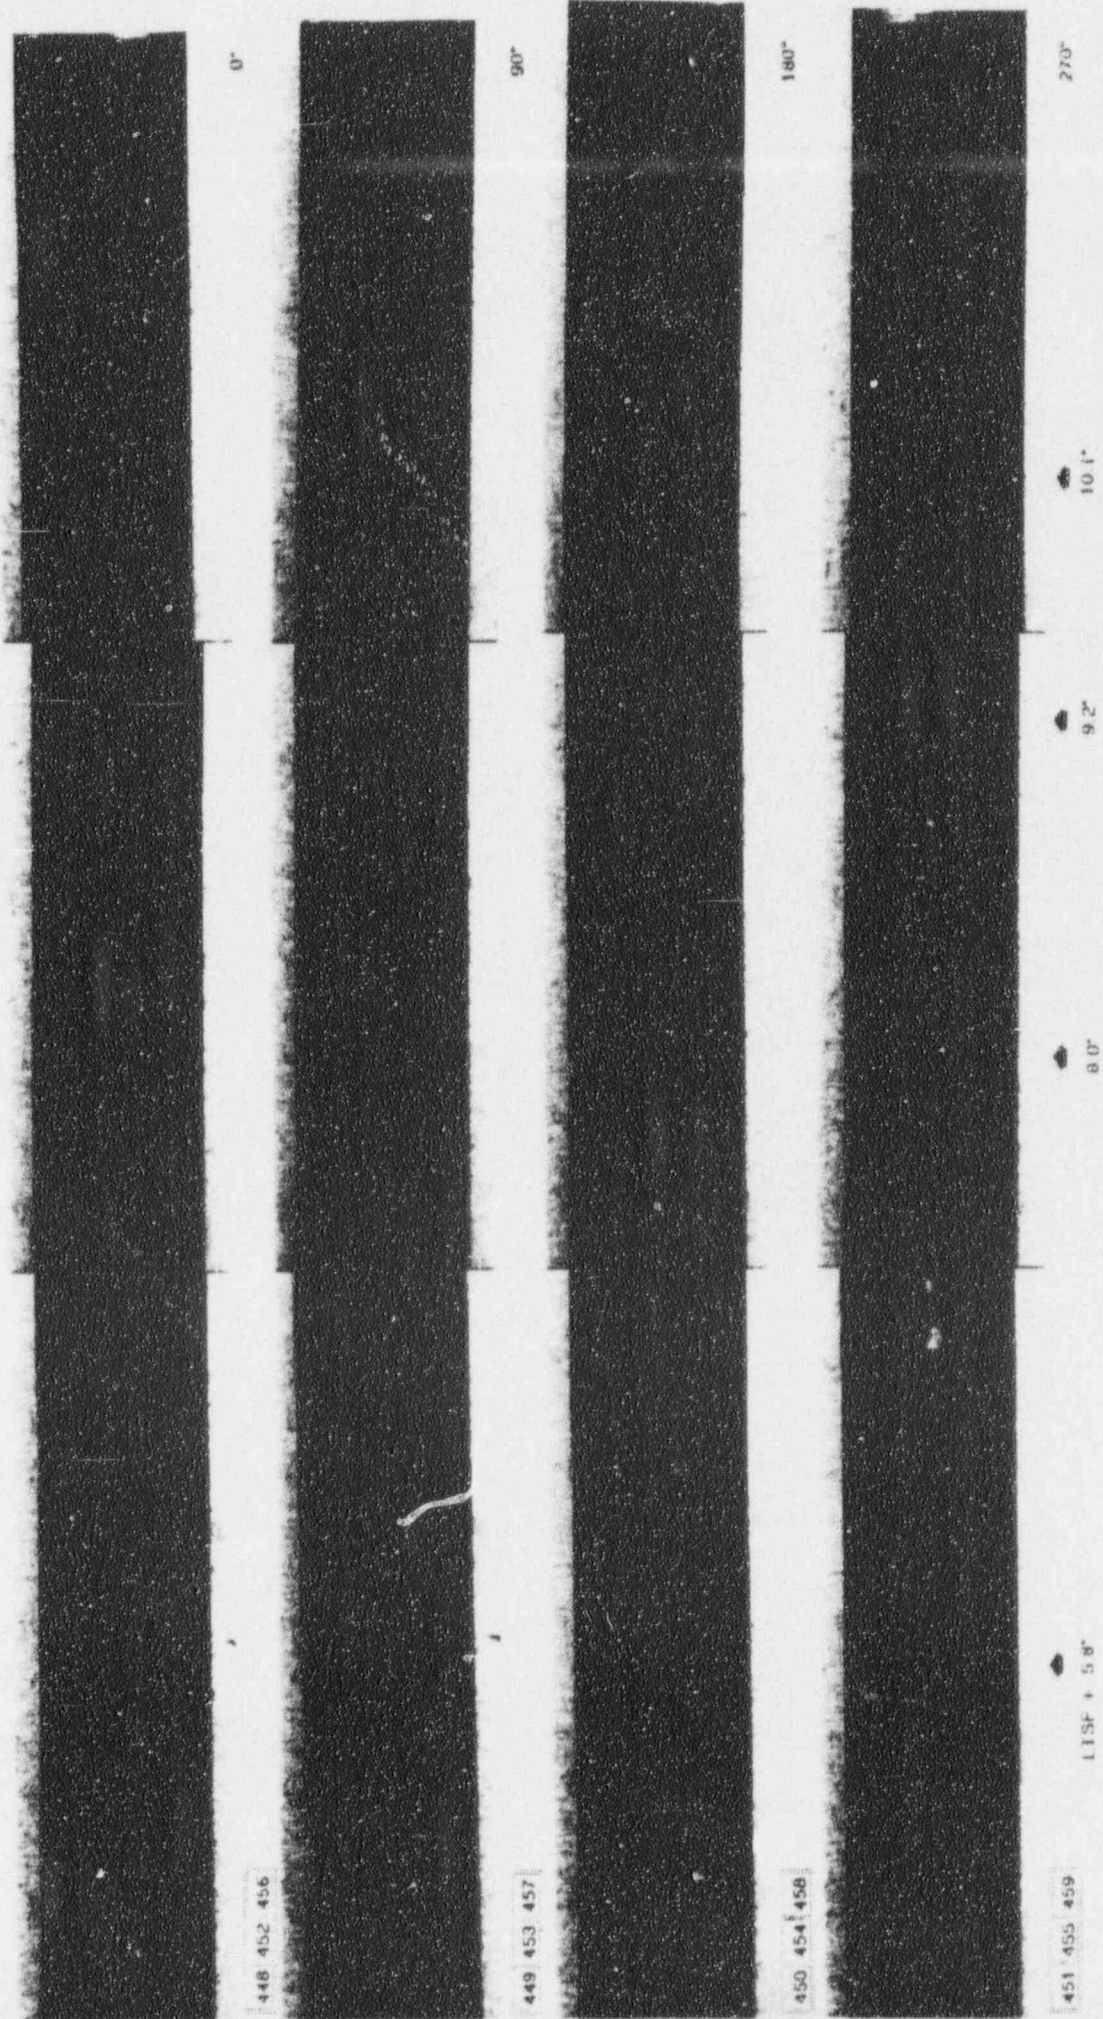
Figure 2.7: Tube Section 52-51-2, Freespan above LTSF As Received

Tube Section 52-51-2: The scalloped patterns were less prevalent in the 0° orientation. Also, coarser scallop patterns were present along the 180° and 270° orientations. A half inch wide circumferential band of relatively smooth uniform deposit was noted 19 inches above the LTSF; immediately adjacent to and on either side of this band, the scallop patterns were very coarse and appeared to have some significant depth (see Fig. 2-13). A 3/8 inch wide circumferential band of apparently deep scallop patterns was observed about 21 inches above the LTSF (see Fig. 2-14).

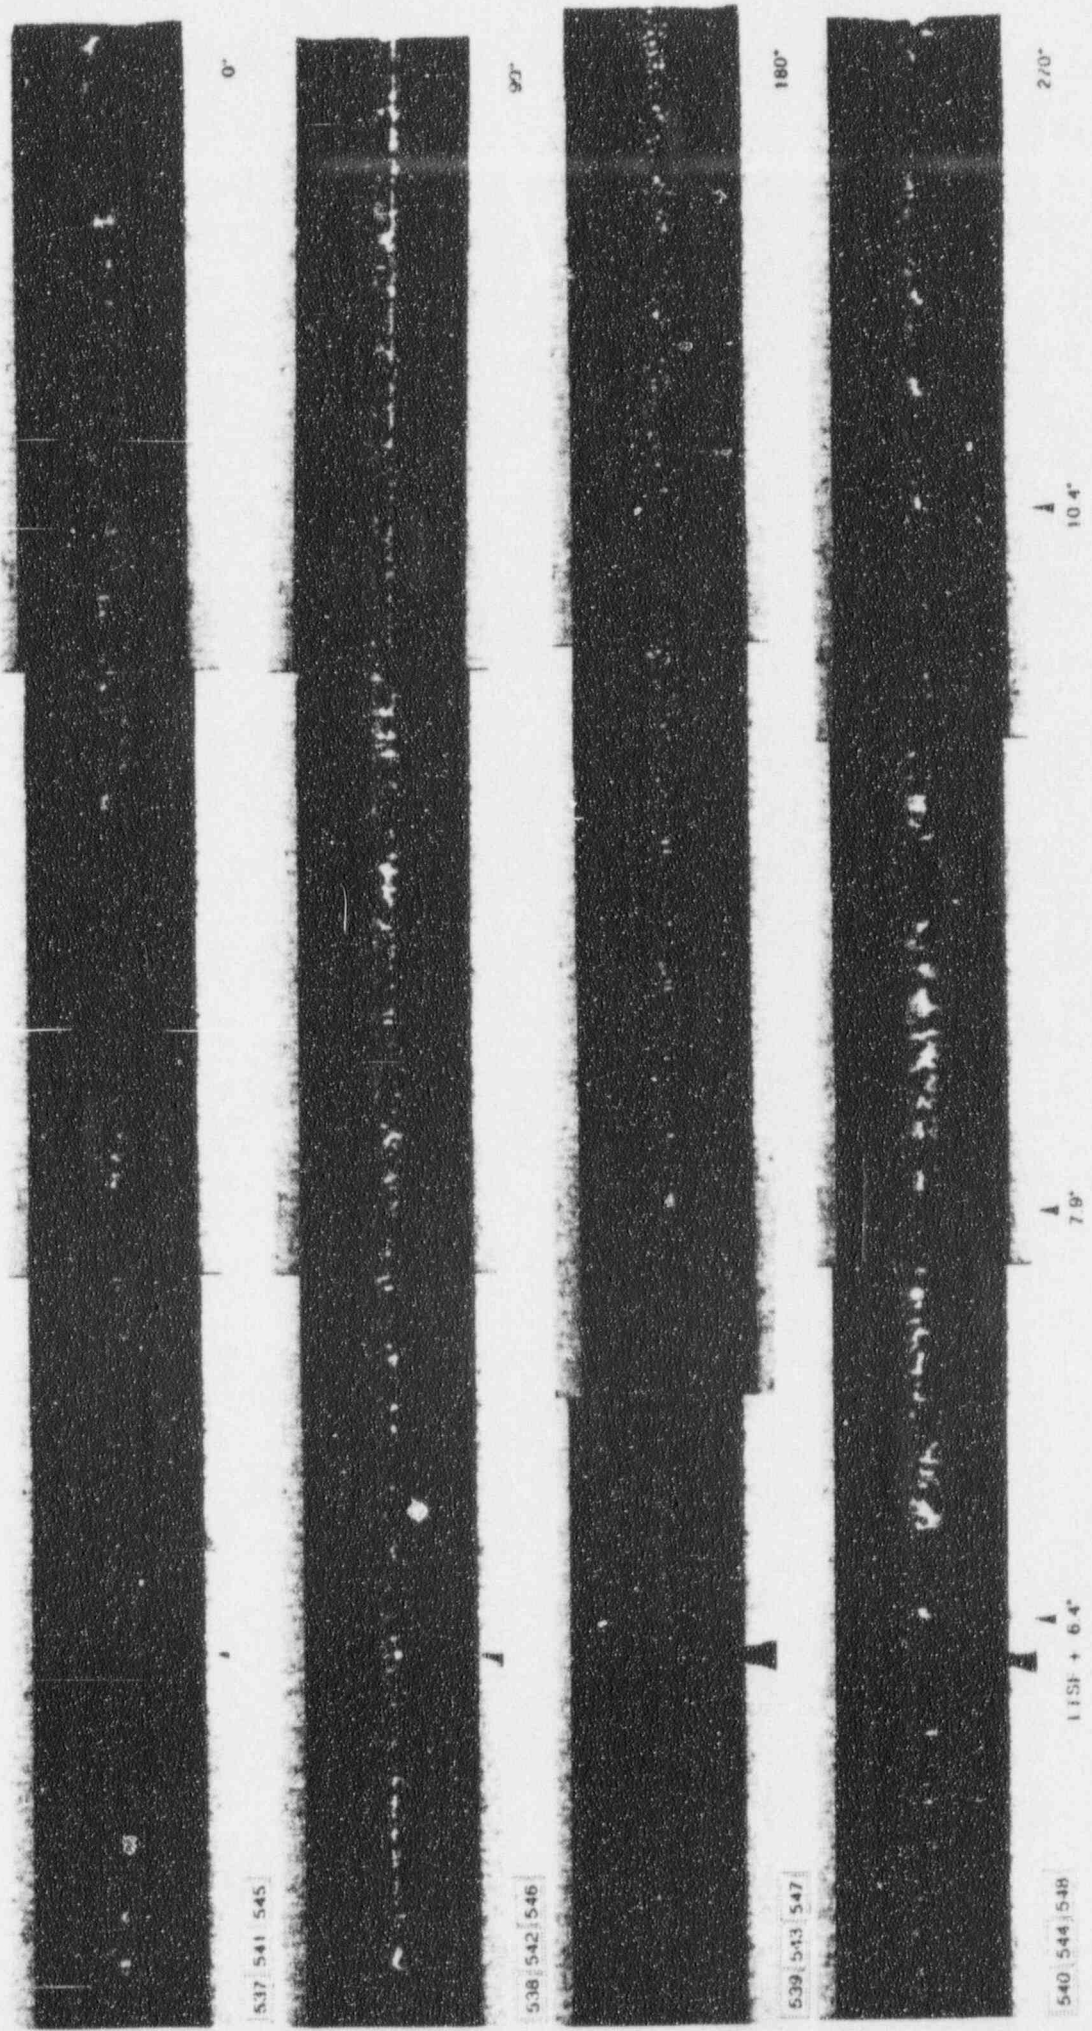
Figure 2-8: Tube Section 90-28-2, Freespan above LTSP As Received

Tube Section 90-28-2: The scalloped deposit patterns were generally coarser than 52-51-2 and were more prevalent in the 0° and 270° orientations. Also, there was large areas of spalled deposit.

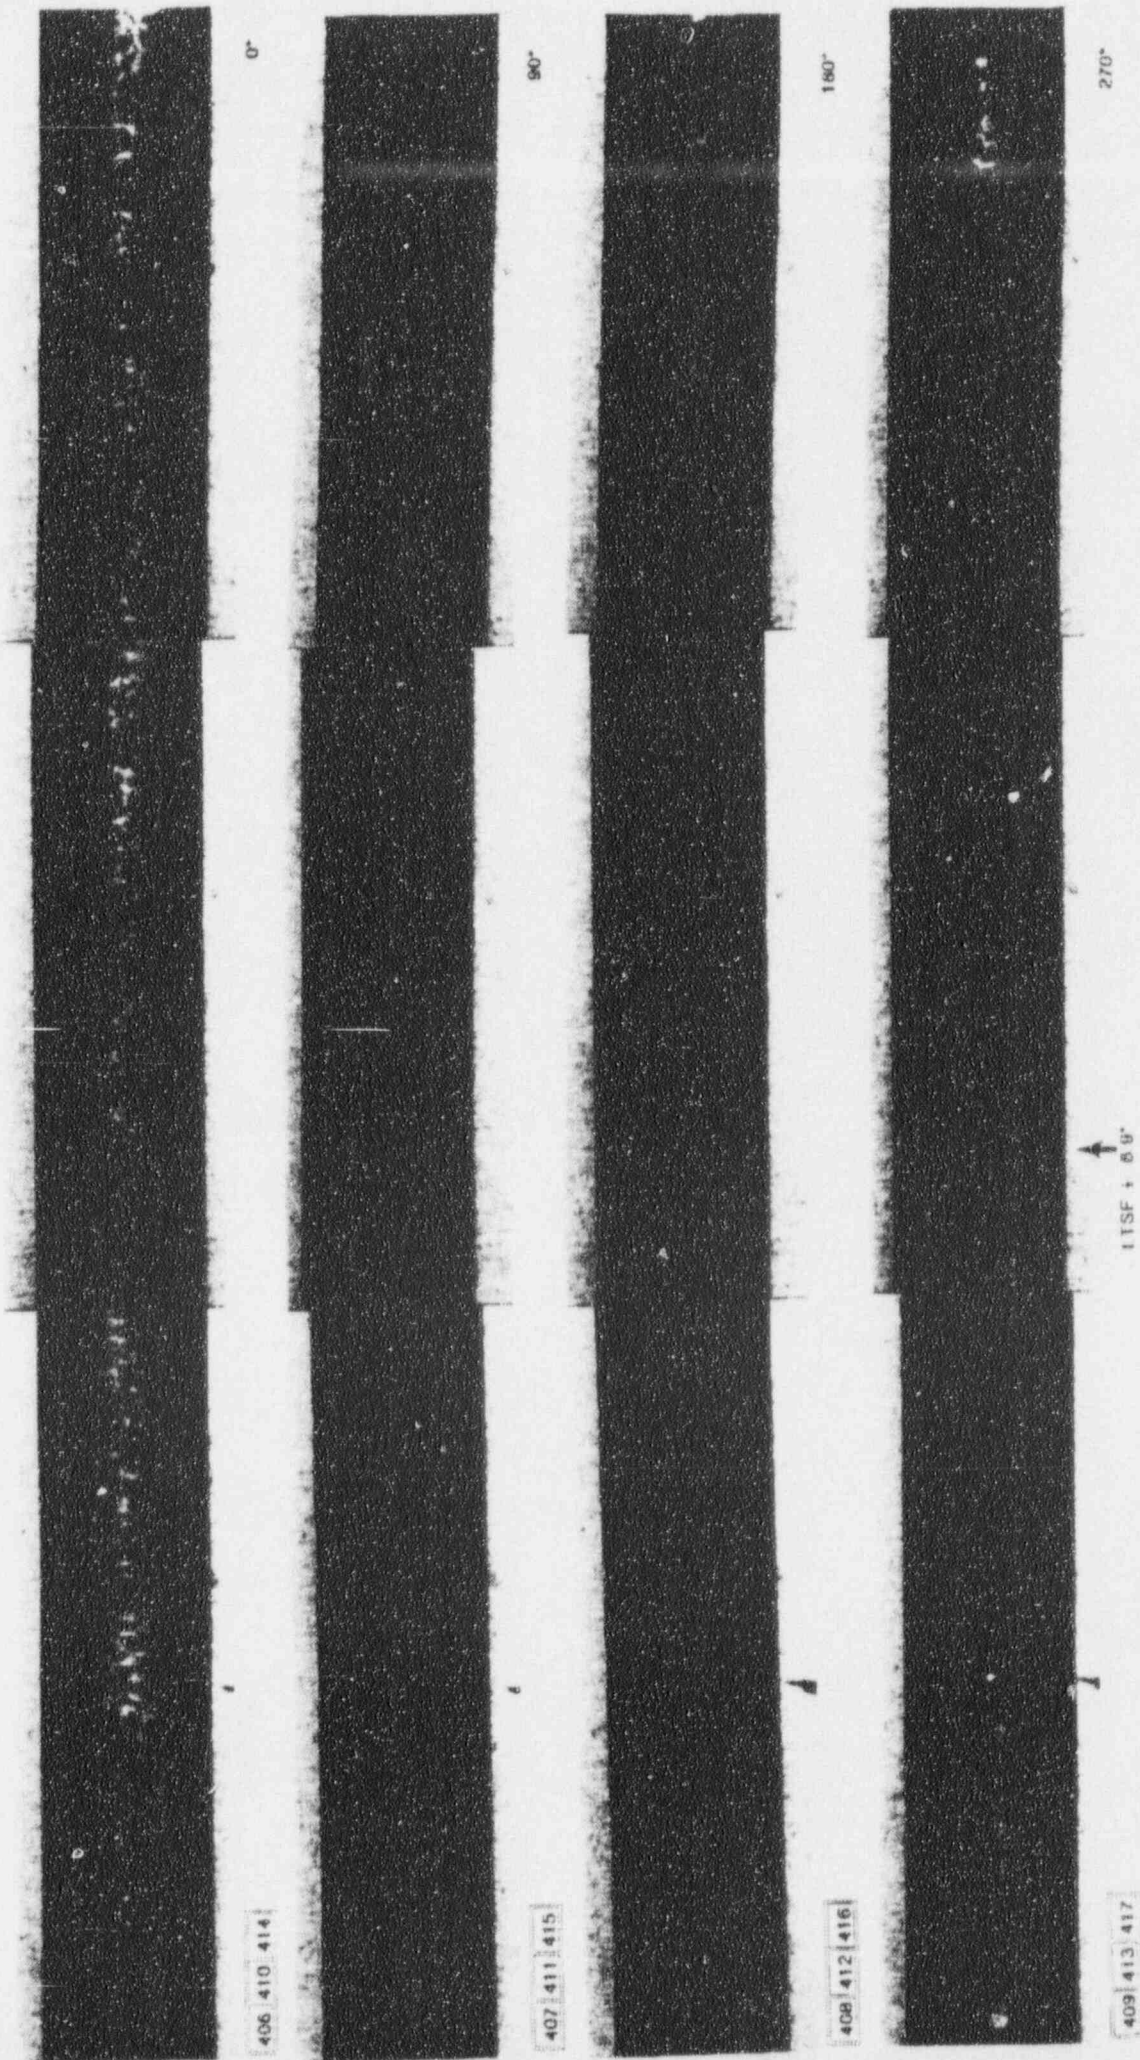
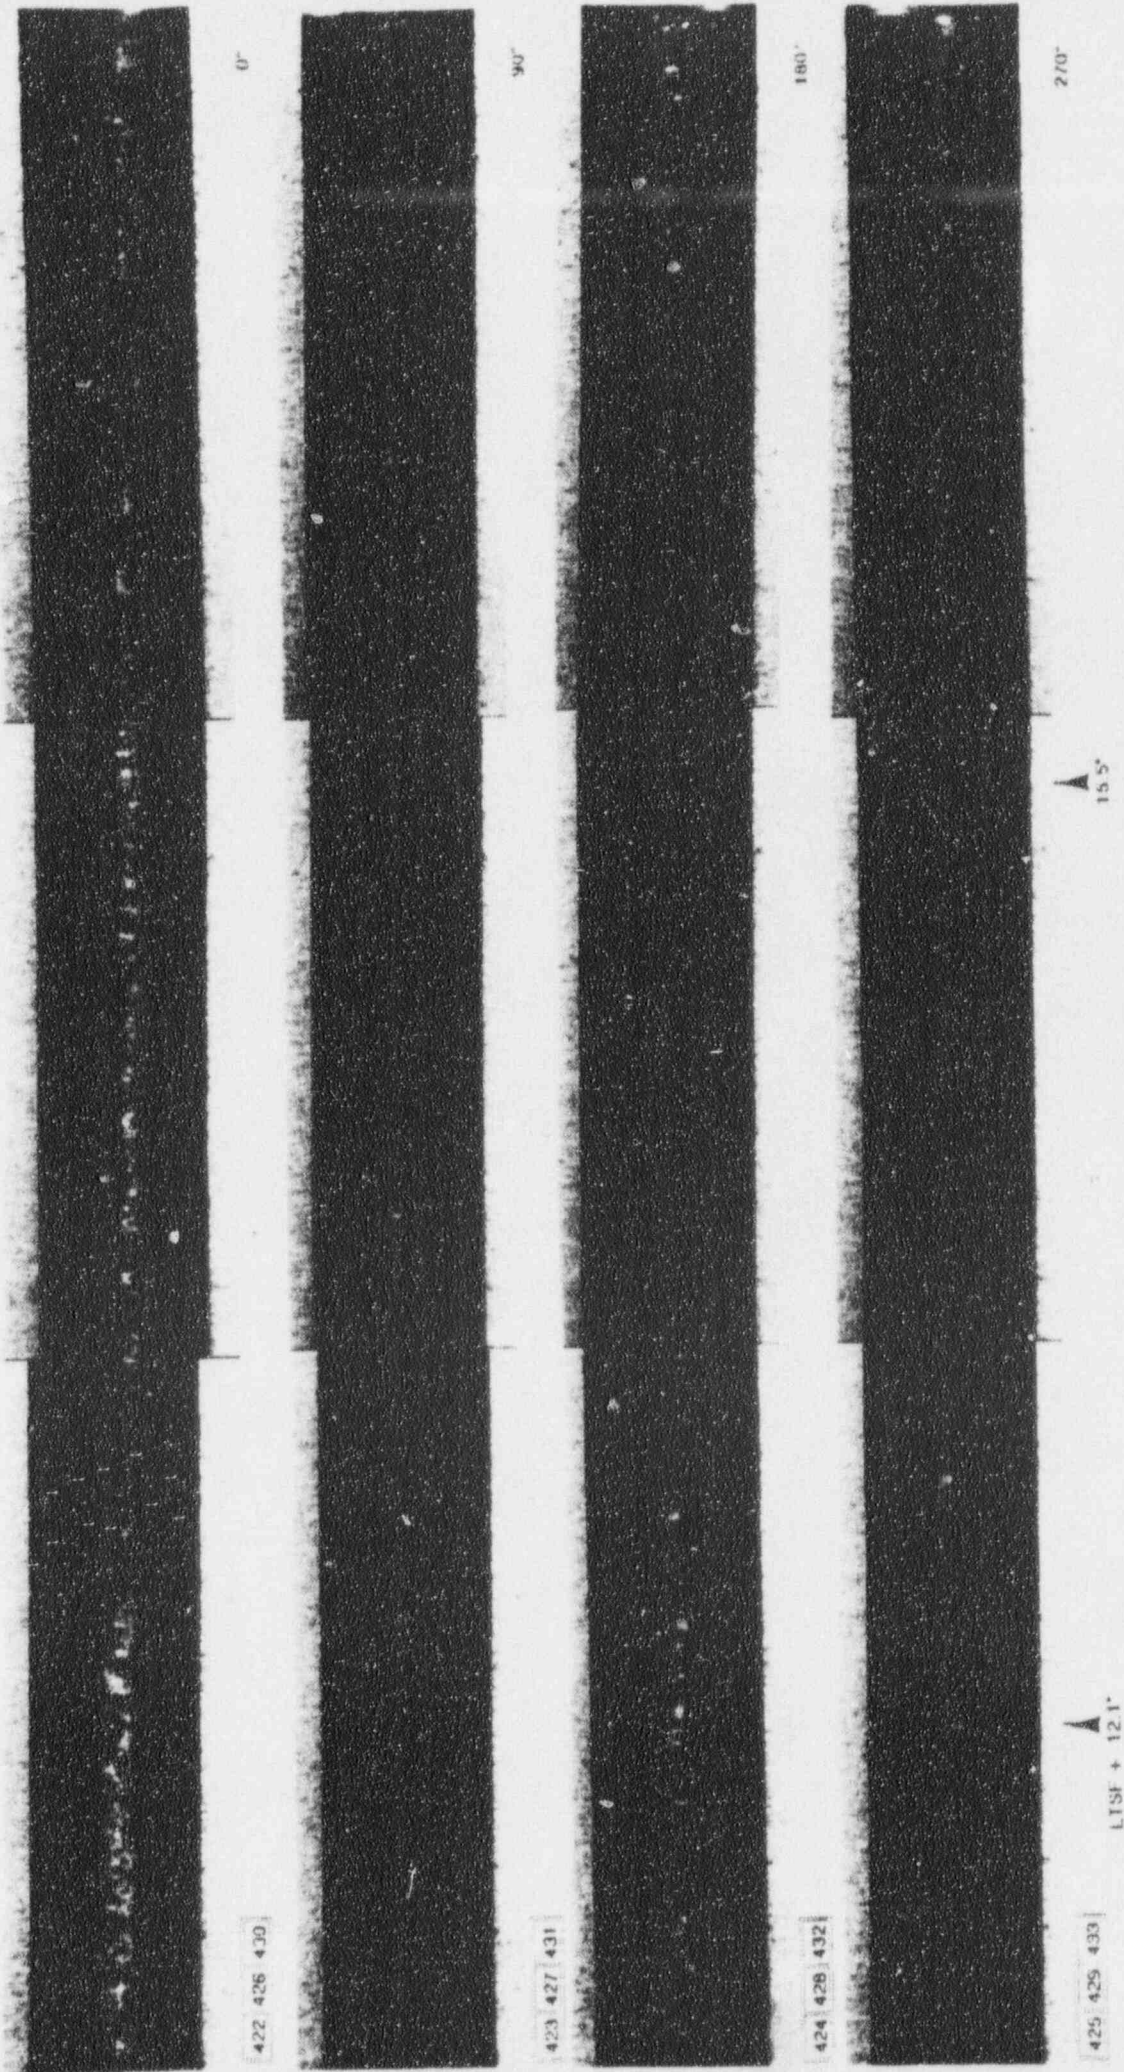
Figure 2-12A: Tube Section 41-44-2, Firespan above 1.TSF As-Received

Tube Section 41-44-2: The deposit patterns on this tube section were very similar to 52-51-2, except that the scallop patterns were more uniformly coarse around the tube circumference. Also, an axial band of spalled deposit was observed along the 0° orientation.

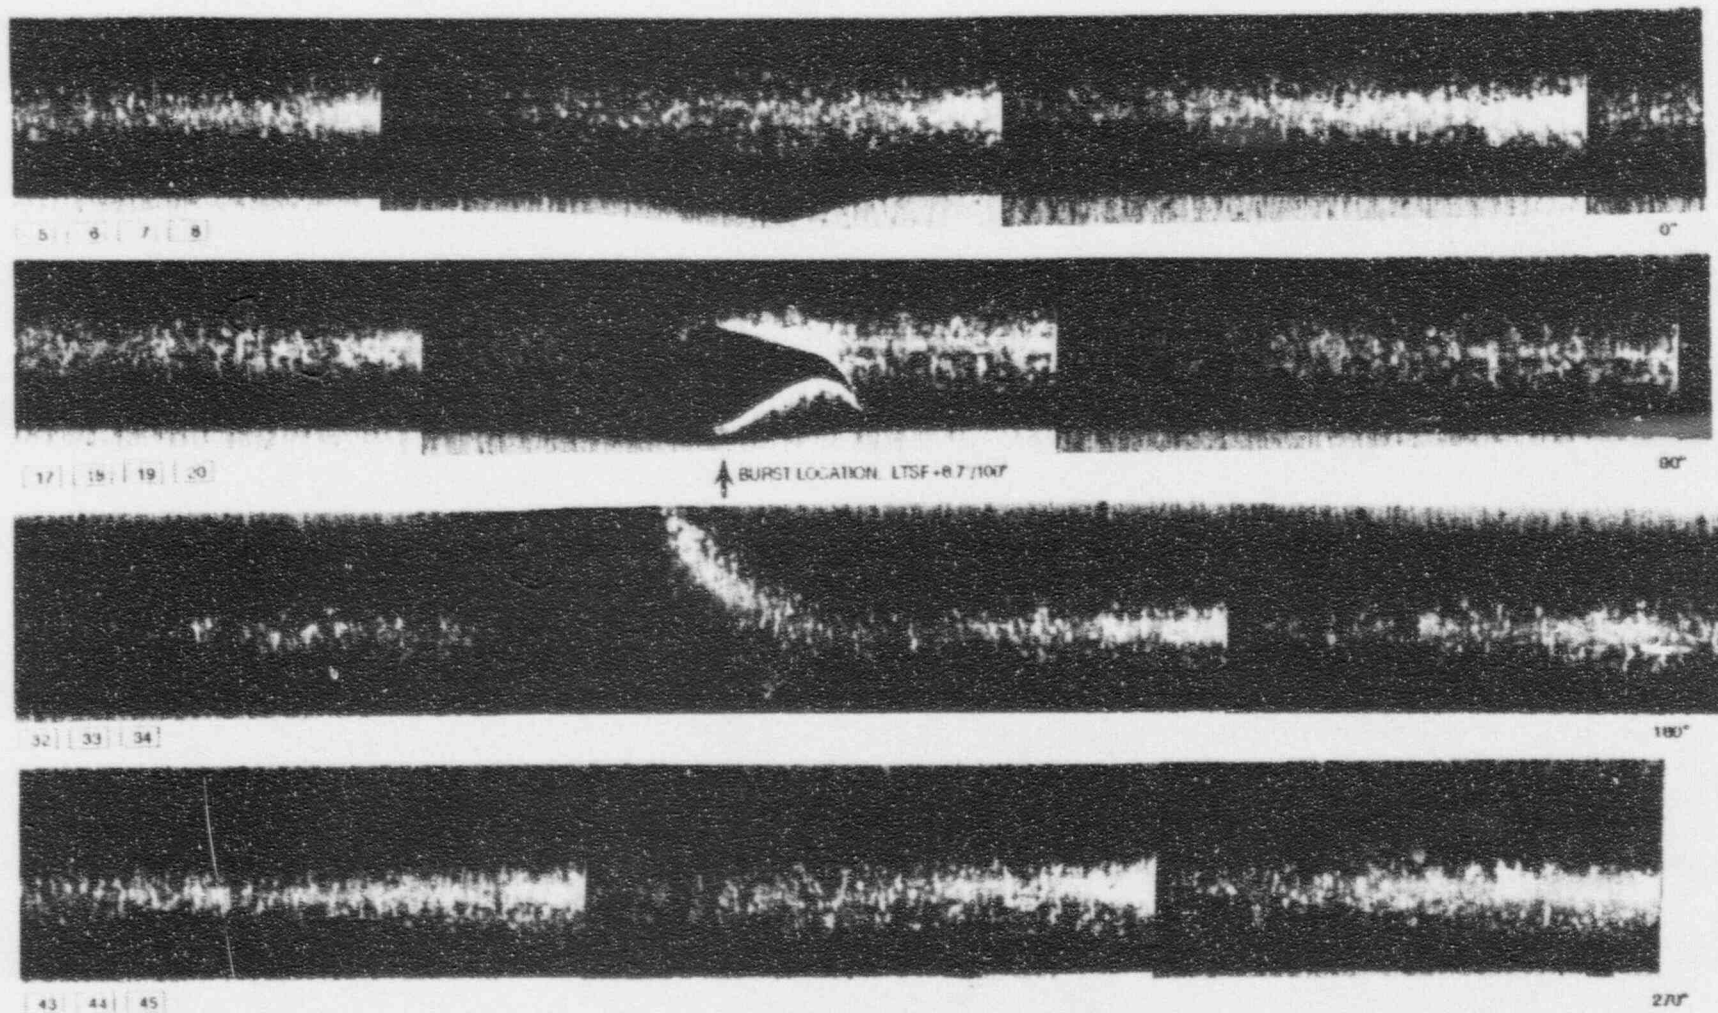
Figure 2-30: Mosaic of 106-32-2 After Being Burst

NOTE IGA PATCHES CONTAINED WITHIN
WHITE DEPOSIT STAINS (SURFACE
APPEARS SLIGHTLY ETCHED)
AFTER DESCALING AND AFTER BURST

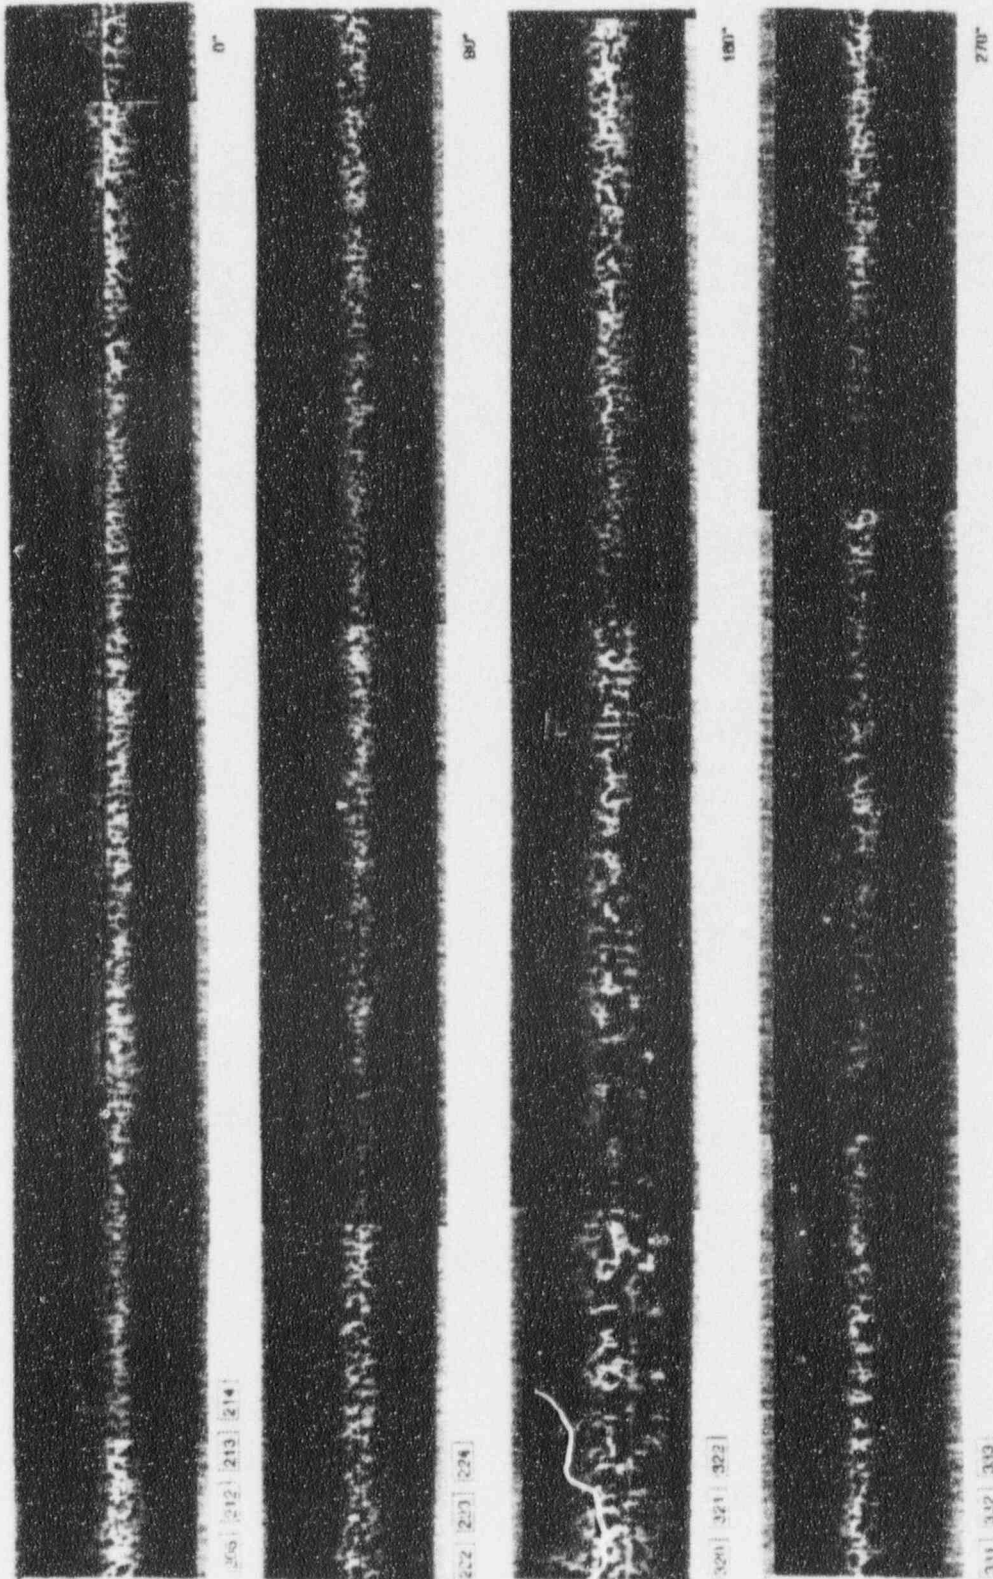
Figure 2-32: Mosaic of 52-51-2 After Swelling

TYPICAL DEPOSIT APPEARANCE AFTER
SWELLING. (GA PATCHES ASSOCIATED
WITH DARK DEPOSITS (STAINS))

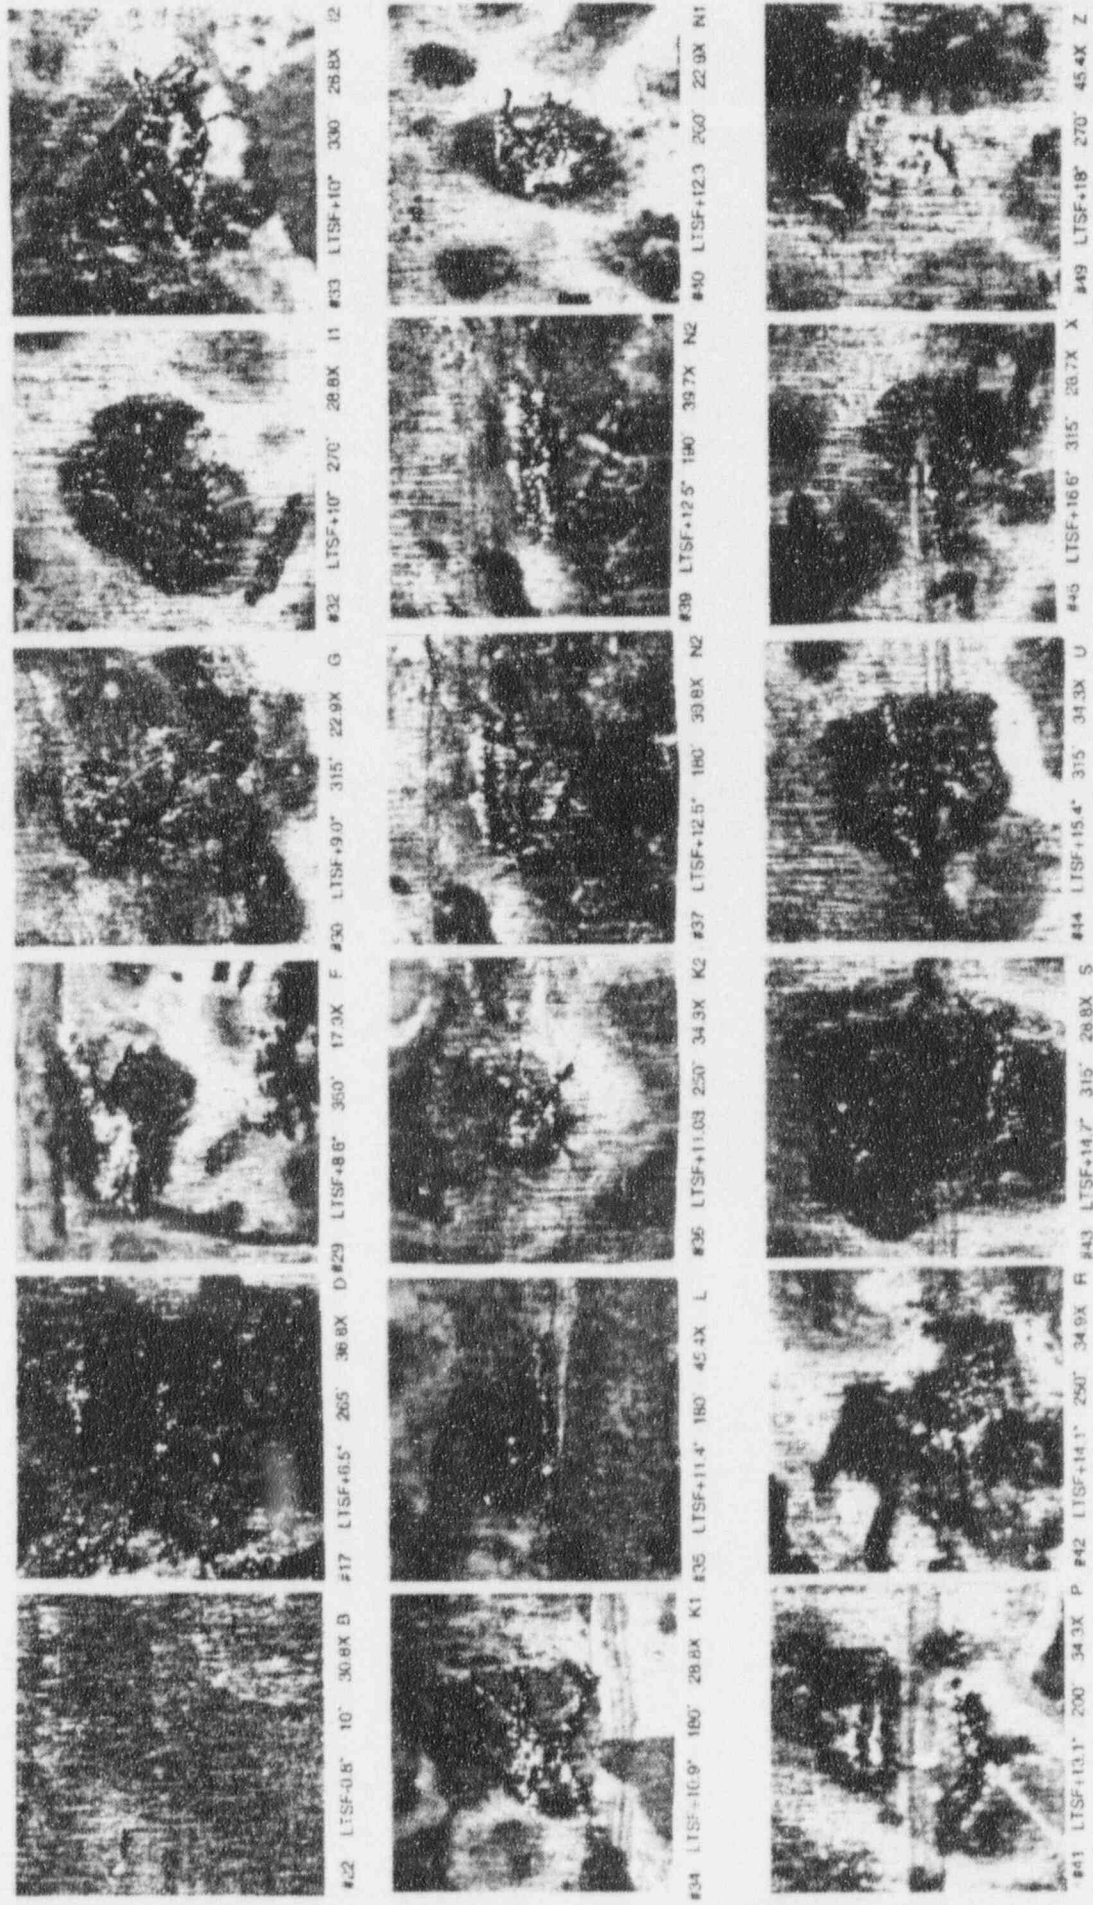
Figure 2-34: Stereovisual Result on 52-51-2 After Swelling

NO DEFECT BY MET.

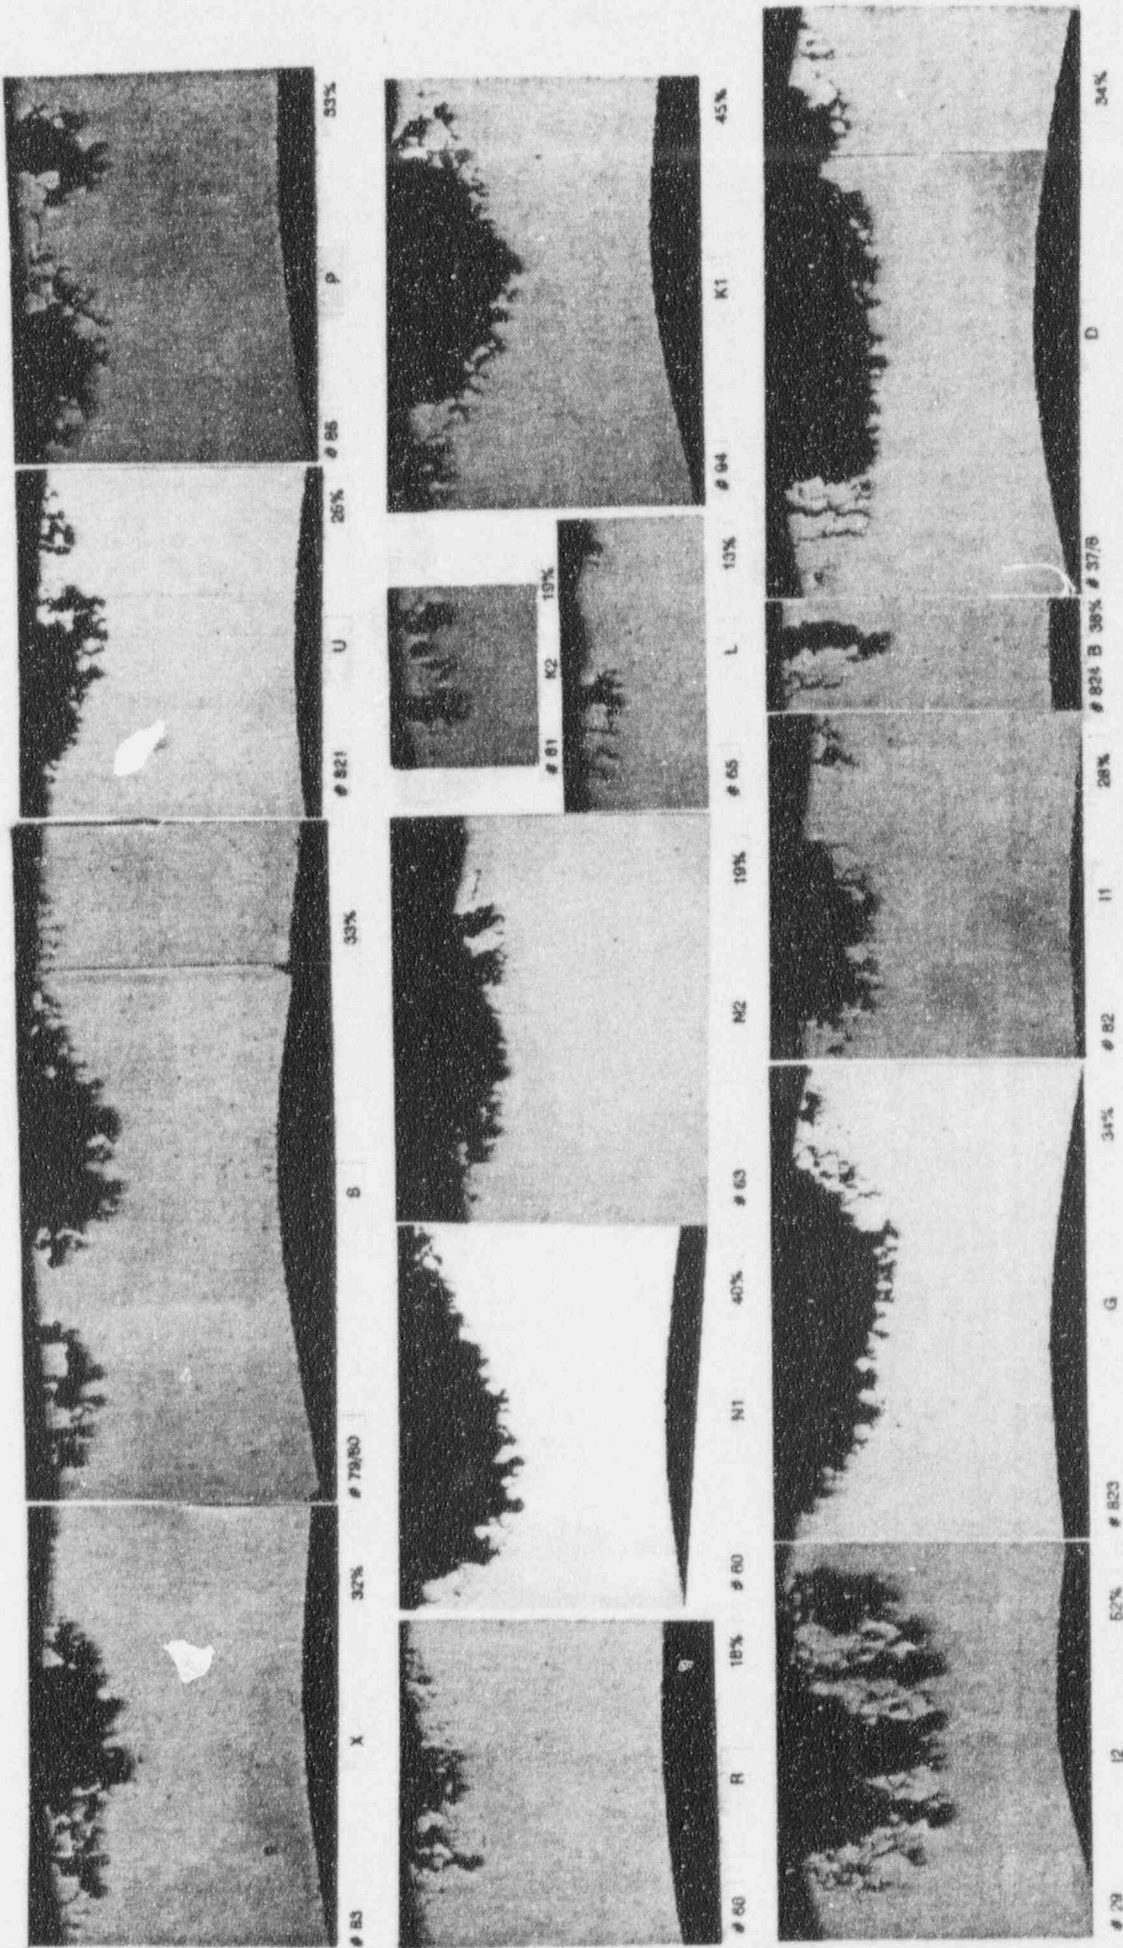
Figure 2-40: Metallography Results on 52-51-2 (63X)

NOTE IGA CONTAINED WITHIN STAIN AND ADJACENT CRACK

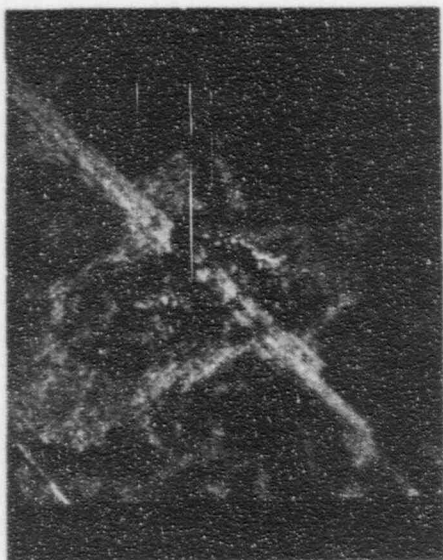
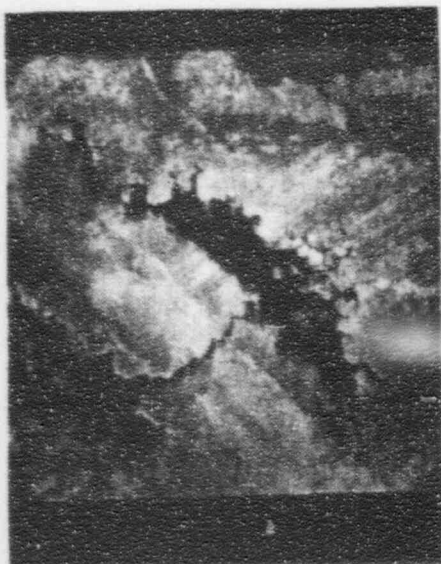
Figure 2-42: SEM/EDS Results on Specimen 52-51-2P
 (IGA Patch at LTSE+13.1" and 200°)

NOTE DARK STAINS SURROUNDING IGA AND ADJACENT SCRATCH

NOTE HIGH S IN GRAIN BOUNDARY CORROSION FILM

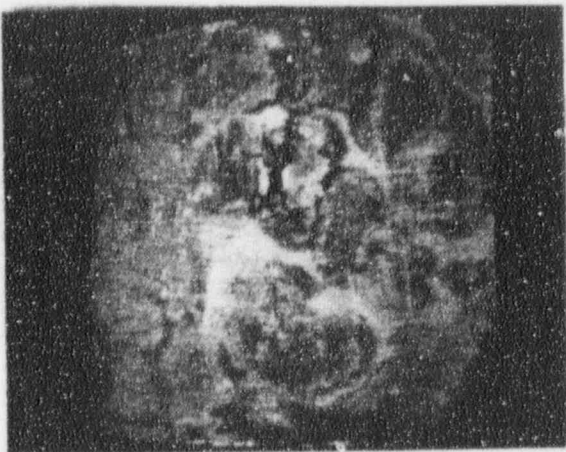
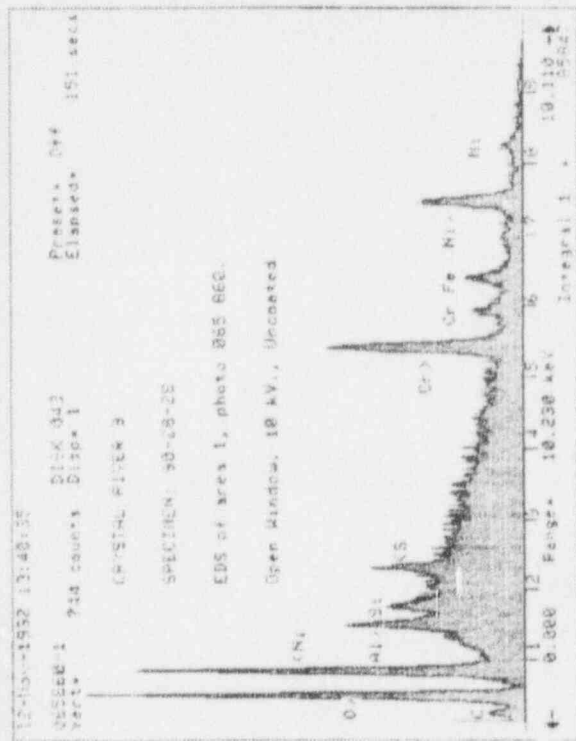
Figure 2-43: SEM/EDS Results on Specimen 90-28-2B (IGA Patch at LTSF+5.1" and 315°)

NOTE STAINS

NOTE GRAIN BOUNDARY CORROSION
FILM AND SULFUR INDICATIONS

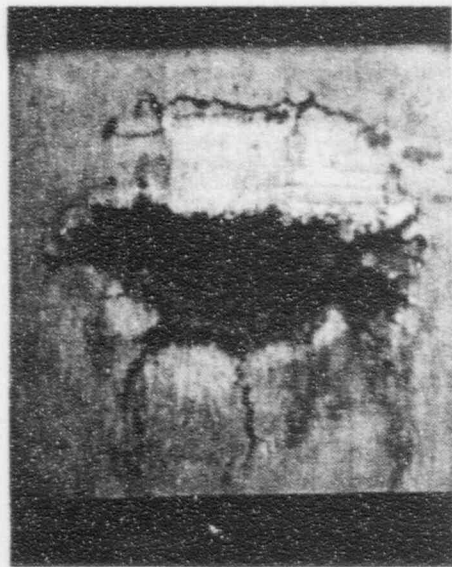
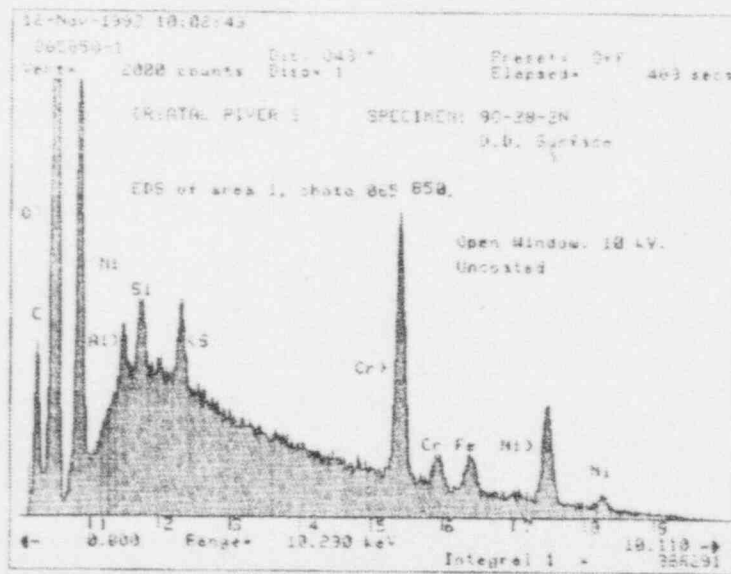
Figure 2-44: SEM/EDS Results on Specimen 90-28-2N (IGA Patch at LTSF+11.6" and 100°)

NOTE GRAIN BOUNDARY CORROSION
 FILM AND SULFUR INDICATIONS ABOVE

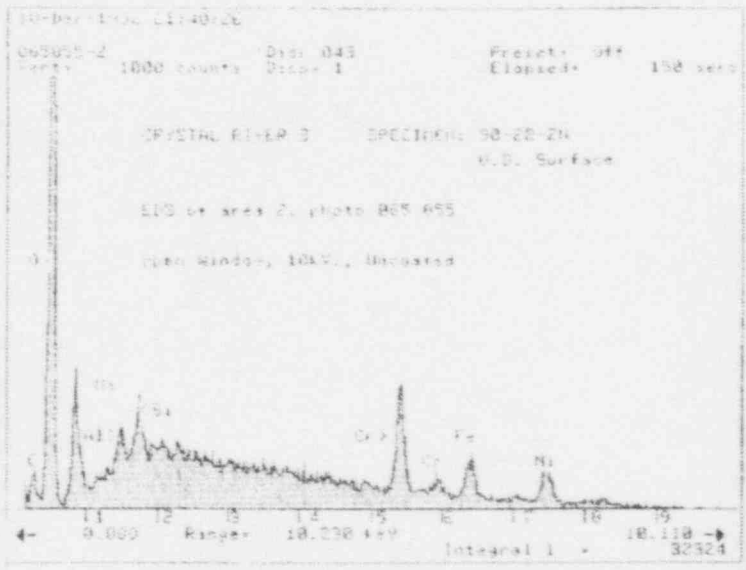
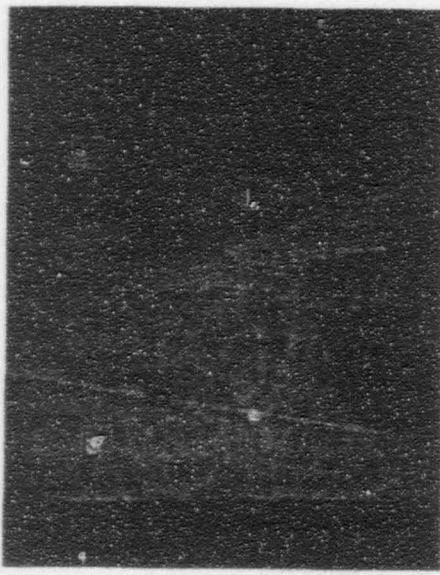
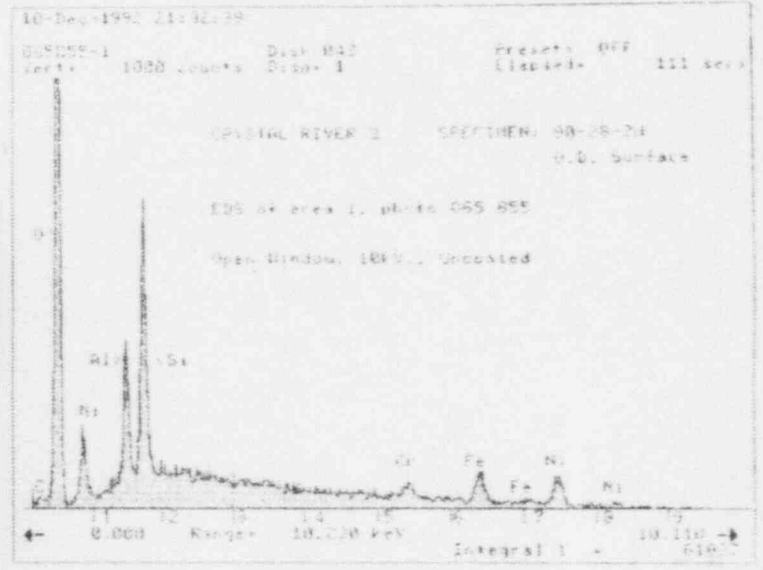
Figure 2-45: SEM/EDS Results on Specimen 90-28-2N OD Tube Surface

2 INNER PORTION ON STAIN
SOME SI AND Al; SLIGHTLY Cr-RICH

1 OUTER RING HIGH SI AND Al

3 "CLEAN" TUBE OD SURFACE
LOW SI AND Al; Ni/Cr/Fe RATIO
ABOUT SAME, BUT LOWER O

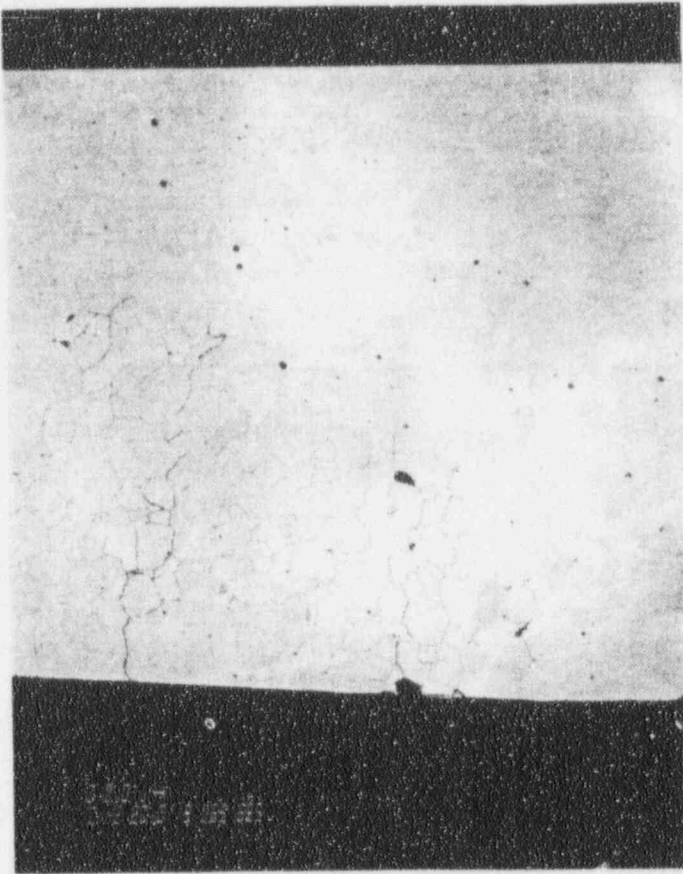
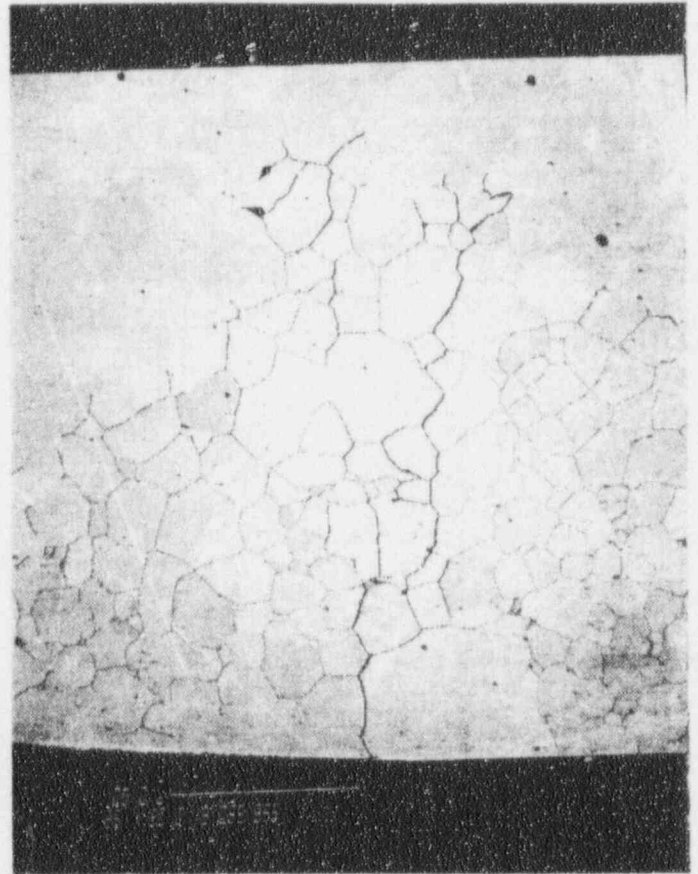
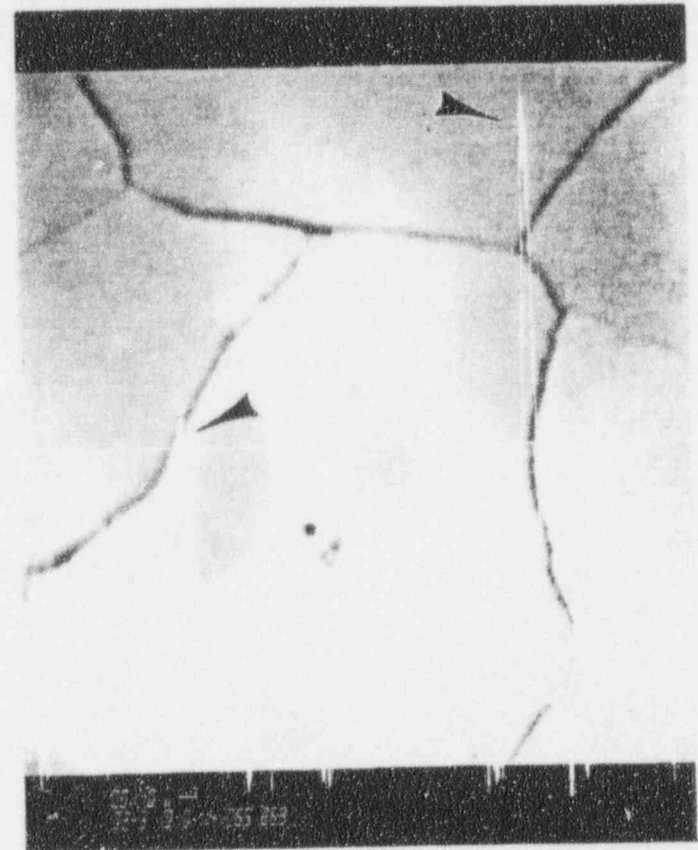
Figure 2-47: SEM/EDS Results on Specimen 109-30-2B, 8th Grind, 80° IGA Patch
(Note sulfur enrichment at grain boundaries)
