SUBJECT: POTENTIAL GENERIC ISSUE - RHR VALVE INTERLOCK  
POWER SUPPLIES

Carolina Power & Light Company  
H. B. Robinson Unit 2  
Operating Plant Feedback - Non-vital Power  
Supply Used in Valve Interlock Logic

Re: Reportable Event 84-18  
Turkey Point Unit 3  
Date of Event: July 17, 1984  
Design Deficiency in Control Circuitry for MOV 863A and B

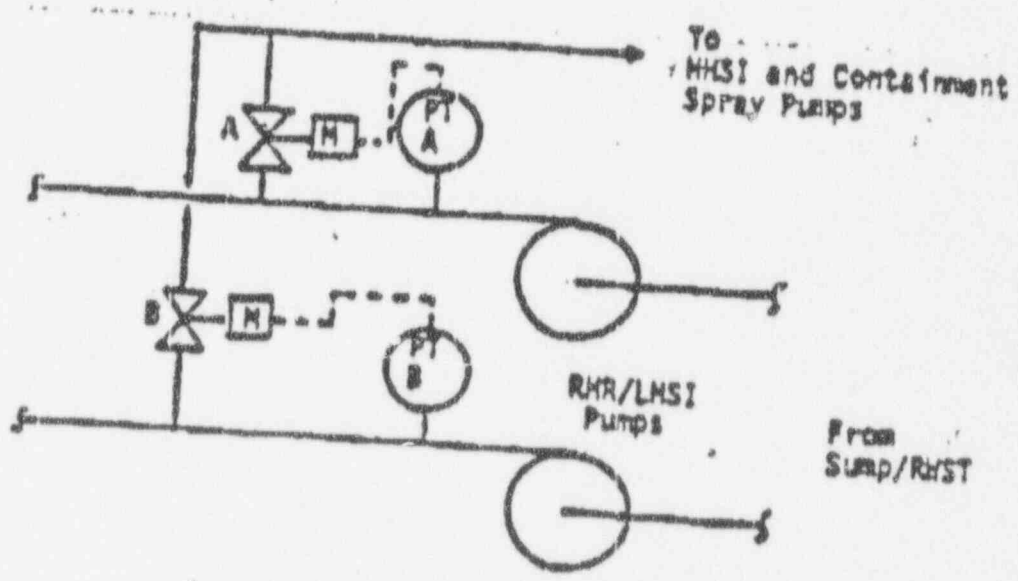
TYPICAL ARRANGEMENT

The potential problem involves the capability to establish post-LOCA recirculation flow. Please refer to the attached sketch. During certain accidents, a flow path from the containment sump through the Residual Heat Removal/Low Head Safety Injection (RHR/LHSI) pumps, to the High Head Safety Injection (HHSI) pumps is required. To establish this flow path, valves A or B must be opened. However, valves A and B are also interlocked with pressure transmitters A and B, respectively. The interlock logic includes a feature such that these valves cannot be opened when the RHRS pressure is above about 200 psig to 250 psig. The intent of this interlock logic is to insure that valves A and B remain closed during normal RHRS cooldown operation. This precludes the possibility of overpressurizing the lower pressure piping in the suction of the HHSI and Containment Spray Pumps.

For the operating plant, the pressure transmitters A and B were powered from non-vital power. The situation resulted in the potential where valves A and B could be blocked from opening if the non-vital power failed, even though the valves were powered from separate emergency power.

It is recommended that you review the current interlock logic and power arrangements for the subject valves and instrumentation to insure that failure of non-vital power still allows both valves to be opened. It is acceptable for the single failure of emergency power to preclude one valve from being opened.

If remote valve operation cannot be assured, several interim changes could be made to allow continued plant operation. These include bypassing the interlock logic or manual operation of the valves using the handwheel. (Note: The corresponding emergency procedure should reflect any changes.) Longer-term solutions include changing power supplies or modifying the interlock logic.
