Rio Algom Mining Corp.

Re: Lisbon Facility
License SUA-1119, Docket No. 40-8084
Tailings Technical Evaluation

Subject: Bisco Lake Dam Inspection
Upper Tailings Dam Inspection
Lower Tailings Dam Inspection

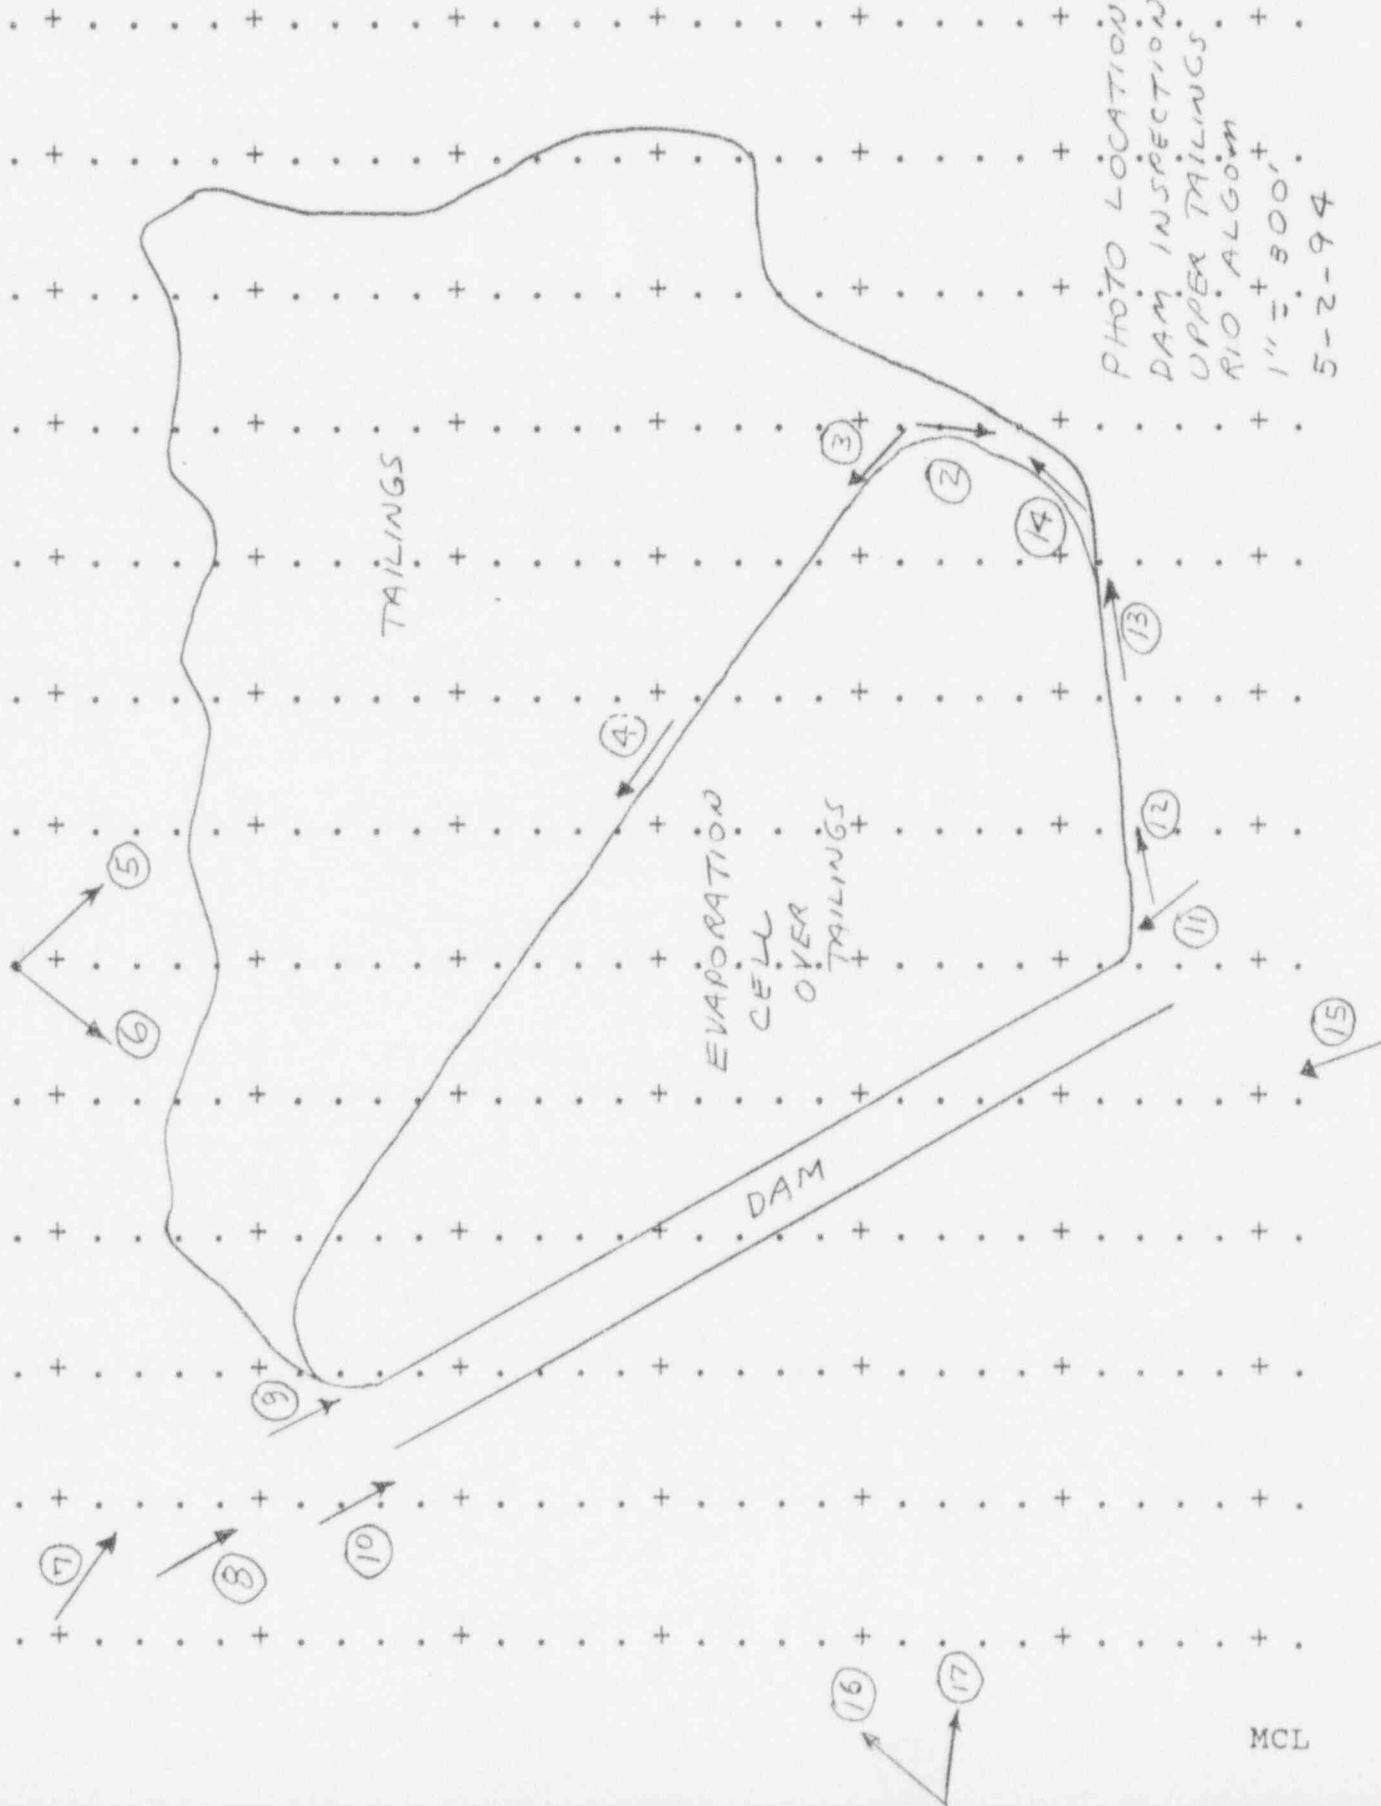
PHOTO LOCATIONS
DAM INSPECTION
UPPER TAILINGS
RIO ALGOM
1" = 500'
5-2-94

* WAVE EROSION HAS OCCURRED ON THE INSIDE FACE OF THE EVAPORATION CELL BERM. RIO ALGOM IS PRESENTLY WIDENING THE BERM ON THE OUTSIDE, AND IT IS MY UNDERSTANDING THAT RIO ALGOM PLANS TO REPAIR THE ERODED AREA. IN MY OPINION, THIS EROSION HAS NOT YET PROGRESSED TO A POINT WHERE THE BERM IS STRUCTURALLY UNSTABLE.

2. WAVE EROSION HAS OCCURRED ON THE INSIDE FACE OF THE EVAPORATION CELL BERM. RIO ALGOM IS PRESENTLY WIDENING THE BERM ON THE OUTSIDE, AND IT IS MY UNDERSTANDING THAT RIO ALGOM PLANS TO REPAIR THE ERODED AREA. IN MY OPINION, THE EROSION HAS NOT YET PROGRESSED TO A POINT WHERE THE BERM IS STRUCTURALLY UNSTABLE.

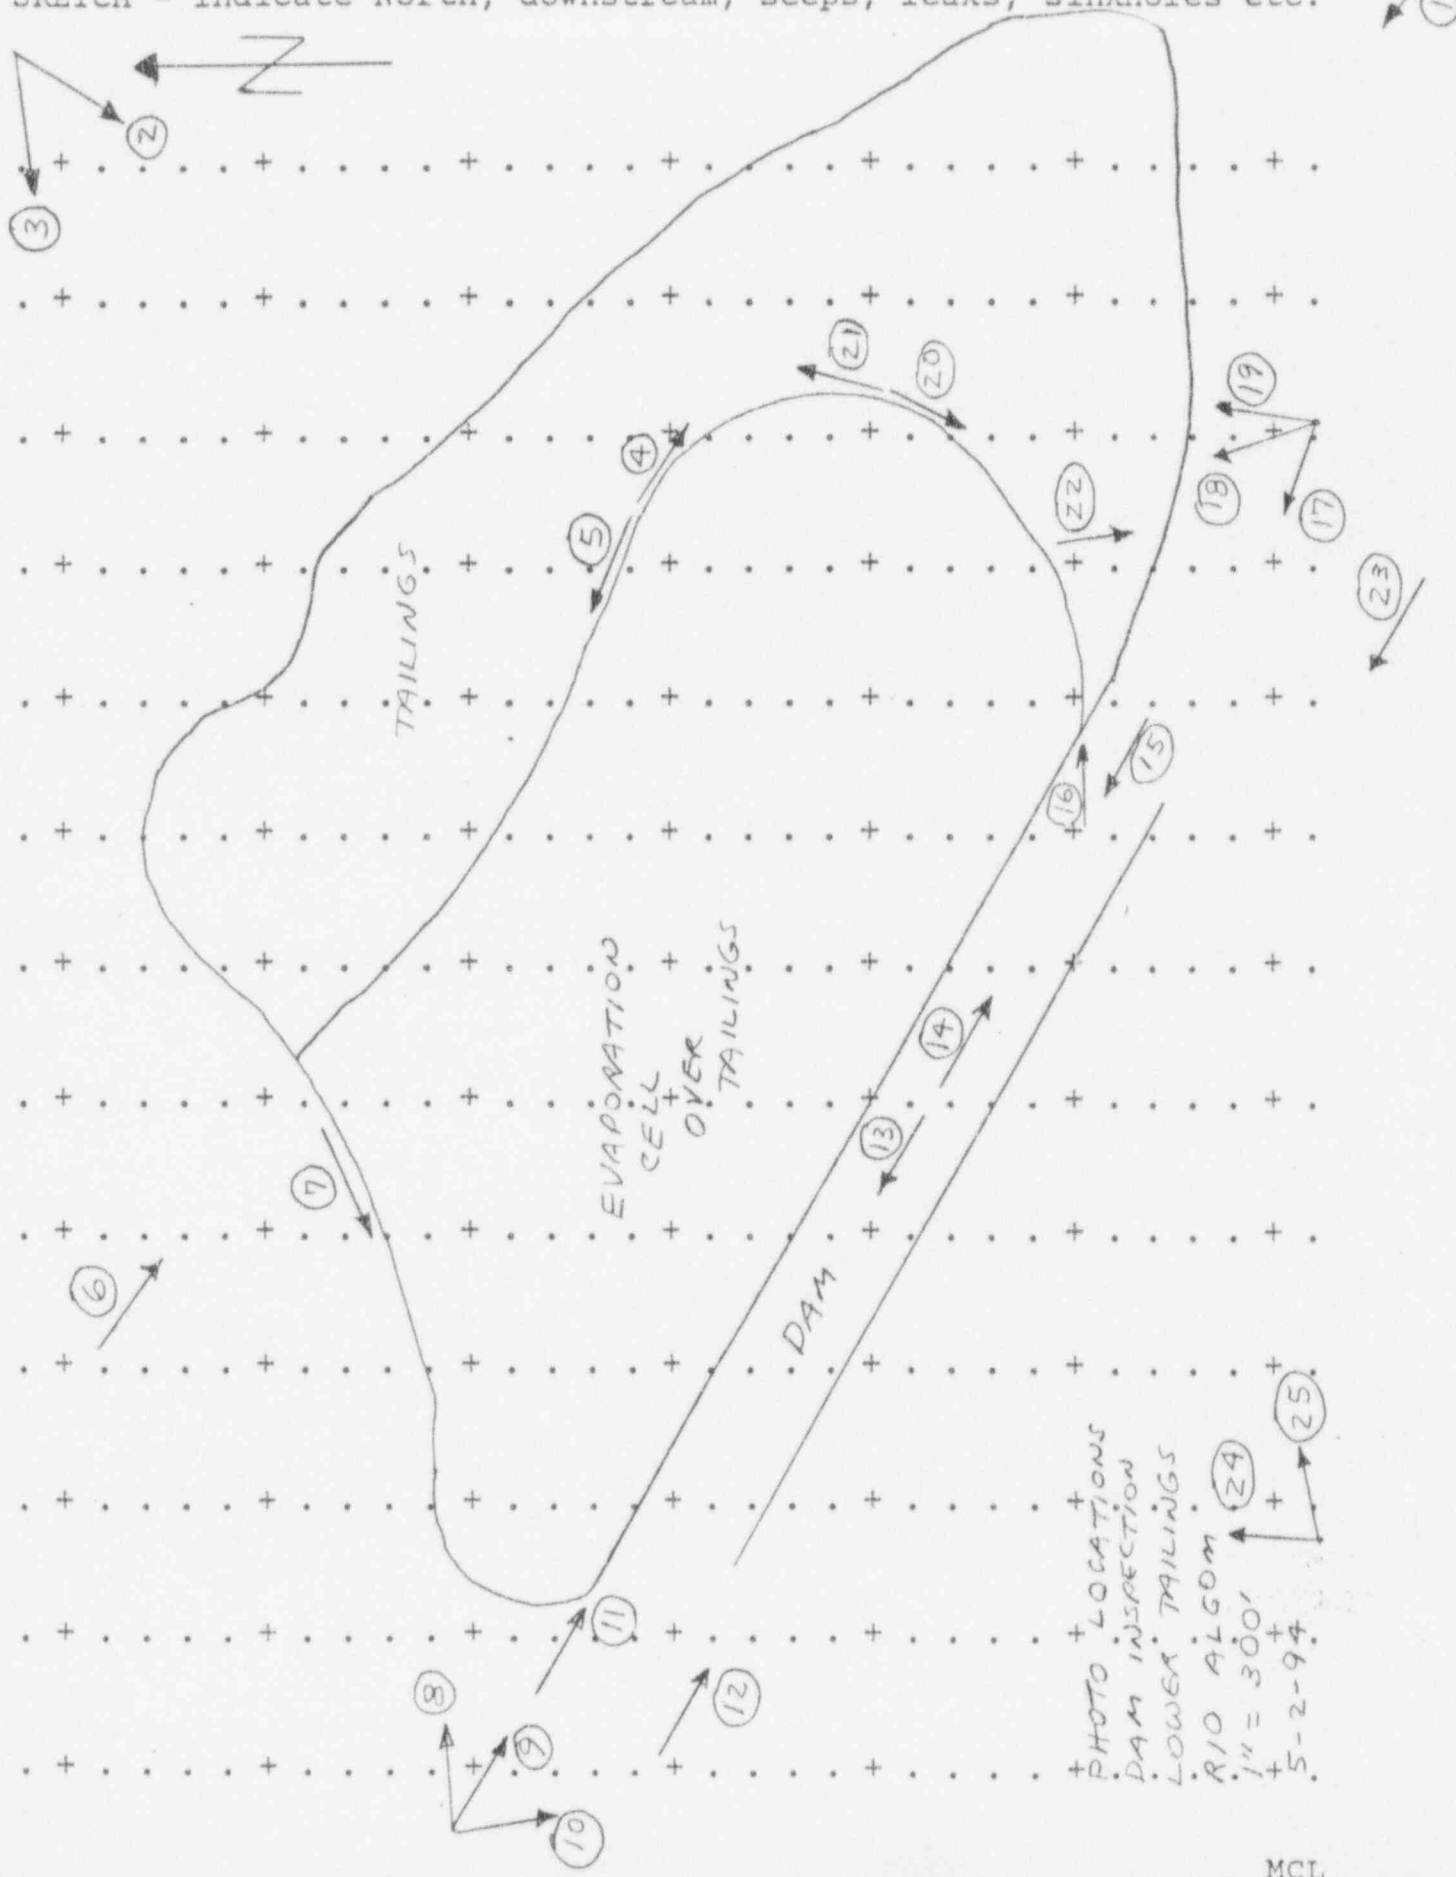
SKETCH - Indicate North, downstream, seeps, leaks, sinkholes etc.

* WAVE EROSION HAS OCCURRED ON THE INSIDE FACE OF THE NEW EVAPORATION CELL (BUILT DURING THE SUMMER OF 1993) BERM, IT IS MY UNDERSTANDING THAT RIO ALGOM PLANS TO REPAIR THE ERODED AREA. IN MY OPINION, THIS EROSION HAS NOT PROGRESSED TO A POINT WHERE THE BERM IS STRUCTURALLY UNSTABLE.

1. VERY MINOR SURFACE EROSION HAS OCCURRED ON THE DAM WHERE VEGETATION HAS NOT YET BEEN ESTABLISHED, BUT THIS POSES NO RISK TO STABILITY
2. DURING THE SUMMER OF 1993, AN EVAPORATION CELL WAS BUILT OVER PART OF THE LOWER TAILINGS ON TOP OF THE SOIL CAP COVERING THE TAILINGS. OBSERVATION OF THIS EVAPORATION CELL AND BERMS, AND REVIEW OF THE 11-15-93 CONSTRUCTION REPORT SUBMITTED BY RIO ALGOM TO THE U.S. NUCLEAR REGULATORY COMMISSION INDICATES THIS EVAPORATION CELL CONSTRUCTION MEETS STANDARDS. SOME WAVE EROSION HAS OCCURRED ON THE INSIDE FACE OF THE BERM. IT IS MY UNDERSTANDING THAT RIO ALGOM PLANS TO REPAIR THIS ERODED AREA. IN MY OPINION, THIS EROSION HAS NOT PROGRESSED TO A POINT WHERE THE BERM IS STRUCTURALLY UNSTABLE.

3. DURING THE SUMMER OF 1993, A PORTION OF THE OUTSLOPE ON THE LOWER TAILINGS DAM WAS MODIFIED FROM A 3H:1V SLOPE TO A 5H:1V SLOPE. IT IS MY UNDERSTANDING THAT THE QUALITY OF CONSTRUCTION, MATERIALS USED, AND TESTING ACCOMPLISHED, WAS SIMILAR TO THAT USED WHILE BUILDING THE EVAPORATION CELL OVER PART OF THE LOWER TAILINGS.
