NUREG/CR-2932/1 of 2
SAND81-2027/1 of 2

Equipment Qualification Research Test of Electric Cable With Factory Splices and Insulation Rework Test No. 2 Report No. 1

E. E. Minor, D. T. Furgal

This report records the results of tests performed by Sandia National Laboratories to provide the NRC with data for assessing the methods and procedures for environmental qualification tests of electric cable repairs and splices as outlined in IEEE 383-1974.

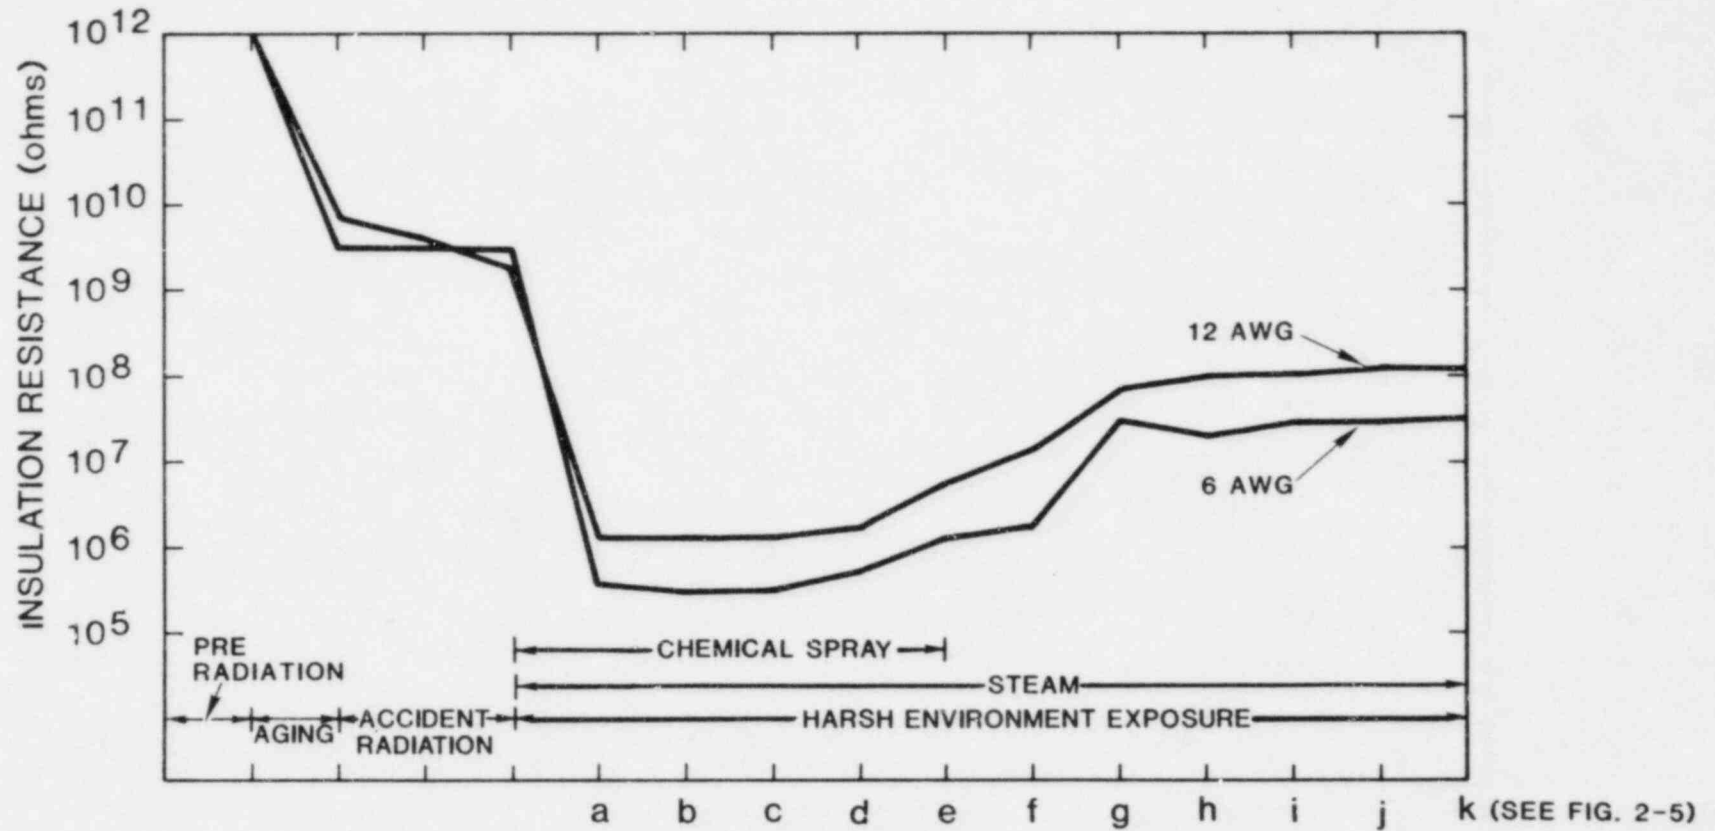
Figure 2-6. Insulation Resistance Profile

Insulation resistance measurements taken during the initial accident profile steam pressure peak (see Figures 2-5 and 2-6, point a) showed significantly degraded readings in the range of 6.0×10^5 and 1.5×10^6 ohms for the No. 6 and No. 12 AWG cables, respectively. Cables 10, 19, 20, 21 and 22 had readings below 5.0×10^5 ohms. At the second pressure peak (Figure 2-5, point b), Cables 17, 18, 24, 25, and 27 had also measured below 5.0×10^5 ohms. Also, during both peaks, eight of the nine No. 6 AWG cables (Cables 19 and 21 through 27) began weeping at the ends of the cables extending from the chamber. This was due to the pressure differential between the chamber and atmospheric pressures. The subsequent visual inspection showed that the weepage occurred both on cables where insulation material handling damage was observed and on cables where no visible damage was apparent. We therefore conclude that some of the weepage may be attributable to thermal softening and expansion of the insulation material or to insulation damage not readily visible to the naked eye. At nine hours into the profile (Figure 2-5, point c), Cable 13 also measured below 5.0×10^5 ohms. At four days into the profile (Figure 2-5, point f), Cables 10, 19, 22, 23, 24, and 27 still measured below 5.0×10^5 ohms. As the exposure continued, insulation resistance readings improved. At the end of the exposure profile, Cables 19, 24, and 27 had readings below 5.0×10^5 ohms.

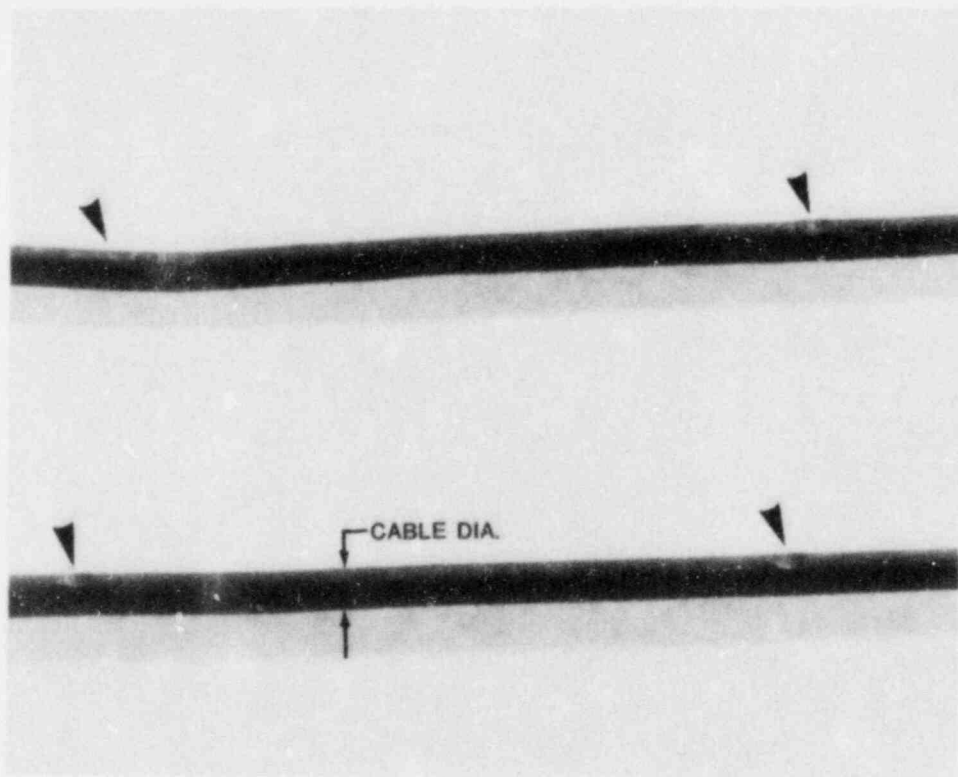
Figure 2-7. View of Cable Showing Insulation Material Deformation

Indentations in the cable insulation material were observed during post-exposure visual inspection (see Section 2.3.3 and Figure 2-7). The indentations occurred at cable pressure points and were assumed to be the result of insulation material thermal softening. The cables were snug but not tightly wound on the mandrels. However, we believe that expansion of the mandrel and insulation material during thermal aging caused the cable to tighten-up around the mandrel posts, thus causing pressure points.

It was noted that where cables crossed mandrel pressure points, such as rods and supports, insulation material indentations occurred (see Figure 2-7). It is assumed that this condition occurred because of insulation material thermal softening. Cables in these tests were snugly wrapped around the mandrel. In future tests, more space will be allowed between the cables and the mandrel to reduce the probability of these test-induced failures. Since we do not know the pressure at the cable-mandrel interface, we cannot relate this information to loads that may occur on cables at the bottom of cable trays or on cables that cross end point supports in power plant installations.

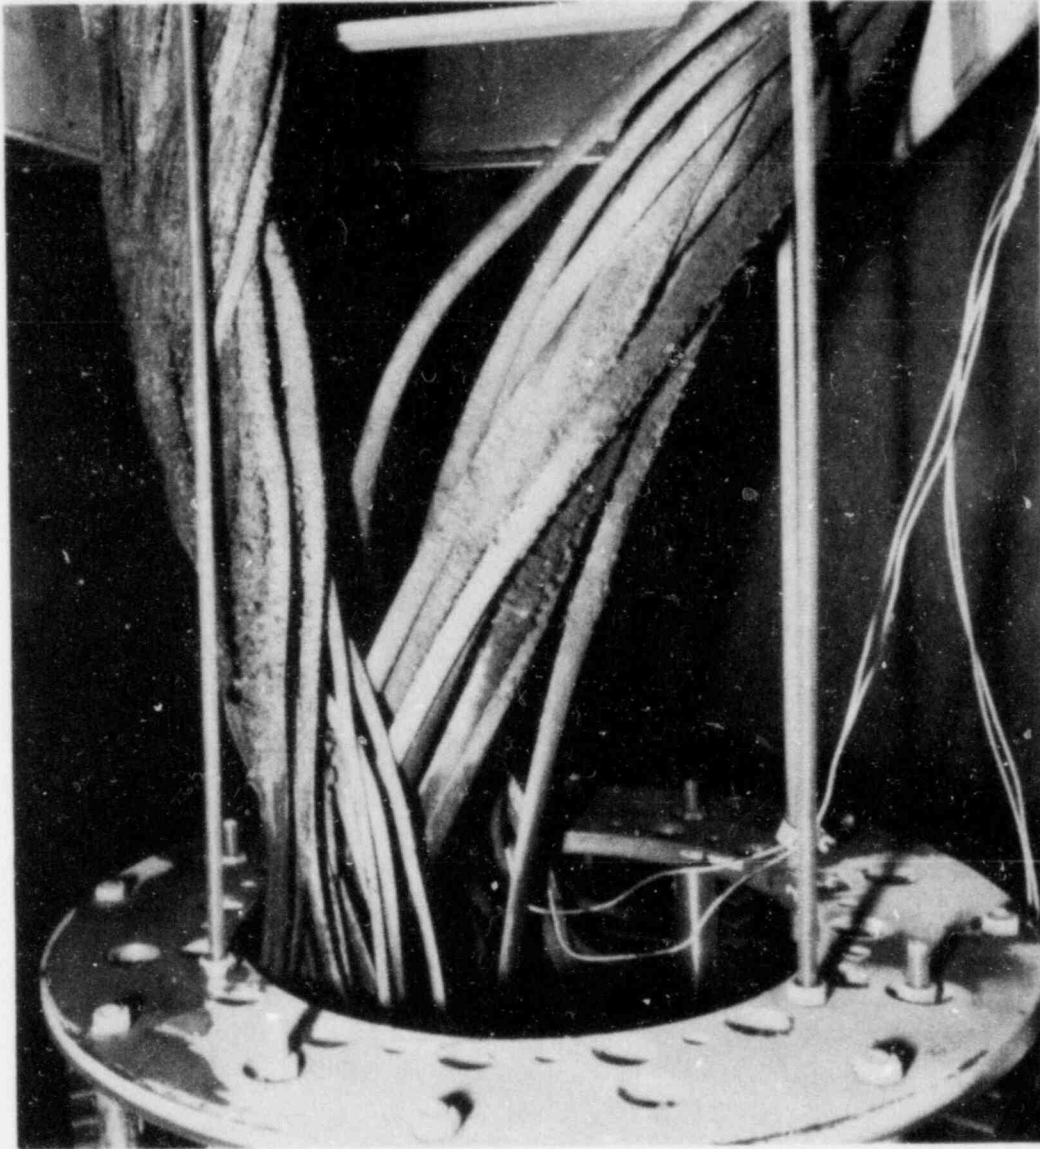
Figure 2-8. View of Residue Build-up Above Mandrels

A build-up of residue was observed where the steam and chemical spray came into direct contact with the cables (see Section 2.3.5 and Figures 2-8 and 2-9). Chemical analysis of this residue showed that there was a reaction between the chemical spray and the insulation material causing the residue to form. Physical analysis of the insulation material showed a four percent reduction in weight from virgin material values when the residue was scraped off.

Above the mandrels, where the steam and chemical spray came in direct contact with the cables, a build-up of residue was observed (see Figures 2-8 and 2-9). The residue was analyzed using a Perkin-Elmer B 240 Elemental Analyzer. The analysis showed the presence of carbon and hydrogen in proportions similar to those found in virgin insulation material. Therefore, it was evident that there was a reaction between the chemical spray and the insulation material and that the residue was not simply a deposit of condensed chemical spray. To determine the extent of degradation, virgin and exposed insulation material samples were analyzed. The weight of each sample was measured. The residue was carefully scraped from the insulation and the remaining insulation sample reweighed. Comparing the weights of the scraped and virgin samples, the measurements showed that four percent of the weight was removed. Although the quantity of residue build-up gives the appearance of severe insulation degradation,

the measurements indicate that the insulation material loss was not significant when evaluating its effect on cable function during a LOCA/MSLB.
