Prairie Island Nuclear Generating Plant

Steam Generator Inspection Reports

STEAM GENERATOR TUBE PLUGGING/SLEEVING SUMMARY

Prairie Island No. 12 Steam Generator
Category C-3 Tube Inspection
Special Report

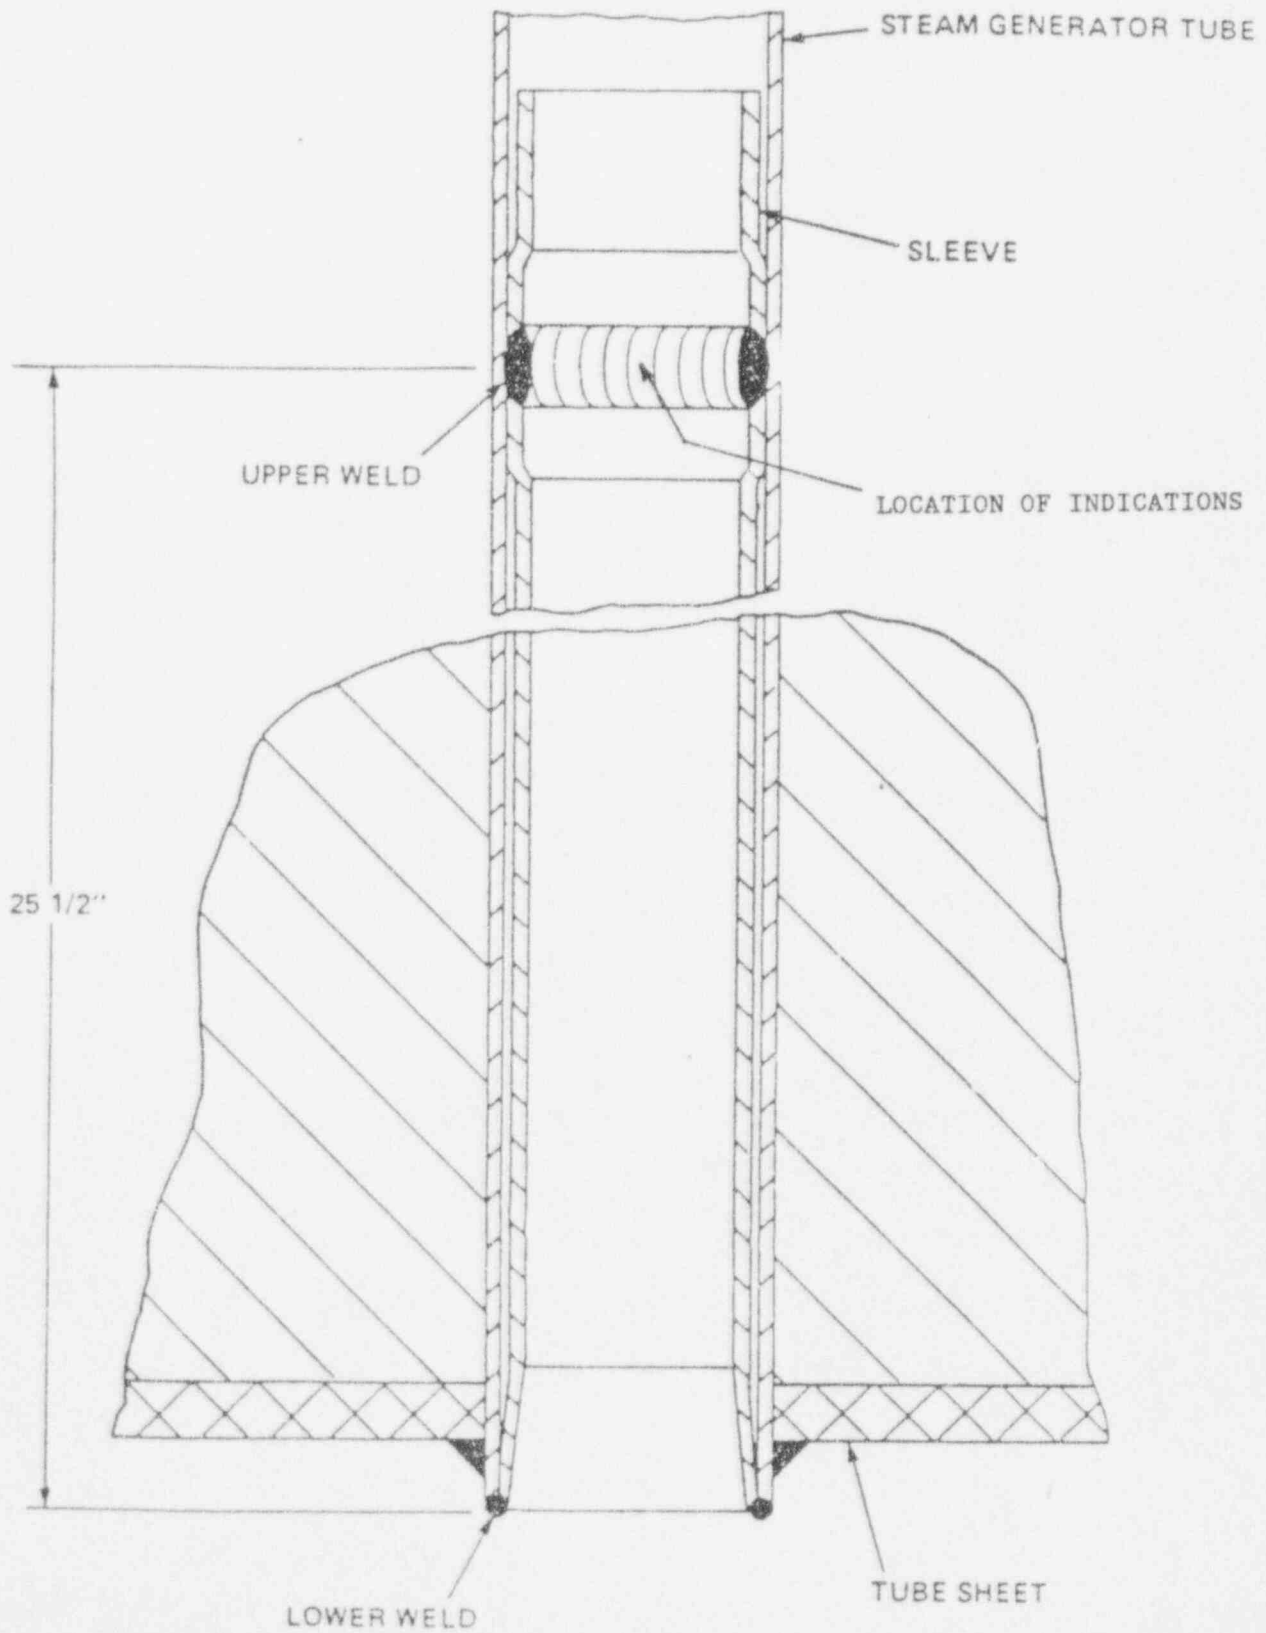
When using rotating I-coil and pancake eddy current probes, volumetric indications were found in the upper weld of 27 Combustion Engineering welded tubesheet sleeves. These indications were characterized as shallow and on the inside surface. The visual examination showed the welds to be acceptable. There were some weld artifacts on the weld surface which could explain the eddy current indications. All of the welds were examined this outage by ultrasonic testing and found to be acceptable. The indications are not due to corrosion since they were found in sleeves from 3 different outages, 1987, 1992, and 1994. All sleeves with these indications were left in service.

- B. The sleeve material is Alloy 690.
- C. The attached Table 3 provides the list of sleeves with indications at the weld. The attached Figure 1 is a drawing of the Combustion Engineering Tubesheet Sleeve installed at Prairie Island.

- F. The indications were all located at the sleeve upper weld. Four of these sleeves were installed in the April 1987 outage and sixteen were installed in October 1992 outage. Seven were installed this outage.

- C. The sleeves with the welding artifacts, as identified by eddy current RPC probes, are acceptable based on acceptable visual examination, ultrasonic examination, and indication location. There is currently no known primary side degradation which is volumetric in nature. In addition, since these indications are found in the both the oldest and newest sleeve welds, they are not a result of corrosion.
- D. Combustion Engineering has been requested to keep NSP apprised of further developments for the examination of sleeve welds. NSP will conduct future examinations of the sleeve welds using RPC probe technology.
