Carolina Power & Light Company

BRUNSWICK NUCLEAR PLANT UNIT 2  
DOCKET NO. 50-324/LICENSE NO. DRP-62  
LICENSEE EVENT REPORT 2-94-008

Dispatcher Switching Evolution Results in Loss of Offsite Power to Unit 2

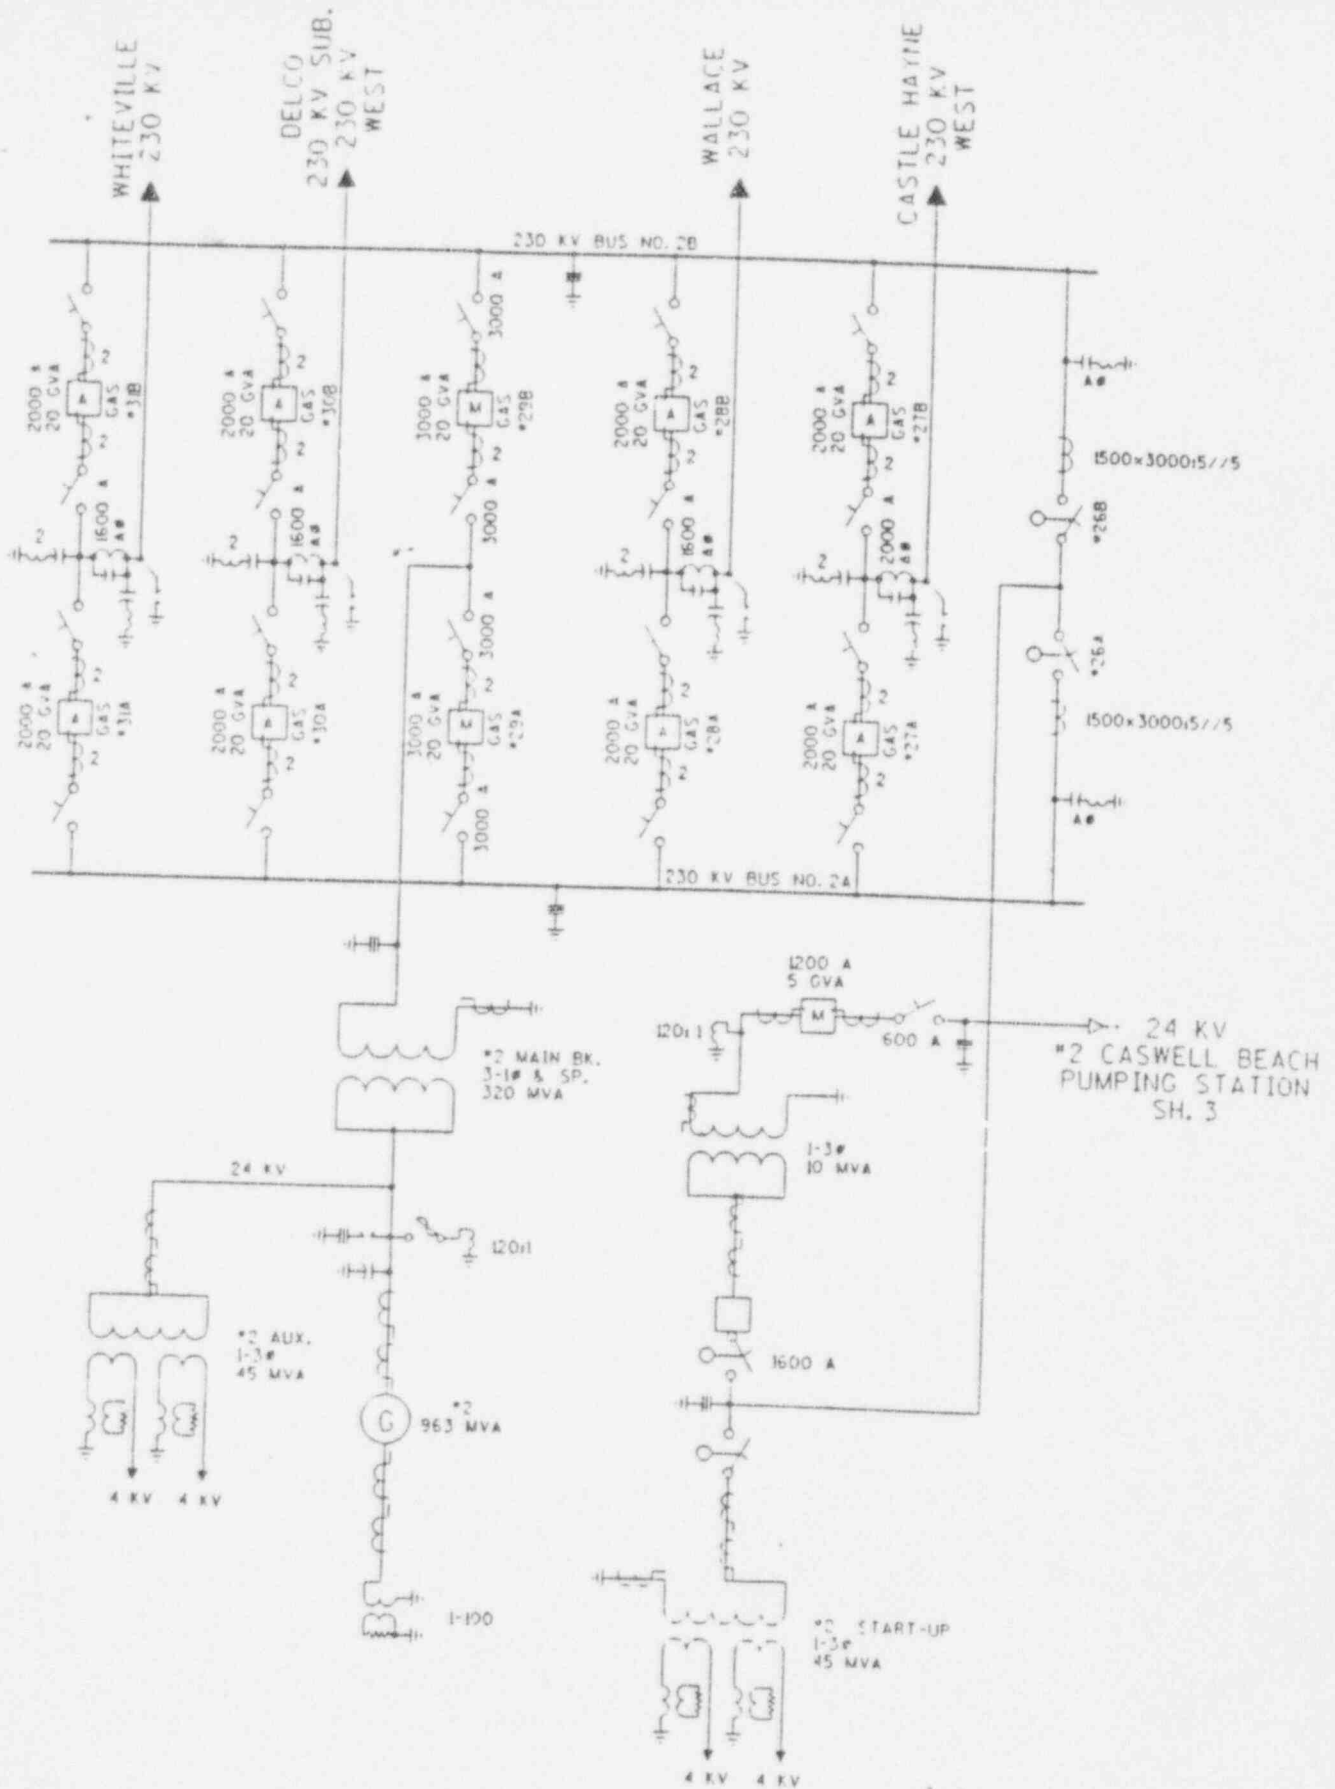
The Unit 2 230 kV electrical system configuration (see attachment) has four incoming feeders from the grid (Whiteville, Delco West, Wallace, and Castle Hayne West). The feeders can be lined up to either the 2A or 2B Bus. The Unit Main Transformers, the Startup Auxiliary Transformer (SAT), and the Unit Auxiliary Transformer (UAT) also supply either the 2A or the 2B Bus. The SAT supplies power to the plant during shutdown conditions. During power operations the SAT feeds the Reactor Recirculating Pumps and the UAT supplies all other plant loads. At the time of the switching evolution the SAT was being supplied from the Switchyard 2B Bus with the Delco West, the Castle Hayne West and the Wallace circuit breakers feeding the bus.

The Unit 2 Reactor Operator informed the dispatcher that there had been an auto start of the diesel generators. The dispatcher realized that the "B" breakers had been opened rather than the "A" breakers and notified Brunswick of the error. At 1511 hours the "B" circuit breakers were closed and power was restored to the Unit 2 SAT.

The cause of the event was personnel error. The dispatcher executed the actions specified in the switching instructions too rapidly. The switching instruction contained six actions in one step, allowing the performance of multiple actions without referencing the procedure. All six actions were completed in 52 seconds which did not allow time for self-checking. Additionally, the time between actions did not allow communications (intended action and feedback) with the BNP Control Room which should have identified that the intended action was incorrect.

The switching instructions contained actions for both the "A" and "B" bus in one step. The dispatcher had previously reviewed the switching instructions and noted that actions were required on both "A" and "B" buses. He had underlined the differences, yet when referencing the step prior to execution, only "B" registered in his mind.

1. Appropriate controls were established to ensure that switching instructions follow established plant procedure format.
2. The event was reviewed by appropriate system dispatchers.
3. P job briefings will be required for all planned switching activities involving nuclear power plants.

4. Instructions for any planned switching activity at a nuclear power plant will require dual verification ensuring that the correct device has been selected.
5. Senior Reactor Operator review of switching instructions will be documented on the BNP Control Room copy prior to authorization of planned switching activities.
6. The event will be reviewed by appropriate BNP operations personnel.
7. System dispatchers will be trained on the STAR (Stop, Think, Act, Review) method of self-checking.
