Docket No. 50-213  
B14881

Attachment B  
Haddam Neck Plant  
Walkdown Summary Report  
Replacement Pages

June 1994

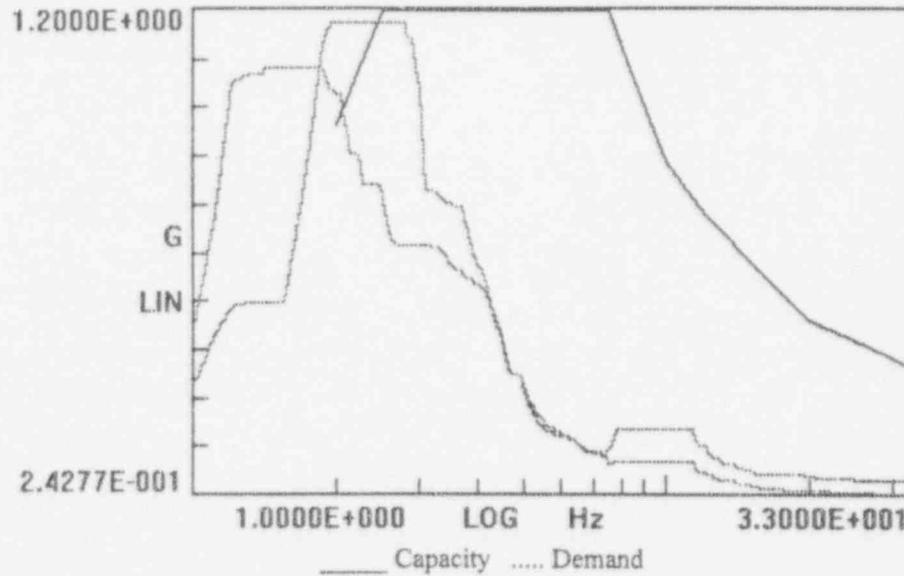
Capacity Basis - Component reference spectra envelops conservative floor response spectra for frequency greater than 2 Hz, component frequency is significantly higher than 2 Hz therefore the non enveloping region is inconsequential.
