TRIP REPORT

On-Site Investigation and Analysis of
the Human Factors of an Event
at Braidwood Unit 1
on October 4, 1990

(Reactor Coolant System Loss)

October, 1990
INEL/EG&G Idaho, Inc.

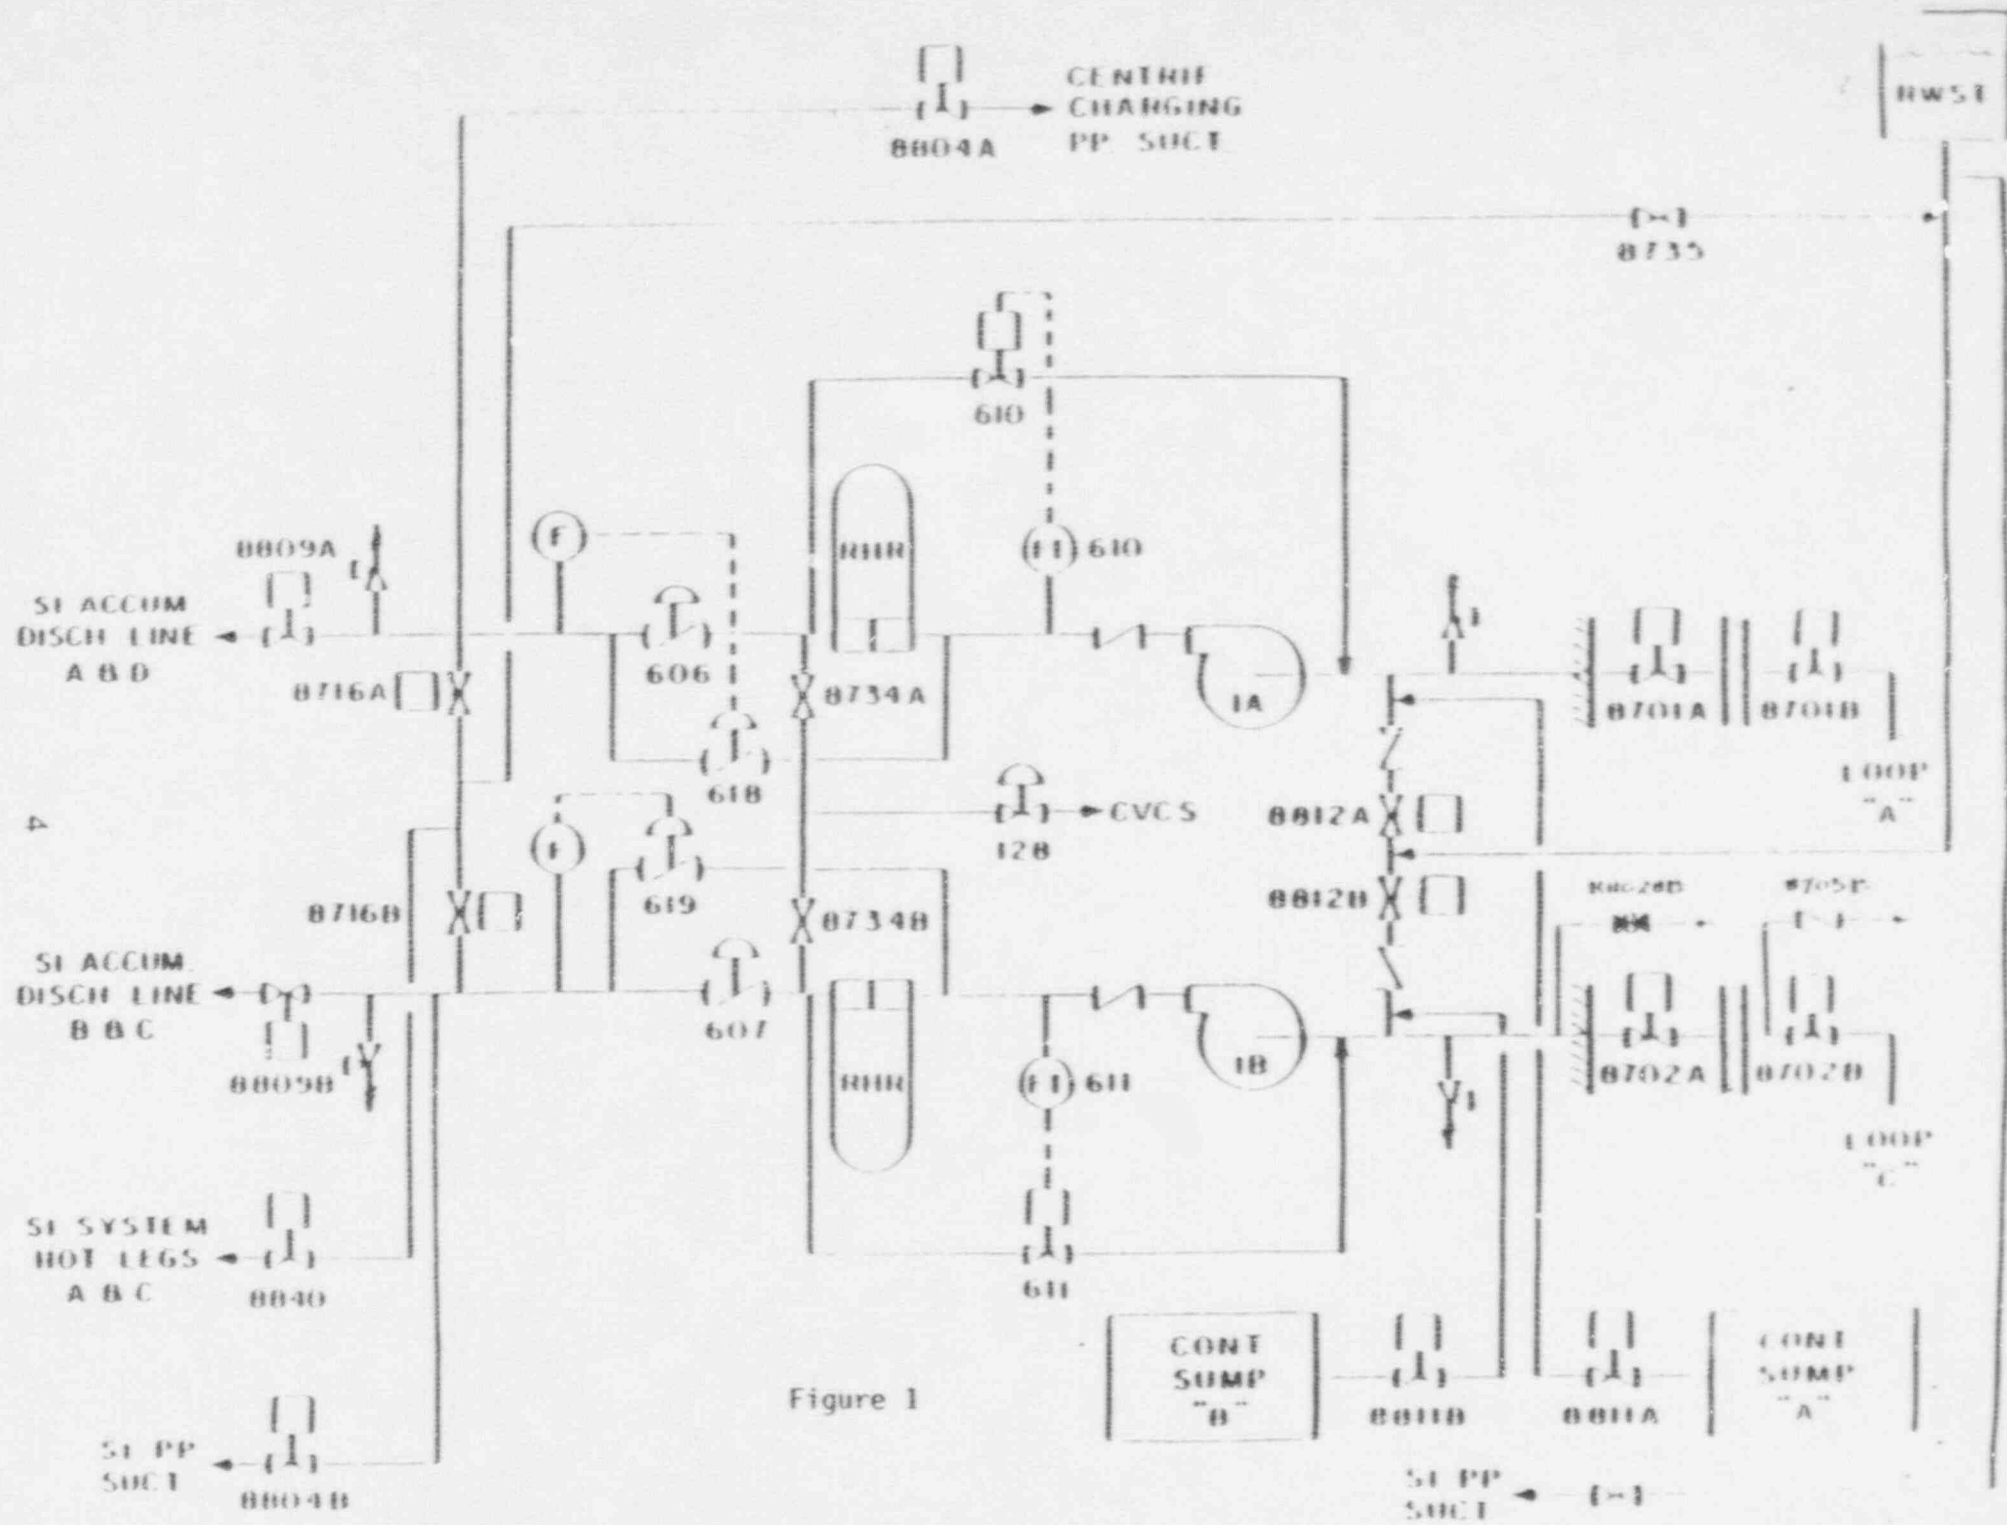
During performance of Procedure BwVS 4.6.2.2-1, Reactor Coolant System Pressure Isolation Valve Leakage Surveillance on March 4, valve 1RH0288, RH Hot Leg Suction Vent Valve, was opened to collect leakage past the RH Hot Leg Suction Valves, 1RH8702A and 1RH8702B, and past the RH Hot Leg Suction Line Pressure Relief Check Valve, 1RH8705B. Procedure BwVS 0.5-2.RH.2-1, Residual Heat Removal Valve Stroke Test, which times the opening stroke of the Hot Leg Suction Valves 1RH8702A&B, was also being performed in parallel with BwVS 4.6.2.2-1. The 1RH8720A valve had been timed when it was opened via BwVS 4.6.2.2-1 to change lineups to check leakage past the 1RH8702B and 1RH8705B valves. Figure 1 depicts schematically the various valve configurations and lineups.

Opening valve 1RH8702B aligned the RCS to the inlet of the still open vent valve 1RH028B. During the time that the 1RH8702A valve was open and the 1RH028B valve was closing, leakage through the vent increased and burst the tygon tubing attached to the valve, resulting in personnel in the Auxiliary Building being sprayed with hot water. Total indicated loss of pressurizer level was 5%, from 40 to 35%, which represents an approximate loss of 600 gallons.

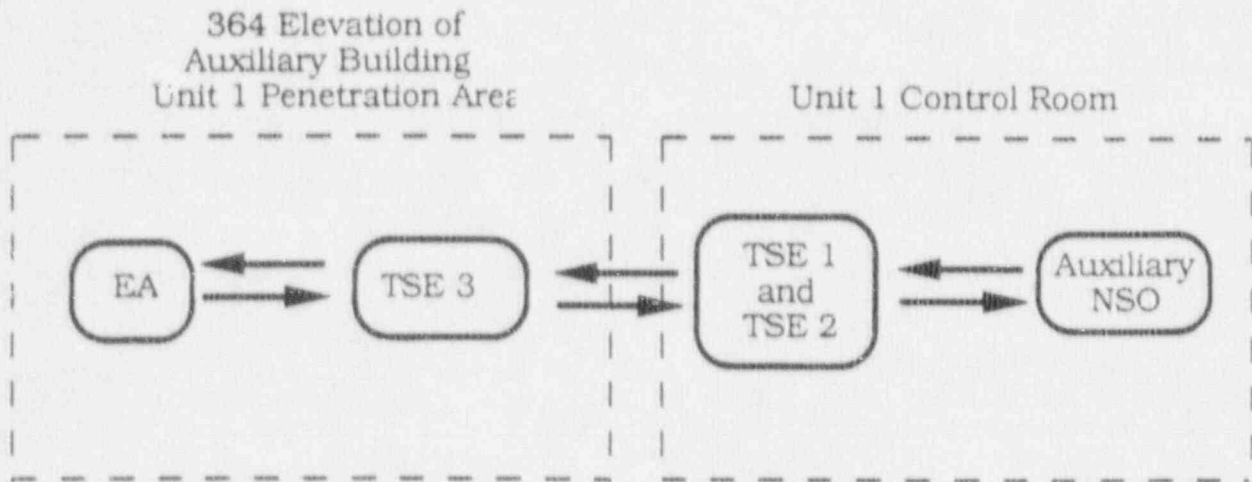
Figure 2. Communication patterns.

As illustrated in Figure 2, communication patterns at the time of the incident included direct communication between TSEs 1/2 and TSE 3 in the Auxiliary Building, between TSE 3 and the EA in the Auxiliary Building, and between TSEs 1/2 and the Auxiliary NSO in the Unit 1 Control Room. The Auxiliary NSO was not in direct or continuous communication concerning the execution of the two surveillances with any other operating staff personnel (e.g., NSO, SCRE, SA, and SE). This observation is substantiated by the fact that the NSO, SCRE, SA, and SE were unaware that two surveillances were being conducted in parallel. Also, it is important to note that the Auxiliary NSO and TSE 3 were not in direct communication with each other, but rather interfaced through TSEs 1/2. Figure 2 further illustrates that the standard command, control, and communication structure was bypassed, with the NSO, SCRE, and SE completely out of the command/control loop. As will be noted, this absence resulted in a lack of system redundancy or checks on the activities being performed by technical staff engineering personnel.

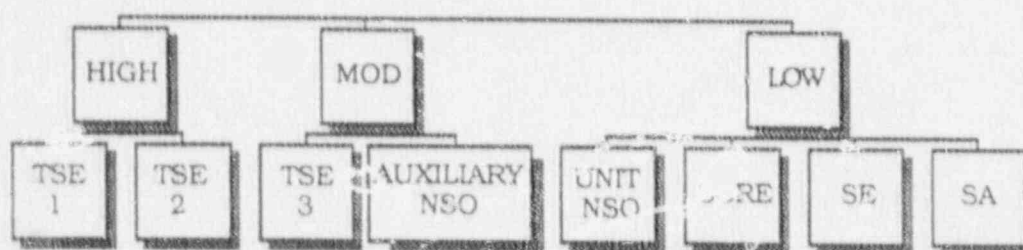
Figure 3. Personnel task awareness/involvement.

A determination of task involvement/awareness among various operational personnel was also attempted. Task involvement refers to the degree in which an individual directly participated in executing the various steps of the two procedures. System awareness refers to the extent those same individuals were aware of changes in system configuration based on executing those steps (e.g., aware that by opening a valve, a change in the configuration of the system had occurred, and being able to mentally "picture" and understand that change). Three levels of involvement/awareness were identified: high, medium, and low. Based on this categorization, personnel were assigned to each level, as illustrated in Figure 3.

As depicted in the figure, the SCRE, Unit 1 NSO, SA, and SE had a low level of task involvement/awareness and in fact, were not even cognizant that both a leakage and a stroke surveillance were being conducted in parallel. This low task involvement/awareness appears to have been caused by an inadequate shift turnover, inadequate shift briefings, failure of the Auxiliary NSO to appraise the NSO of the extent of testing taking place, failure of the NSO to appraise himself of the exact nature of the tasks being conducted within the Unit 1 control room, and bypassing of the normal command, control, and communication structure.

TSE 3 and the Auxiliary NSO had a moderate level of task involvement/awareness. Although they were directly involved in executing some of the tasks required per the two procedures, they did not execute all of them. For example, the Auxiliary NSO was not always aware of instructions being given to TSE 3 by TSEs 1/2, nor was TSE 3 aware of instructions given to the Auxiliary NSO. As a result of this incomplete involvement and not communicating directly, neither

TSEs 1/2 had a high involvement/awareness of the two surveillances. They were involved in monitoring all facets of the two procedures, issuing all procedural directives, performing all required calculations, signing off all completed procedural steps, acting as the critical communications interface between themselves and TSE 3 and the Auxiliary NSO, and continuously monitoring all changes in system configuration.

Based on this task involvement/awareness configuration, successful task performance was essentially dependent on the successful performance of TSEs 1/2. However, TSEs 1/2 performance was affected by attempting to coordinate a fairly complex dynamic task, as described in section 2.3.3, and in a possible state of physical and mental fatigue, suggested by the number of hours worked (approximately 19 and 17 hours, respectively). Also, this configuration
