Beaver Valley Power Station, Unit No. 1  
Docket No. 50-334, License No. DPR-66  
LER 91-002-00

LER 91-002-00, 10 CFR 50.73.a.2.i.a, "Reactor Coolant System Pressure Boundary Leakage Results in Plant Shutdown".

Reactor Coolant System Pressure Boundary Leakage Results in Plant Shutdown

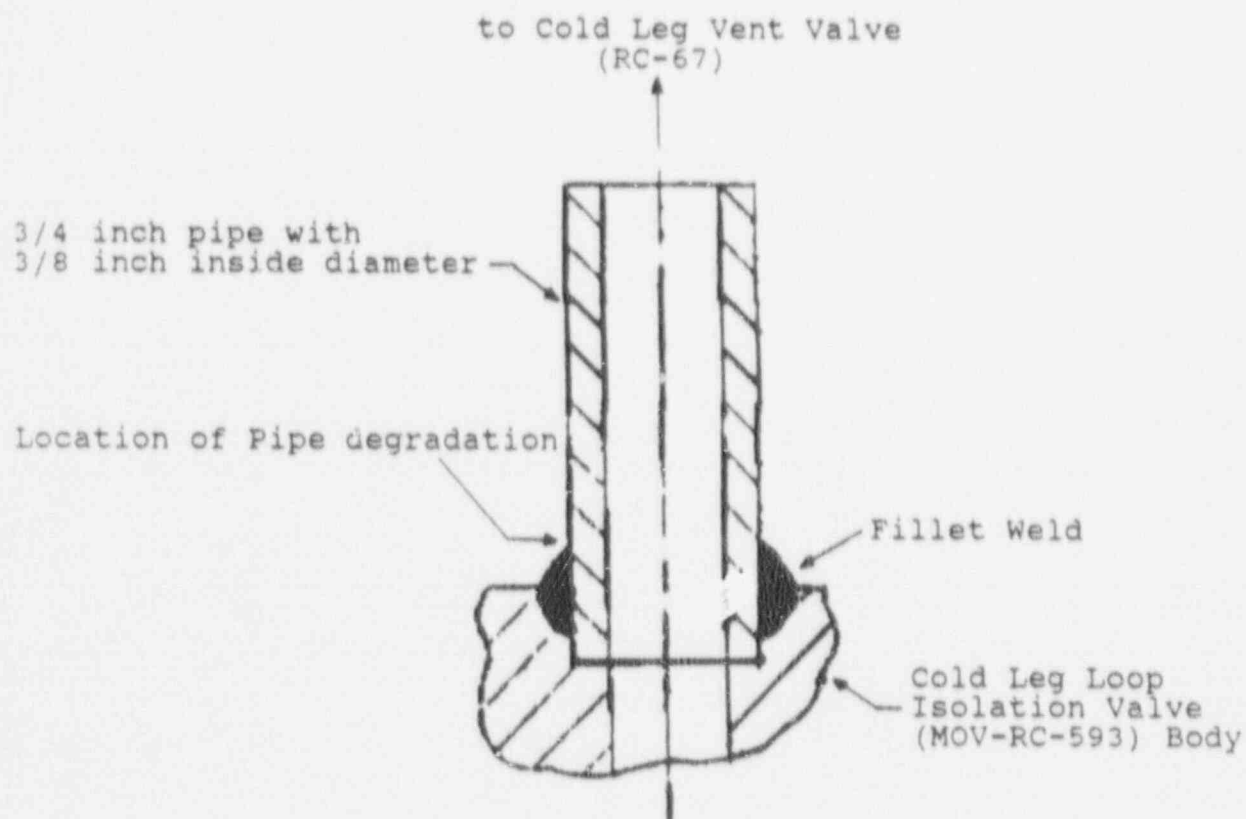
Figure 1

The cause for this event was degradation of the piping on RC-67. Initial analysis show that the degradation initiated in the piping at the toe of the fillet weld and propagated through the piping. The cause for the piping failure is under investigation.

3. A Temporary Modification was initiated to remove the disc pressurization system connection from the Loop 1B Cold Leg Vent Valve, RC-67, and to install a plug in the reactor coolant system penetration and a cap over the plug.
4. A root cause investigation (metallurgical analysis) will be conducted to identify the cause of the pipe failure.
5. Liquid dye penetrant testing of all other similar penetrations on the other loop stop valves was performed. No deficiencies were found.
6. A permanent repair of the connection will be evaluated based on the root cause of the failure.
