## AEOD ENGINEERING EVALUATION REPORT

UNIT: Several EE REPORT NO.: AEOD/E91-01  
DOCKET NO: Several DATE: February, 1991  
LICENSEE: Several  
NSSS/AE: Several EVALUATOR/CONTACT: E. J. Brown  
SUBJECT: A REVIEW OF WATER HAMMER EVENTS AFTER 1985  
EVENT DATE: Multiple

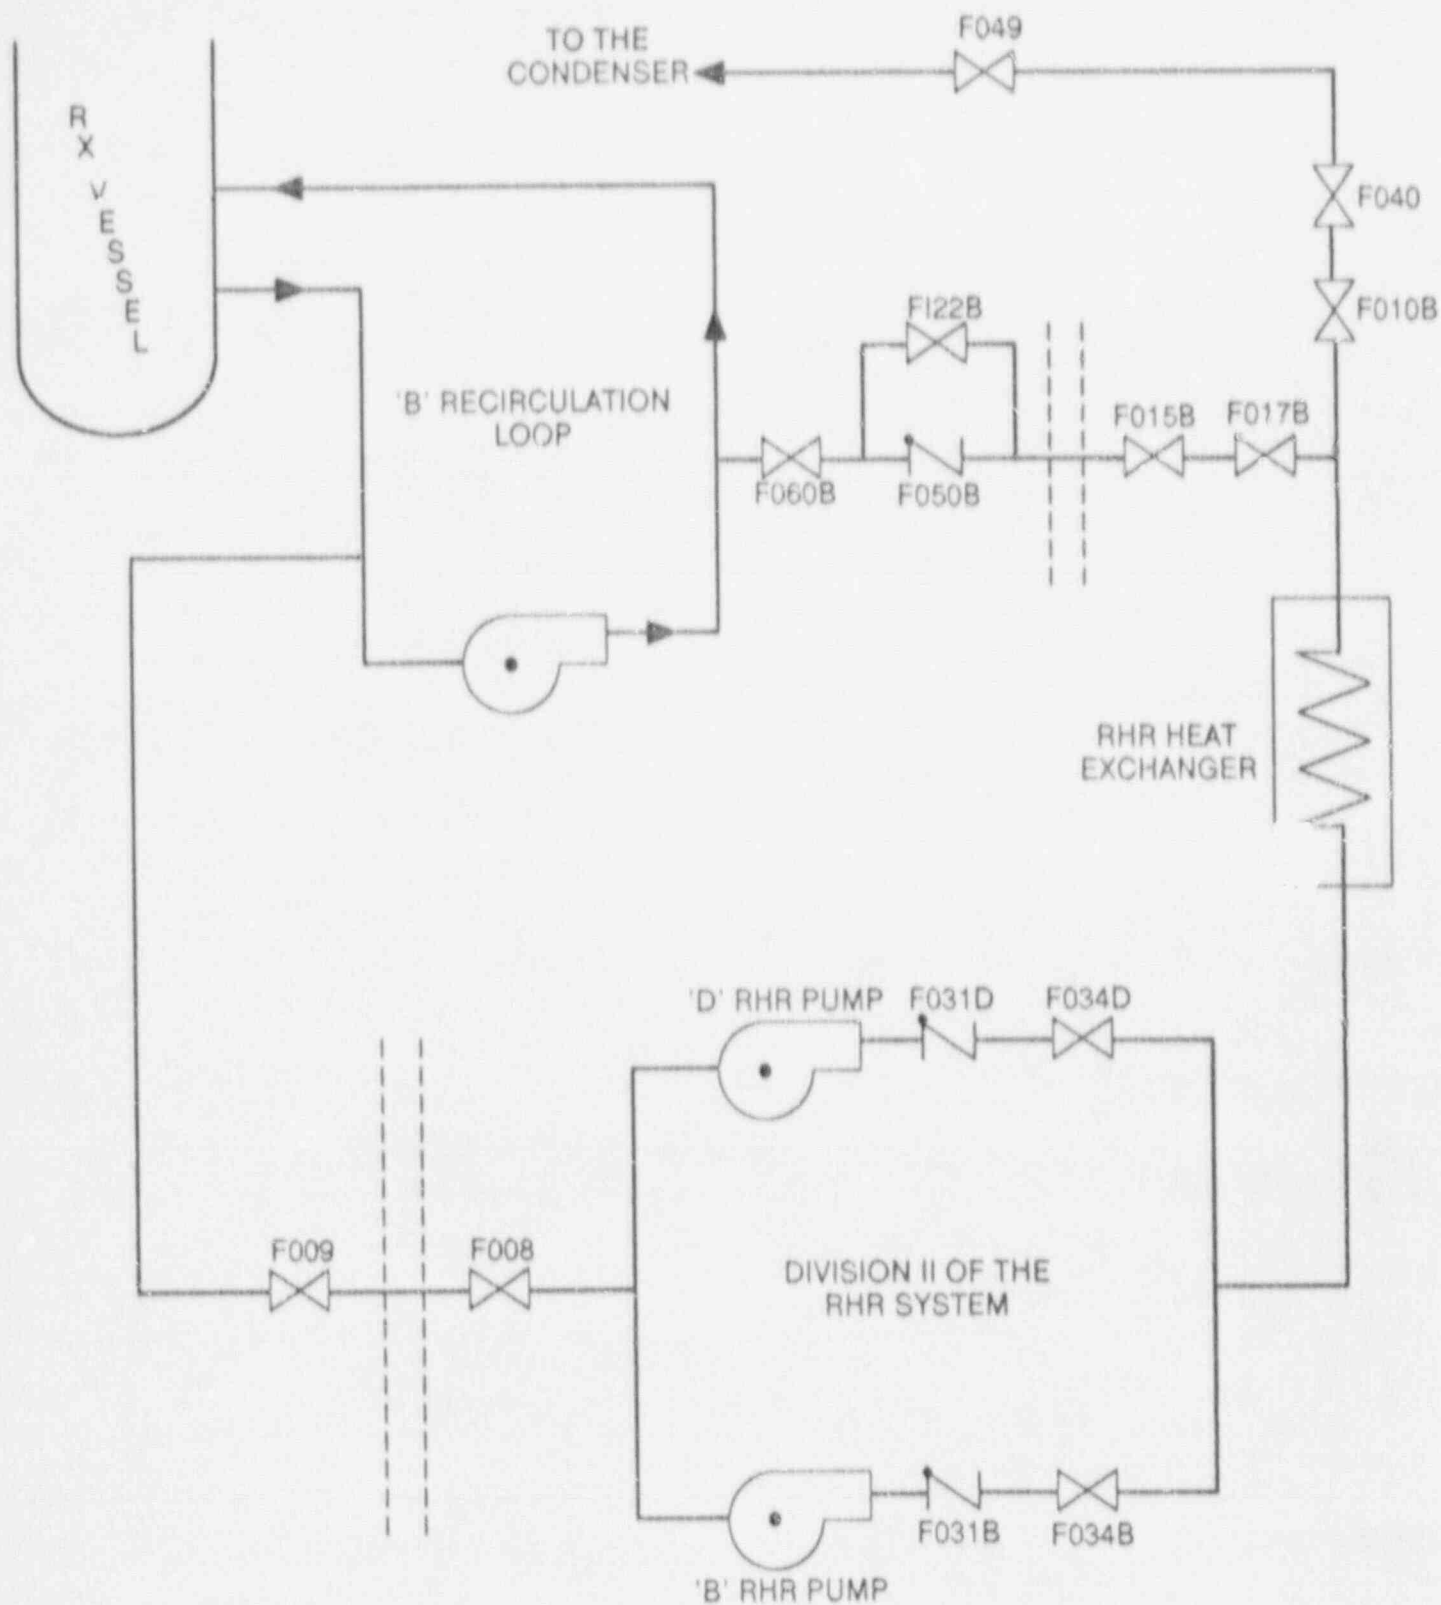
FIGURE A1.  
RHR SHUTDOWN COOLING FOR SUSQUEHANNA UNIT 2

On October 12, 1986 Unit 2 was in the shutdown cooling mode, condition four, with the "D" residual heat removal (RHR) pump in service. With the "D" pump running, the "B" RHR pump was then started (See Figure A1). The switchover to the "B" pump in service was completed with shutdown of the "D" pump. However, at approximately the same time, closure of the outboard isolation valve (F008) occurred in the letdown line from the "B" recirculation loop to the suction of the "B" RHR pump. Closure of the suction valve caused the "B" RHR pump to trip. Operations personnel reset the logic and reopened the F008 valve. Opening the F008 valve resulted in water hammer and the F008 valve again closed. The water hammer was due to partial draindown of the system through a pathway to the condenser. This pathway was present to control reactor water level while the RHR system was in service. The operators failed to fill and vent the system piping after the "B" RHR pump tripped.

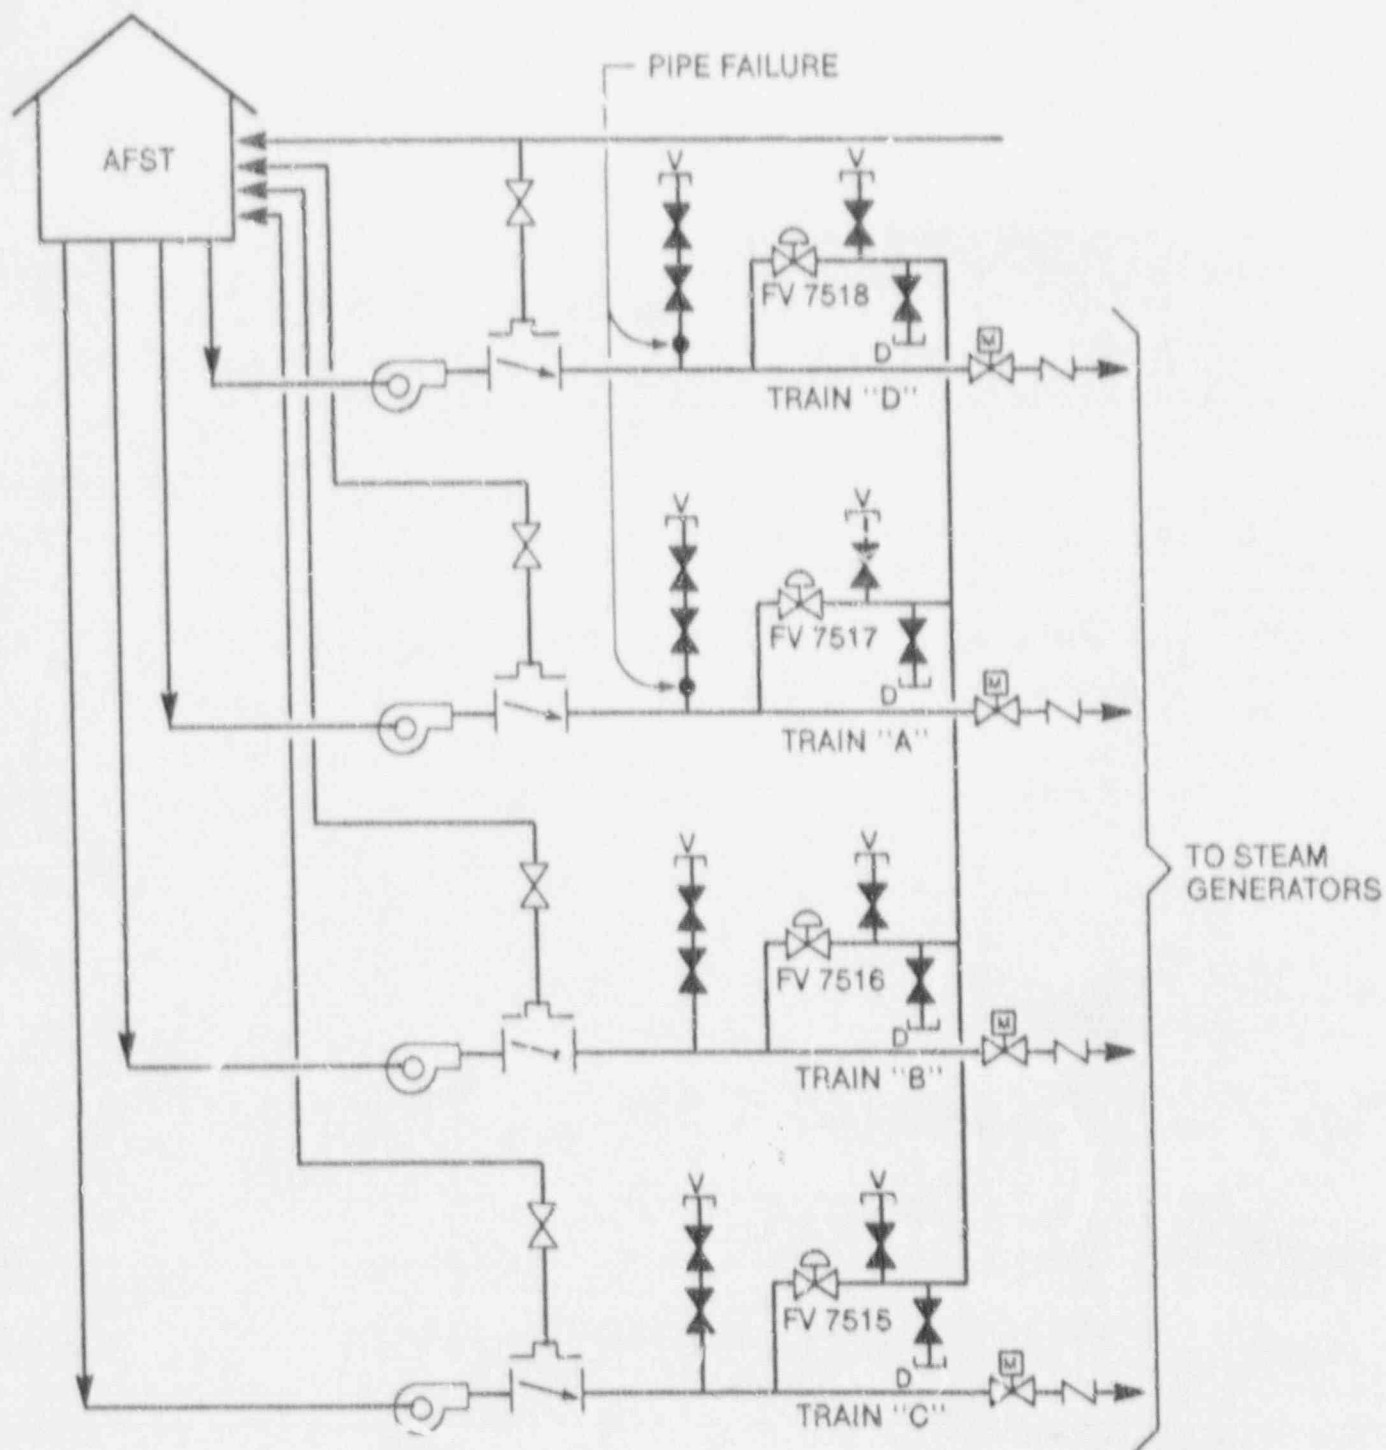
FIGURE A2. SOUTH TEXAS AFW SYSTEM SCHEMATIC

On November 5, 1987, while in mode 4, prior to initial criticality, a one inch double valve vent line in the pump discharge piping of the auxiliary feedwater (AFW) train "A" broke off. A second failure occurred three days later in a similar manner in a double valve instrument tap for the train "D" AFW pump discharge line (See Figure A2). The initial assessment cited the cause as water hammer resulting from improper venting of the system. The AFW system continued to experience vibration. Subsequent testing identified that flow control valves in Trains "A" and "D" introduced a pressure fluctuation when they were in a highly throttled position. The dominant pressure fluctuation frequency of 24 Hz matched one of the piping system acoustic natural frequencies. Mechanical stops were installed to prohibit excessive throttling of the valves. Resolution of this issue involve an extensive test program and special reports ST-HL-AE-2461 (Ref. 8) and ST-HL-AE-2516 (Ref. 9) were issued.

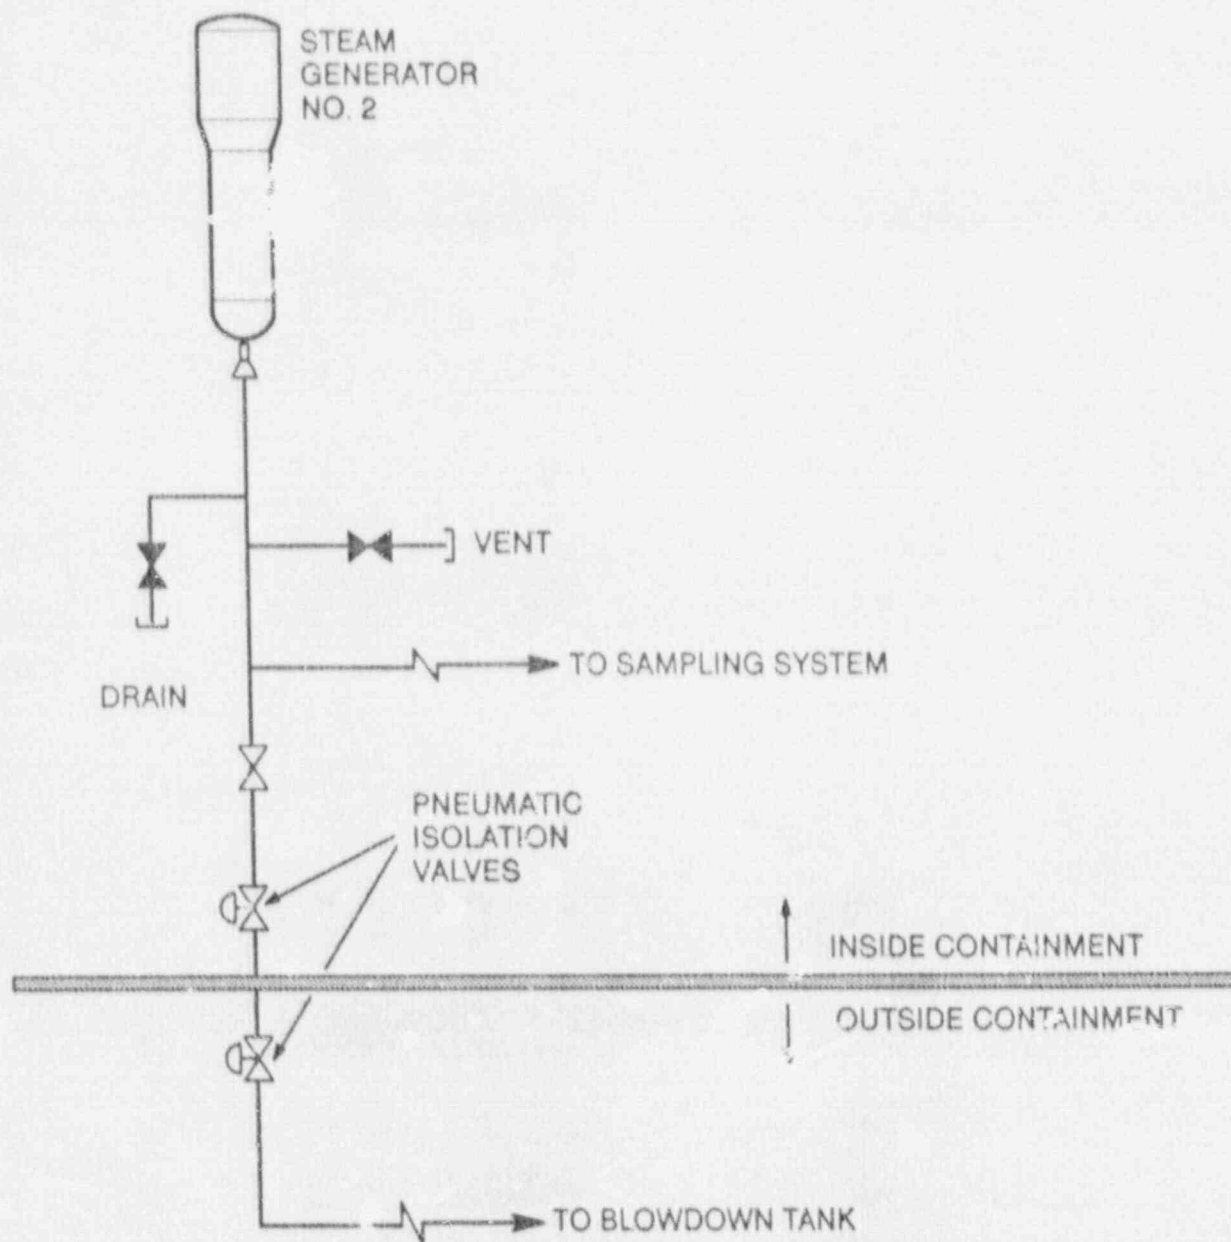
FIGURE A3. WATERFORD STEAM GENERATOR BLOWDOWN SYSTEM SCHEMATIC

With the plant at 100% power, a damaged pipe support was identified on steam generator No. 2 blowdown system piping during a routine system walkdown on July 14, 1989. It was later determined that in this condition structural integrity of the blowdown system (including the outside containment isolation valve and shield building penetration) could not be assured during a seismic event. The support was undamaged when observed during a walkdown the week of June 19, 1989. The operating test "Engineered Safety Feature Actuation Signal (ESFAS) Subgroup Relay Test" was conducted between the two system walkdowns. This test involved cycling the inside containment isolation valve to verify its operability in response to a containment isolation actuation signal or an emergency feedwater system actuation signal. The procedure did not require shutting the outside containment isolation valve (See Figure A3) or to minimize the blowdown flow prior to opening the inboard isolation valve. Thus, a water hammer transient most likely occurred when the inboard isolation valve opened.

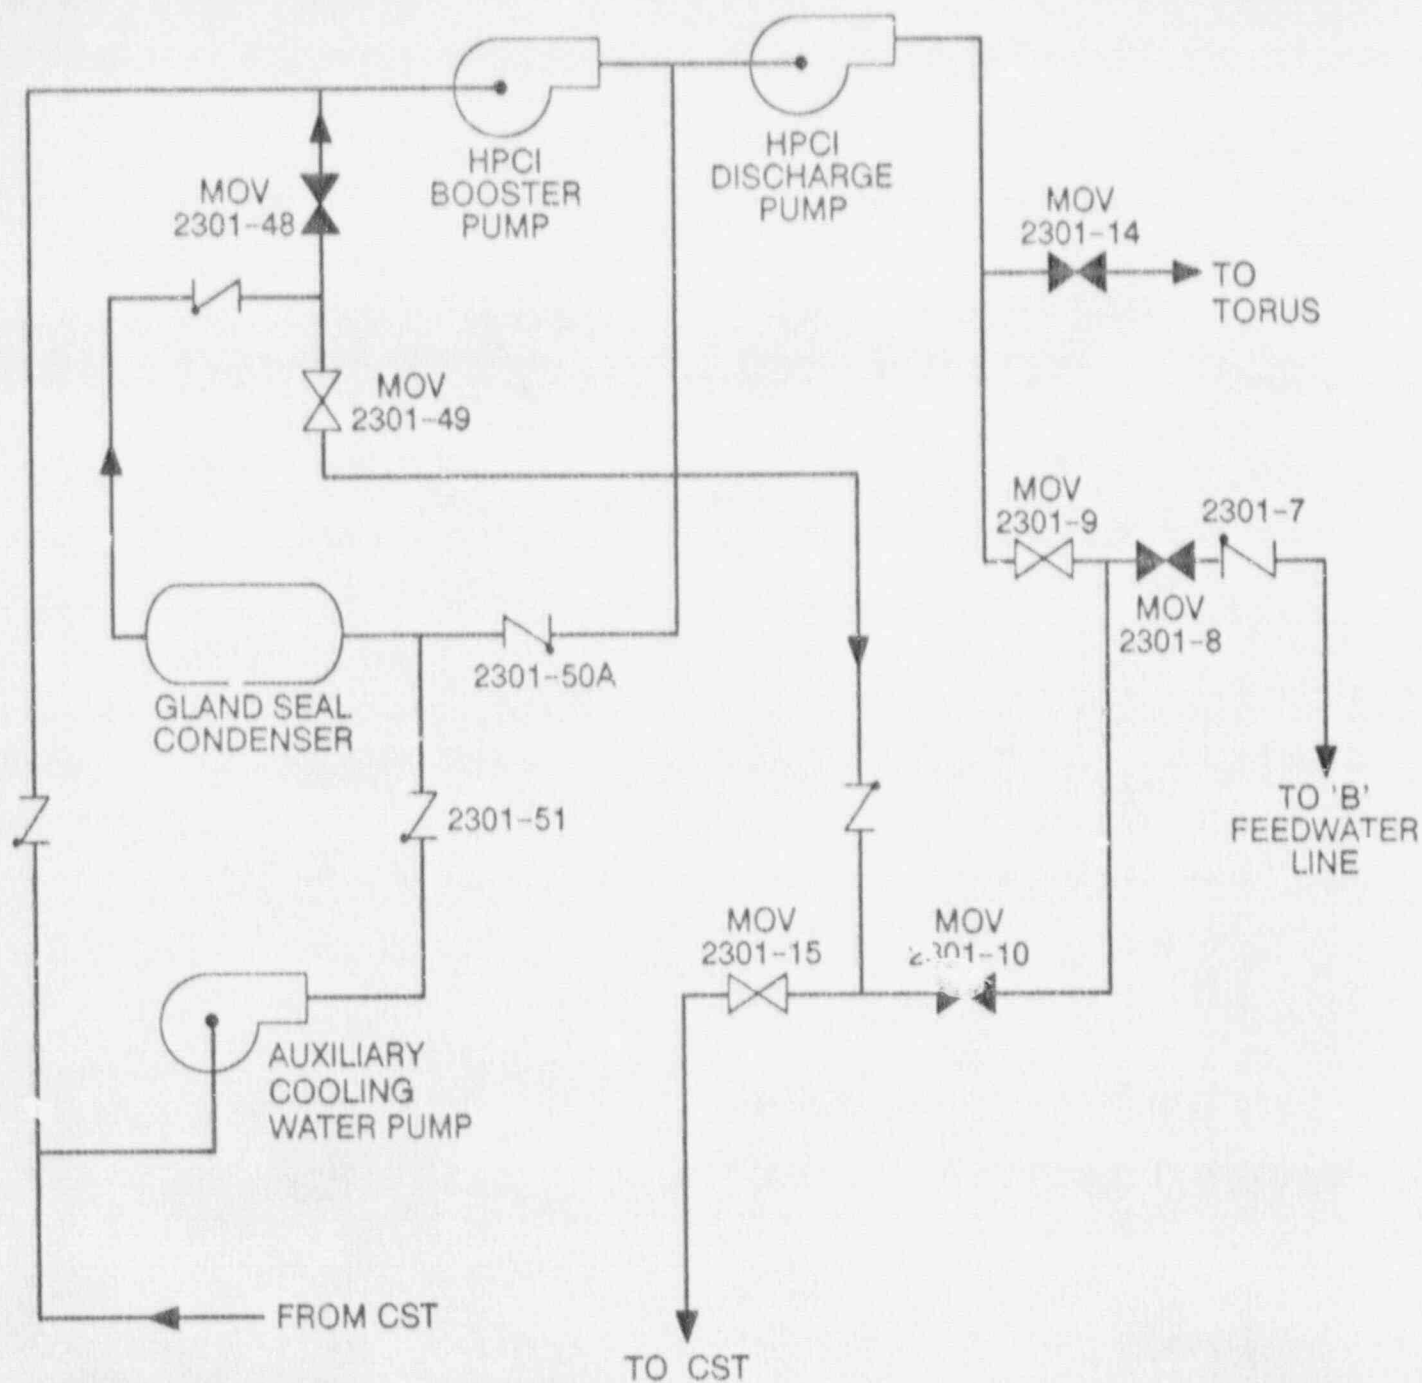
FIGURE A4.  
BASIC HPCI SYSTEM (UNIT 3 PRESENTLY)

The series of water hammer events in the HPCI system at Dresden Units 2 and 3 were all related to known continued leaking of isolation valves during plant operation. Plant operation with the leaking valves (a check valve between the feedwater and HPCI system\* and the normally closed HPCI isolation or injection valve) was initially attempted by utilizing monitoring techniques intended to identify undesirable system temperature conditions.

A series of three events involving water hammer in the high pressure coolant injection (HPCI) system at Dresden Units 2 and 3 are discussed in LER 237/89-029-01. Preliminary indications of a precursor to the initial Unit 2 damage to the HPCI system were provided by measurement of increasing HPCI cubicle temperatures in May 1989. The pipe temperature at the HPCI pump was measured at 140° F while the piping between MOVs 2-2301-8 and 2-2301-9 was 160° F. Refer to Figure A4 for the normal HPCI system configuration. Further pipe temperature measurements in July 1989 identified the HPCI pump discharge pipe at 175° F while the pipe between MOVs 2-2301-8 and 2-2301-9 was 220° F. Subsequent closing and reopening of MOV 2-2301-9 produced pipe temperatures of 106° F after 12 hours and a return to 220° F after MOV 2-2301-9 was opened. Thus, check valve 2301-7 and MOV 2301-8 were both back leaking feedwater to the HPCI system piping. A pipe temperature survey conducted on October 23, 1989, revealed the HPCI pump discharge pipe temperature was 246° F while the pipe between MOVs 2-2301-8 and 2-2301-9 was 275° F. An evaluation determined that steam voids could form in certain sections of the pipe under these conditions. Subsequent inspections of the Unit 2 HPCI discharge piping supports identified there were deficiencies in 47% (or 16) of the supports. The Unit 2 HPCI system valve lineup was changed to that shown in Figure A5 which changes the injection valve function to MOV 2-2301-9 from MOV 2-2301-8. Also, with MOV 2-2301-8 open, MOV 2-2301-10 becomes an isolation valve subject to feedwater pressure.

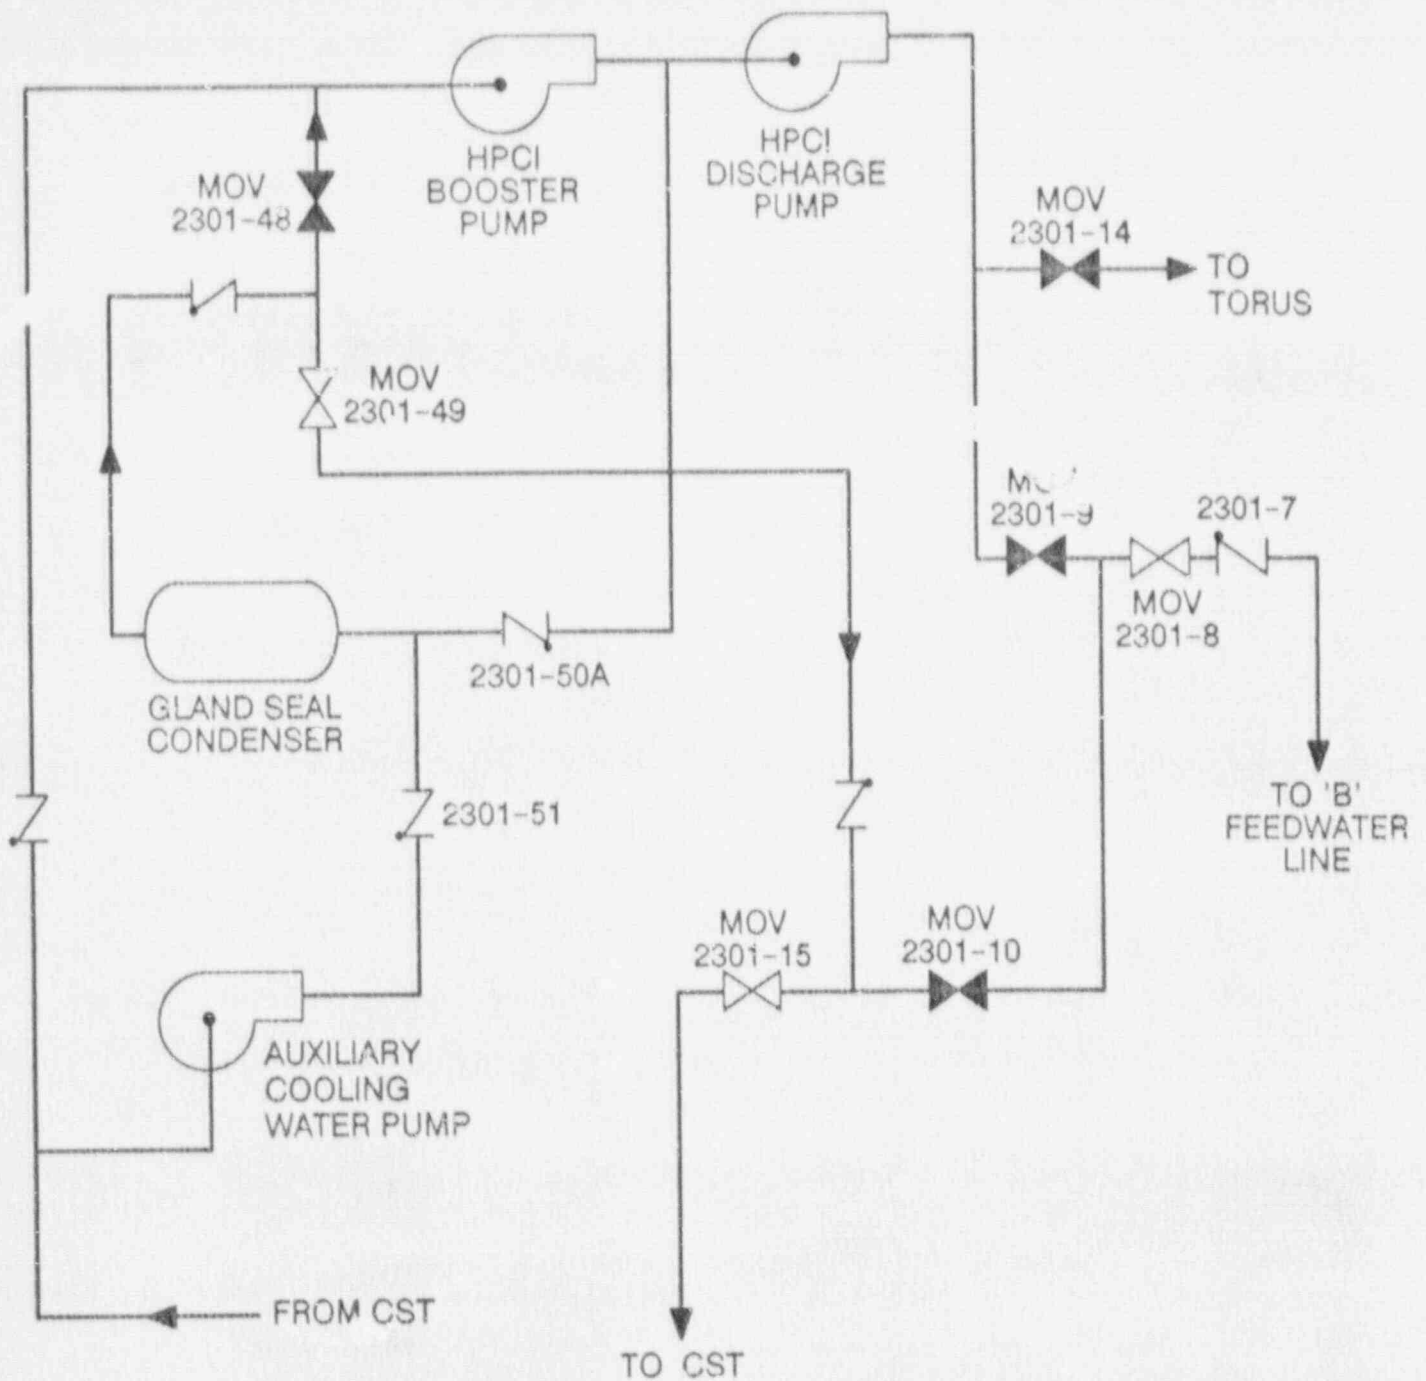
FIGURE A5.  
UNIT 2 HPCI ALTERNATE VALVE LINEUP (POST OCTOBER EVENT)

As a result of the elevated temperatures discovered on the Unit 2 HPCI pump discharge piping, an investigation of the Unit 3 HPCI pump discharge pipe was initiated. Temperature measurements obtained with an infrared thermometer on October 31, 1989, identified HPCI pump discharge pipe temperatures ranging from 256° F between MOVs 3-2301-8 and 3-2301-9 to 112° F at the discharge of the HPCI pump. This was evidence of possible steam void formation in the Unit 3 HPCI pump discharge piping. Subsequent monitoring of the HPCI pump discharge pipe temperature and pressure revealed that the temperature was increasing on November 3, 1989. The temperature increase was attributed to leakage past MOV 3-2301-10. MOV 3-2301-10 was manipulated both electrically and manually to seat the valve and MOVs 3-2301-15 and 49 were also closed. After the latter MOVs were closed, the pump discharge pressure increased from 650 psig to 1070 psig which confirmed that leakage through MOV 3-2301-10 was stopped. The Unit 3 HPCI system valve lineup was changed (MOVs 3-2301-15 and 49 were closed and MOV 3-2301-48 was opened) to that shown in Figure A6. Subsequent inspection of Unit 3 HPCI discharge pipe supports identified there were deficiencies in 52% (or 21) of the supports. These events at Units 2 and 3 in October and November 1989 were reviewed by an NRC Augmented Inspection Team.

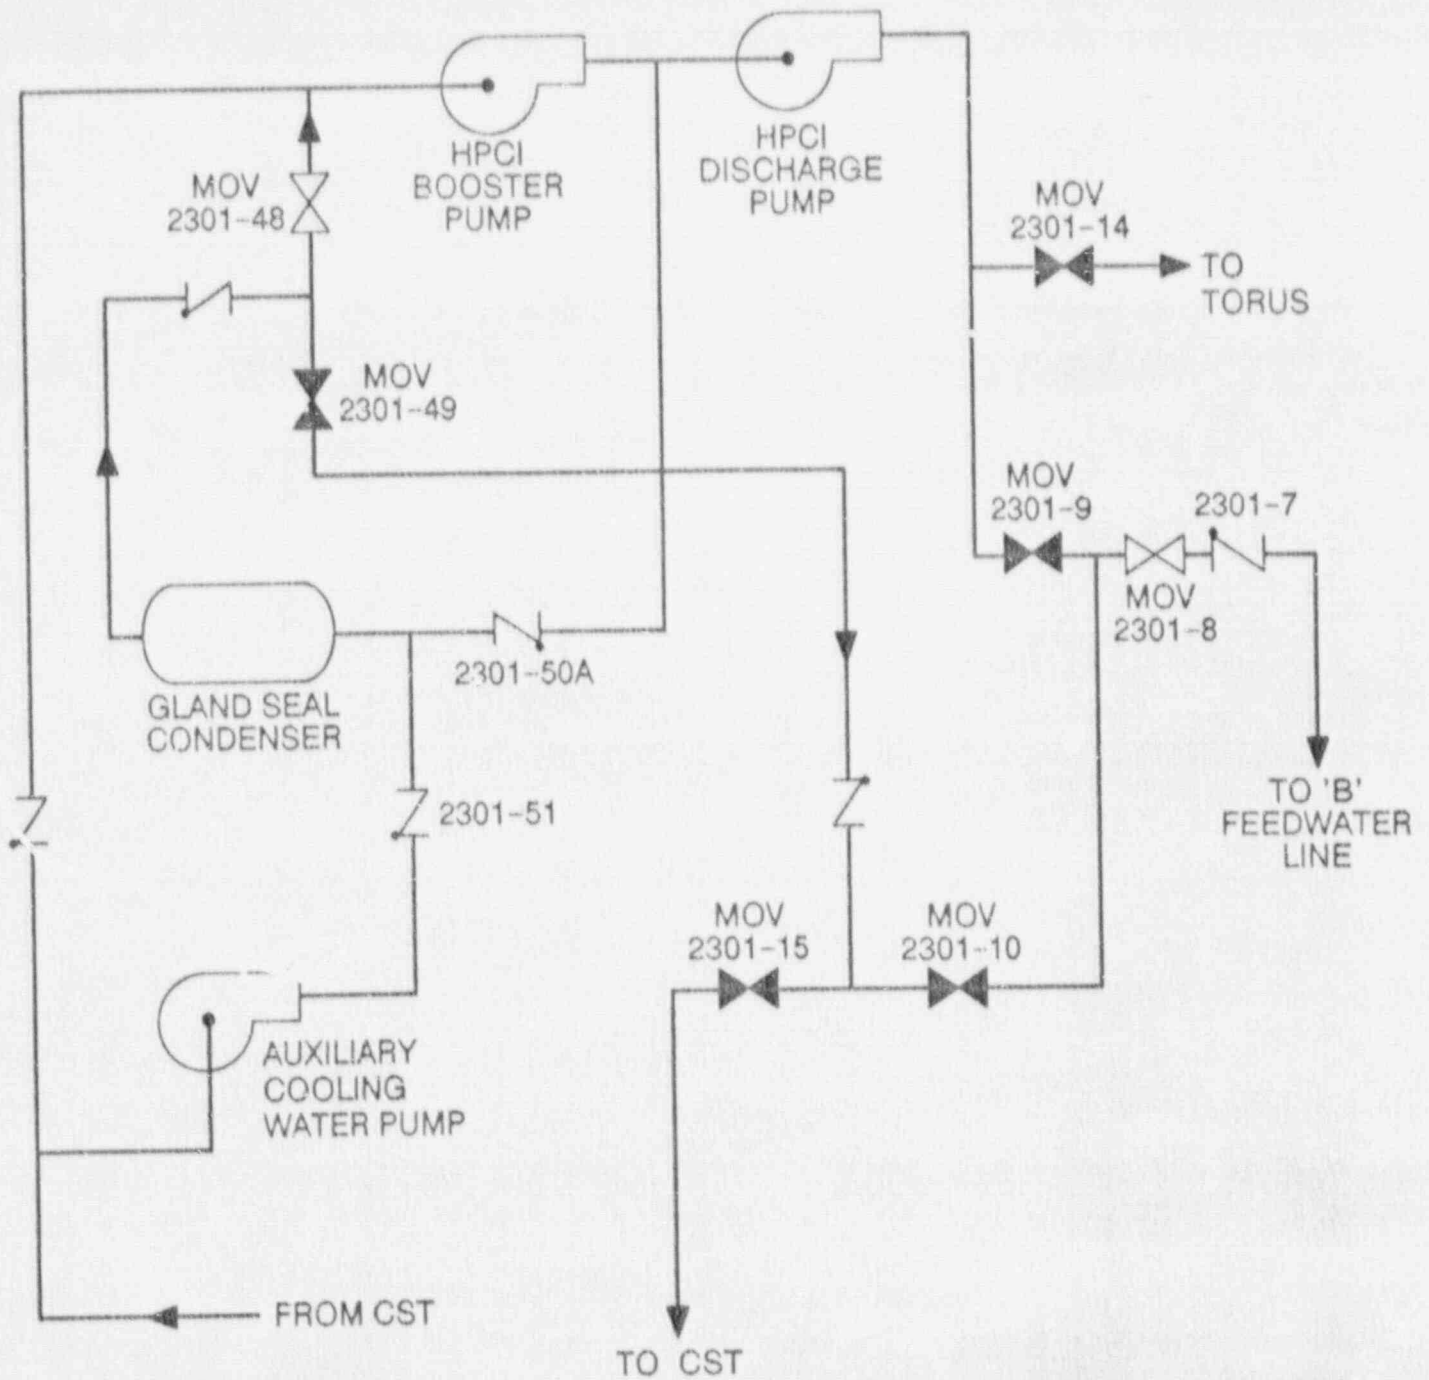
FIGURE A6.  
HPCI REVISED ALTERNATE VALVE LINEUP  
(UNIT 2 PRESENTLY & UNIT 3 POST OCTOBER EVENT)

On March 19, 1990, after completion of routine HPCI valve operability surveillance testing and while performing quarterly valve timing testing on the Unit 2 HPCI pump discharge valves, the Unit 2 Shift Supervisor discovered banging noises emanating from the HPCI pump discharge piping. The valve timing test was terminated and the HPCI system valve lineup was returned to that shown in Figure A5. The pipe banging and motion was monitored until it eventually ceased approximately 1.5 hours later. Subsequent investigation involving valve manipulation and HPCI pump discharge pipe temperature measurements led the licensee to conclude that feedwater back leakage through HPCI test return valve MOV 2-2301-10 was the root cause of this event. Based on the investigation, it was postulated that MOV 2-2301-10 did not fully close after one of the manipulations involved in complying with plant Technical Specification required valve and HPCI system tests. This could occur because of the MOV control system and the way in which the limit switches are used. This valve does not have a seal-in feature to complete the stroke after closure initiation. In addition, the limit switches are set to provide a torque switch bypass function in the open direction until the valve is 25 percent open. The type of limit switch used also controls the indicated valve close light in the control room. Thus, an operator who removed a closure signal when the control room panel lights indicated the valve was closed could leave the valve nearly 25% open. A procedure was introduced to continue the closure signal 30 seconds after the panel lights indicate MOV 2-2301-10 is closed. The Unit 2 HPCI system revised valve lineup was left to correspond with Figure A6.

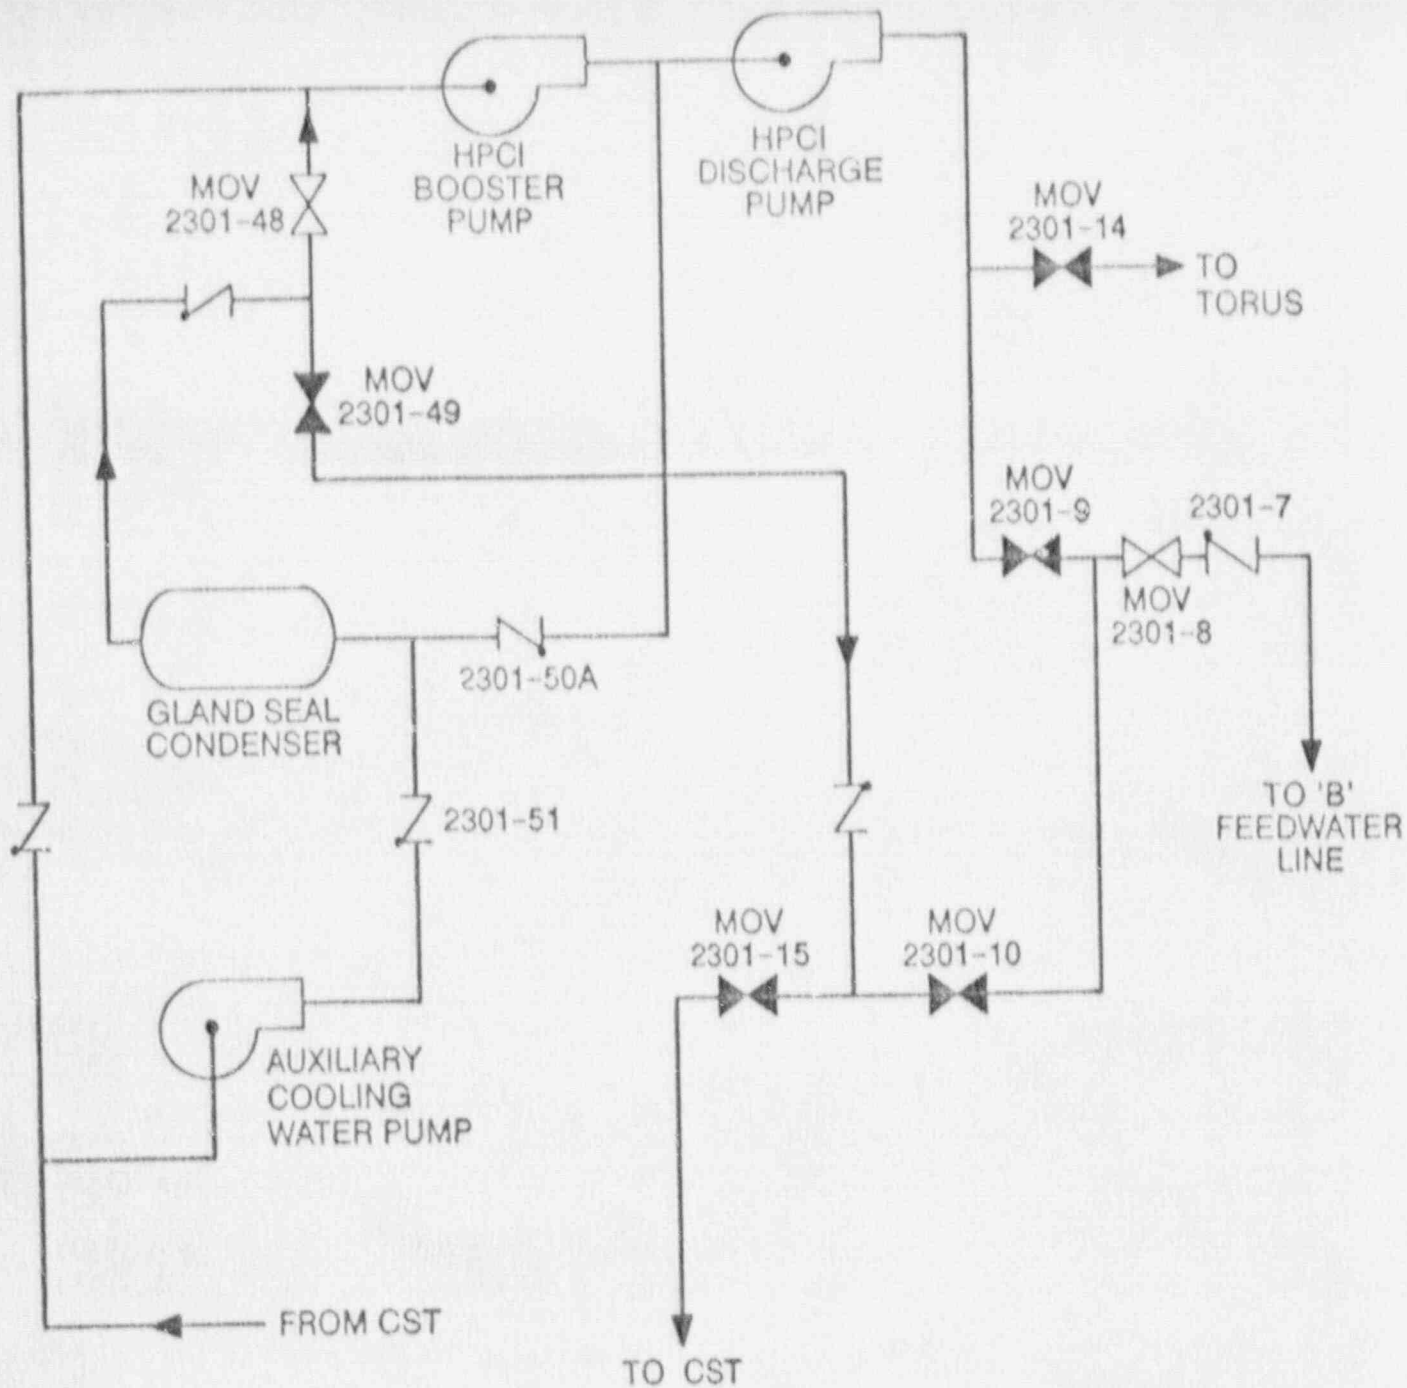
FIGURE B3  
HPCI REVISED ALTERNATE VALVE LINEUP  
(UNIT 2 PRESENTLY & UNIT 3 POST OCTOBER EVENT)

It was found that check valve 2301-7 (Feedwater/HPCI isolation valve) and MOV 2301-8 (HPCI injection valve) were both back leaking feedwater to the HPCI system piping. A pipe temperature survey conducted on October 23, 1989, revealed HPCI pump discharge pipe temperature was 246° F while the pipe between MOVs 2-2301-8 and 2-2301-9 was 275° F. An evaluation determined that steam voids could form in certain sections of the pipe under these conditions. Subsequent inspections of the Unit 2 HPCI discharge piping supports identified there were deficiencies in 47% (or 16) of the supports. The Unit 2 HPCI system valve lineup was changed (See Figure B2) so that the injection valve function was moved to MOV 2-2301-9 from MOV 2-2301-8. Also, MOV 2-2301-10 became an isolation valve subject to feedwater pressure. Subsequent inspection of Unit 3 HPCI piping found similar elevated temperatures with pipe support deficiencies found in 52% (or 21) of the supports. The Unit 3 inspection also found that other valves in the HPCI system could leak so the valve lineup was changed to that shown in Figure B3.

valve manipulation and HPCI pump discharge pipe temperature measurements led the licensee to conclude that feedwater back leakage through the HPCI test return valve 2-2301-10 was the root cause of the event. Based on the investigation, it was postulated that MOV 2-2301-10 did not fully close after one of the manipulations involved in complying with plant Technical Specification required valve and HPCI tests. This valve did not have a seal-in feature to complete the stroke after initiation. In addition, the limit switches were set to provide a torque switch bypass function in the open direction until the valve was 25% open. This limit switch also controlled the valve close light indication in the control room. Thus, a control room operator who removed a closure signal when the control room panel lights indicated the valve was closed could leave the valve approximately 25% open. A procedure was introduced to continue the closure signal 30 seconds after the panel light indicated MOV 2-2301-10 was closed. The HPCI system lineup was revised to that shown in Figure B3.
