Relief Request for Temporary
Non-Code Repair of Service Water Piping
Joseph M. Farley Nuclear Plant - Unit 2

Technical Justification for Performance of a Temporary Repair in Accordance with Generic Letter 90-05

Alabama Power Company - Farley Nuclear Plant
Service Water System - Unit 2 Train B
Diesel Generator Building Return Header

SERVICE WATER TEMPORARY NON-CODE REPAIR
RELIEF REQUEST

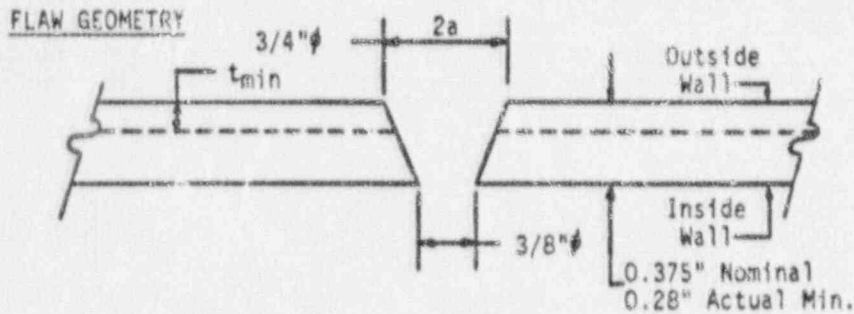
Figure 1:

$$\text{Through-wall flaw length} = 2a = 0.75 \text{ in.}$$

As $(2a = 0.75 \text{ in.}) < 3 \text{ in.}$,

and as $(2a = 0.75 \text{ in.}) < [15\% \times (40.06 \text{ in.})] \leq 6 \text{ in.}$,

the flaw is acceptable for the "Through-Wall Flaw" Approach
