SUBJECT: OPERATING REACTORS EVENTS BRIEFING JUNE 29, 1994 - BRIEFING 94-22

OPERATING REACTORS EVENTS BRIEFING 94-22

SOUTH TEXAS, UNIT 2

WASHINGTON NUCLEAR PROJECT, LOSS OF FOREIGN MATERIAL UNIT 2

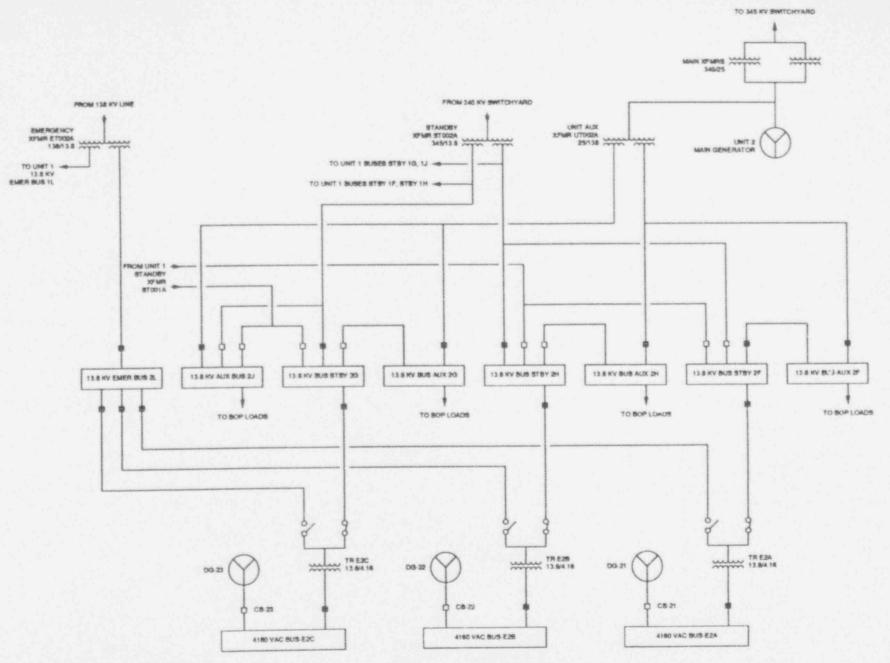
Figure 3.10-3. South Texas Station Electric Power System

- EMERGENCY DIESEL GENERATOR 21 STARTED AND SUPPLIED POWER TO EMERGENCY BUS E2A AS EXPECTED. THE NORMAL POWER SUPPLY FOR THE OTHER TWO EMERGENCY BUSSES WAS UNAFFECTED DURING THE EVENT. (FIGURE 1)
