**CAMECO RESOURCES
CROW BUTTE OPERATION**

March 4, 2020

Subject: Mechanical Integrity Test failure at I696P-17

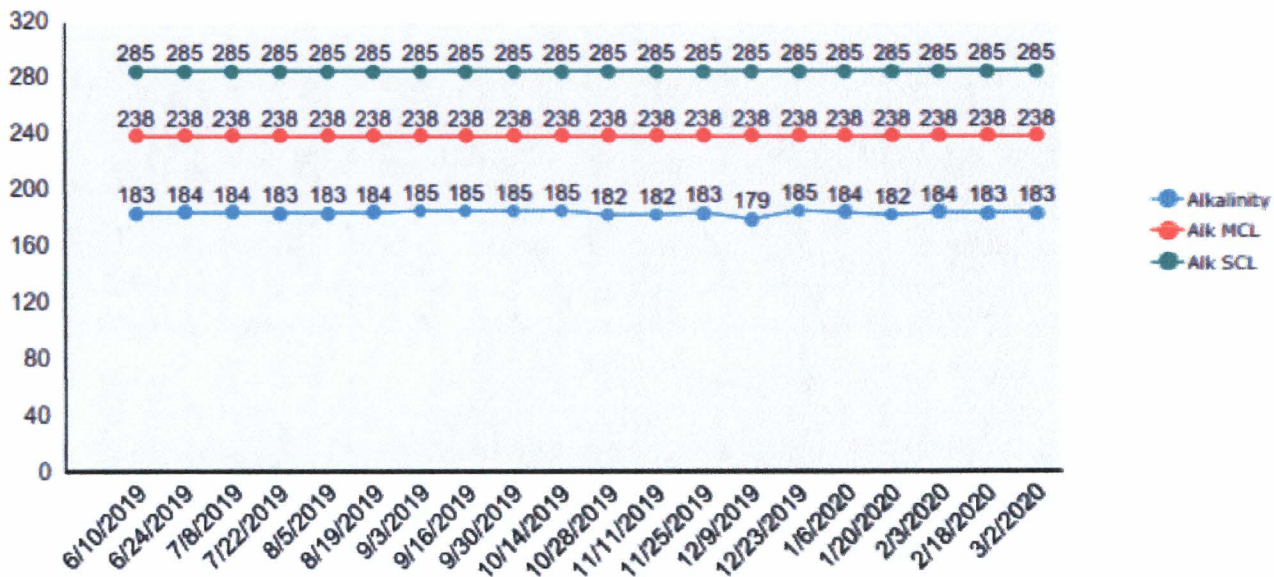
Alkalinity

Graphs of the sampling results for the nearest shallow monitor well, SM5-19 are included for your review.
