July 19, 1994
JPN-94-031

SUBJECT: James A. FitzPatrick Nuclear Power Plant
Docket No. 50-333
**NUREG-0619 Inspection Program
for Feedwater Nozzles**

ATTACHMENT TO JPN-94-031

Change to the NUREG-0619 Inspection Program for Feedwater Nozzles

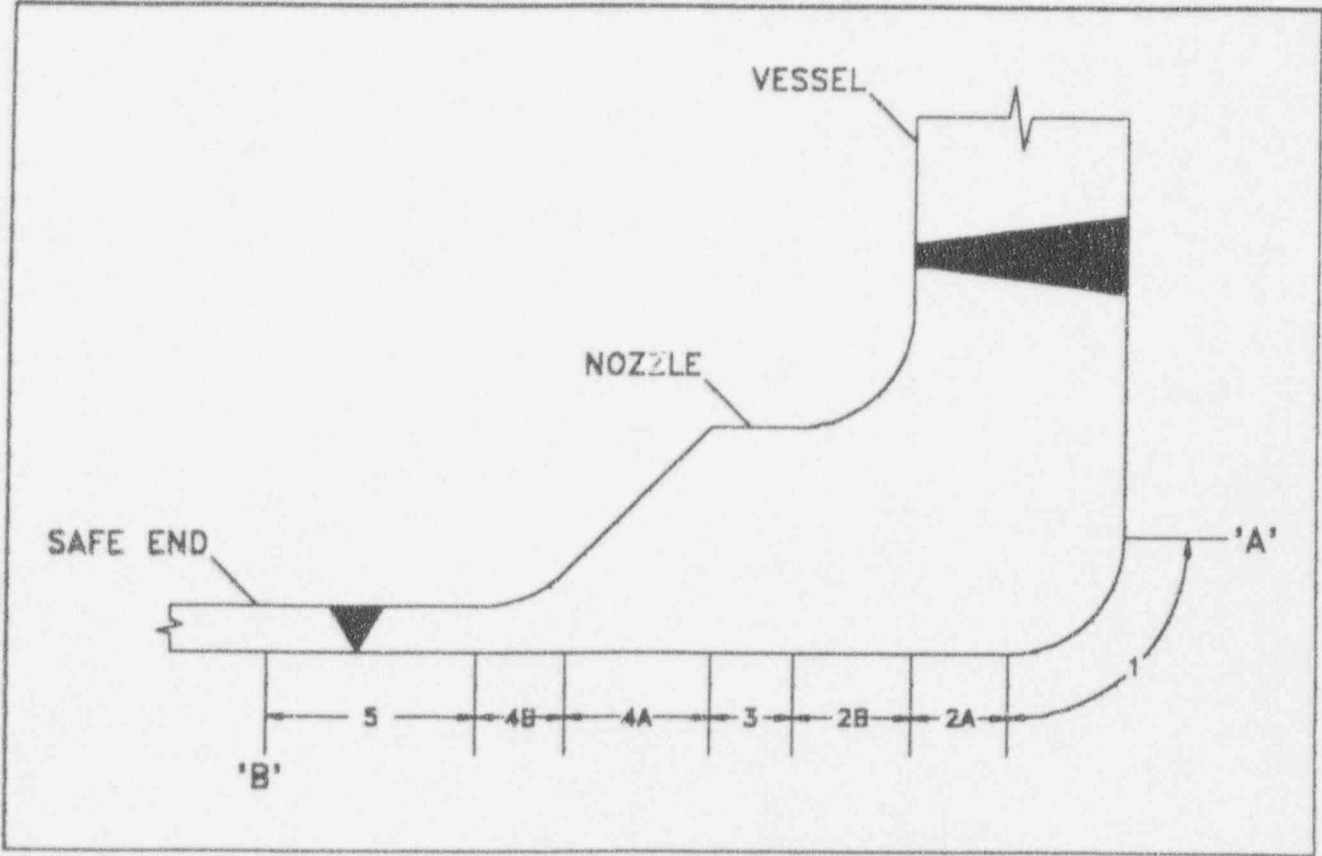
Figure 1 - Feedwater Nozzle Examination Zones

The General Electric GERIS automated UT system was used to perform NUREG-0619 examinations on the four FW nozzles during the 1990 FitzPatrick refueling outage. FW nozzle zones 1 through 3 (Figure 1), which is the expected area of cracking, were examined using the following techniques:

- Zone 1: From vessel wall with shear waves
- Zone 2A & 2B: From nozzle OD quarter point with shear waves
- Zone 2A & 2B: From nozzle OD mid point with shear waves
- Zone 2A & 2B: From nozzle OD three quarter point with shear waves
- Zone 3: From nozzle OD with shear waves

Nondestructive examinations of the FW nozzles, in accordance with NUREG-0619, have not revealed any reportable indications to date. This includes the UT examinations performed in 1982, 1985, and 1990; and the VT examinations performed in 1985, 1987, and 1990.

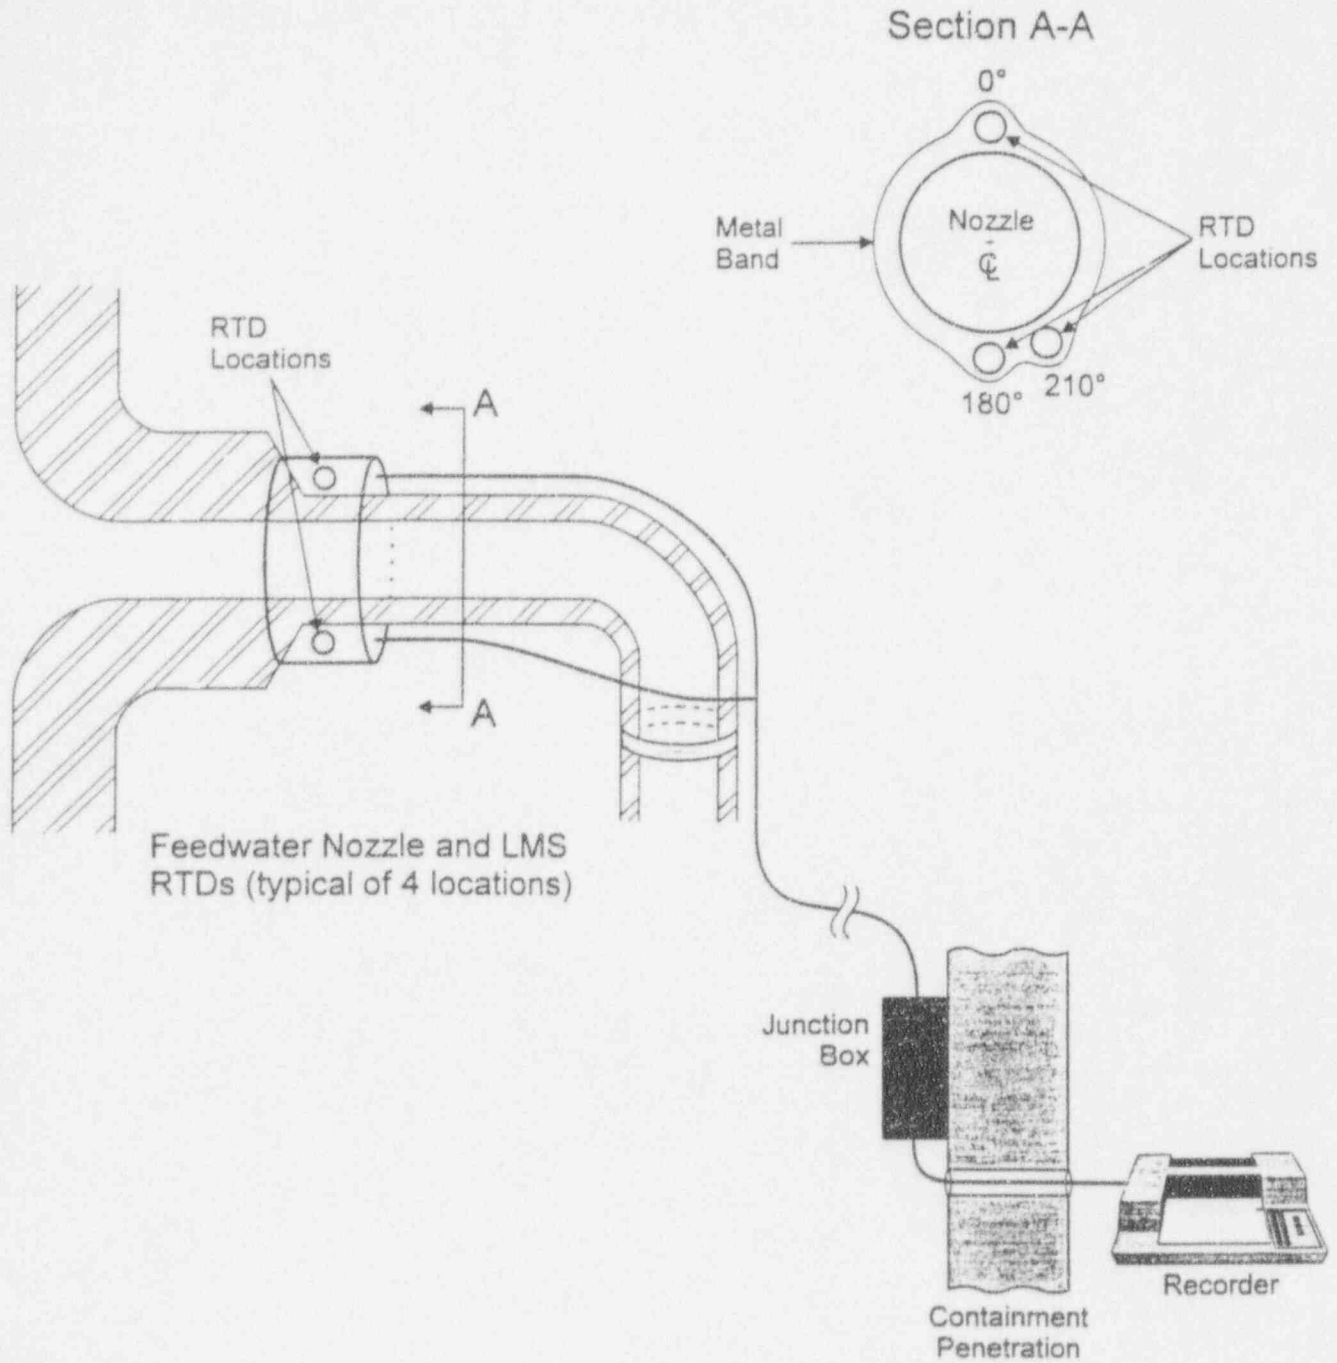
FIGURE 2

The LMS includes three local temperature sensors (RTDs) mounted on each of the four feedwater nozzles, and a data collection recorder located outside the drywell (Figure 2). The RTDs are strapped to the nozzle at a location several inches downstream of the secondary thermal sleeve seal. For a nozzle with non-leaking thermal sleeve seals, the RTD located at the top of the nozzle (0° azimuth) is expected to track the reactor temperature closely. The two RTDs located near the bottom of the nozzle (180°, 210° azimuths) are expected to read slightly lower, due to the thermal stratification in the annulus between the thermal sleeve and the FW nozzle. Leakage is reflected by decreased RTD readings on the nozzle, with the maximum effect on the bottom RTDs.

Currently, the RTD data from the LMS confirms acceptable bypass leakage levels for all four FW nozzles. The RTD data from the A, B, and D nozzles confirms the absence of leakage. The data from the C nozzle corresponds to a leakage rate of approximately 0.75 gpm. NUREG-0619, Appendix C, endorses the use of General Electric Company report NEDE-21821-02 (Reference 7) in support of activities related to the issue of FW nozzle cracking. Based on NEDE-21821-02, figure 4-131, a seal bypass leakage of 0.5 gpm or less produces a fatigue usage factor of approximately 0.1 over the remaining 20 years life of the plant. Leakage of 0.75 gpm produces a fatigue usage factor of approximately 0.14 over the same 20-year period. This corresponds to an annual usage factor increment of 0.002 due to leakage which the Authority does not consider significant.

The LMS data is recorded daily and evaluated at least every four months during periods of power operation to detect any degradation of the sparger thermal sleeve seals which could potentially lead to thermal fatigue related damage to the nozzles. If the trends of the LMS data suggest unacceptable seal degradation, corrective actions will be taken on a schedule to prevent any significant fatigue damage to the nozzles. The NRC will be notified, in writing, of an LMS evaluation implying unacceptable seal degradation, along with the plans and schedule for resolution. Further, the operating status of the LMS, and the measured leakage for the FW nozzles, will be reported in the Inservice Inspection Summary Report prepared in accordance with Section XI of the ASME Boiler and Pressure Vessel Code. This report is submitted following the refueling outages. A PT examination will be performed on a FW nozzle whenever its sparger is removed for refurbishment.

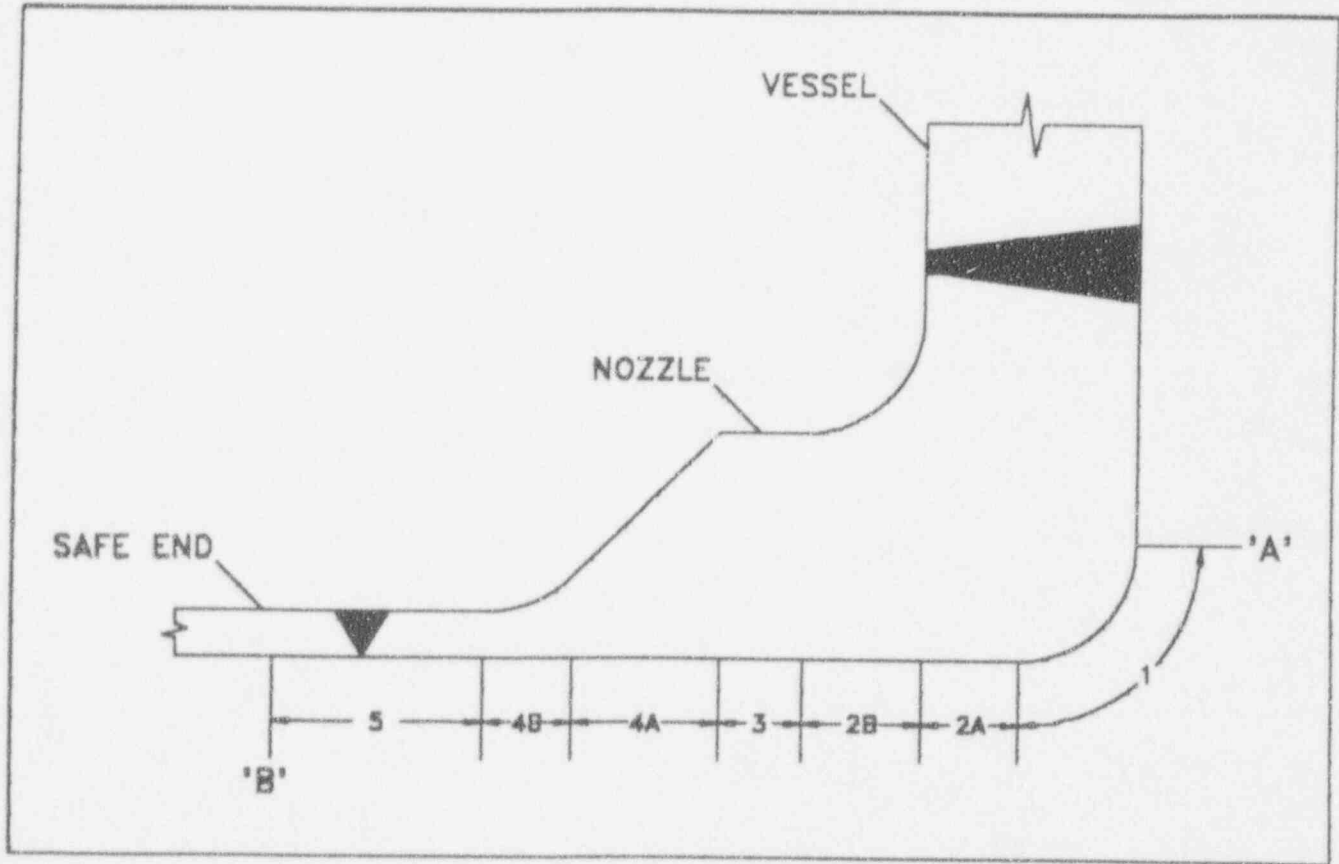
Figure 1 - Feedwater Nozzle Examination Zones

The General Electric GERIS automated UT system was used to perform NUREG-0619 examinations on the four FW nozzles during the 1990 FitzPatrick refueling outage. FW nozzle zones 1 through 3 (Figure 1), which is the expected area of cracking, were examined using the following techniques:

- Zone 1: From vessel wall with shear waves
- Zone 2A & 2B: From nozzle OD quarter point with shear waves
- Zone 2A & 2B: From nozzle OD mid point with shear waves
- Zone 2A & 2B: From nozzle OD three quarter point with shear waves
- Zone 3: From nozzle OD with shear waves

Nondestructive examinations of the FW nozzles, in accordance with NUREG-0619, have not revealed any reportable indications to date. This includes the UT examinations performed in 1982, 1985, and 1990; and the VT examinations performed in 1985, 1987, and 1990.

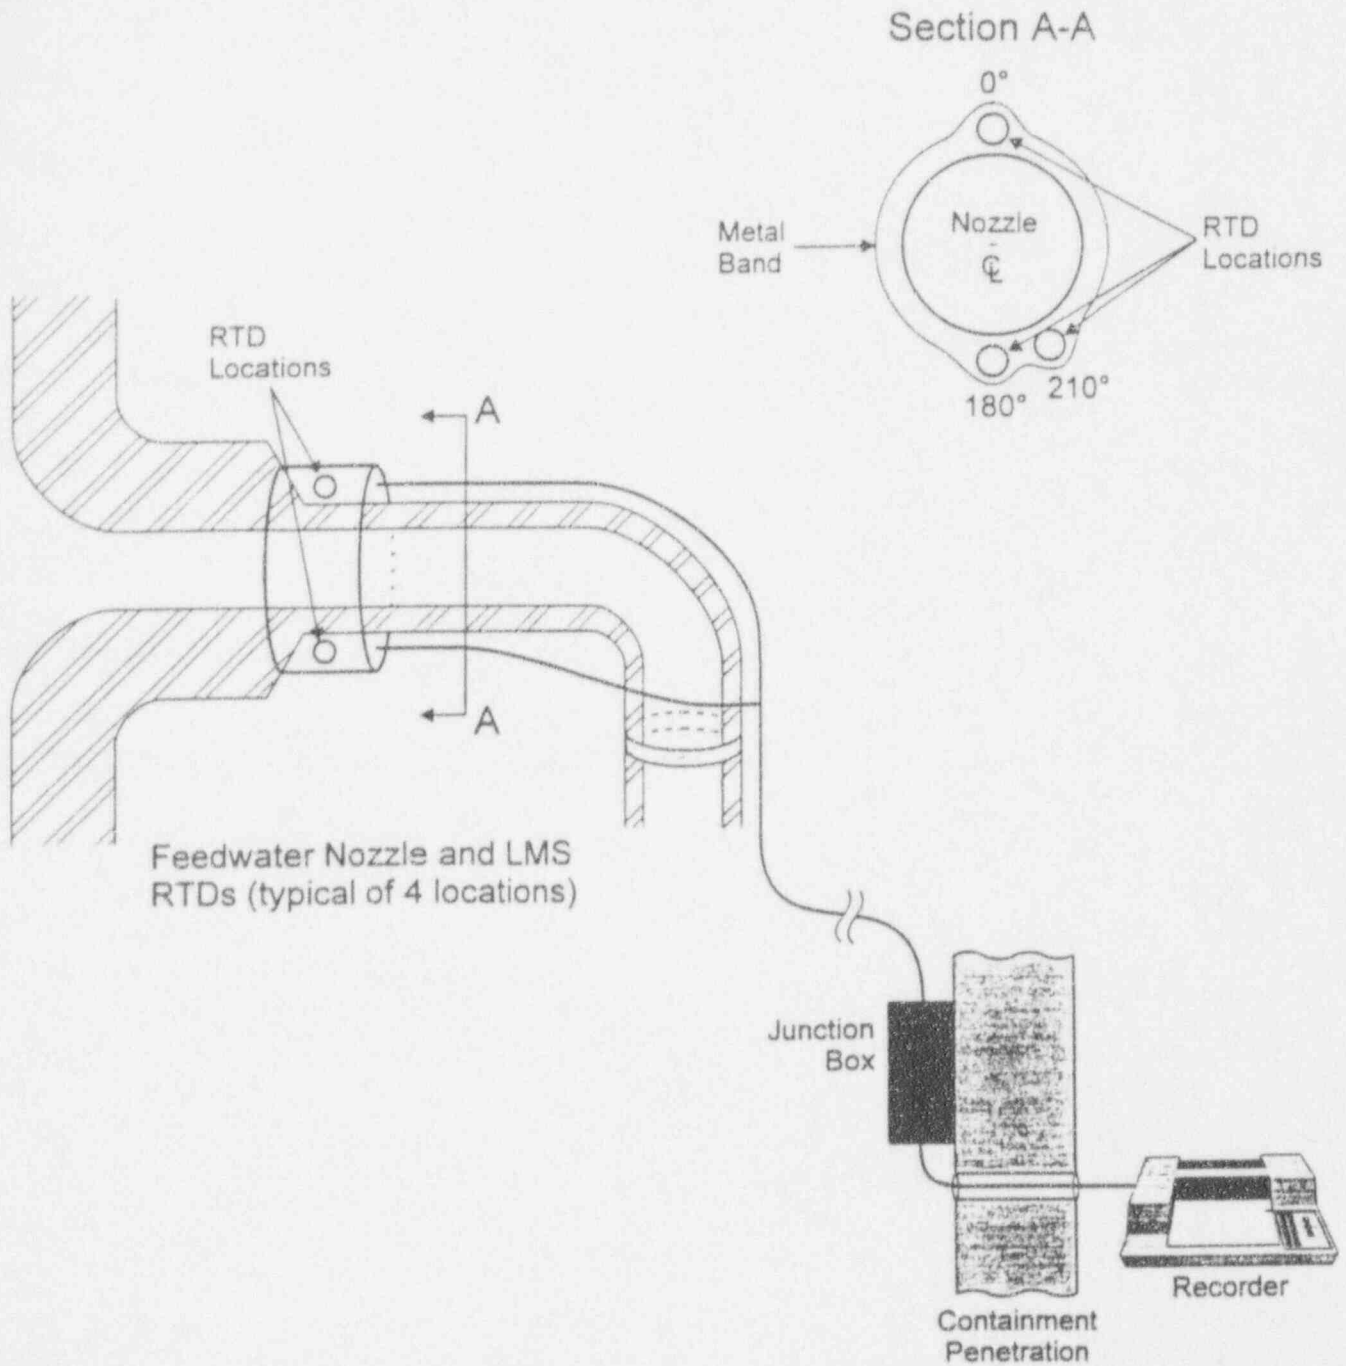
FIGURE 2

The LMS includes three local temperature sensors (RTDs) mounted on each of the four feedwater nozzles, and a data collection recorder located outside the drywell (Figure 2). The RTDs are strapped to the nozzle at a location several inches downstream of the secondary thermal sleeve seal. For a nozzle with non-leaking thermal sleeve seals, the RTD located at the top of the nozzle (0° azimuth) is expected to track the reactor temperature closely. The two RTDs located near the bottom of the nozzle (180°, 210° azimuths) are expected to read slightly lower, due to the thermal stratification in the annulus between the thermal sleeve and the FW nozzle. Leakage is reflected by decreased RTD readings on the nozzle, with the maximum effect on the bottom RTDs.

Currently, the RTD data from the LMS confirms acceptable bypass leakage levels for all four FW nozzles. The RTD data from the A, B, and D nozzles confirms the absence of leakage. The data from the C nozzle corresponds to a leakage rate of approximately 0.75 gpm. NUREG-0619, Appendix C, endorses the use of General Electric Company report NEDE-21821-02 (Reference 7) in support of activities related to the issue of FW nozzle cracking. Based on NEDE-21821-02, figure 4-131, a seal bypass leakage of 0.5 gpm or less produces a fatigue usage factor of approximately 0.1 over the remaining 20 years life of the plant. Leakage of 0.75 gpm produces a fatigue usage factor of approximately 0.14 over the same 20-year period. This corresponds to an annual usage factor increment of 0.002 due to leakage which the Authority does not consider significant.

The LMS data is recorded daily and evaluated at least every four months during periods of power operation to detect any degradation of the sparger thermal sleeve seals which could potentially lead to thermal fatigue related damage to the nozzles. If the trends of the LMS data suggest unacceptable seal degradation, corrective actions will be taken on a schedule to prevent any significant fatigue damage to the nozzles. The NRC will be notified, in writing, of an LMS evaluation implying unacceptable seal degradation, along with the plans and schedule for resolution. Further, the operating status of the LMS, and the measured leakage for the FW nozzles, will be reported in the Inservice Inspection Summary Report prepared in accordance with Section XI of the ASME Boiler and Pressure Vessel Code. This report is submitted following the refueling outages. A PT examination will be performed on a FW nozzle whenever its sparger is removed for refurbishment.
