July 19, 1994

MONTICELLO NUCLEAR GENERATING PLANT
Docket No. 50-263 License No. DPR-22

Clarification of Circumstances Related to Safety Relief Valve Leakage

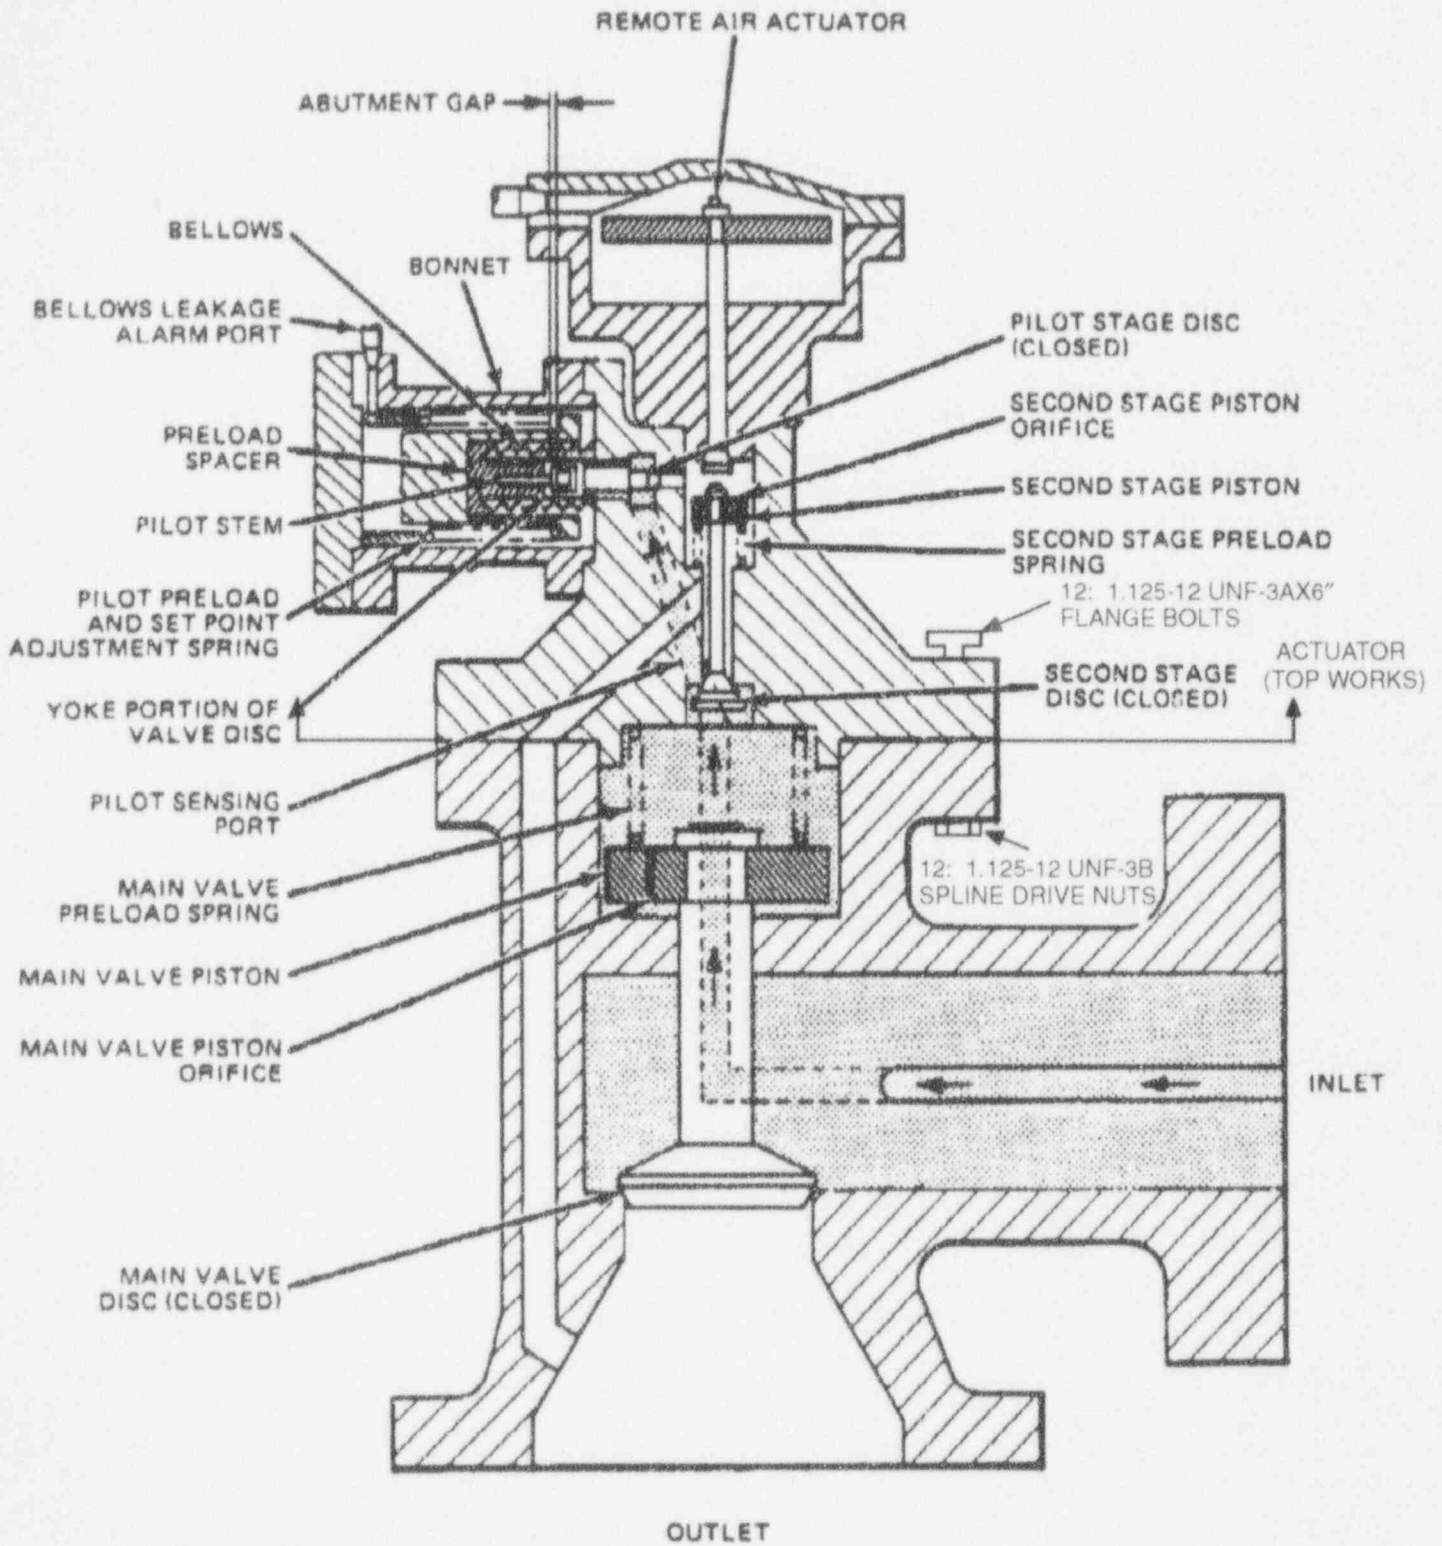
MONTICELLO SAFETY RELIEF VALVE

The leaking safety relief valve was disassembled and inspected. It was determined that the elevated discharge line temperature was indeed caused by seat leakage at either the second stage disc or at the pilot stage disc (see

attached Figure 1), which are integral components of the valve actuating mechanism (also referred to as the valve top works). Contrary to what was implied in the July 5, 1994 letter from the three Representatives to Chairman Selin, the leakage was in no way linked, either directly or indirectly, to any bolting concern.

The "B" safety relief valve seat leakage was repaired by replacing the actuating mechanism (top works) for the valve (see attached Figure 1). Reactor startup was commenced on March 25, 1993 and full power operation was reached on March 26, 1993. Safety relief valve temperatures were monitored closely during ascension to full power operation and no further abnormalities were observed.
