Subject: McGuire Nuclear Station Unit 1  
Docket No. 50-369  
Licensee Event Report 369/91-01

FACILITY NAME (1)  
McGuire Nuclear Station, Unit 1

TITLE (4)  
A Unit 1 Reactor Trip Occurred Due to A Loss Of Offsite Power Caused By An Inappropriate Action, A Management Deficiency, and An Equipment Failure

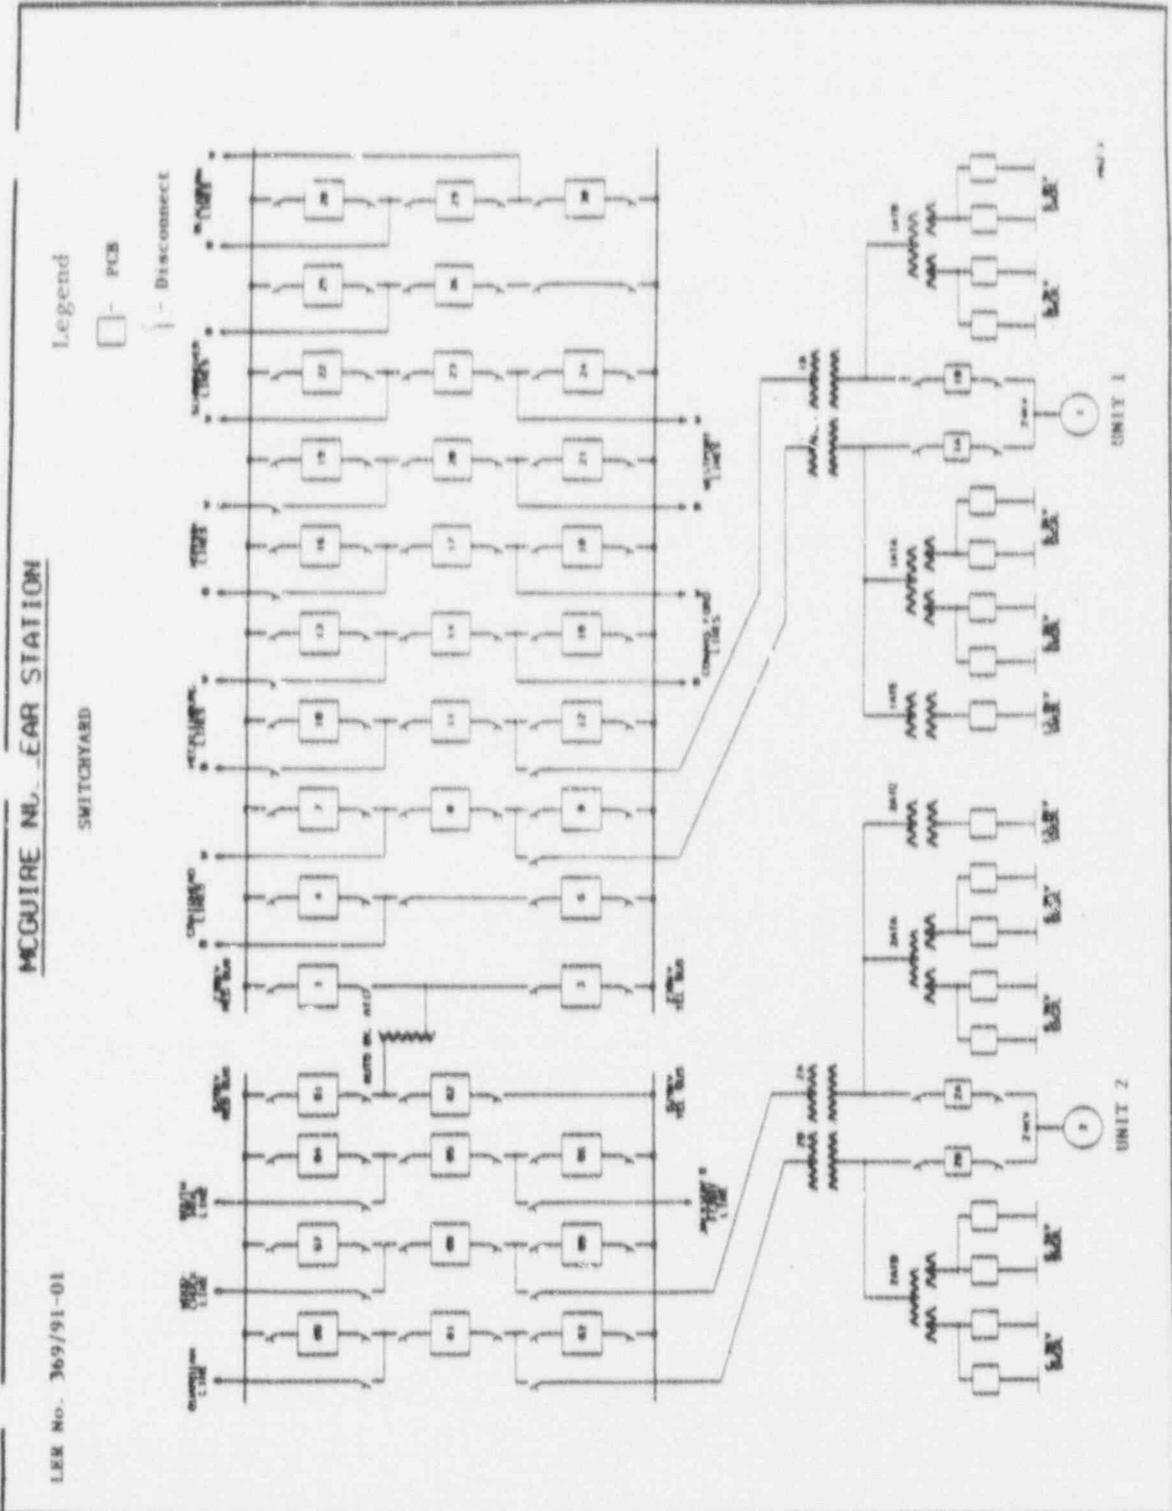
Each unit generates power at a voltage of 24 Kilovolts (KV) that is delivered through two half-size step-up transformers [EIIS:XFMR] to the McGuire Switchyard by overhead transmission lines. Unit 1 is connected to the 230 KV switchyard, while Unit 2 is connected to the 525 KV switchyard. The output of each unit is then delivered into Duke's transmission system through switchyard power circuit breakers [EIIS:52] (PCB) in a breaker and a half configuration and transmission lines. (See page 18 of 18.)

Craighead White transmission line. This defective relay satisfied the logic required to trip PCB8 when the red and yellow bus cleared. This provided abnormally high current through the line and completed the permissive to trip PCB8. Thus, the PCB tripped clearing the Craighead line and eliminated 1 of the 2 remaining Unit 1 ties to the grid. (See page 18 of 18.)
