NUREG/CR-6187
ANL-94/8
TMIV(93)AL02

Results of Mechanical Tests and Supplementary Microstructural Examinations of the TMI-2 Lower Head Samples

Argonne National Laboratory

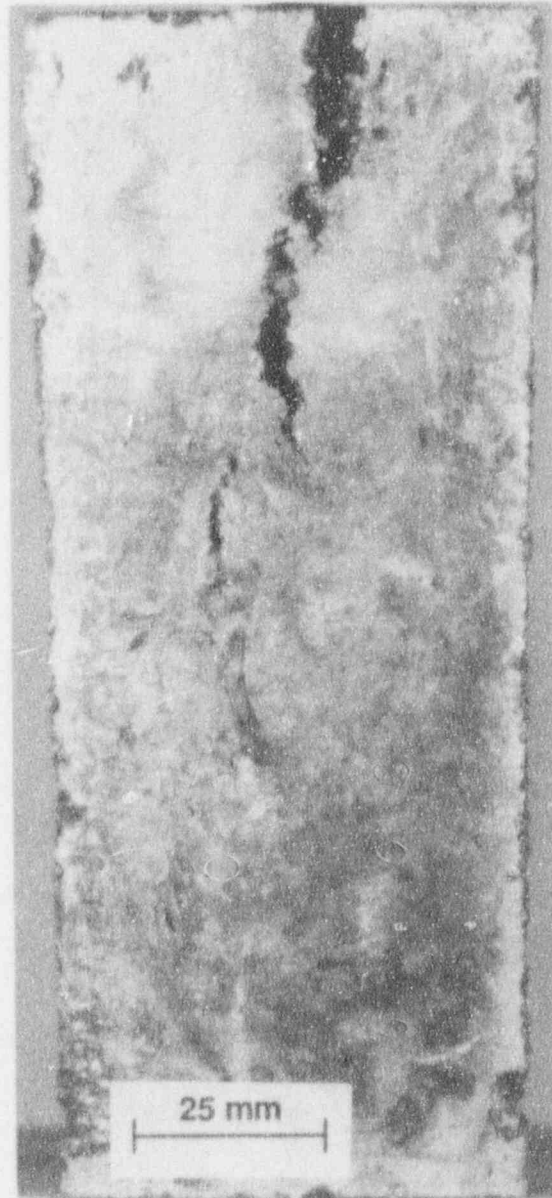
Fig. 5. Surface of Sample E-6 showing end of one leg of crack around Nozzle E-7.
MCT 276674

After removal of the hard layer of core debris, the lower head was visually examined by video camera. It was found that a significant U-shaped crack in the surface encircled the E-7 nozzle. The E-6 boat sample that was taken encompassed one leg of this crack, as shown in Fig. 5. A cursory visual inspection of Sample E-6 by personnel at TMI-2 immediately after removal suggested that the crack penetrated

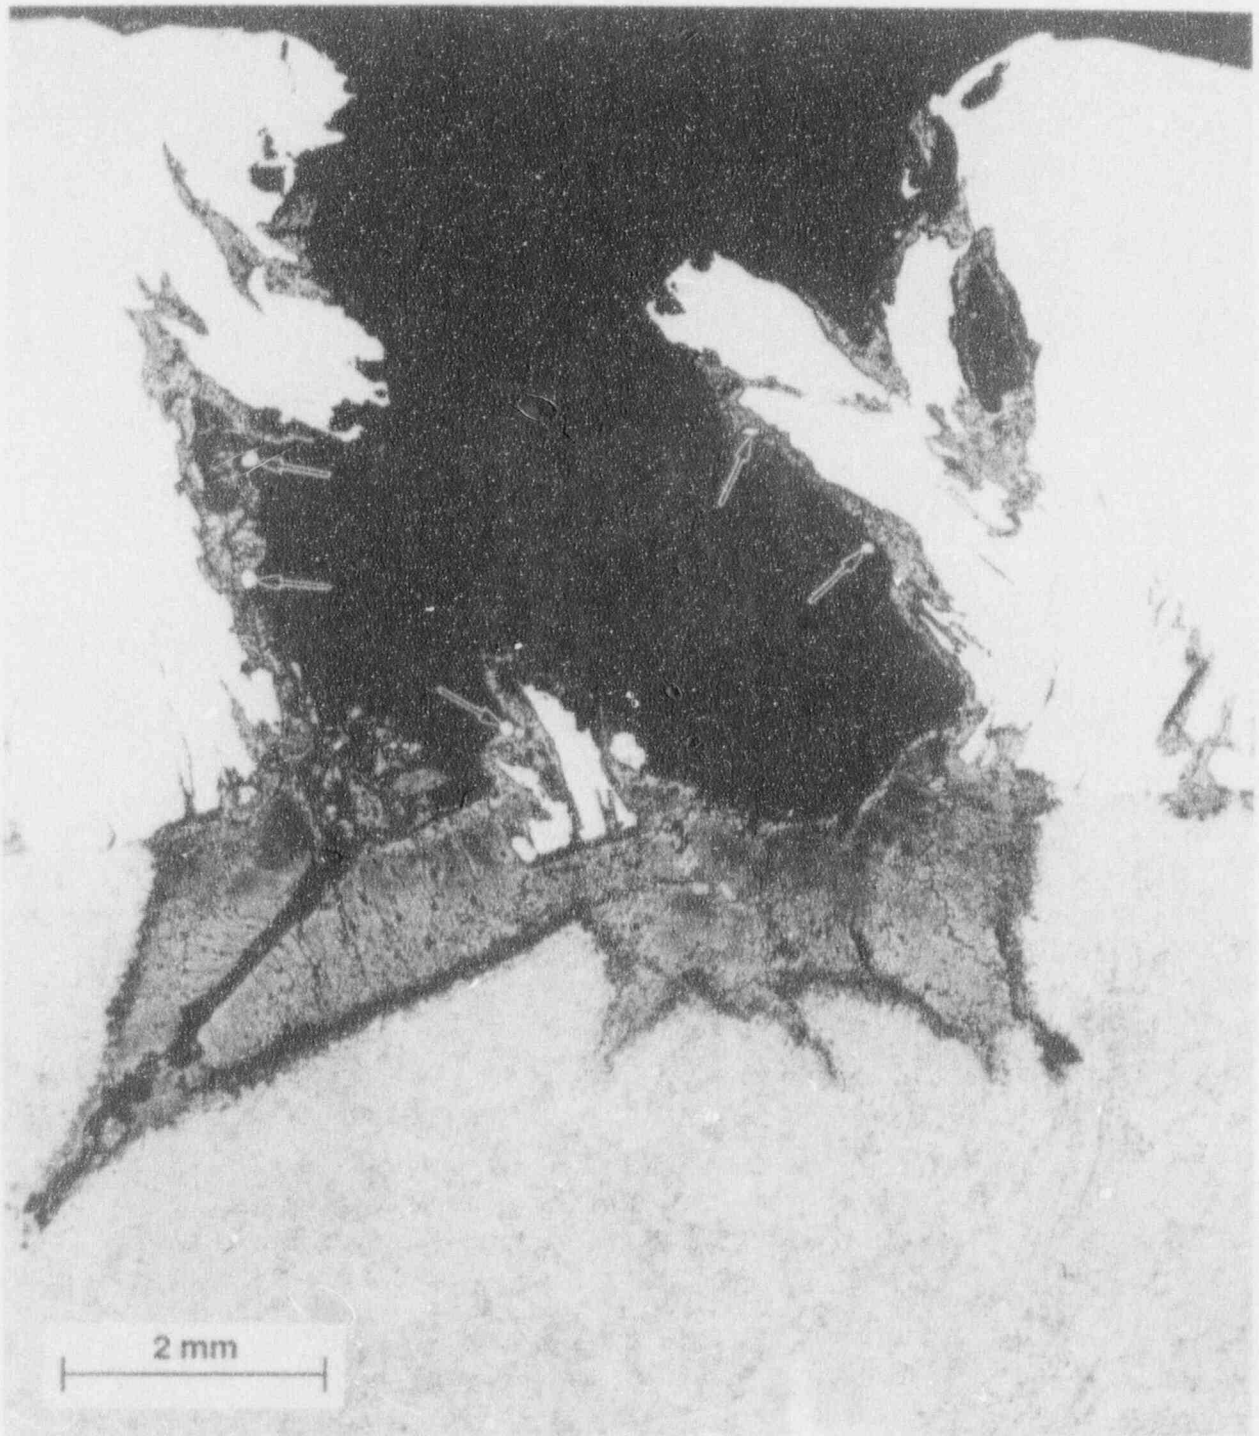
essentially through the entire depth of the sample, i.e., significantly more than 6 cm into the lower head. However, a closer examination at ANL revealed that what was thought to be the penetrating crack on the end of the sample was actually the intersection of the two cutting planes made by the metal disintegration machining process (MDM). Metallographic cross sections through the crack, Fig. 6, confirmed that the crack penetrated the A533 vessel steel only superficially, ≈ 3 mm.

The appearance of the crack in Fig. 6 strongly suggests that the Type 308L cladding failed along interdendritic boundaries by a hot-tearing process that apparently was the result of thermal stress when this location was cooled rapidly at the rate of 10–100°C per min.

Fig. 6. Cross section through principal crack in Sample E-6. Arrows identify larger Ag-Cd nodules. Etched.

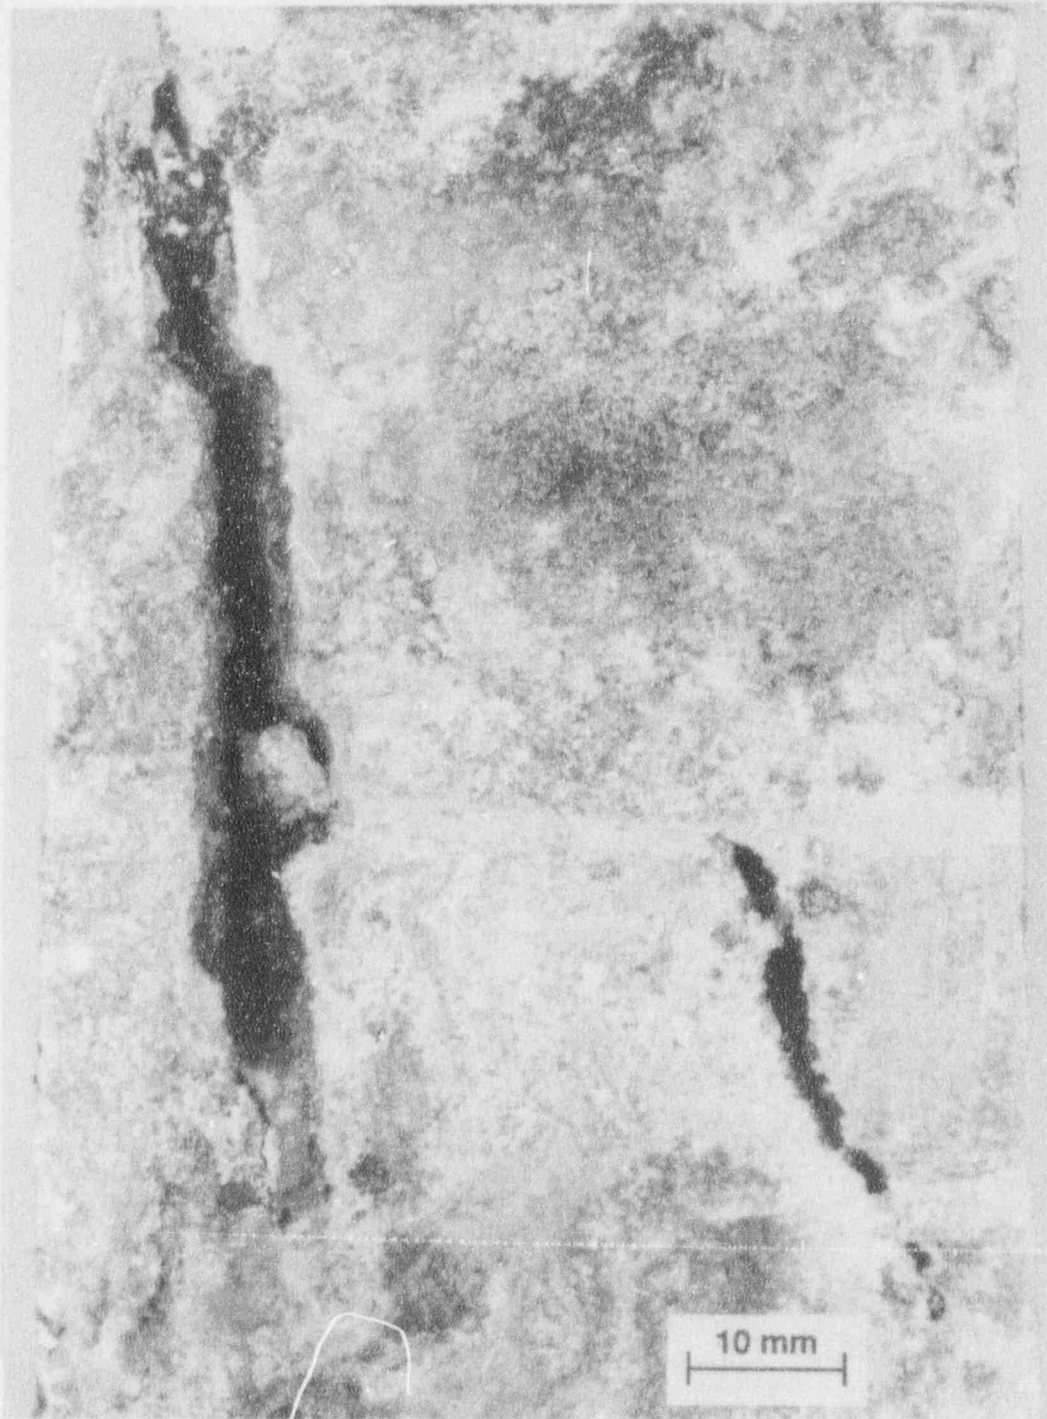
Inspection of two other boat samples at ANL, G-8 and F-10, indicated that they, too, had cracks in the cladding. The cracks in the surface of G-8 are shown in Fig. 7. Whereas the activity of the E-6 metallographic sample was sufficiently low not to require preparation in a hot-cell, the G-8 sample was atypically very radioactive, indicating the presence of fuel/fission products in the cracks. Cross sections through both the large and small cracks, Figs. 8, 9, and 10, indeed, showed fuel particles trapped in an iron (oxide) binder. Both cracks show the same evidence of hot tearing as Sample E-6, with graphic evidence of the elevated-temperature ductility of the Type 308L weldment. Penetration of the A533 vessel steel was somewhat greater than at E-6, i.e., ≈ 6 mm.

Fig. 7. Surface of Sample G-8 showing two cracks in cladding.
MCT 277888

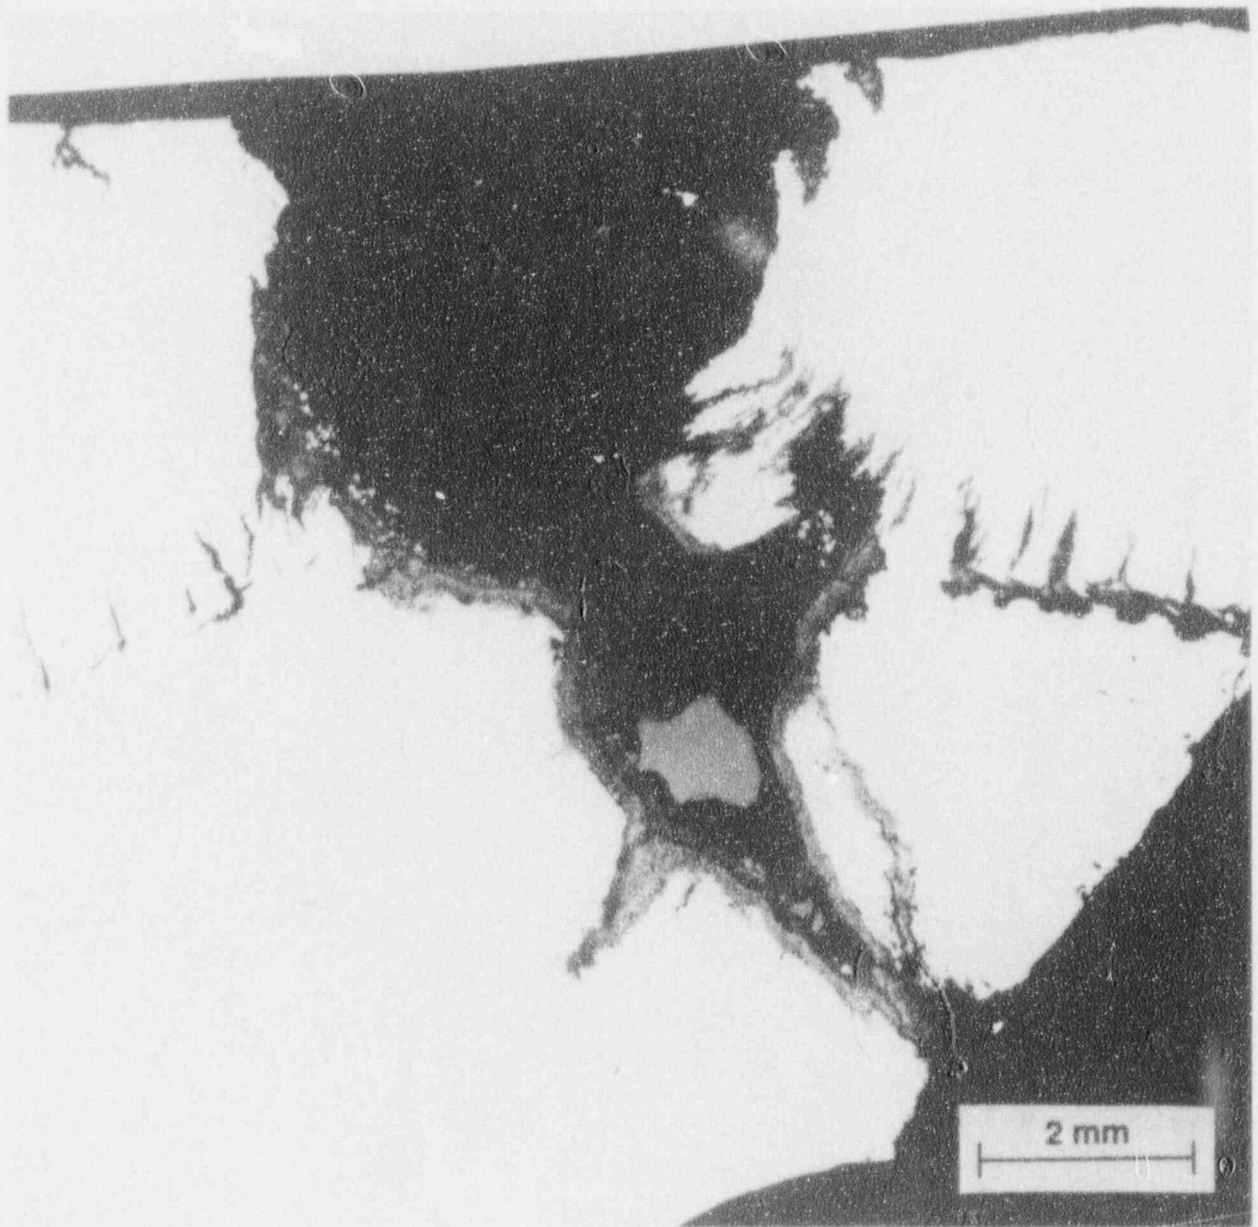
Fig. 8. Cross section of larger crack in Sample G-8. Multi-layered coating is on all crack surfaces. Gray mass at base is U-Zr "fuel." MCT 278760

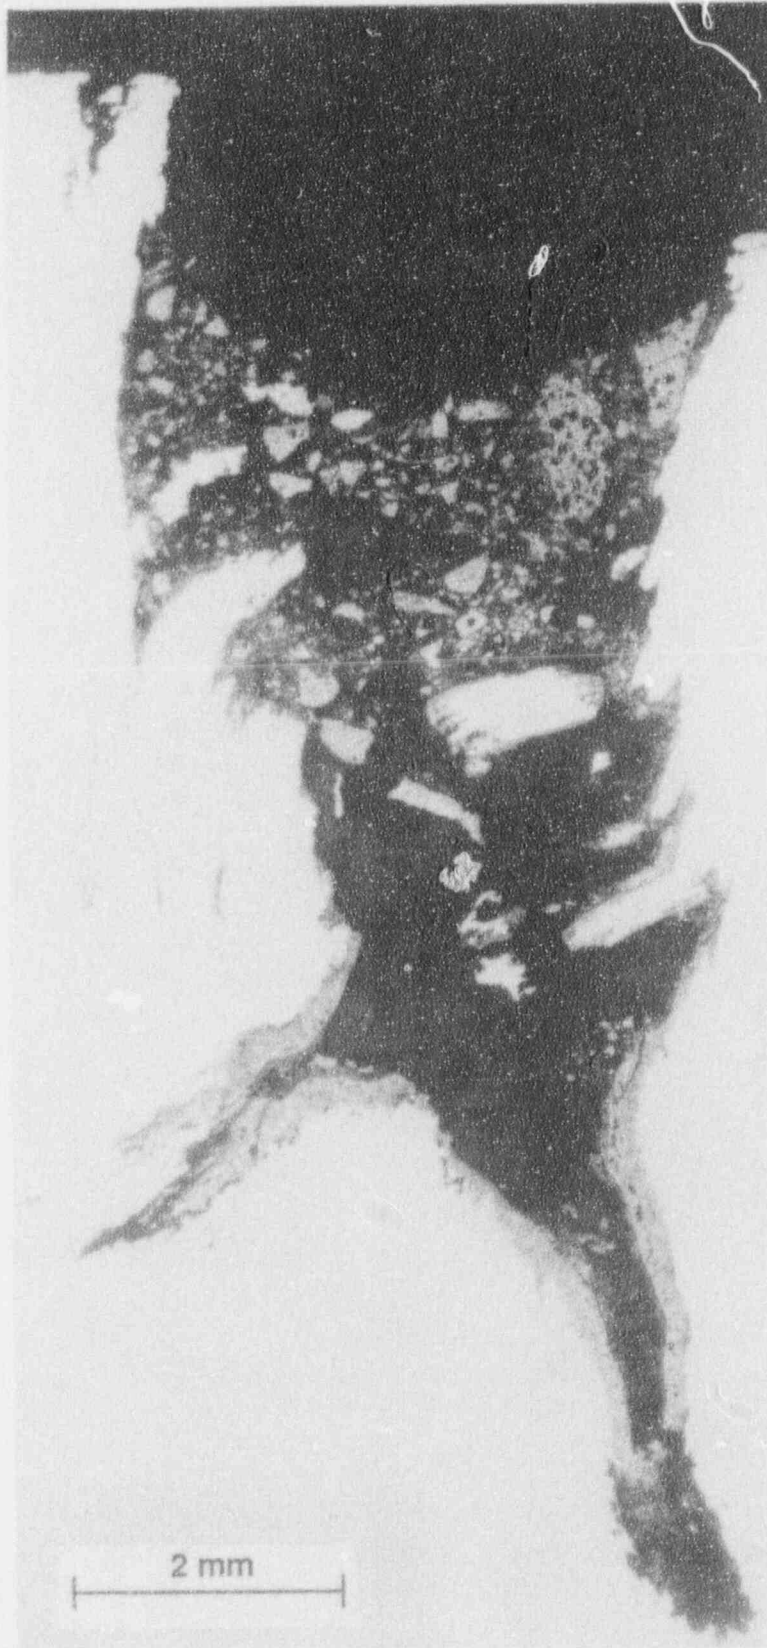
Fig. 9. "Bottom" end of large crack shown in Fig. 8, showing fuel debris in an Fe-oxide matrix.

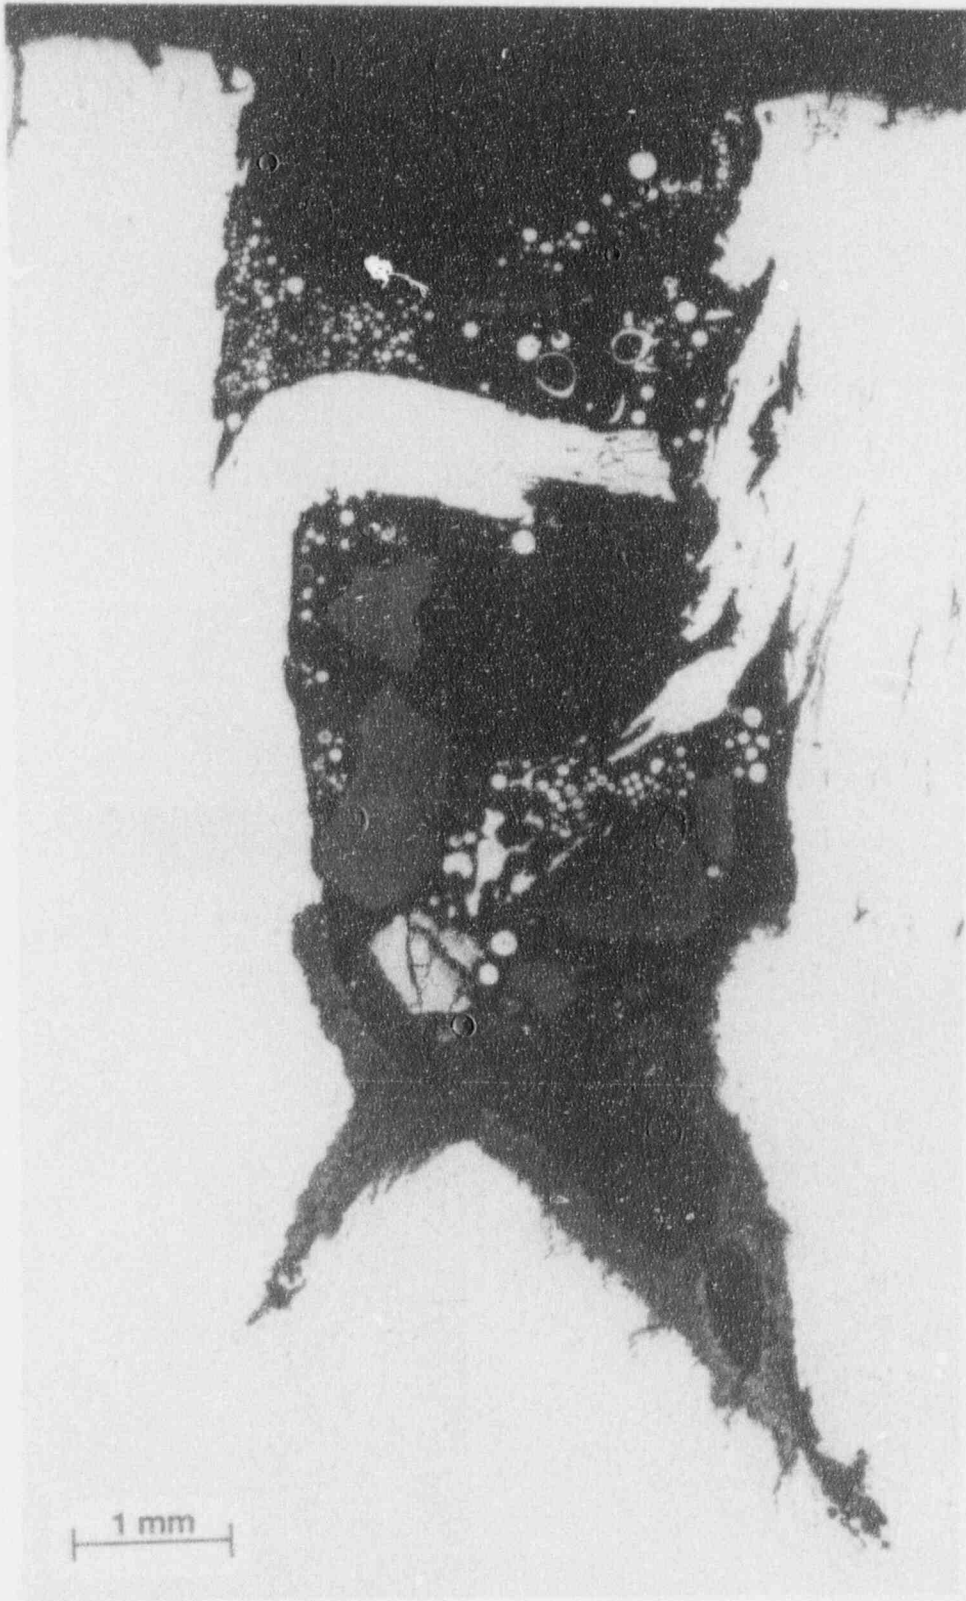
Fig. 10. Cross section through small crack in G-8. Gray masses are U-Zr "fuel;" white spheres are Fe from cutting operations.

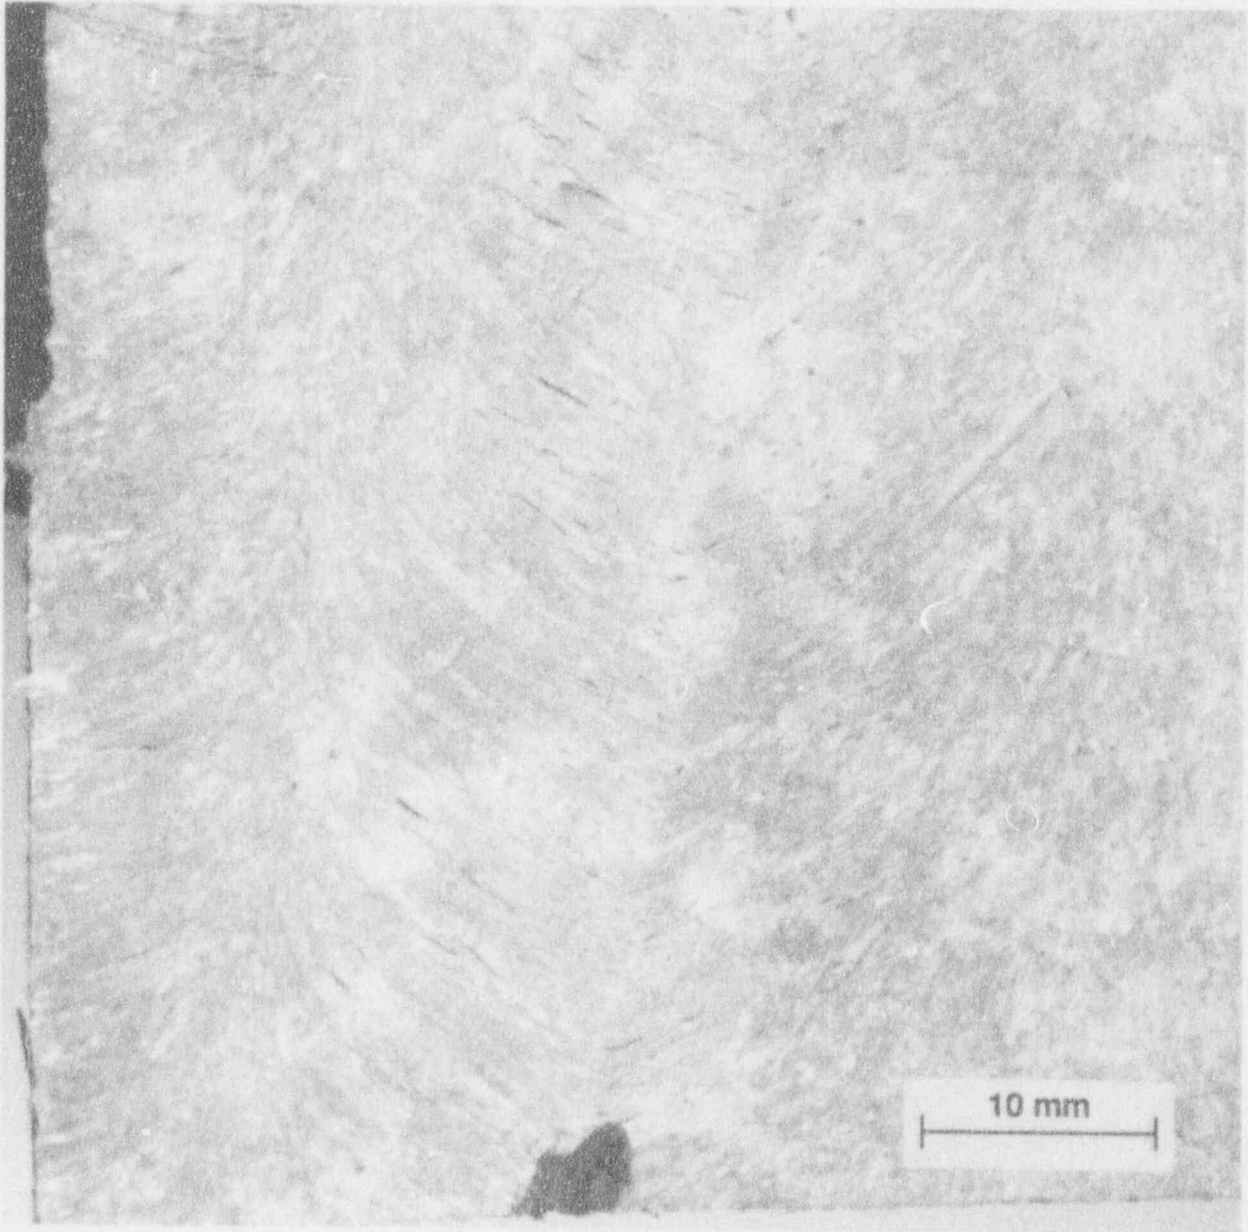
After surface debris had been removed by chemical means, the surface of Sample F-10 was determined to be cracked. A portion of the etched cladding surface is shown in Fig. 11. Light cracking can be seen in the longitudinal interdendritic boundaries in the weld passes. This cracking could have occurred either during fabrication or at the same time as the formation of the cracks at E-6 and G-8; the F-10 sample was on the periphery of the oval-shaped hot spot in the vessel wall. The cracking at the G-8, E-6, and F-10 locations provides additional evidence for this hot spot.

Fig. 11. Cleaned and etched surface of Sample F-10 showing small interdendritic cracks in a weld pass.

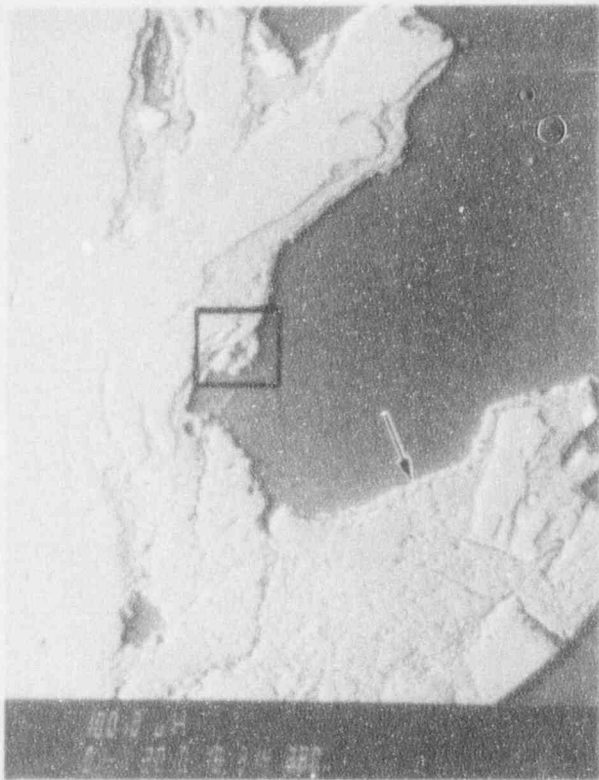
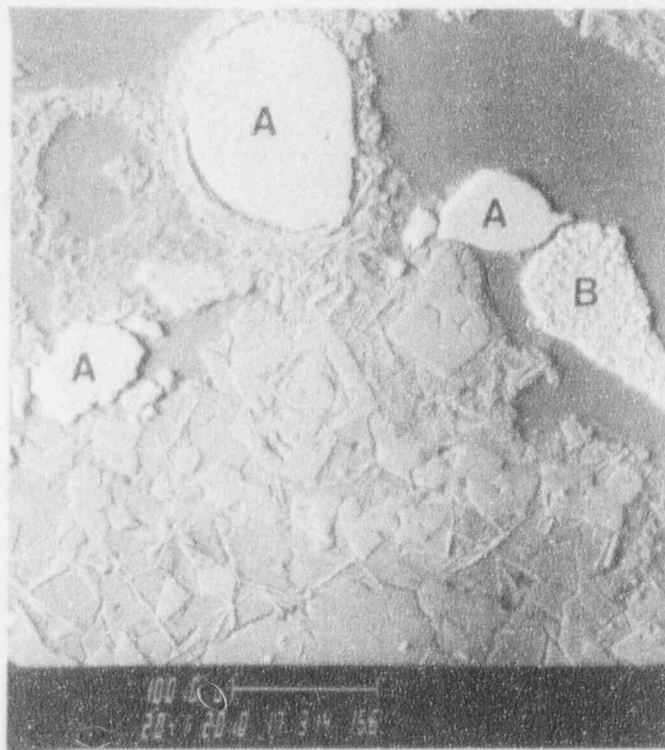
Fuel fragments, such as those shown in Fig. 12, were generally present only atop the adherent surface layers as, apparently, adventitious material trapped somewhat in an Fe-oxide, not as material that had solidified in situ. Some solidified fuel flecks were found in a matrix of other in-situ solidified material in the base of the crack. Some fuel, therefore, was part of the molten material that was on top of the lower head when the cracks were formed. The grain boundaries of the wedge-shaped Fe-oxide in the crack extension into the vessel contained an In-Sn phase, indicating that a liquid was present when this high-temperature columnar-grained oxide was formed. The surface

Fig. 12. SEM-BSE images of multi-layered material on crack surfaces of Sample E-6. (a) Fuel particles (white) on oxide surface (arrow); (b) area outlined in (a); and (c) In-Sn needles in Fe matrix, Ag-Cd spheroids (A), and fuel particle (B).

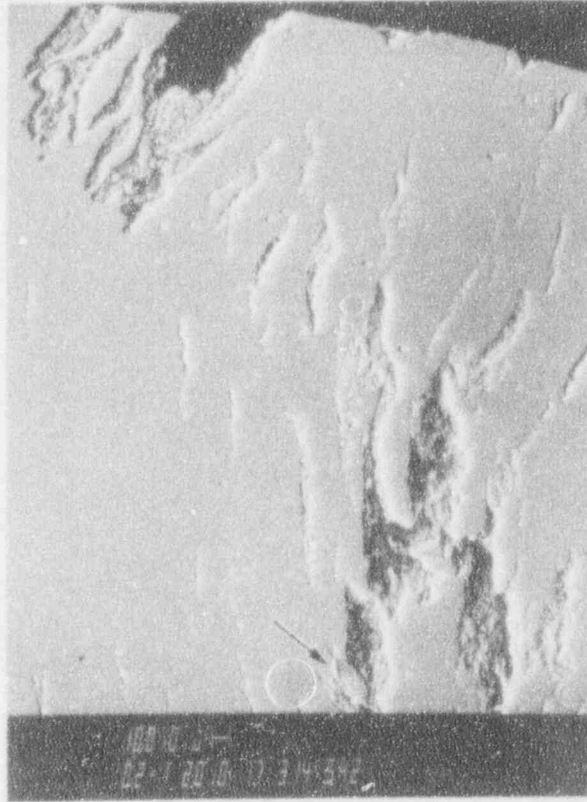
Fig. 13. Internal tears in the cladding of Sample G-8. Solidified Ag-Cd Masses are shown (arrow) \approx 4 mm beneath the surface. (SEM-BSE image)

of the boat sample cladding near the crack contained several small surface penetrations that contained Ag that appeared to have penetrated intergranularly as a liquid. Solidified masses of Ag-In-Cd were also found within some tears \approx 4 mm below the surface of the cladding, as shown in Fig. 13.

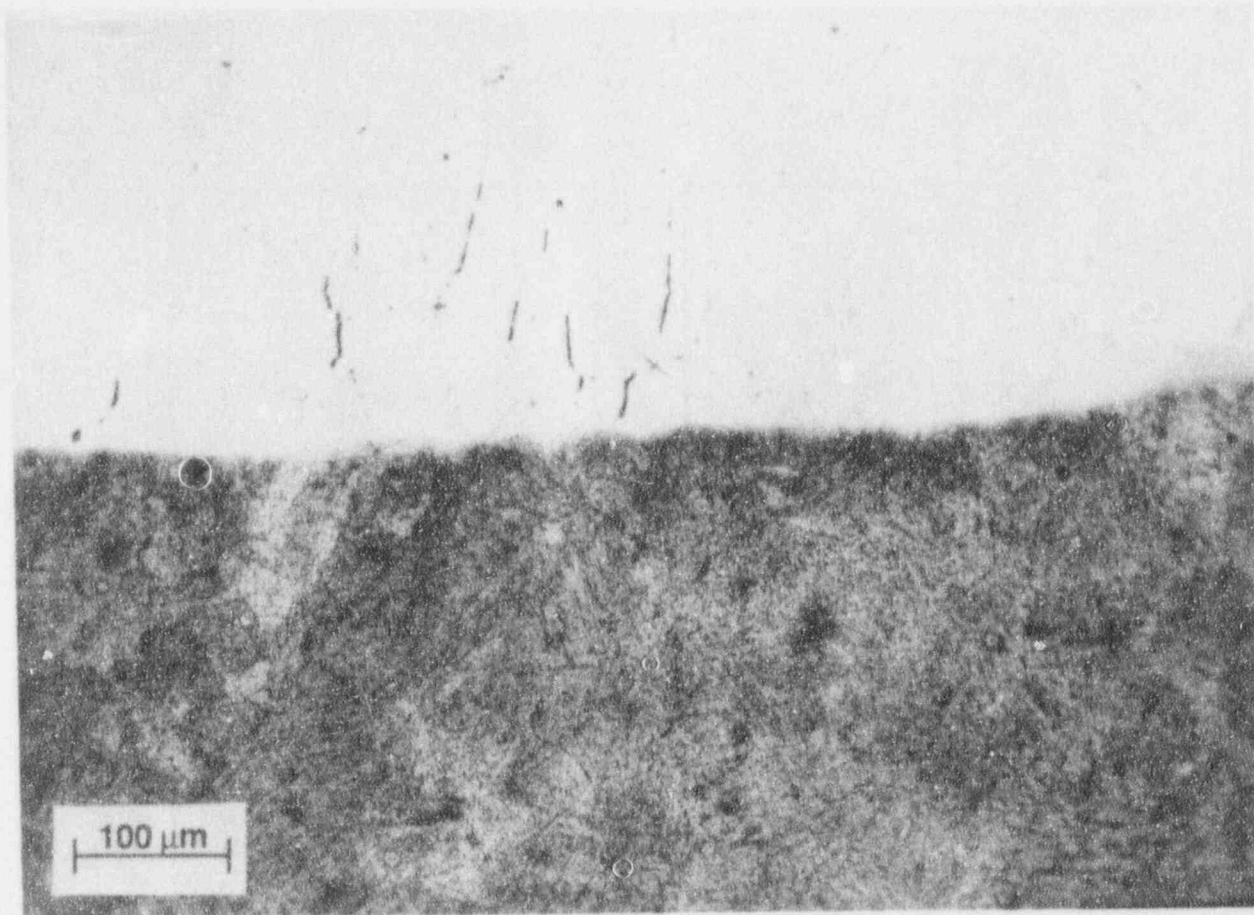
The maximum temperature of between 1000 and 1100°C estimated by ANL for Sample E-6 was based upon several observations. First, a heat-affected zone produced by the weld cladding process is normally present in the base metal to a depth of ≈8 mm below the cladding/base-metal interface. The absence of this heat-affected zone

Fig. 14. Metallographic specimen from lower head sample E-6 showing absence of feathery carbide precipitate layer at cladding/base-metal interface. Note interdendritic cracking of cladding layer in upper half of micrograph.

indicates that the base metal reaustenitized during the accident. Since reaustenitization upon heating begins at 727°C and is complete at ~830°C for A533, Grade B steel, this observation indicates a maximum temperature in excess of 727°C and probably in excess of 830°C. The absence of a feathery carbide layer at the cladding/base-metal interface suggested a maximum temperature in excess of 900°C (Fig. 14). For comparison, the intact carbide layer at the cladding/base metal interface is shown in Fig. 15 for Sample K-13, which did not exceed the ferrite-to-austenite transformation temperature of 727°C during the accident.⁵ In addition, the prior austenite grain size in the bainitic microstructure of Sample E-6 near the interface corresponded to that produced in the Midland archive material by a 2-h isothermal heat treatment at 1000-1100°C. The spheroidization and partial redissolution of the delta ferrite phase in the weld cladding indicated similar maximum temperatures (Fig. 16). At 50 mm below the interface, the grain size corresponded to that produced by a similar heat treatment at 900-1000°C. The observed hardness of 250-260 VHN in the base metal suggested a cooling rate of between 10 and 100°C/min from the austenitizing temperature.

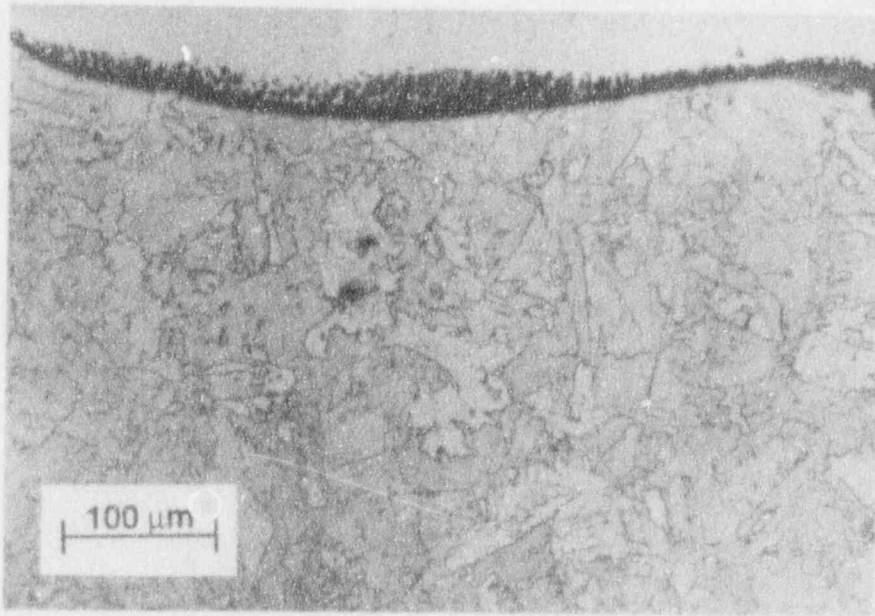
Fig. 15. Metallographic specimen from lower head Sample K-13 showing presence of feathery carbide precipitate layer at cladding/base-metal interface. The maximum temperature did not exceed 727°C at this location during the accident. (From Ref. 5).

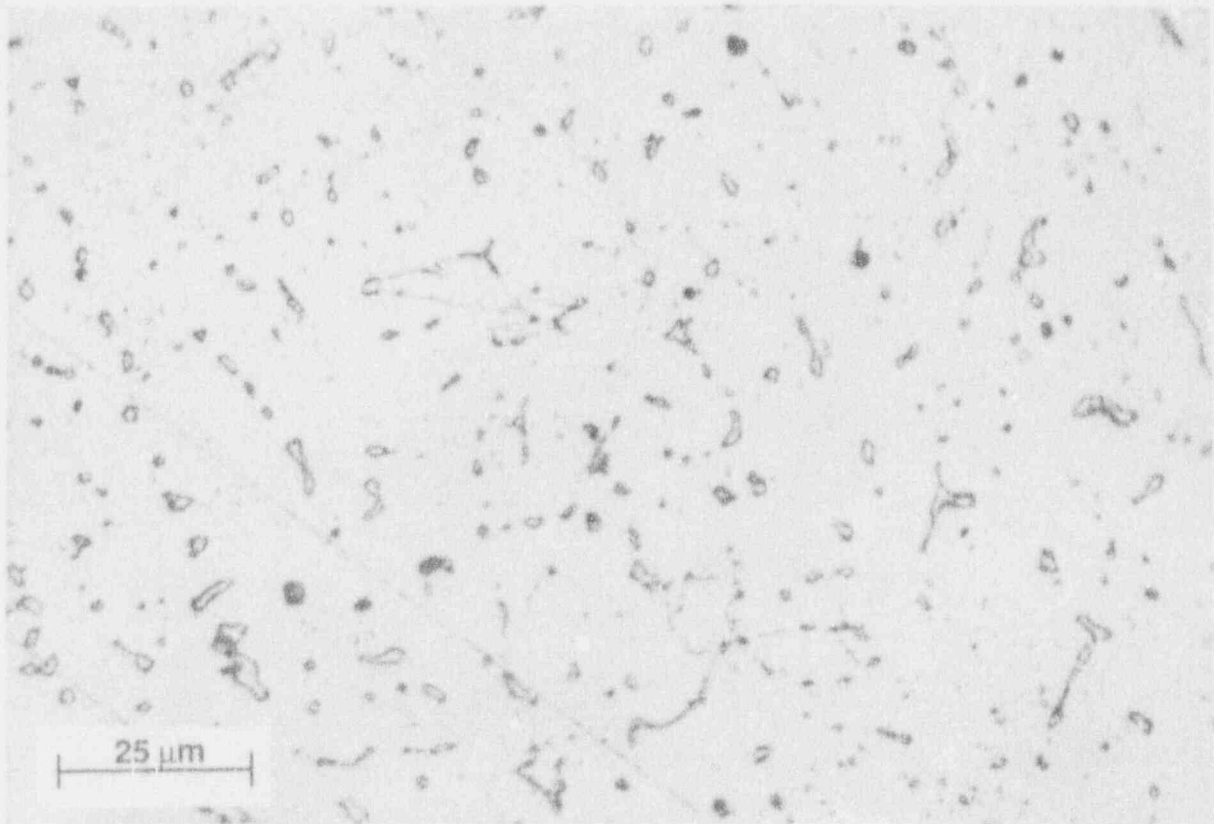
The examination conducted at the SCK/CEN in Belgium revealed the absence of a heat-affected zone in the base metal, spheroidization and partial dissolution of the delta ferrite phase in the cladding, and austenite grain growth near the interface (Figs. 17 and 18). These observations, coupled with the observed increase in hardness throughout the base metal, led to the conclusion that the maximum temperature of this specimen during the accident was substantially above 727°C.

Fig. 16. Metallographic specimen from lower head Sample E-6 showing spheroidization of delta ferrite phase in Type 304L weld cladding layer.

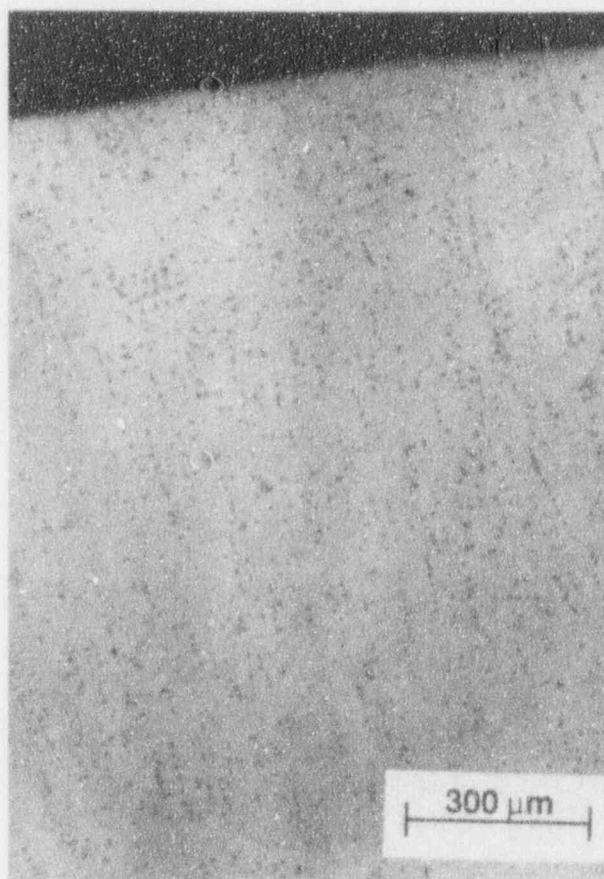
Personnel at the MPA in FRG also observed the absence of a heat-affected zone in the base metal of Sample E-8, the dissolution of carbides at the interface, and hardnesses characteristic of complete austenitization during the accident. They estimated the maximum temperature to have exceeded 850°C and probably 1000°C.

Fig. 17. Metallographic specimen from lower head Sample E-8 showing spheroidization of delta ferrite phase in cladding. (From Ref. 5)

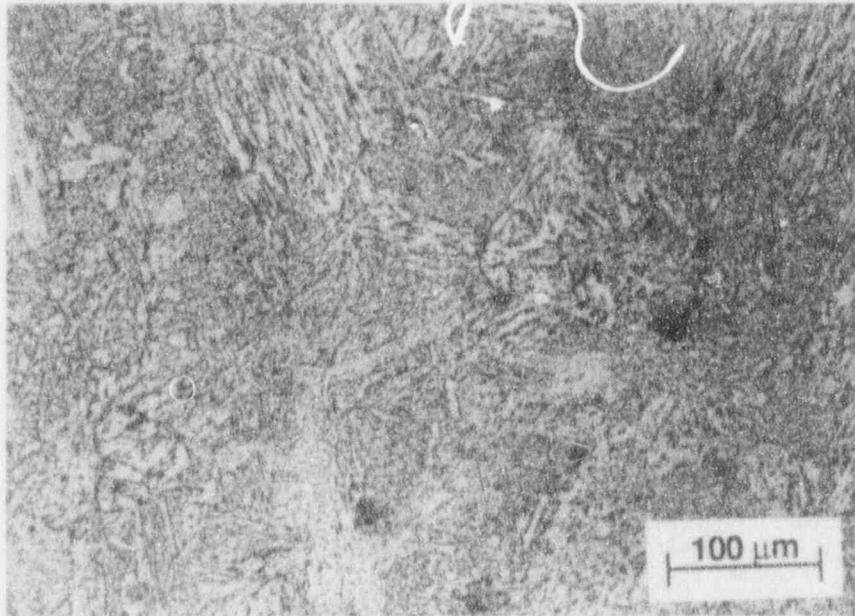
Fig. 18. Metallographic specimen from lower head Sample E-8 showing austenite grain growth in base metal (a) 1 mm below cladding/base-metal interface and (b) 3 mm below interface. (From Ref. 5)

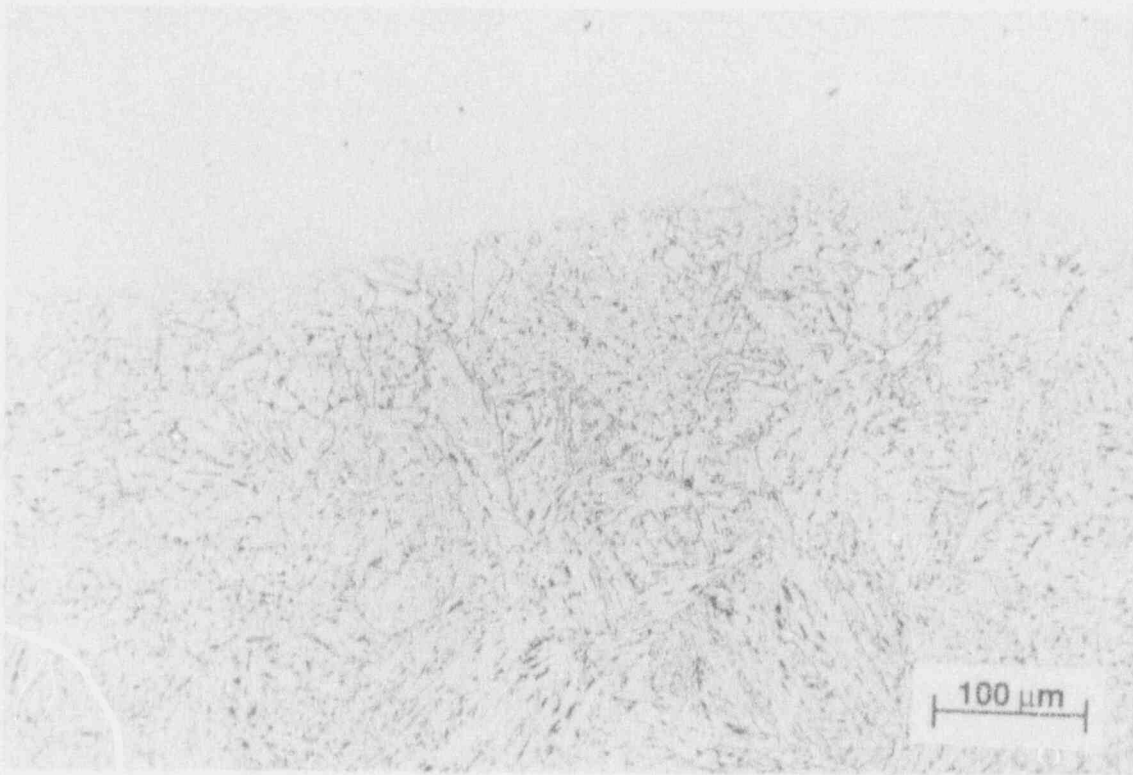
Fig. 19. Metallographic specimen from lower head Sample E-8 showing absence of carbide layer at cladding/base-metal interface. (From Ref. 6)

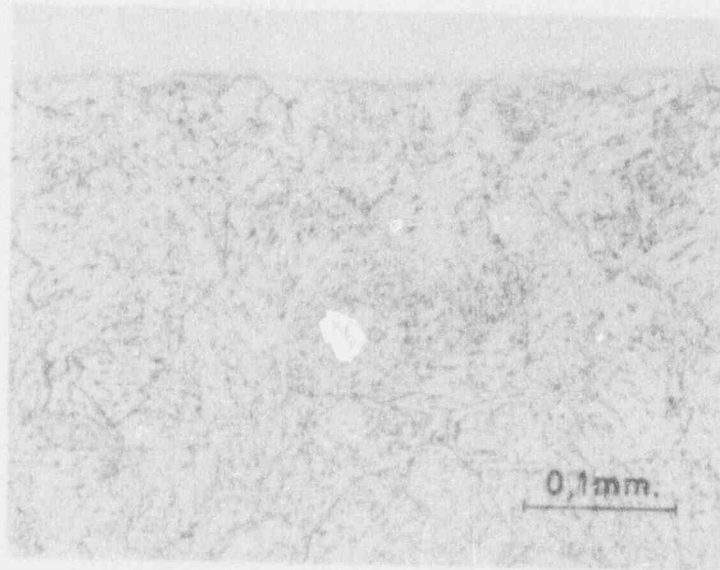
Fig. 20. Metallographic specimen from lower head Sample E-8 showing (a) absence of carbide layer at cladding/base-metal interface and (b) austenite grain growth in base metal 4 mm below interface. (From Ref. 9)

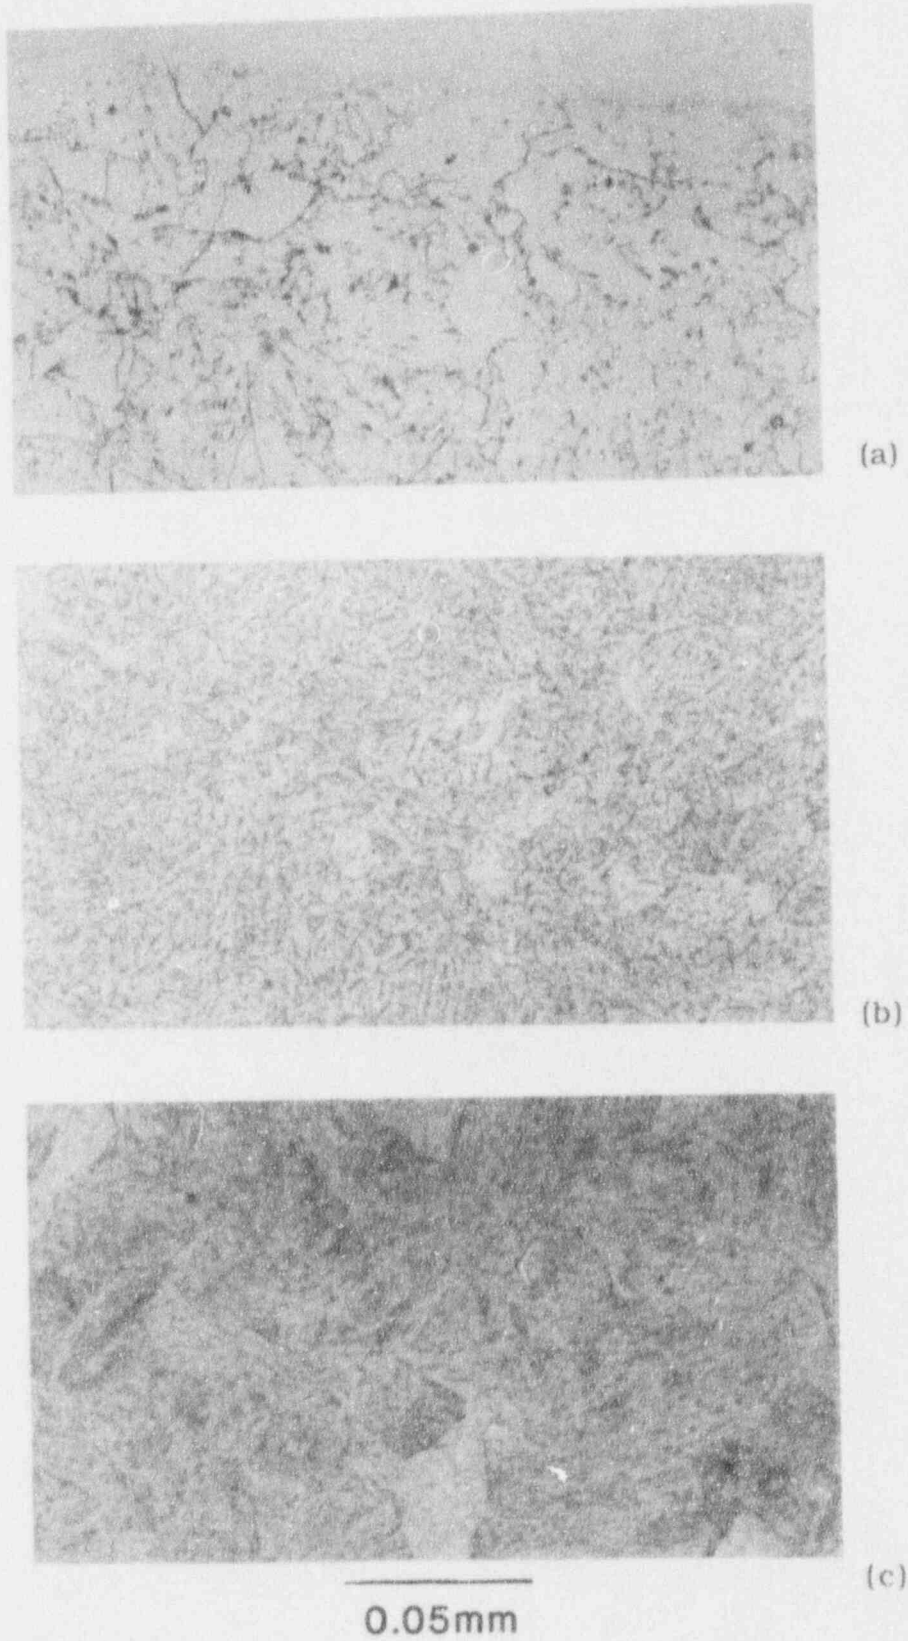
Sample F-10. Sample F-10 was examined at INEL, ANL, and Harwell Laboratory in the U.K.¹⁰ Using examination techniques similar to those described above for Sample E-8, INEL personnel estimated the maximum temperature of this sample to have been between ≈ 1040 and 1060°C at the interface, and the cooling rate was again placed at between 10 and $50^{\circ}\text{C}/\text{min}$. The examination at ANL suggested a slightly lower maximum temperature of between 900 and 1000°C , based primarily on the somewhat smaller prior austenite grain size as compared with Samples E-6 and E-8. The Harwell examination indicated that the maximum temperature had been "considerably above the A1" (727°C), based upon both microstructural evidence and observed hardness values (Fig. 21).

Fig. 21. Metallographic specimen from lower head Sample F-10 showing absence of carbide layer at cladding/base-metal interface (a) and austenite grain growth in base metal 1 mm (b) and 5 mm (c) below interface. (From Ref. 10)

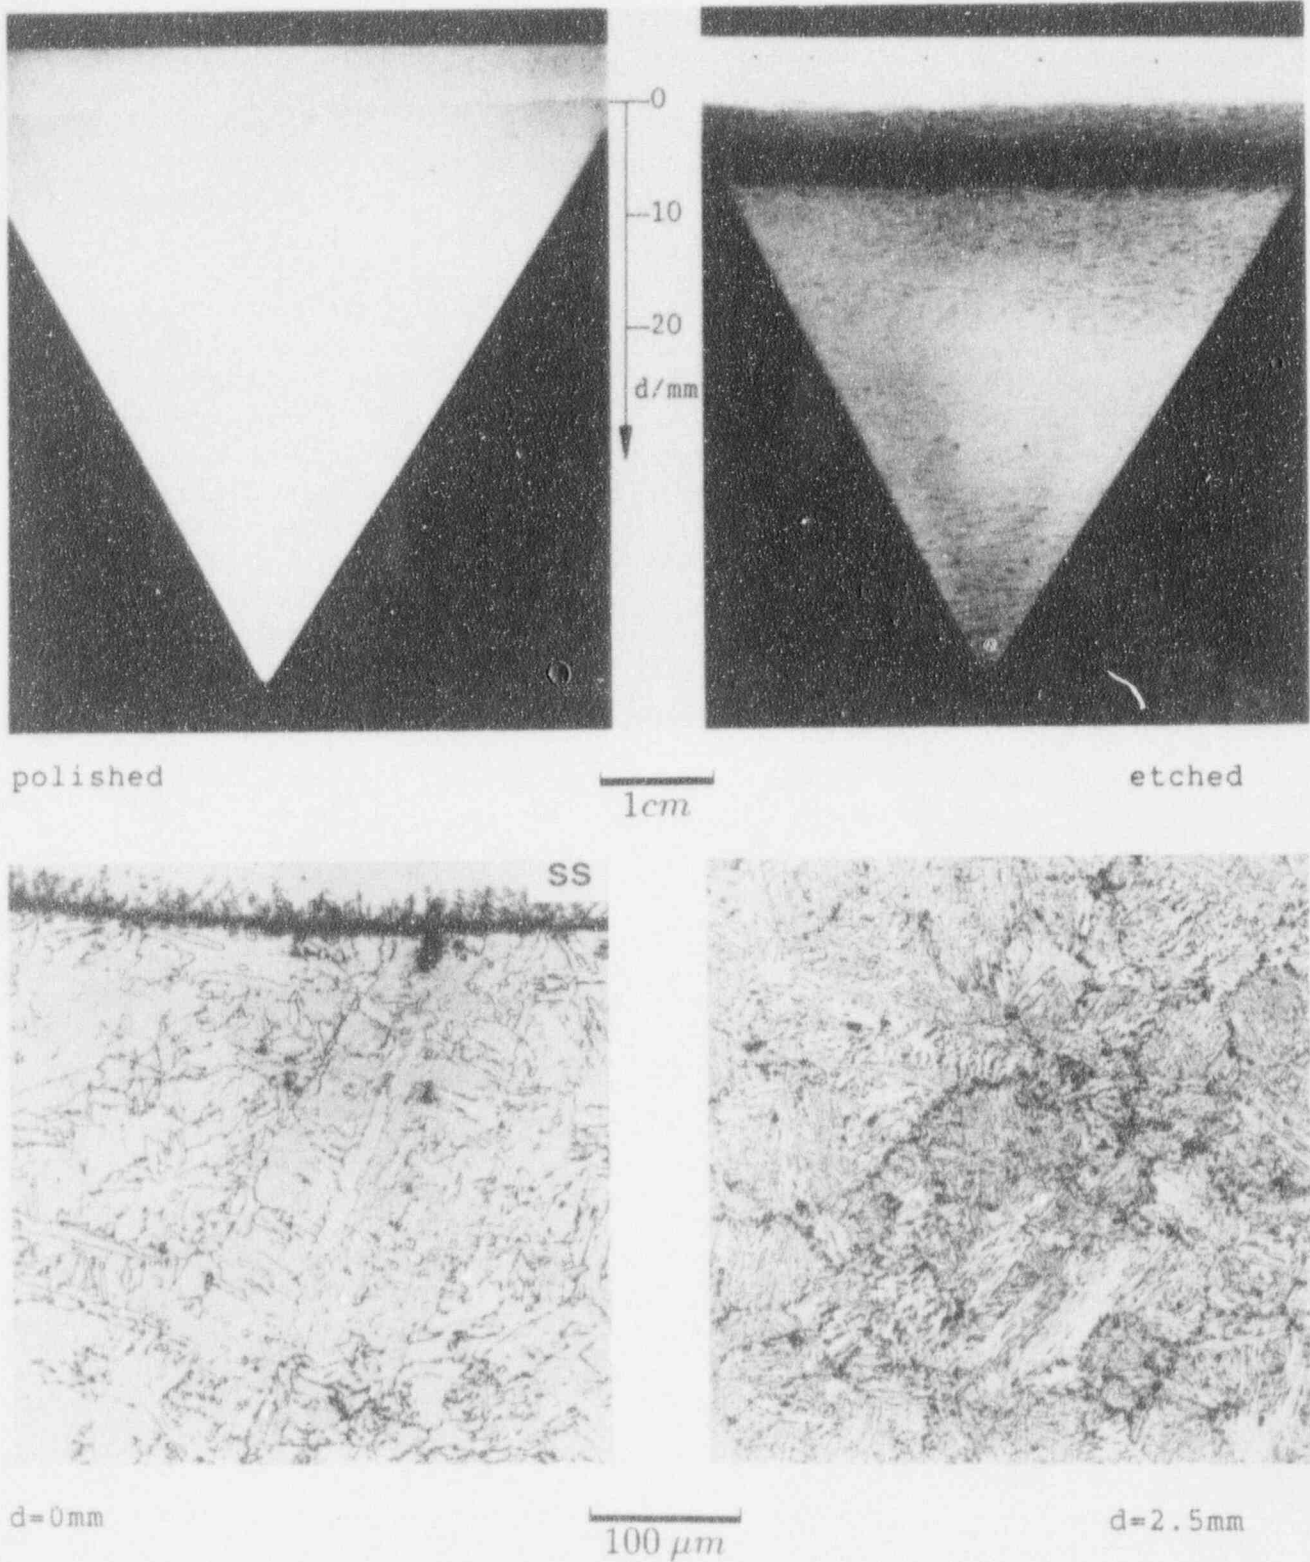
Sample F-5. Sample F-5 was adjacent to one end of the "hot spot" identified near the bottom of the TMI-2 lower head. While ANL and INEL found that their metallographic specimens had not exceeded 727°C, observations at Belgium, FRG, and the U.K. on adjacent metallographic specimens (see Appendix A) suggested a maximum temperature slightly in excess of 727°C, although the results from Belgium were somewhat ambiguous.

Fig. 22. Metallographic specimen from lower head Sample F-5 showing evidence of partial reaustenitization of base metal to a depth of ≈ 15 mm below the cladding/base-metal interface. (From Ref. 8)
