March 22, 1991

SUBJECT: COMANCHE PEAK STEAM ELECTRIC STATION (CPSEG)
DOCKET NOS. 50-445 AND 50-446
AUXILIARY FEEDWATER SYSTEM CHECK VALVES
SDAR CP-89-015 (SUPPLEMENTAL REPORT)

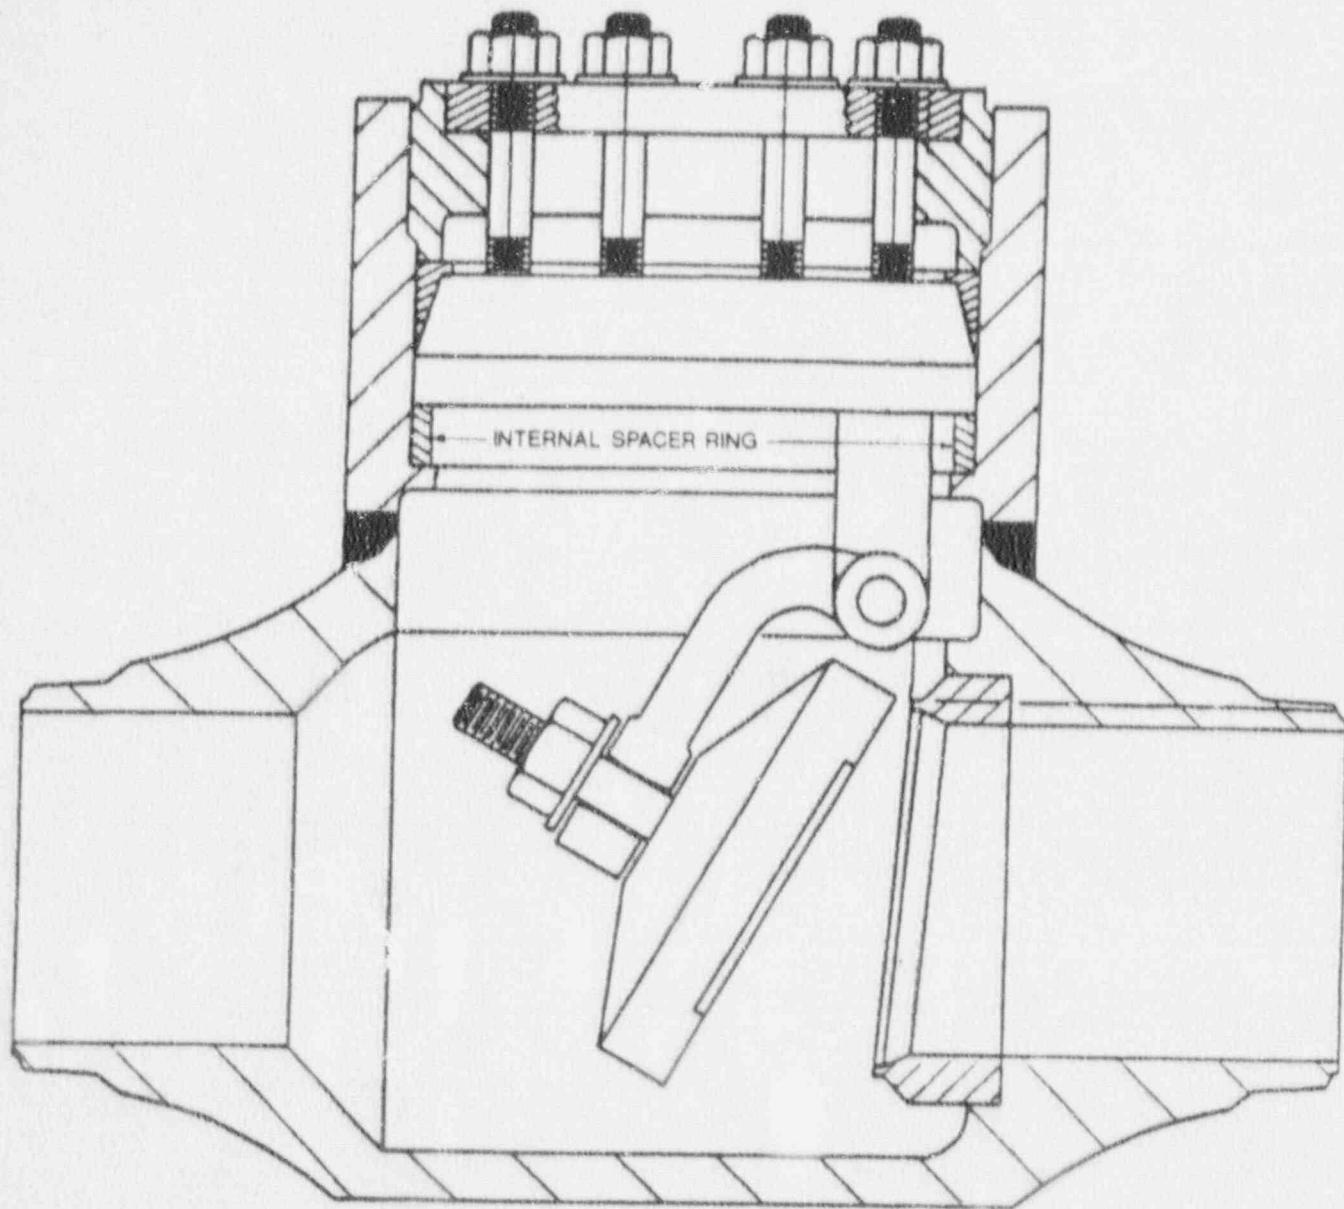
SIDE VIEW OF BWIP CHECK VALVE

To simplify the reassembly process, a modification will be made to the BWIP pressure seal check valves. This modification consists of an internal spacer ring and an external alignment device (see enclosed drawings). The internal spacer ring positions the bonnet assembly at the height required for correct disc contact on the seat. Each valve is measured, a spacer ring is machined to the required dimensions, and the spacer ring is welded in place.

The external alignment device consists of an alignment block welded to the top of the valve body and an alignment bar welded to the valve bonnet (see enclosed drawings). When the valve is reassembled, the alignment bar fits into the alignment block, preventing axial misalignment of the disc.
