U. S. NUCLEAR REGULATORY COMMISSION

Report Number: 50-295/304-94013(DRP) EA 94-079
Docket Numbers: 50-295; 50-304
License Numbers: DPR-39; DPR-48
Licensee: Commonwealth Edison Company
Opus West III
1400 Opus Place - Suite 300
Downers Grove, IL 60515
Meeting Conducted: May 11, 1994
Meeting Location: Region III Office
801 Warrenville Road
Lisle, Illinois 60532-4351
Type of Meeting: Enforcement Conference
Inspection Conducted: Zion Nuclear Generating Station
March 24, 1994 through April 26, 1994
Inspectors: J. D. Smith
M. J. Miller
V. P. Loughheed
Approved By:

Meeting Summary

Enforcement Conference on May 11, 1994 (Report No. 50-295/304/94013(DRP))
Areas Discussed: Four apparent violations, identified in special inspection report 295/304-94010, were discussed, along with the corrective actions taken or planned by the licensee. The apparent violations involved (1) low flow rates through the high-head safety injection throttle valves, (2) the missed limiting condition for operation action requirements when two trains of auxiliary feedwater were inoperable, (3) the inadvertent capping of all four containment pressure sensing lines, and (4) the inoperability of the high-head safety inj

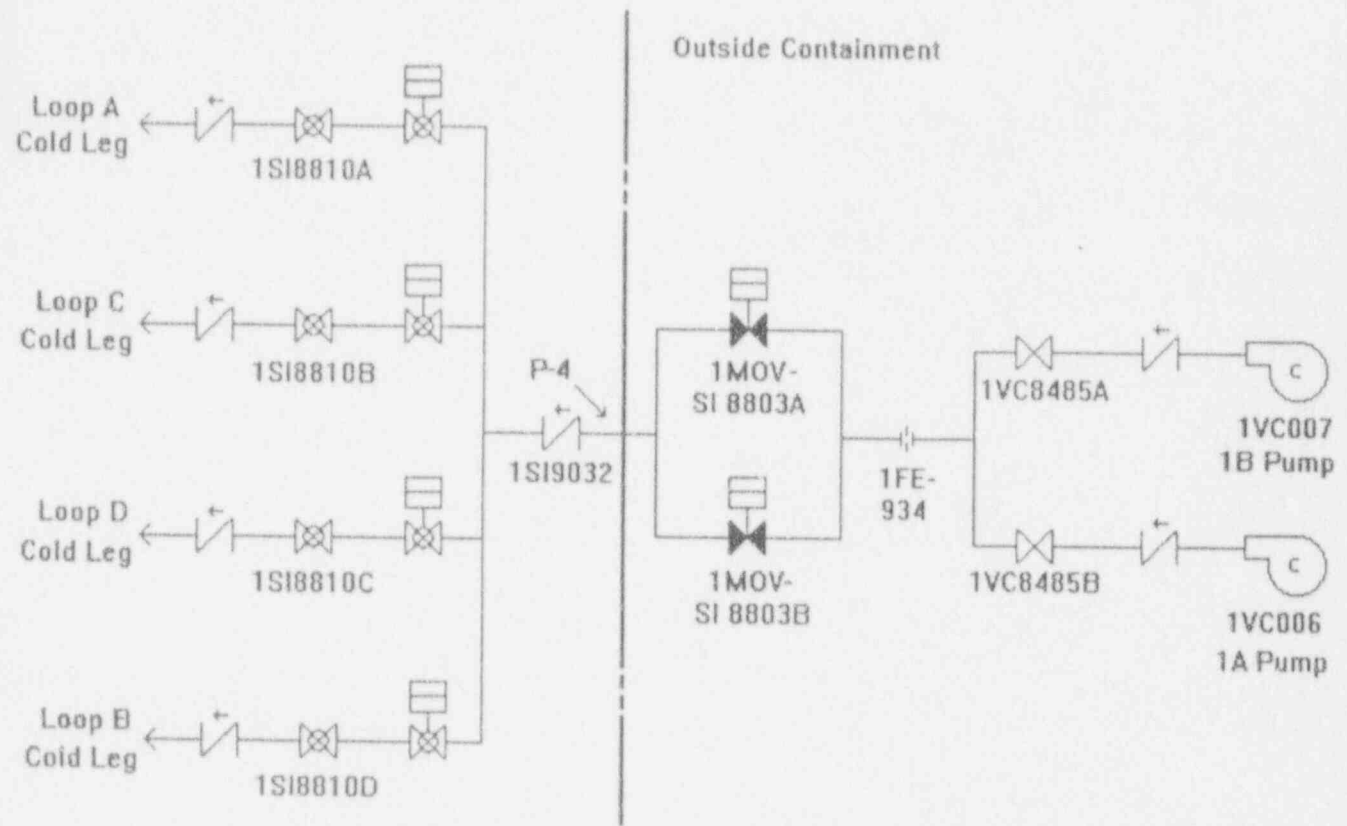
High Head Safety Injection Low Flow Rate

Event Cause: Procedure Deficiency — flow verification was not required subsequent to installation of valve restraining devices

Safety Significance: The lowest total three loop flow (249 gpm) was 26 gpm less than the minimum acceptable flow of 275 gpm.

Corrective actions: Throttle valves were repositioned and stem measurements were made for future reference.

Injection flows were verified after restraints were installed.

A permanent procedure change to TSS 15.6.84 "Charging and Safety Injection Check Valve Test" will be made to ensure that flow measurements are verified following the installation of throttle valve restraints.

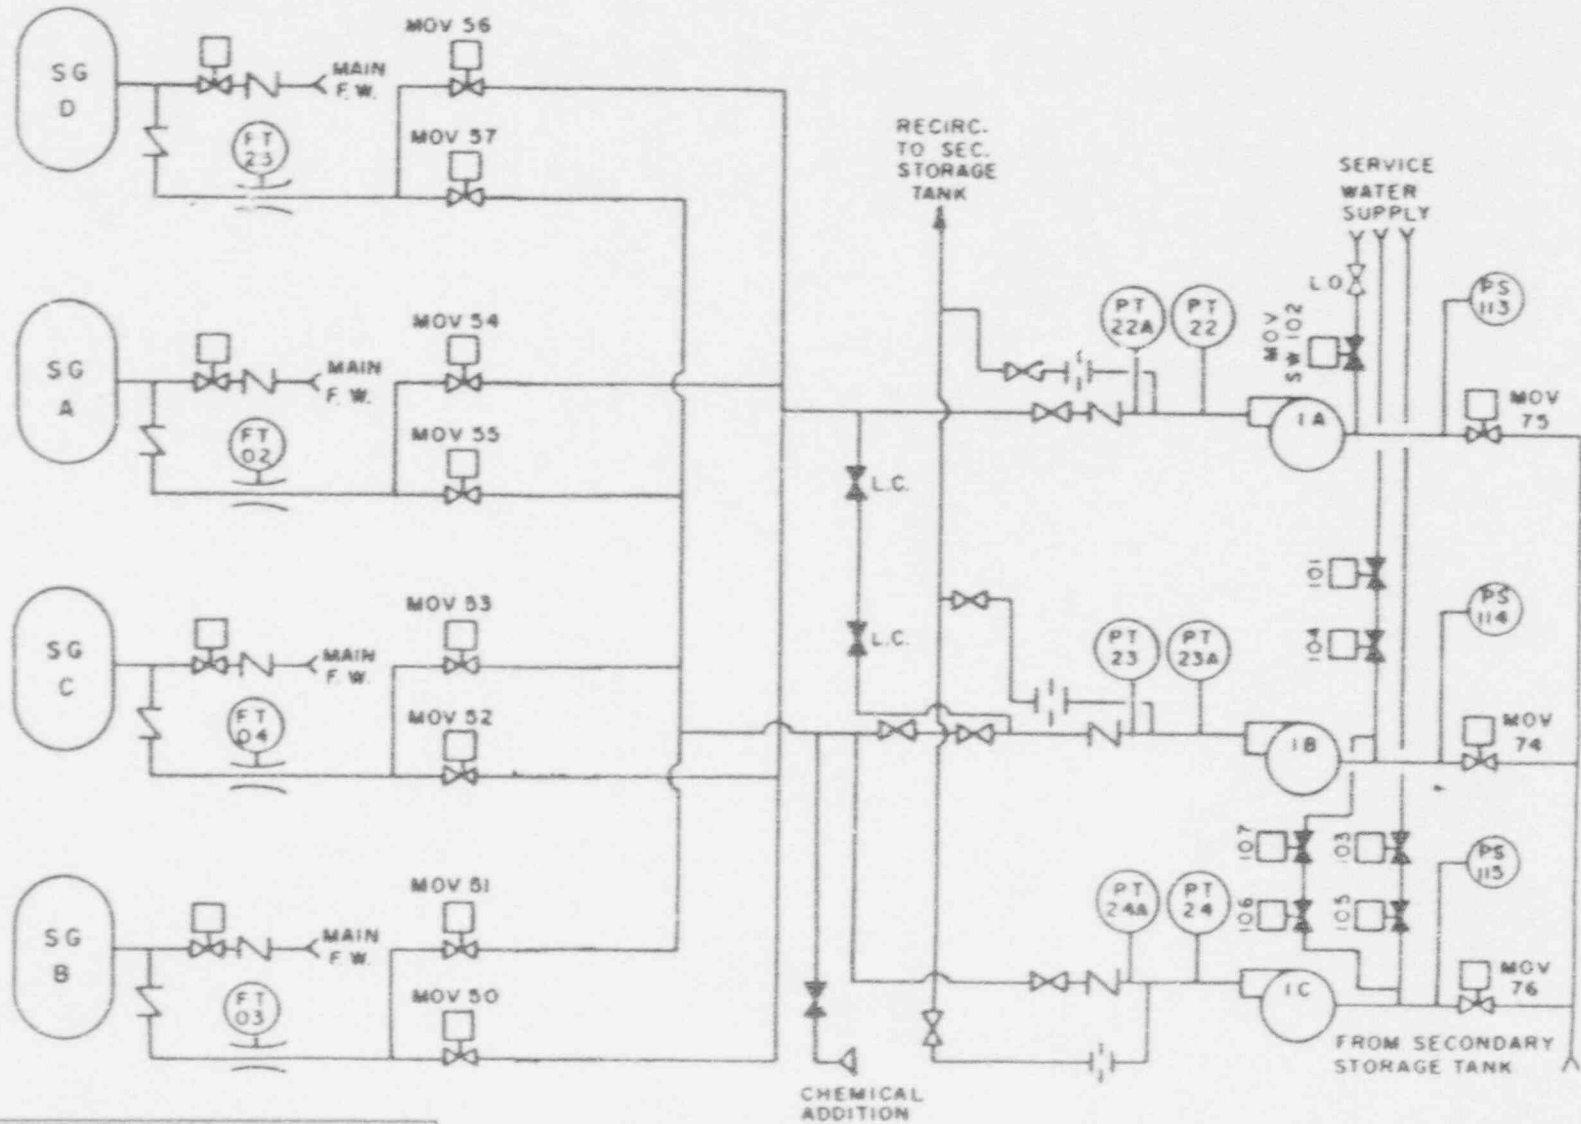
Failure to take actions required by Technical Specifications for two inoperable trains of auxiliary feedwater (AFW) within the required time period.

Event Causes: Human Performance Deficiency

- Operators failed to recognize that inoperability of the 2B Emergency Diesel Generator (EDG) in conjunction with the inoperable 2A AFW pump resulted in the 2C AFW pump being inoperable.

Procedural Deficiency

- Procedures did not direct operators to review the appropriate Technical Specifications

Corrective Actions: Repaired the 2A AFW pump.

Repaired the 2B EDG.

PT-14 "Inoperable Equipment Surveillance Tests", was revised to require a licensed shift supervisor review of Technical Specification 3.0.5, applicability and the Zion Operability Determination Manual (ZODM) for each PT-14 initiated.

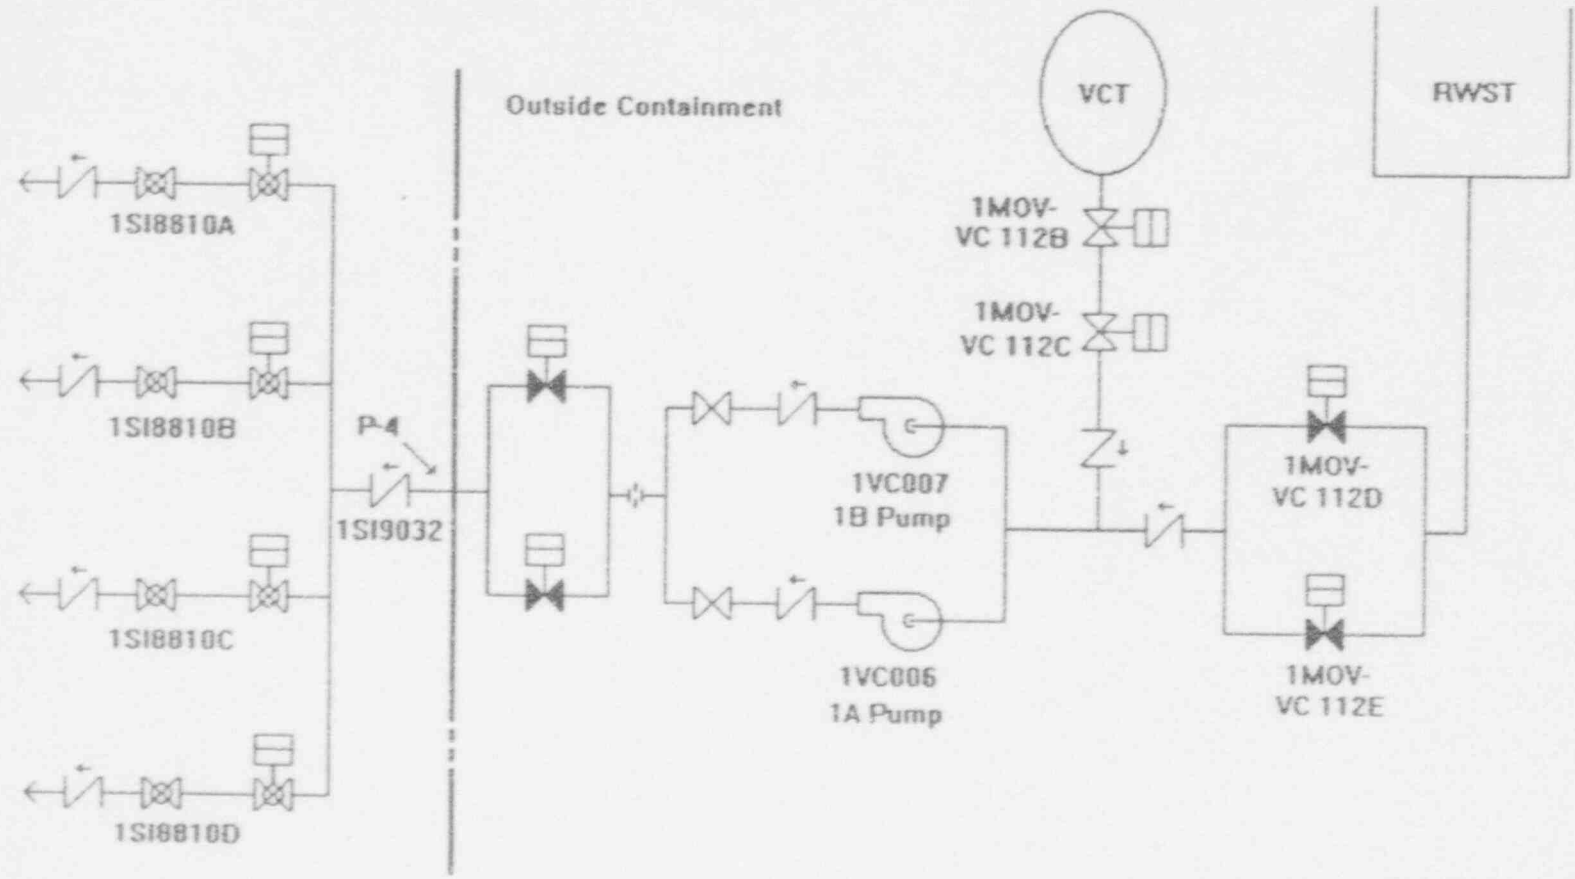
ECCS Valves found with lifted leads
(1MOV-VC112D and VC112E)

Event Causes: Management Deficiency

- Cumbersome paperwork and processes led to improper signoffs.

- Individuals reviewing paperwork failed to identify missing signatures.

Safety Significance: The leads that were lifted on 1MOV-VC112D & E disabled the automatic signal for the valves to open on either a low Volume Control Tank (VCT) level or a safeguards actuation.

Corrective Actions: Physical verification performed of Motor Control Cubicle (MCC) wiring on 1MOV-VC112B, C, 2MOV-VC112B, C, D and E to ensure that these MOV's did not have lifted leads.

Zion Station Support Engineering developed a matrix for both units for all safety related MOV's that receive a safeguards actuation signal or perform an interlock function and experienced maintenance during the Dual Unit Outage. All of these MOV's were verified by testing or visual inspection.

- increased management overview of lifted leads
- double verification of lifted leads
- Quality Control performing an independent verification of lifting and landing of leads

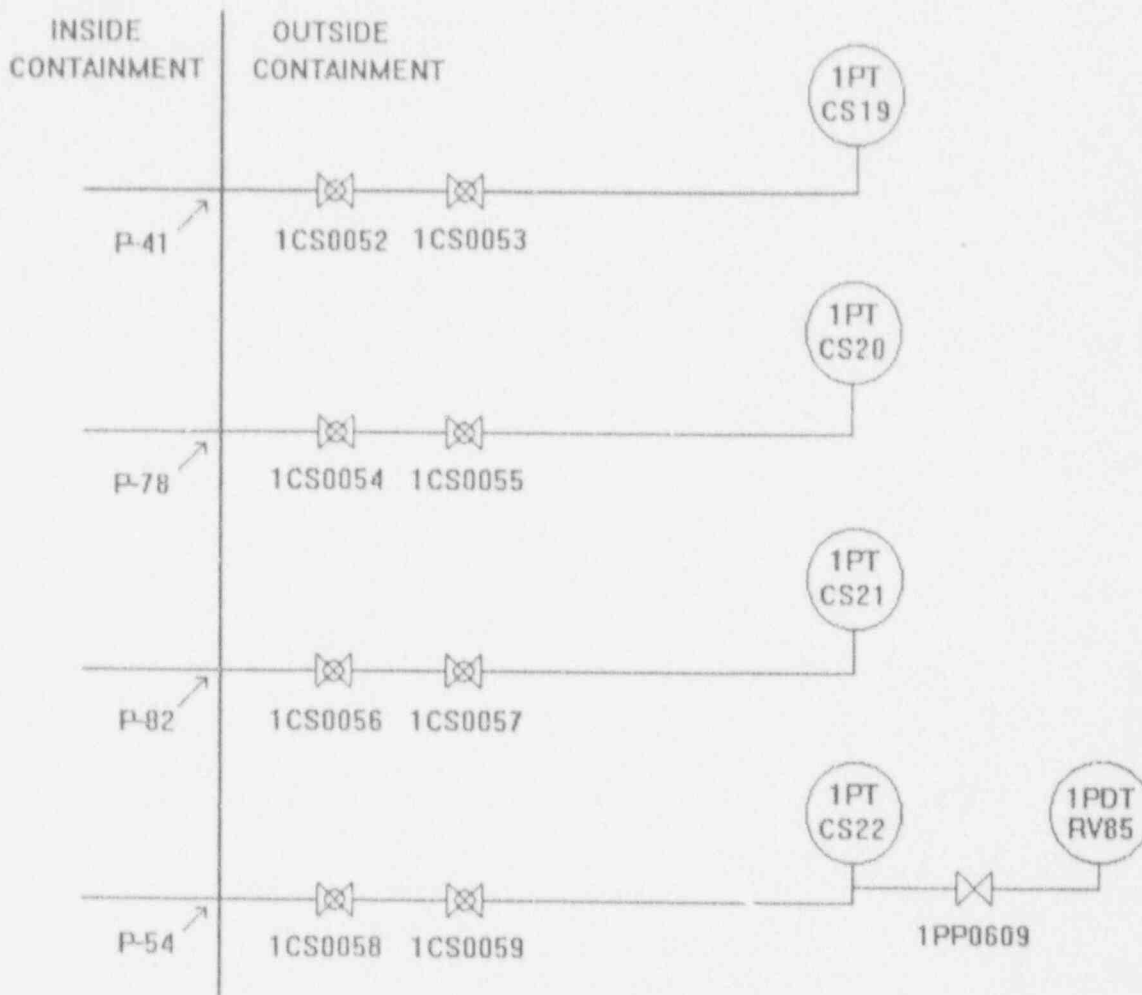
Inadvertent Capping of All Four Containment Pressure Sensing Lines

Event Causes: Management Deficiencies

- Containment penetrations inside containment were not labeled.
- Lack of supervisory follow-up.

- Inadequate communications between the work crew and supervisor regarding the extra lines being capped.
- The grid map identifying the penetrations was incorrectly read.

Safety Significance: Due to inoperable transmitters, the engineered safeguard features (ESF) automatic actuation functions based on the containment pressure signal were also inoperable. The affected ESF functions were:

Corrective Actions: Removed pipe caps from the Unit 1 containment pressure sensing lines.

Reviewing options for labeling of penetrations inside Unit 1 and 2 containments.

Revising General Operating Procedure GOP-0, checklist E, "Containment Close Out", to verify penetrations or associated lines are open/uncapped before plant heatup. This procedure is performed by a Licensed Shift Supervisor.
