SUBJECT: STATUS REPORT - BWR JET PUMP HOLD-DOWN BEAM FAILURES

BWR JET PUMP HOLD-DOWN BEAM FAILURES

NRC INFORMATION NOTICE 93-101: JET PUMP HOLD-DOWN BEAM FAILURE

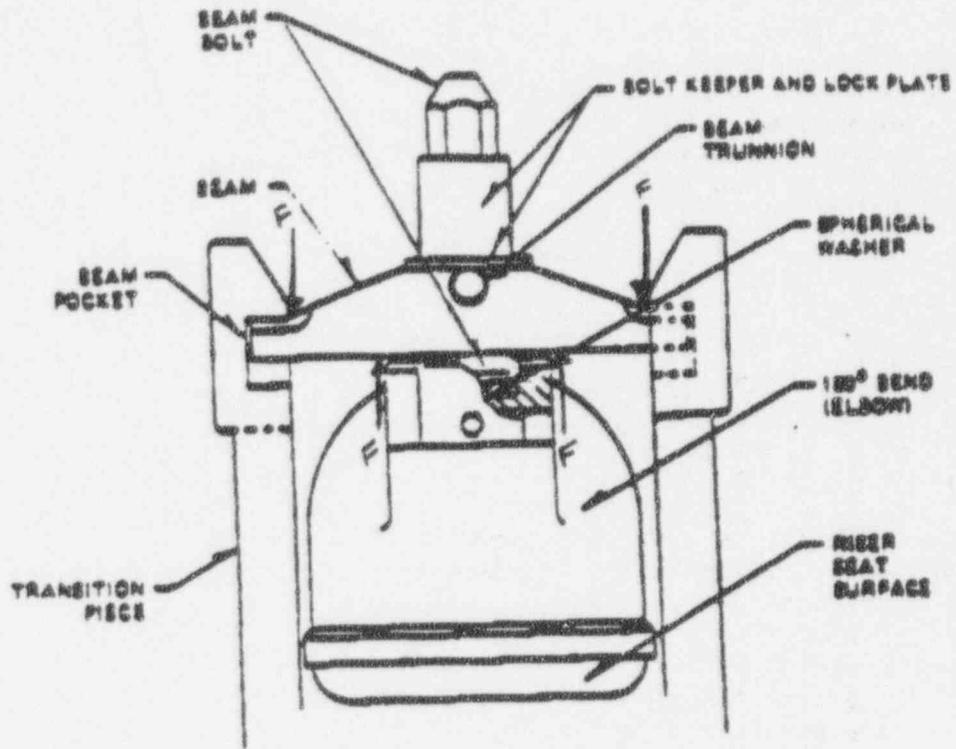
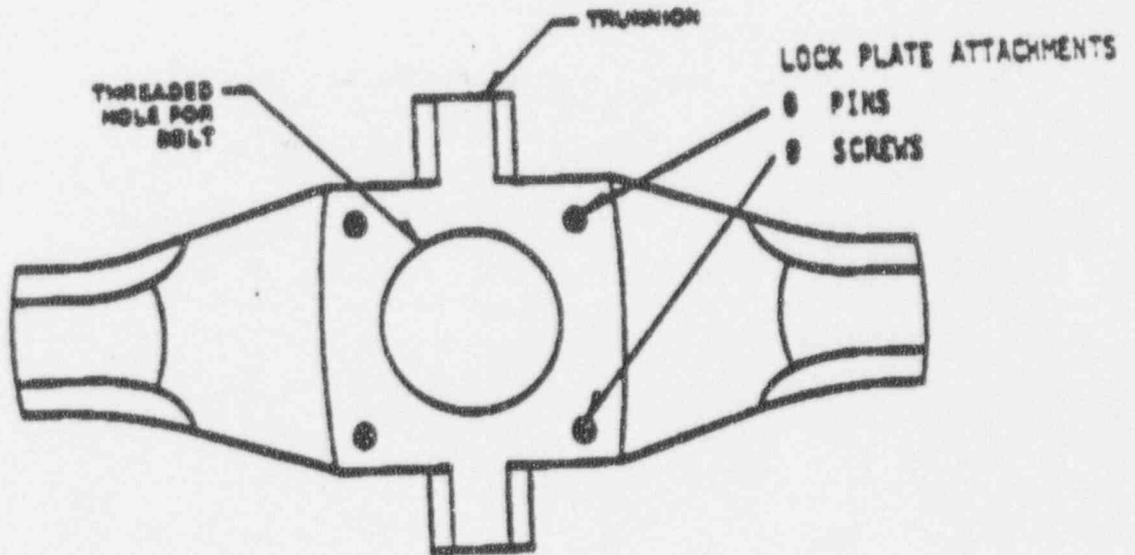
Figure 4. BWR 4 Beam Assembly and Beam Top View

The failures reported in SIL No. 330 occurred in the middle section of the beams. Results of completed laboratory work show that the recent failure occurred in the transition to the arms at the ends of the beam. Initial laboratory examination results of the recent failure show that intergranular stress corrosion cracking (IGSCC) was the failure mechanism, also as reported in SIL 330. However, other factors that may have influenced crack initiation are still under investigation. These factors might isolate the failure to the GE BWR in which it occurred or to some other subset of the total population. Ultrasonic testing (UT) procedures currently in use do not address cracking in beam end locations. GE Nuclear is developing UT and other non-destructive examination (NDE) procedures to examine the beam ends.

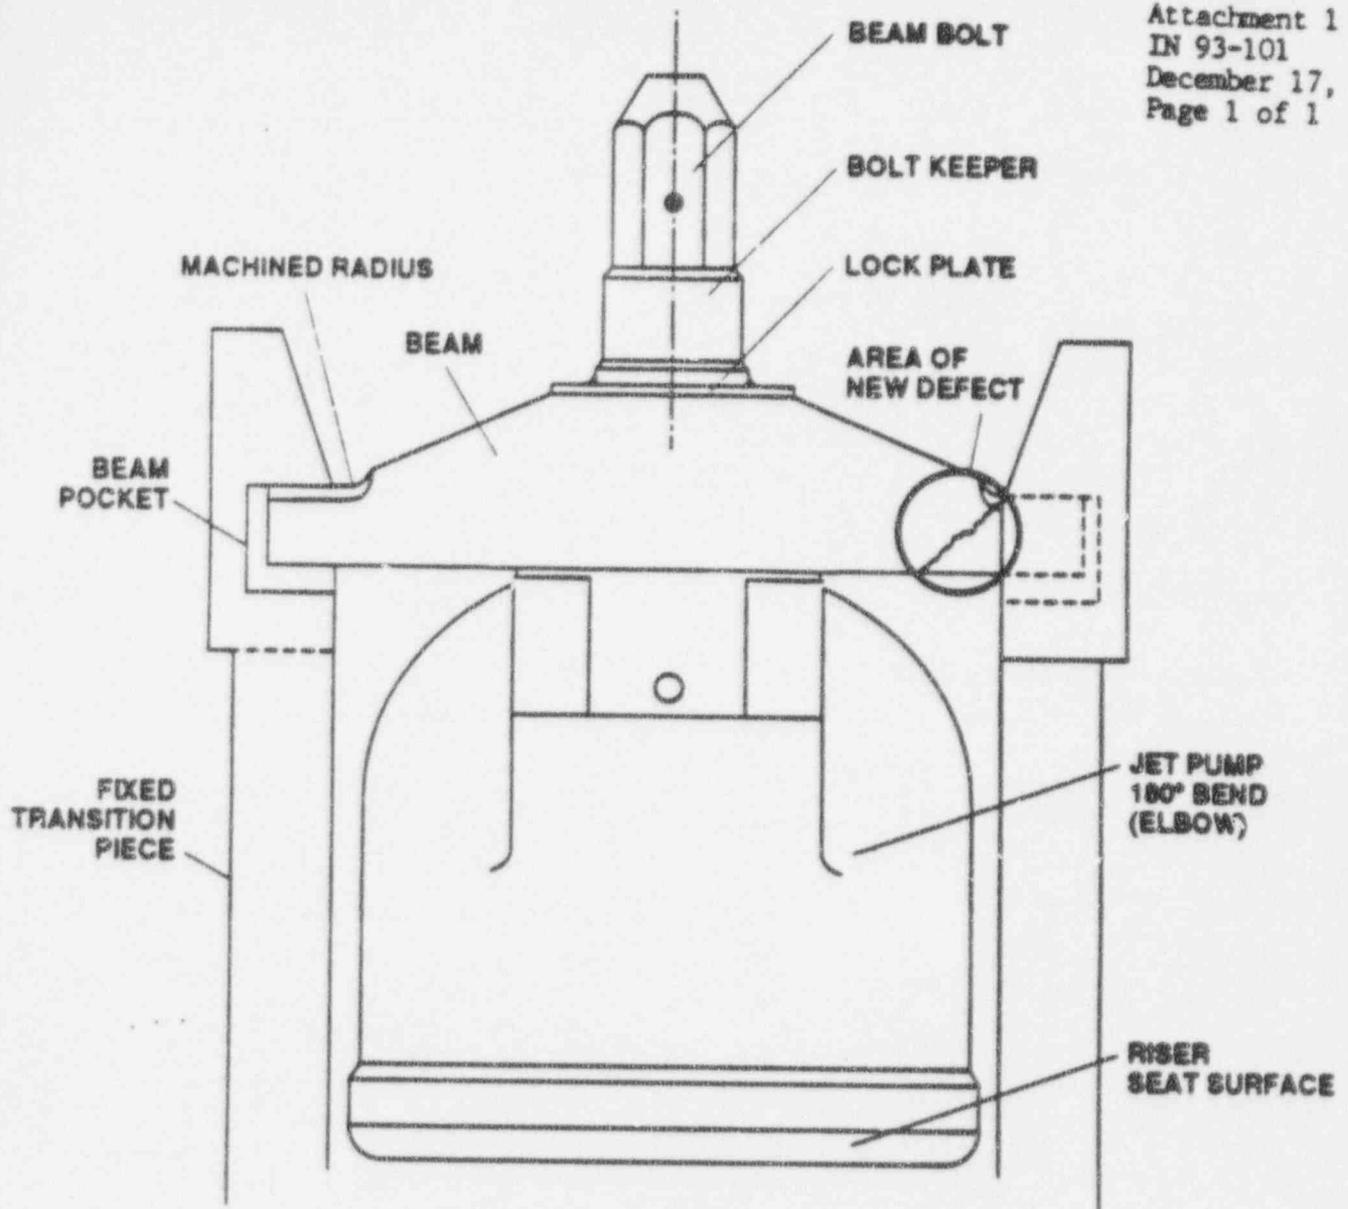
Jet Pump Beam Failure Location

The jet pump hold-down beam failure at the Grand Gulf power station in September 1993 is unlike previous failures in that the hold-down beam for jet pump 10 failed in the transition area between the main body of the beam and the beam end as shown in Attachment 1. There have not been any previous reports of failures in this location. One beam end failed completely, causing the beam to come out of the transition piece, removing the restraint on the jet pump elbow and leading to the disassembly of jet pump 10. There is one hold-down beam for each jet pump assembly. Visual examination of the failed beam showed a crack face covering more than 270° of the cross-section of the intact beam end; the other beam end had cracked in the same location and was missing. The cracks began in an area where a radius machining cut had been made in the forging and led to failure in a location of the beam with a cross-section smaller than the areas that had been affected in previous cases. GE concluded that the probable cause of failure was an intergranular stress corrosion crack that propagated over 80 percent of the fracture surface. Fatigue striations covered the remaining 20 percent of the surface. GE stated that the loss of preload as a result of the intergranular stress corrosion may have induced the fatigue failure.
