SUBJECT: Calvert Cliffs Nuclear Power Plant  
Unit Nos. 1 & 2; Docket Nos. 50-317 & 50-318  
1982 Results of Steam Generator Eddy Current Examinations

ENCLOSURES: (1) Calvert Cliffs Unit 1 Eddy Current Inspection of Steam Generators #11 & 12 Final Report, Prepared by Zetec, Inc., May 1982  
(2) Calvert Cliffs Unit 2 Eddy Current Inspection of Steam Generators #21 & 22 Final Report, Prepared by Zetec, Inc., November 1982  
(3) Combustion Engineering Series 67 Steam Generator Tube Sheet Pattern  
(4) Tubes Plugged #11 Steam Generator  
(5) Tubes Plugged #12 Steam Generator

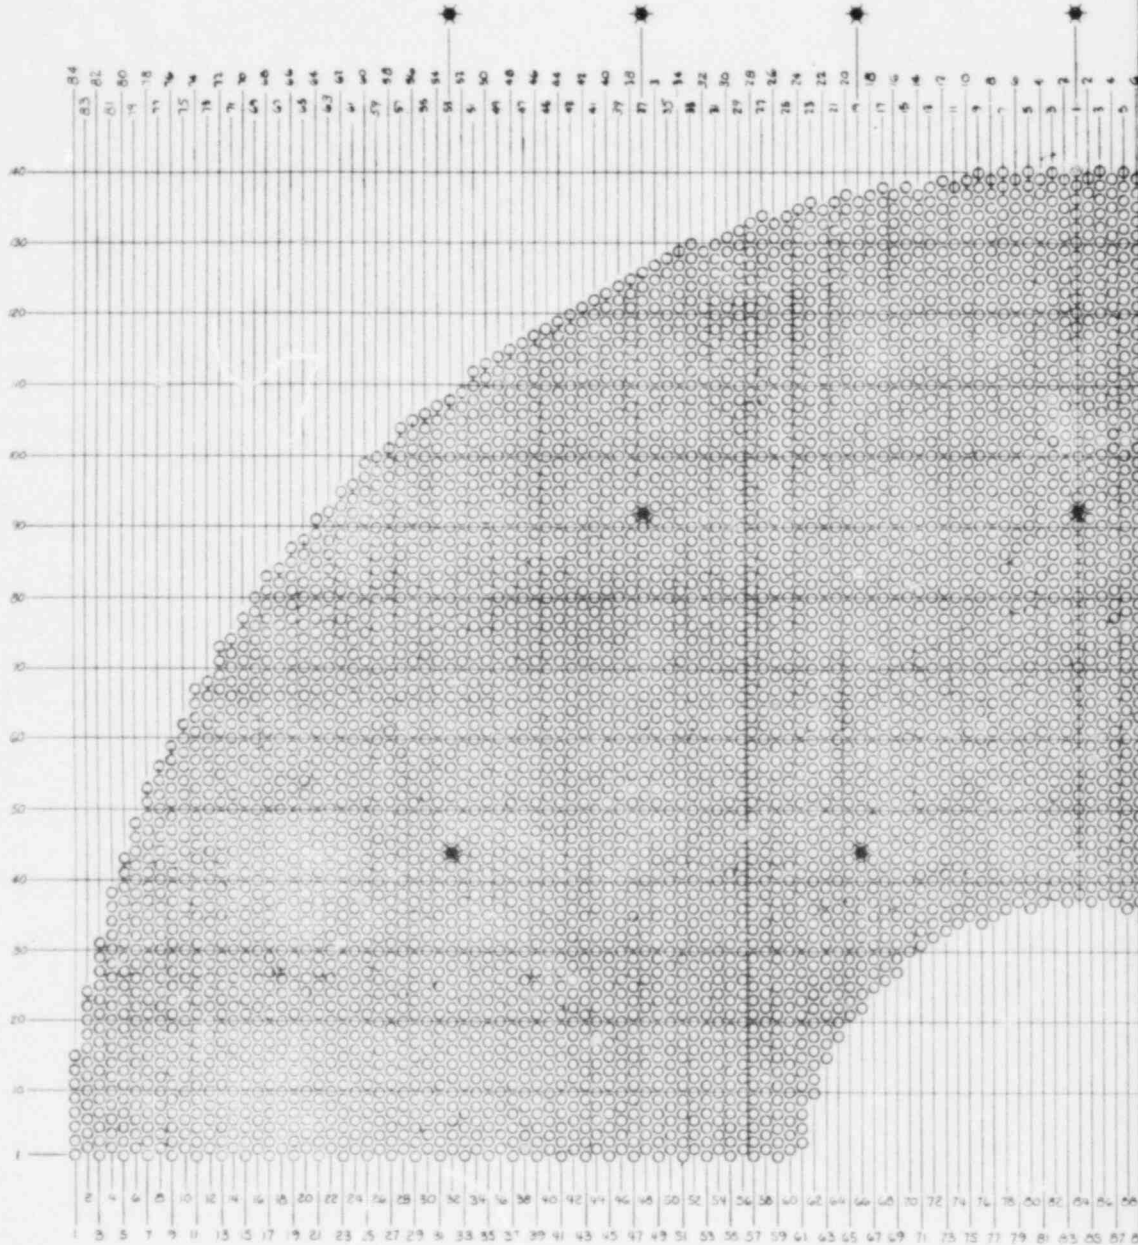
STEAM GENERATOR  
TUBE SHEET DRAWING FROM

Calvert Cliffs Steam Generators are Series 67 Combustion Engineering Units and tube locations are referenced to the hot leg or cold leg tube sheet as shown in Enclosure (3). The hot leg tube sheet is divided into quadrants #2 (right) and #3 (left) with Line No. 1 down the center. Whereas the cold leg tube sheet is divided into quadrants #1 (left) and #4 (right) with Line No. 1 down the center. All steam generators at Calvert Cliffs Unit Nos. 1 & 2 were examined by the eddy current method during 1982. Examinations were conducted in accordance with the requirements specified in references (a) and (b), and
