Subject: Final Report - DER 81-25
A 50.55(e) Report Relating to Bingham-Willamette
Auxiliary Feedwater Pumps Could Not Be Rotated
By Hand For Maintenance During Storage
File: 82-019-026
D.4.33.2

FINAL REPORT - DER 81-25
DEFICIENCY EVALUATION 50.55(e)
ARIZONA PUBLIC SERVICE COMPANY (APS)
PVNGS UNITS 1, 2 AND 3

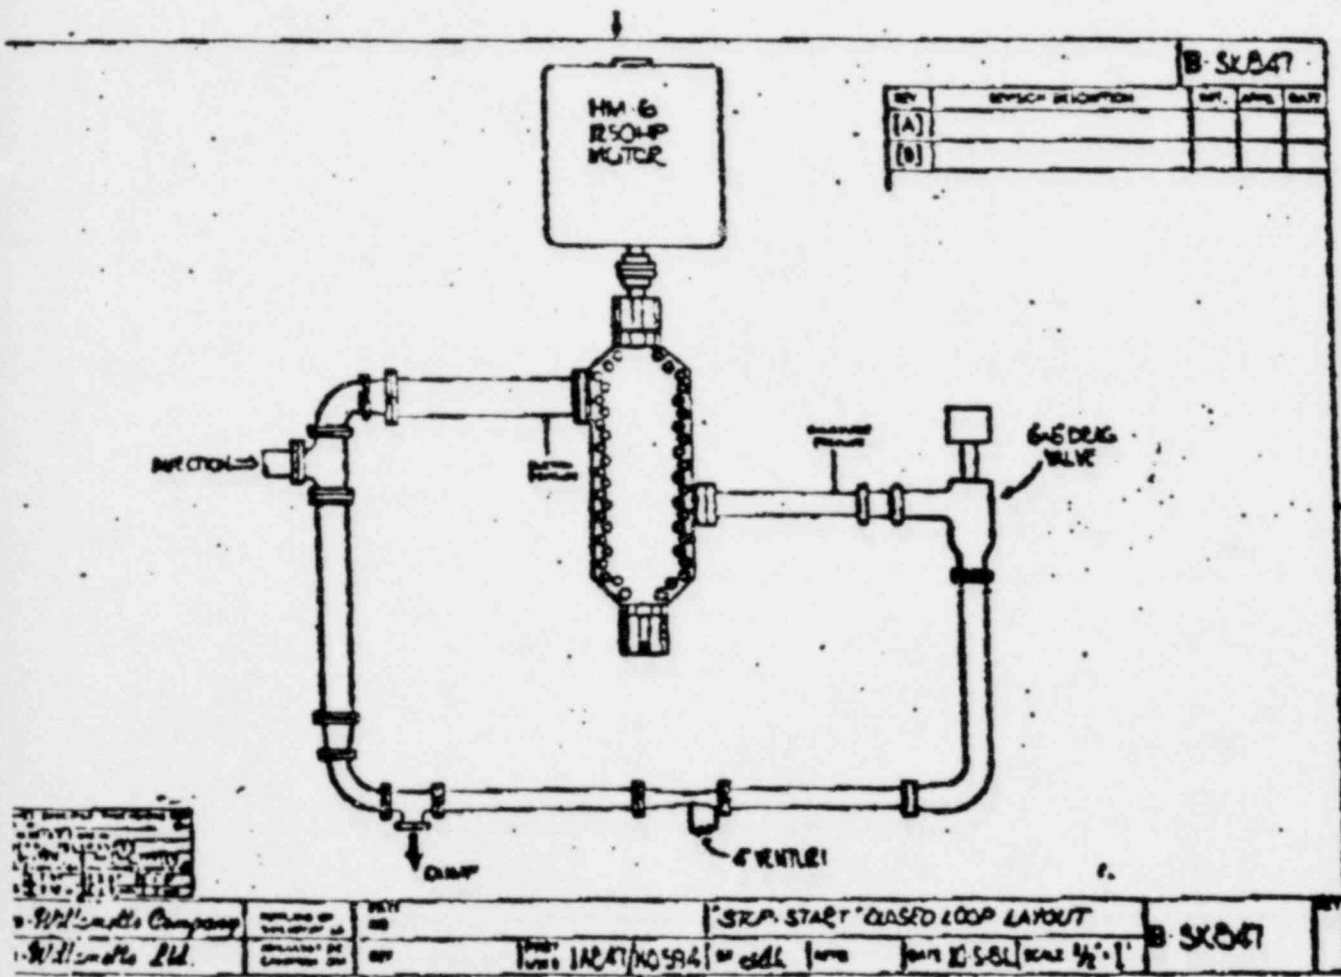
LOOP SCHEMATIC

Sketch B-SK-247 is included as a general schematic of the BVC test loop.
