Subject: Duane Arnold Energy Center  
Docket No: 50-331  
Op. License DPR-49  
Licensee Event Report #94-006, Rev. 01

**LICENSEE EVENT REPORT (LER)**

TITLE (4) Reactor Water Cleanup Isolation Due to Incomplete Valve Closure Caused by Position Indicator Obstruction

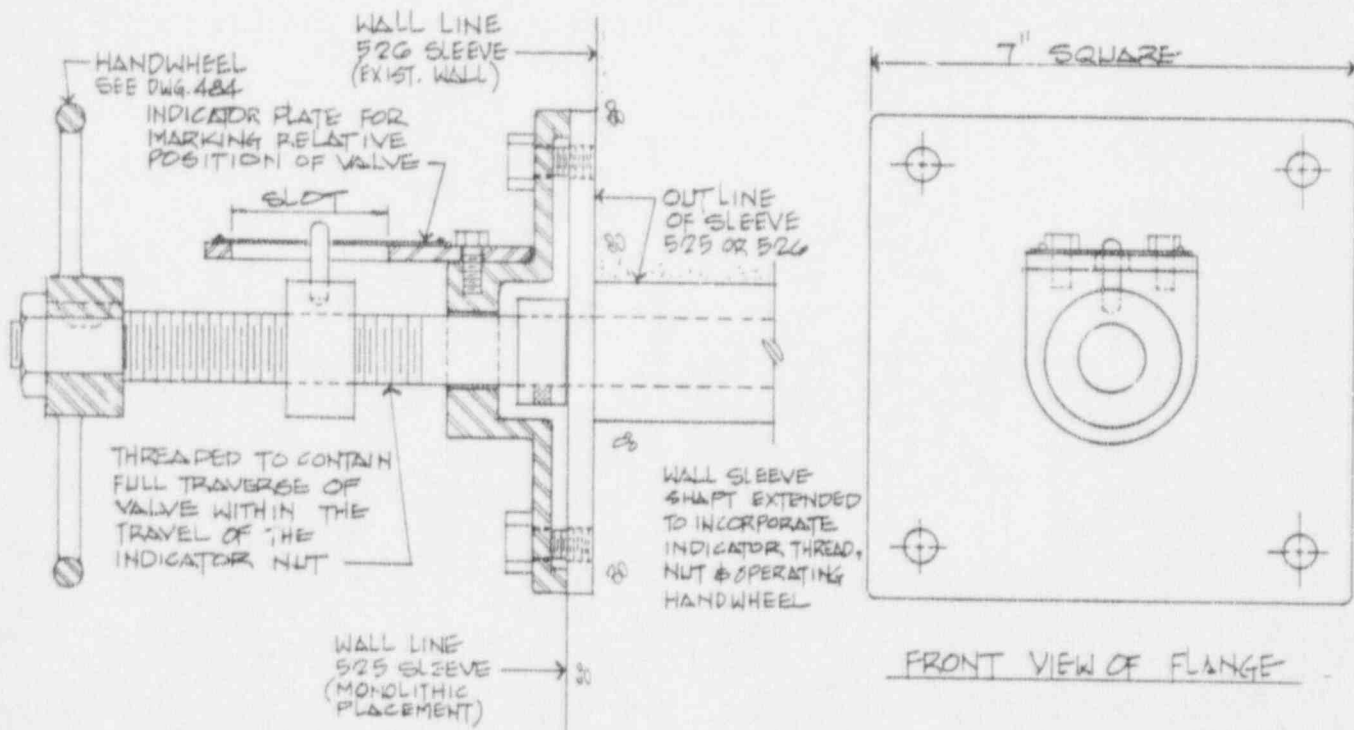
Figure 1

The cause of this event was the remote position indicator on the Roto Hammer valve extension for the "A" RWCU pump discharge valve preventing full valve closure. The position indicator, when at the end of its travel, was able to draw the stem of the remote handwheel tight, simulating valve closing torque (See Fig. 1). This and the fact that it also indicated closed, misled the operator into believing the valve was closed.

A contributing factor to the indicator problem was an improper set up of the indicator nut during previous maintenance. The indicator had been previously broken and was replaced with a new pointer and indicator nut. This work was done with the system operating and the valve in the open position. Upon installation of the new indicator nut, it was adjusted to indicate open. Subsequent cycling of this valve has shown that the position indicator travel length is insufficient to allow for full valve travel. Also, because the critical function of this valve is to isolate the pump, the position indicator should have been set up with the valve in the fully closed position. These considerations were not understood at the time the maintenance was performed.

2. The position indicator was repaired and modified on the "A" RWCU pump discharge valve. The modification eliminated the possibility of the position indicator inhibiting full valve travel. This action was completed on June 28, 1994.

3. An evaluation of the remaining valves in the plant that have similar reach rods and indicators was performed to determine generic corrective actions. As a result of the evaluation, removal of the indicator plate and pointer will be performed to all the valves with the same type valve extensions, including the "A" RWCU pump discharge valve. This action will be completed by September 30, 1994.
