**TMI-1**  
**OTSG Status Review**

**April 7, 1982**

TMI-1 OTSG STATUS REVIEW

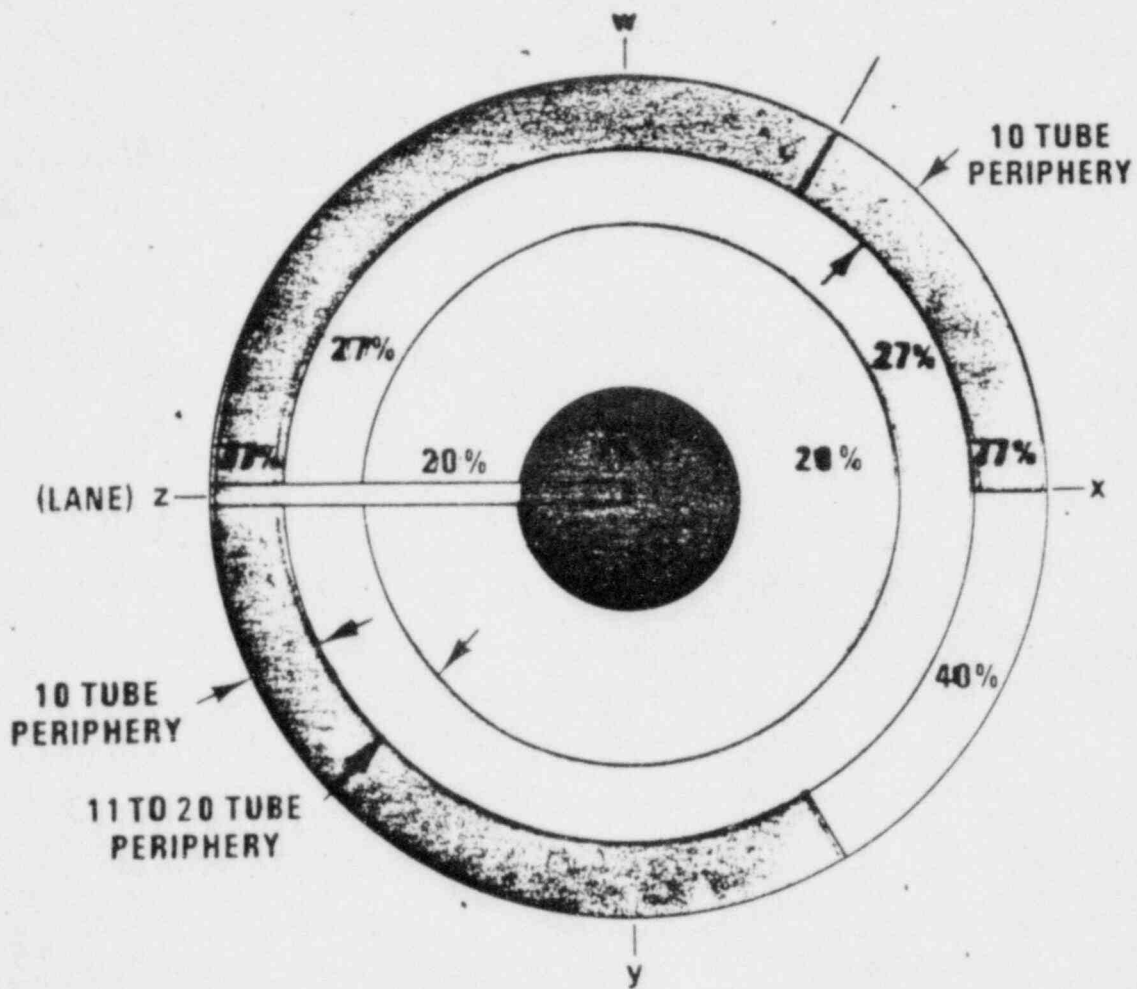
OTSG-A

Potentially Defective Tubes  
(Projection of Eddy Current Data)

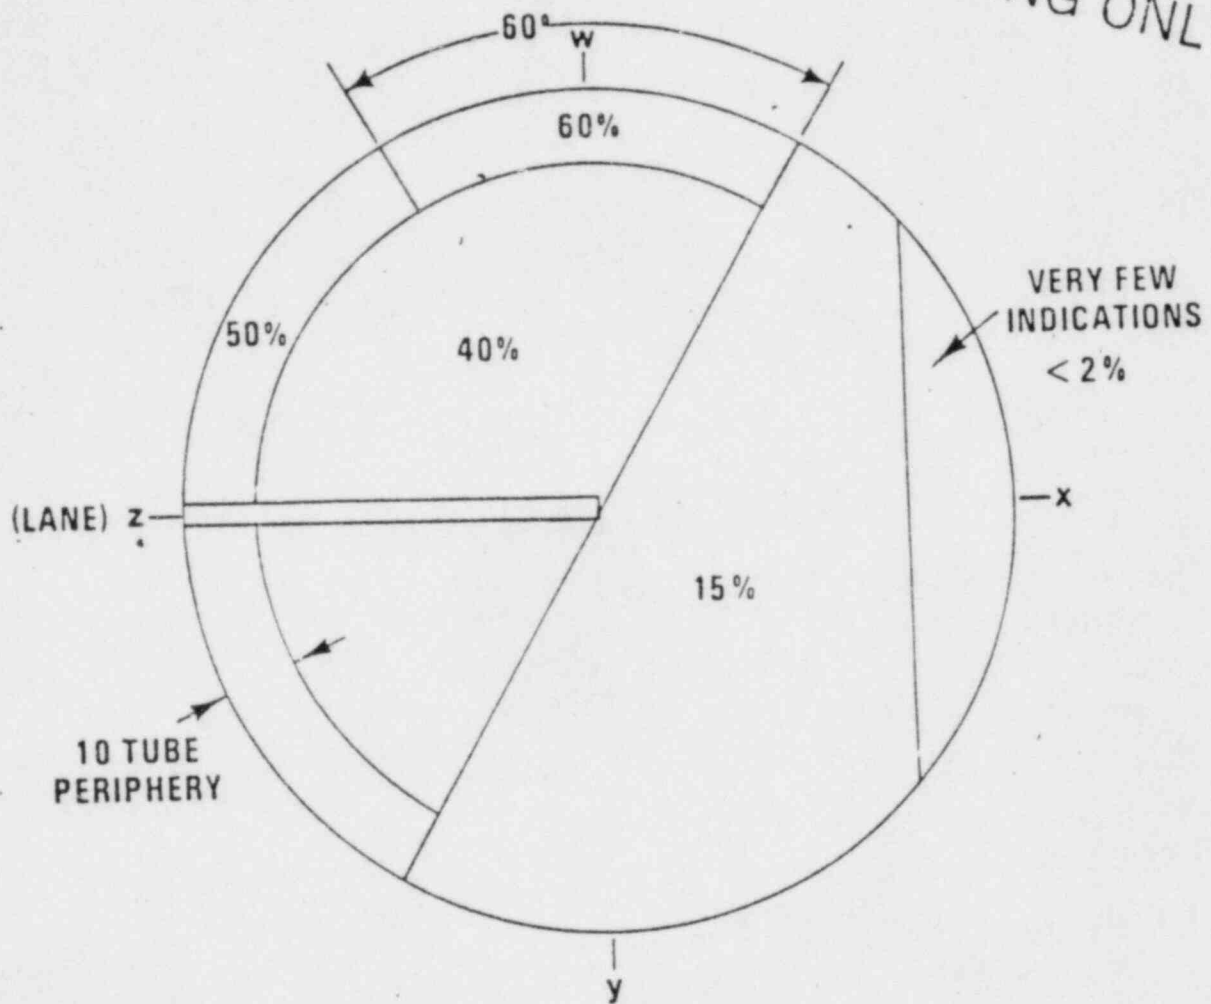
OTSG-B

Potentially Defective Tubes  
(Projection of Eddy Current Data)

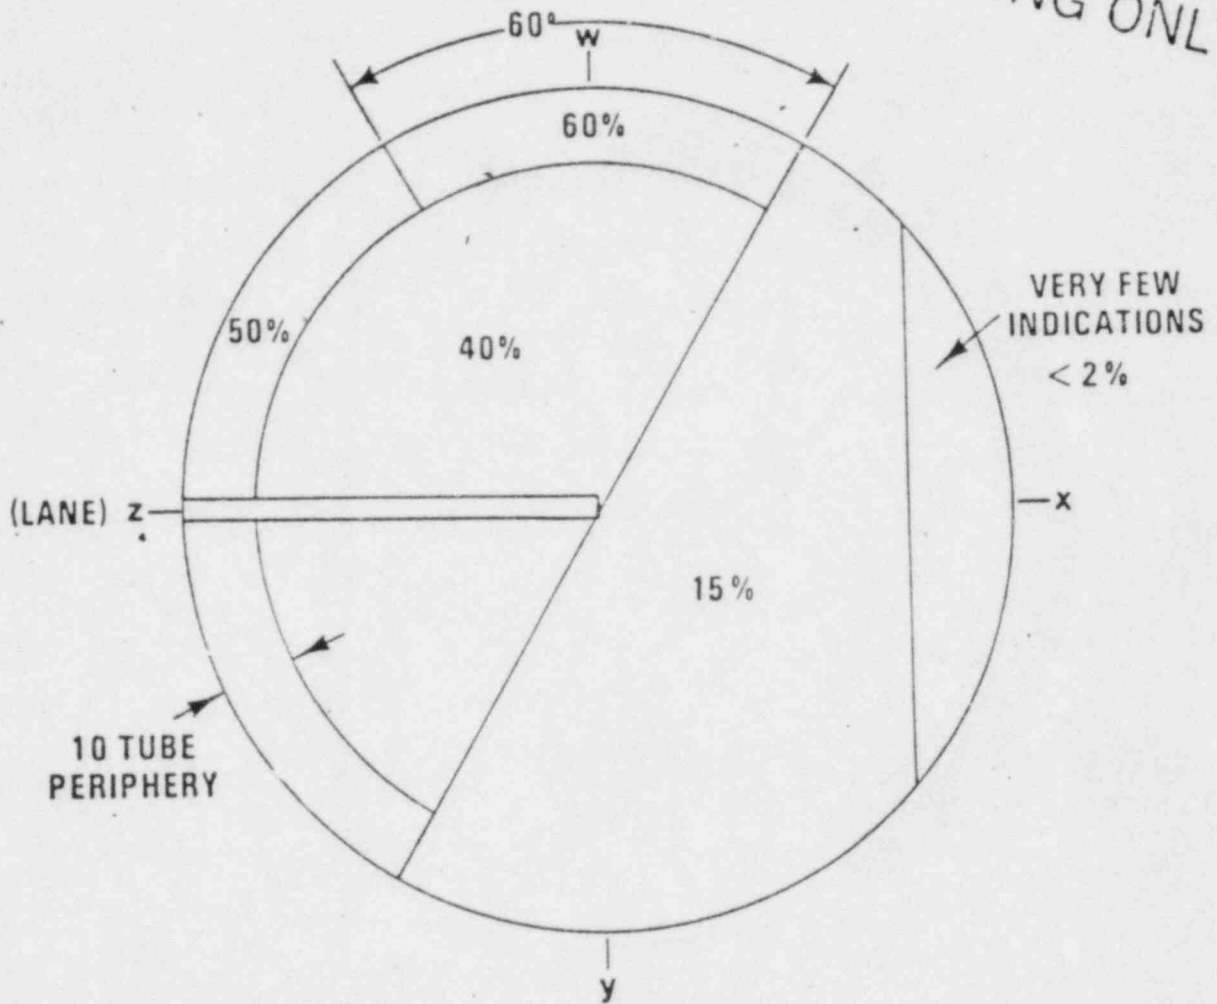
OTSG-B

Potentially Defective Tubes  
(Projection of Eddy Current Data)

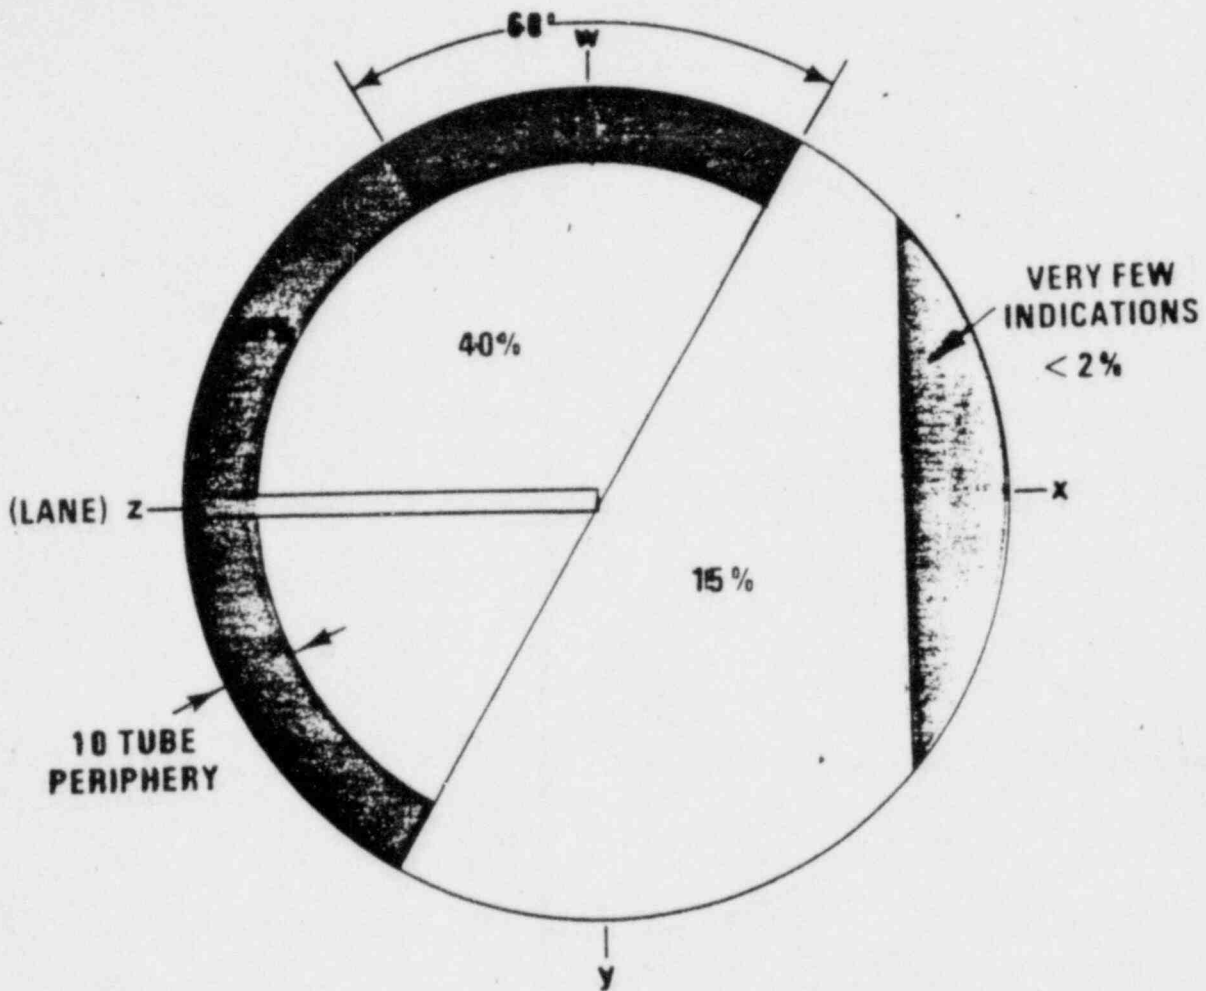
OTSG-B

Potentially Defective Tubes  
(Projection of Eddy Current Data)

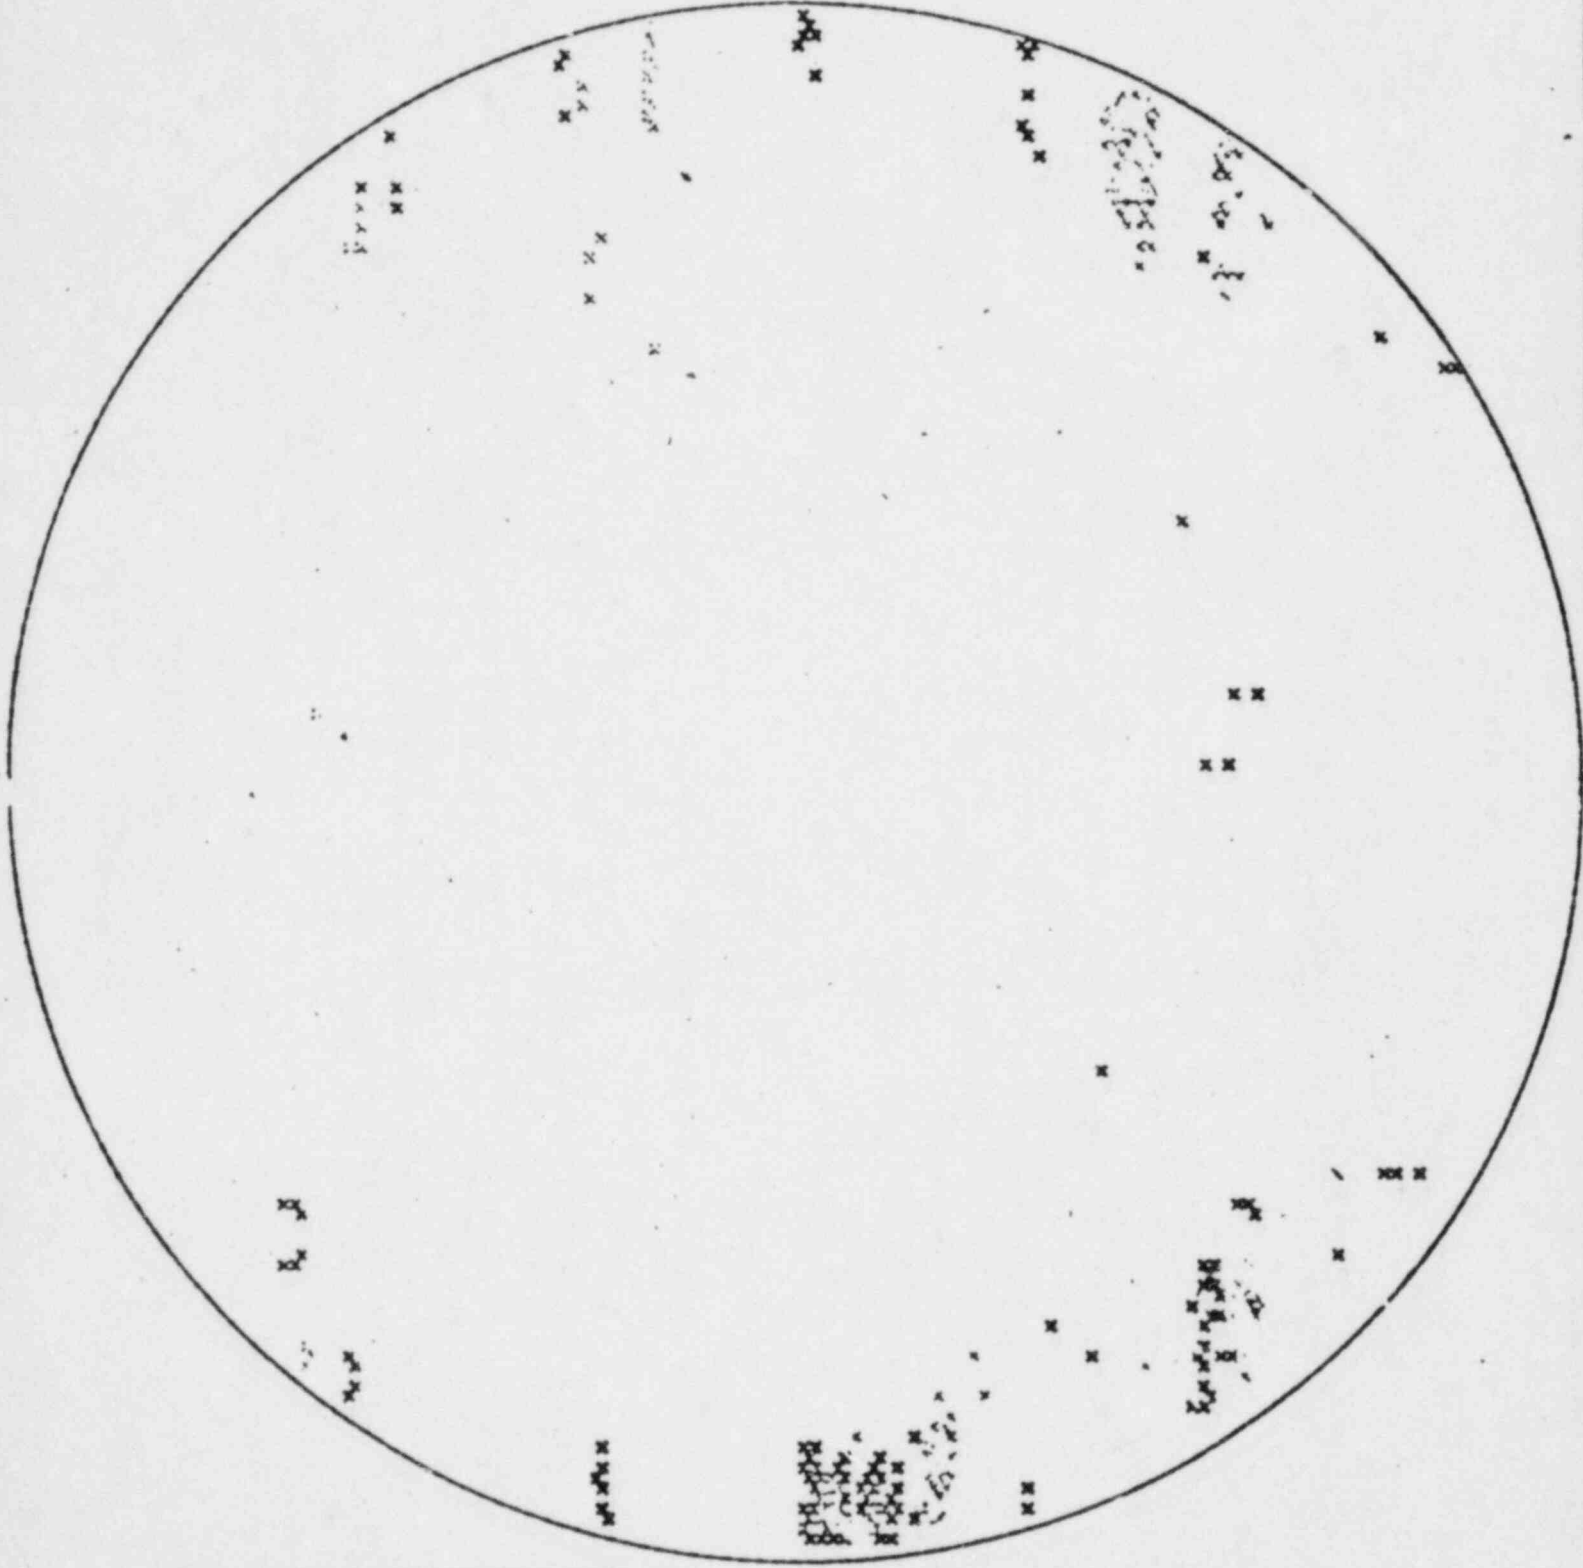
THREE MILE ISLAND NUCLEAR  
GENERATING STATION  
UNIT 1 STEAM GENERATOR A

TUBE LOCATIONS FOR DEFECTIVE TUBES  
FOR TUBE HEAT NUMBERS  
K2328  
K2562

- o TUBE FAILURES ARE ASSOCIATED WITH SPECIFIC LOCATIONS IN THE GENERATOR NOT HEAT RELATIONSHIPS.
- o THE DEFECT PATTERNS IN THE TWO GENERATORS ARE DIFFERENT AND THIS WILL NEED TO BE EXPLAINED BY A PARAMETER OTHER THAN HEAT NUMBER.
- o HEATS OF MATERIAL EXIST WHICH HAVE HIGH DEFECT FREQUENCIES IN BAD AREAS AND THE SAME HEATS WILL HAVE LOW DEFECT FREQUENCIES IN GOOD AREAS.

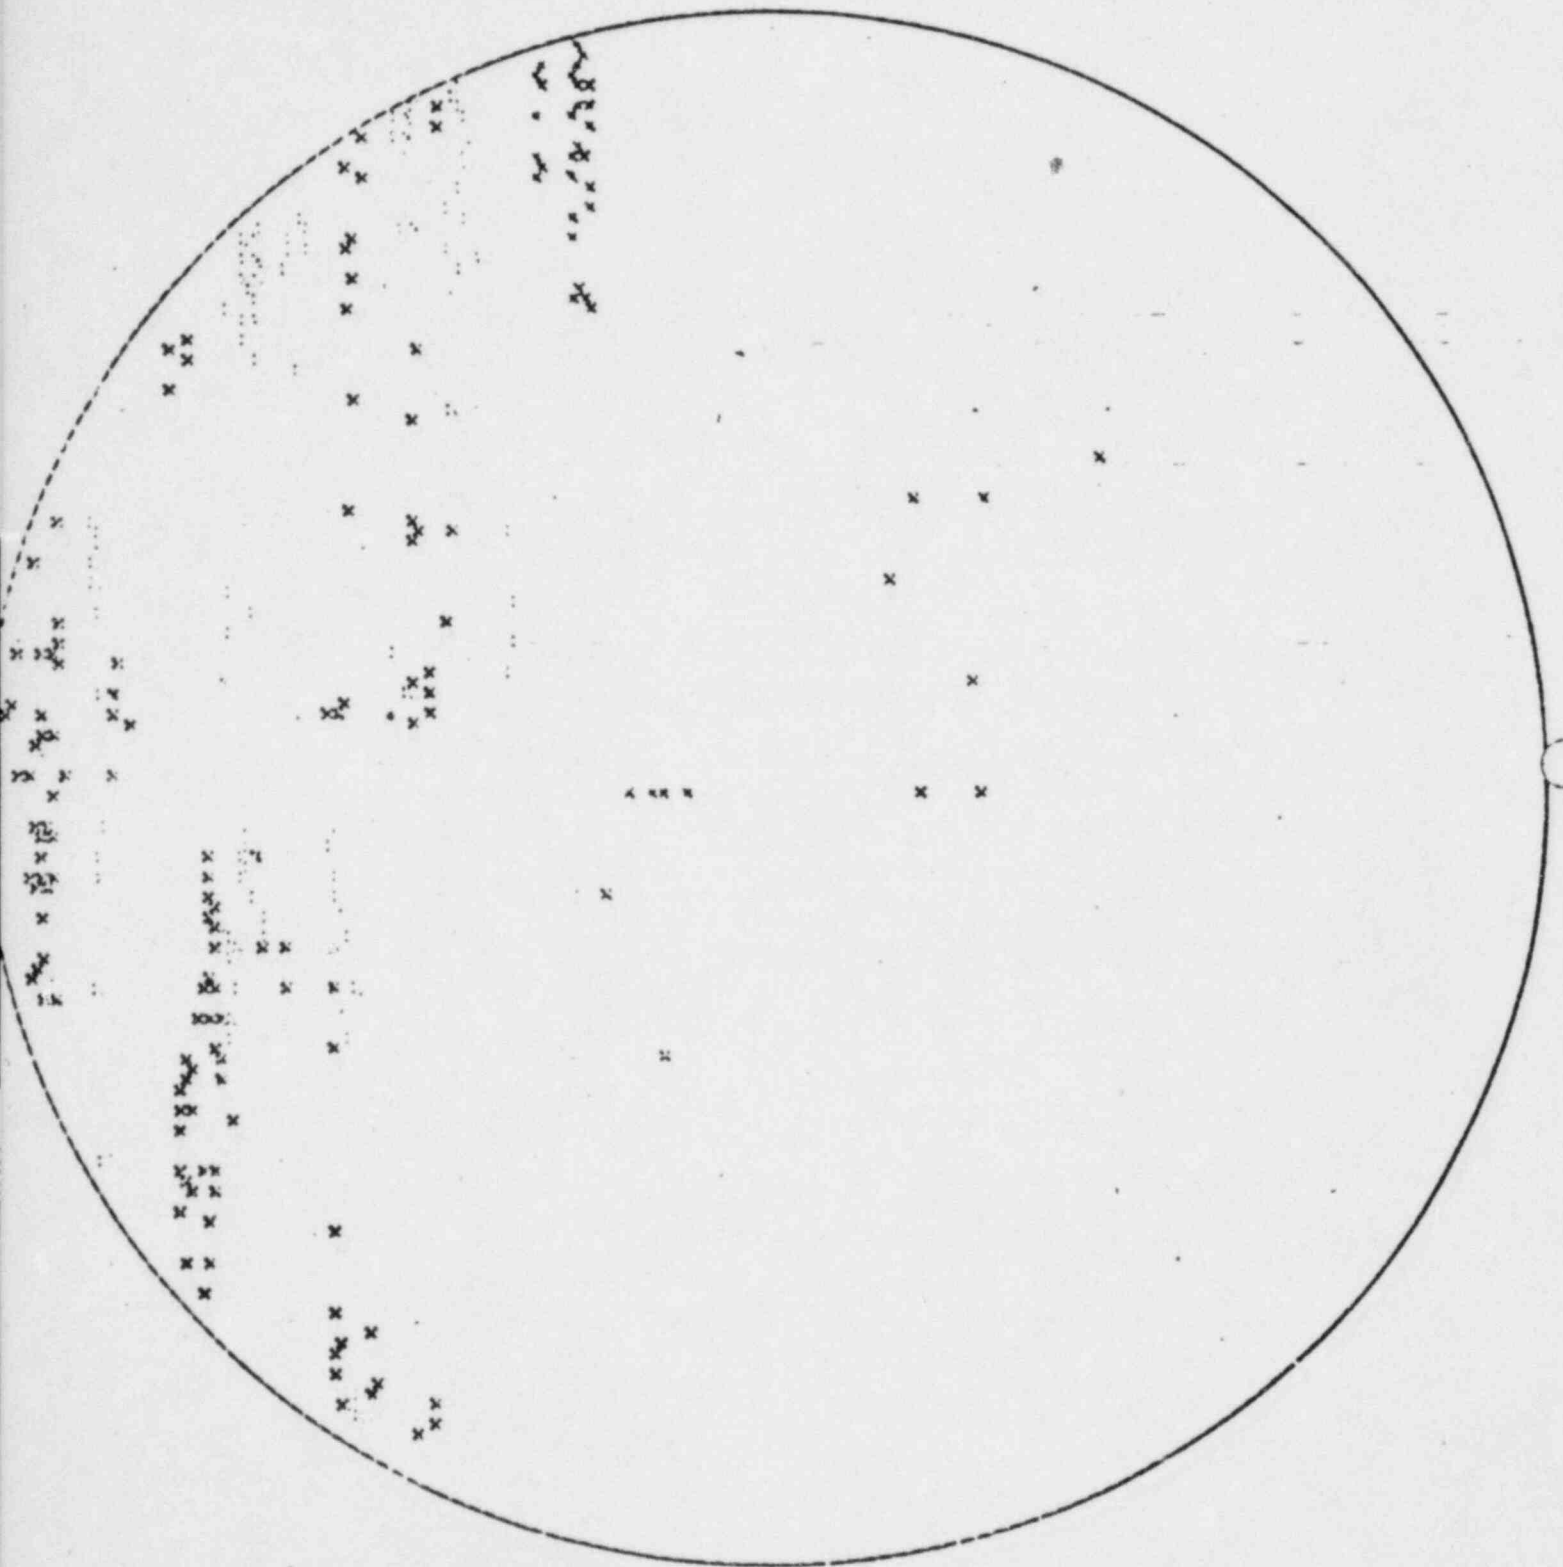
THREE MILE ISLAND NUCLEAR  
GENERATING STATION  
UNIT 1 STEAM GENERATOR B

TUBE LOCATIONS FOR DEFECTIVE TUBES  
FOR TUBE HEAT NUMBERS

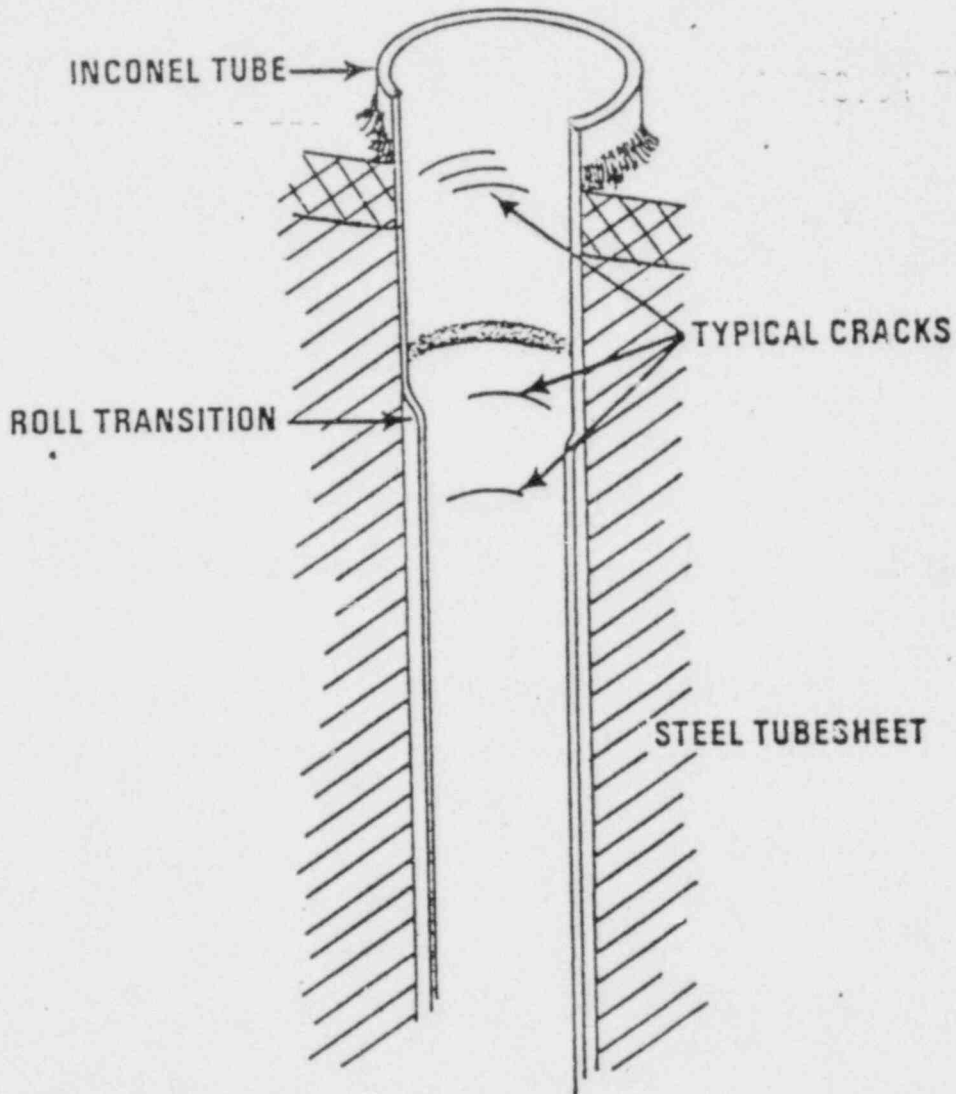
# TMI-1 Steam Generator Typical Cracks

CRACK CHARACTERISTICS: CIRCUMFERENTIAL  
NOT FULL ARC  
GENERALLY VERY TIGHT  
INSIDE INITIATED

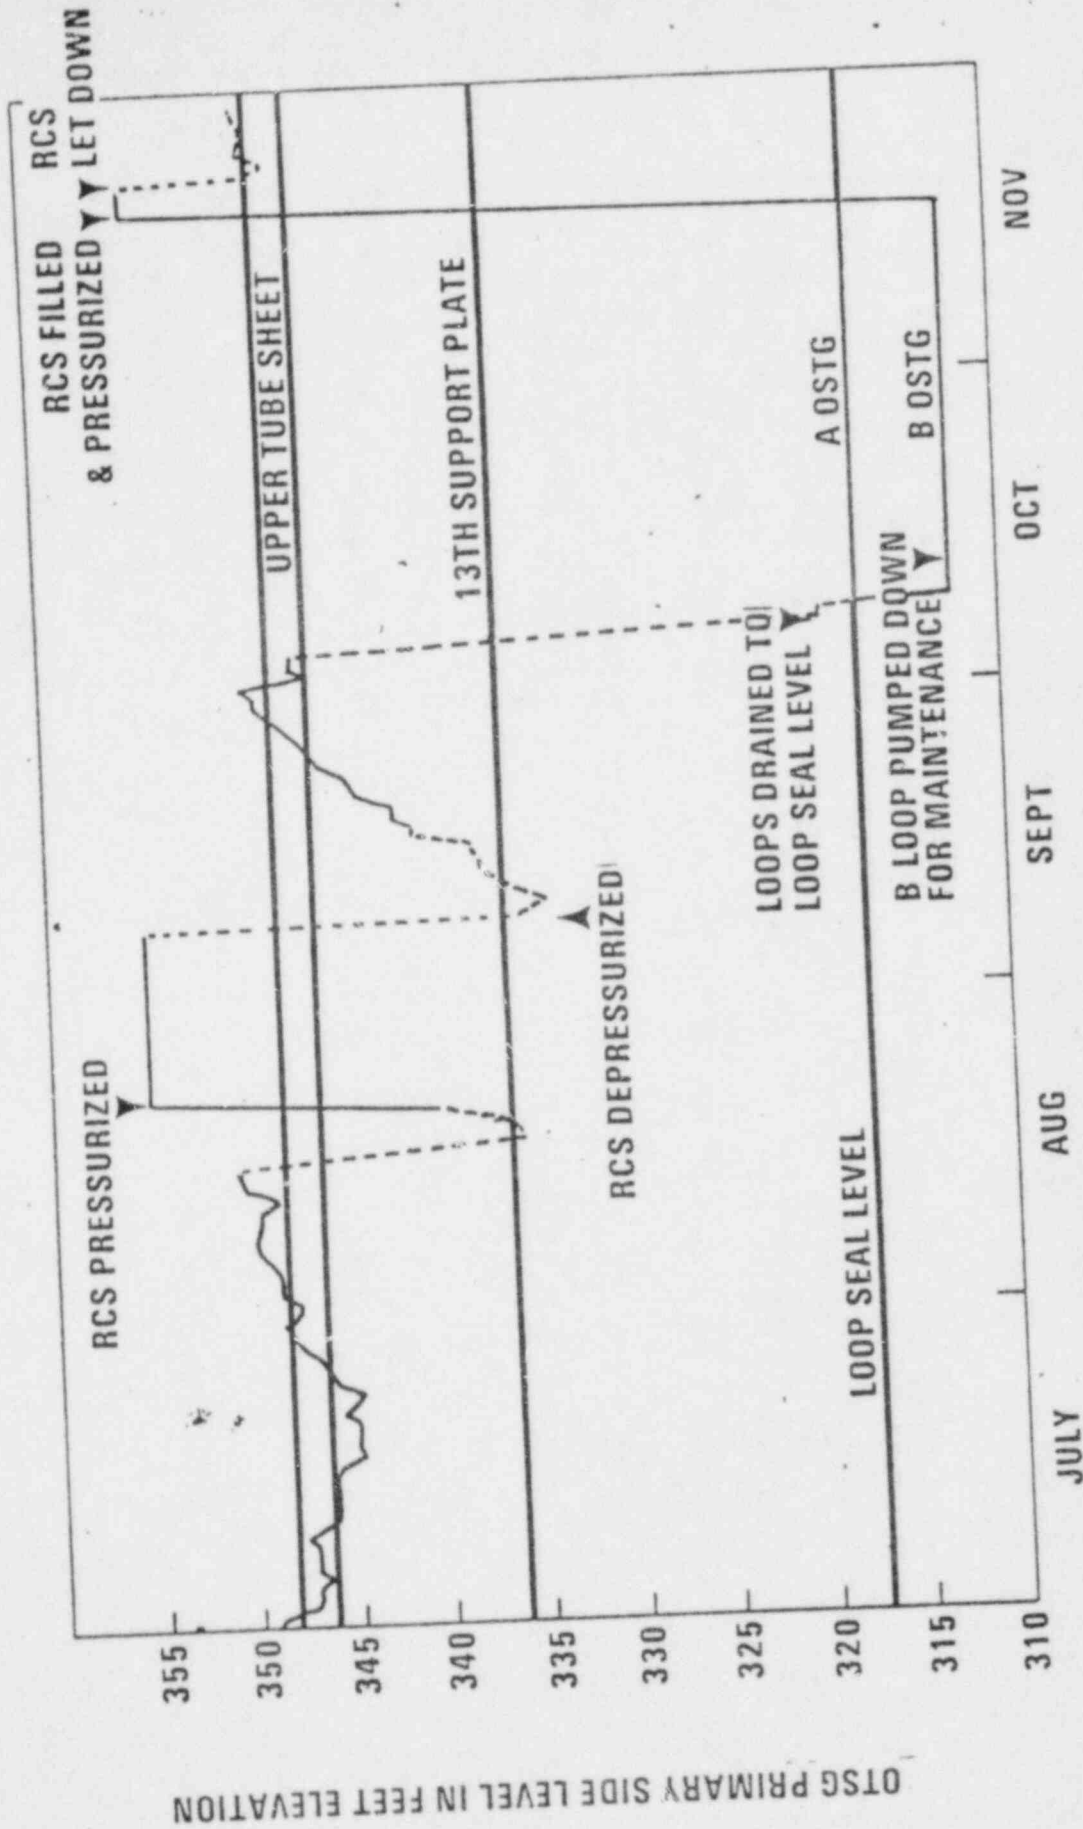
# OTSG Level July 1981 — November 1981

DOTTED LINE MEANS ESTIMATED LEVEL  
VENTING ARRANGEMENT CAUSES UP TO 27" ERROR

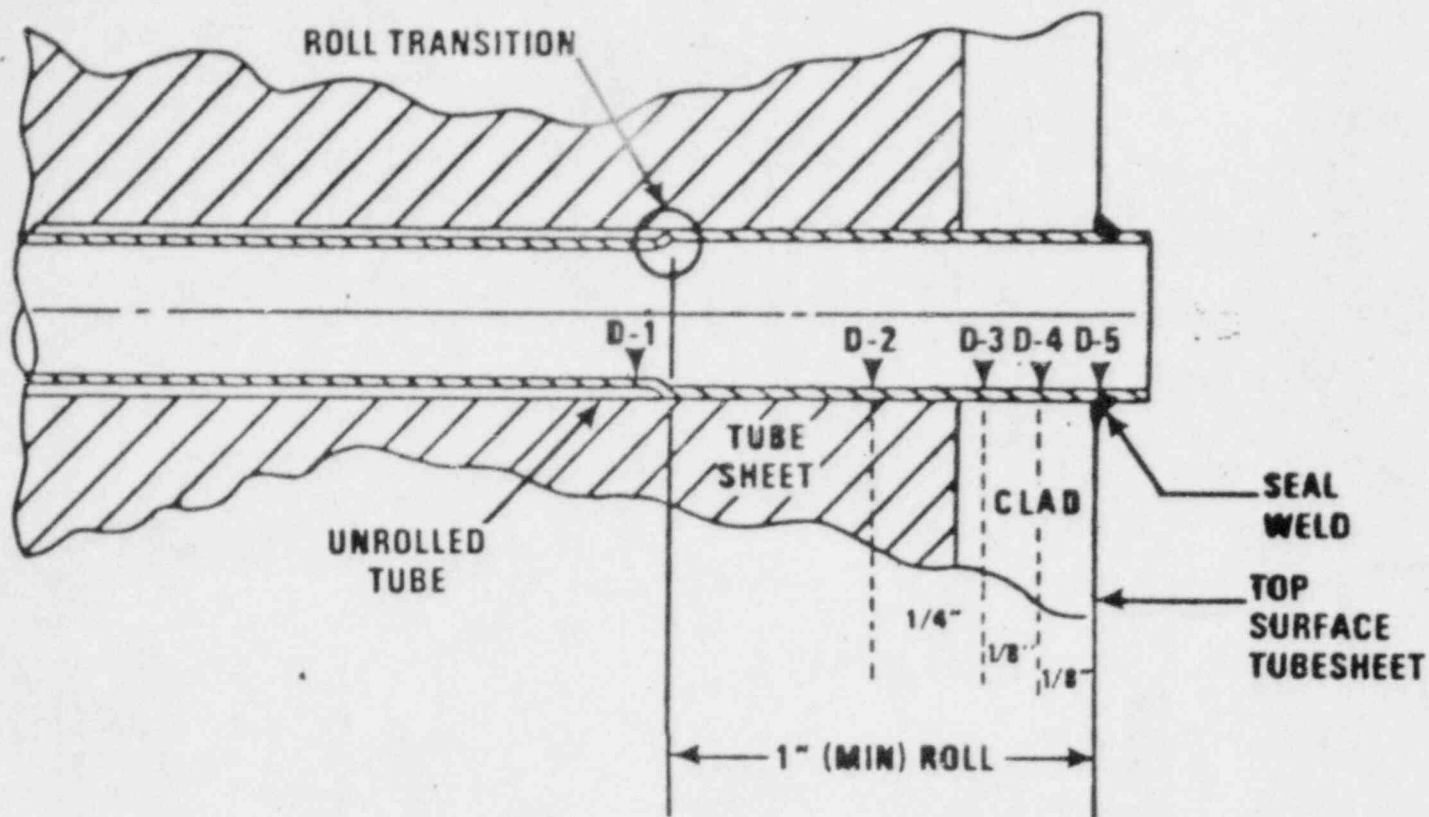
## Eddy Current Defect Mockup Absolute Technique Qualification

- Defects # 1 thru 5 (D1 – D5) are ID defects located as shown
- Extent of defects varied from 20% thru 100% of tubing wall thickness – defects are 3/16 inch long (EDM notches)
- 40% and greater defect depths were detected
