B&W OWNERS GROUP

BOLTING TASK FORCE

SUMMARY REPORT OF
NUCLEAR REGULATORY COMMISSION/
BABCOCK & WILCOX OWNERS GROUP
MEETING ON
REACTOR VESSEL INTERNALS BOLTING
MAY 6, 1983

SUMMARY REPORT OF
NUCLEAR REGULATORY COMMISSION /
BABCOCK & WILCOX OWNERS GROUP
MEETING ON
REACTOR VESSEL INTERNALS BOLTING
MAY 6, 1983
BAW 1784

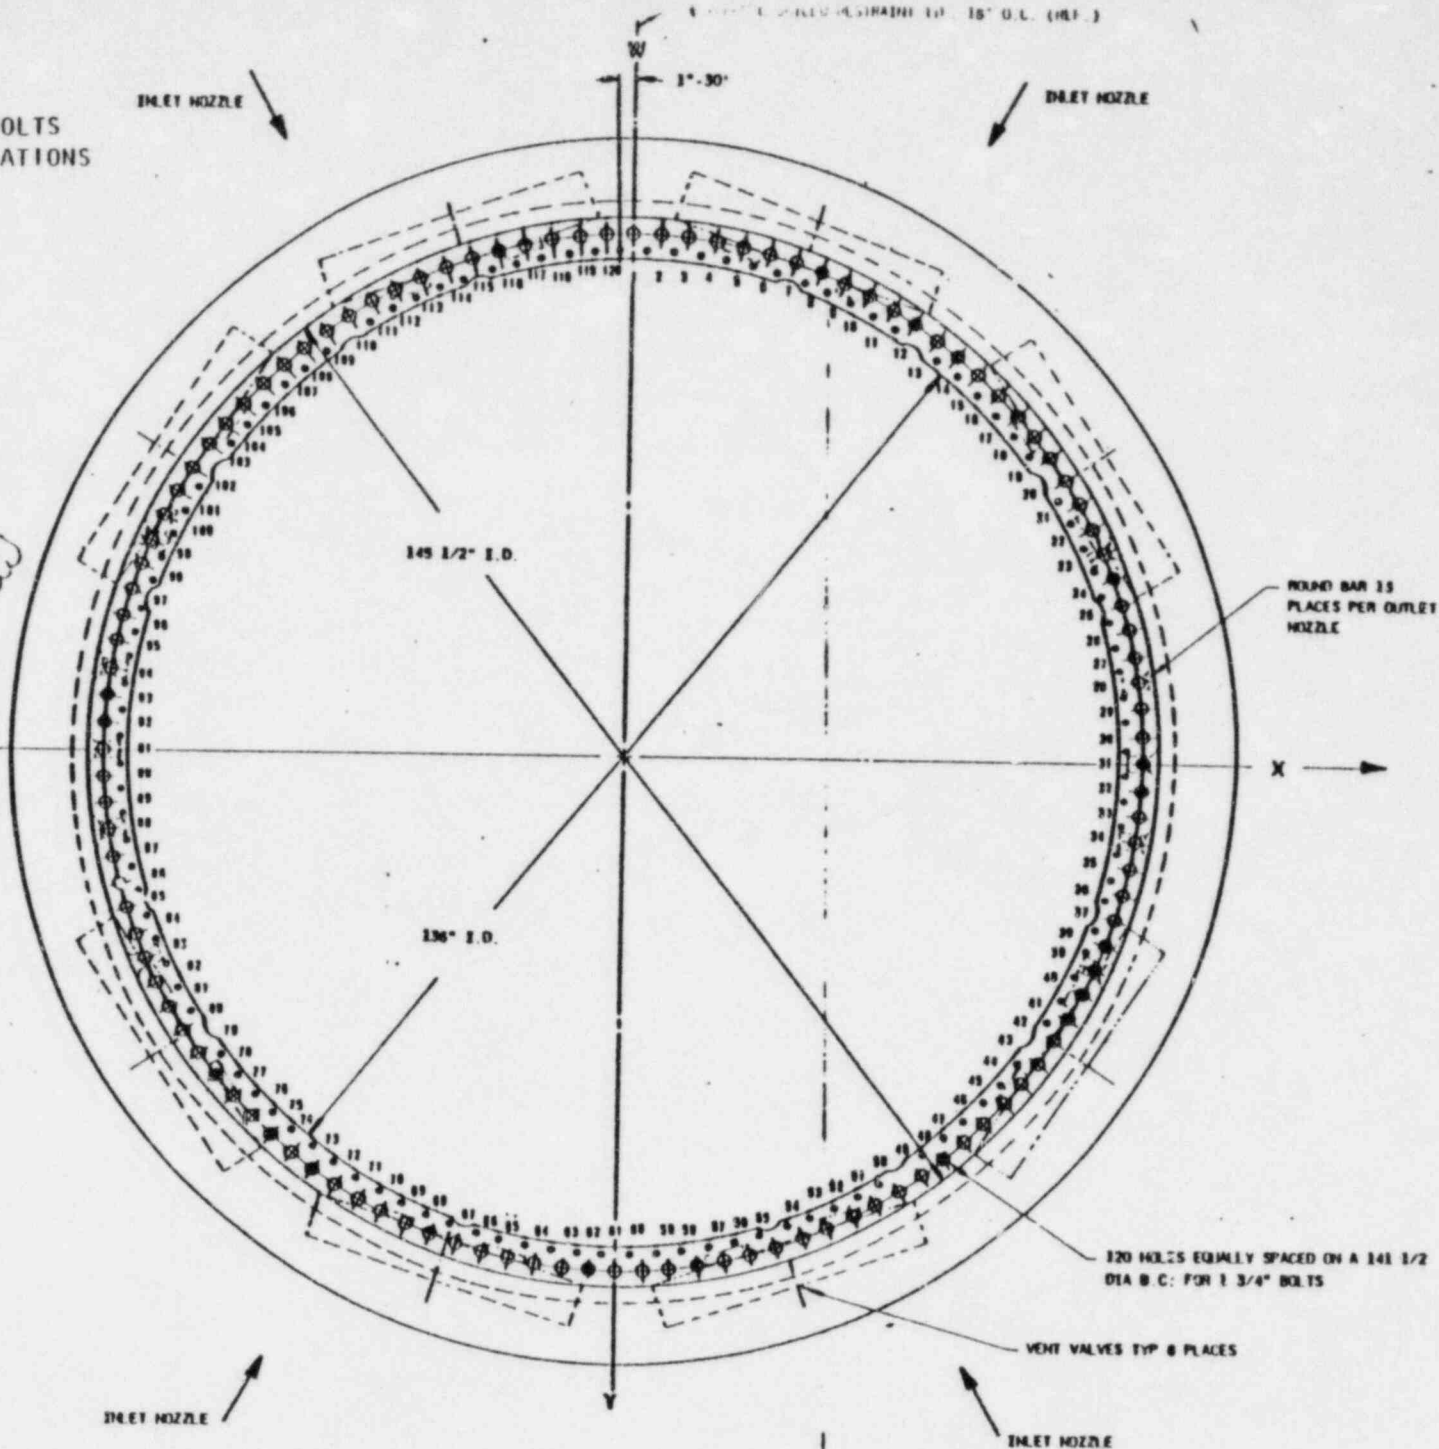
FIG. 3.1

Good Bolt Sample 79

Denotes bolts sent
for Laboratory
Examinations

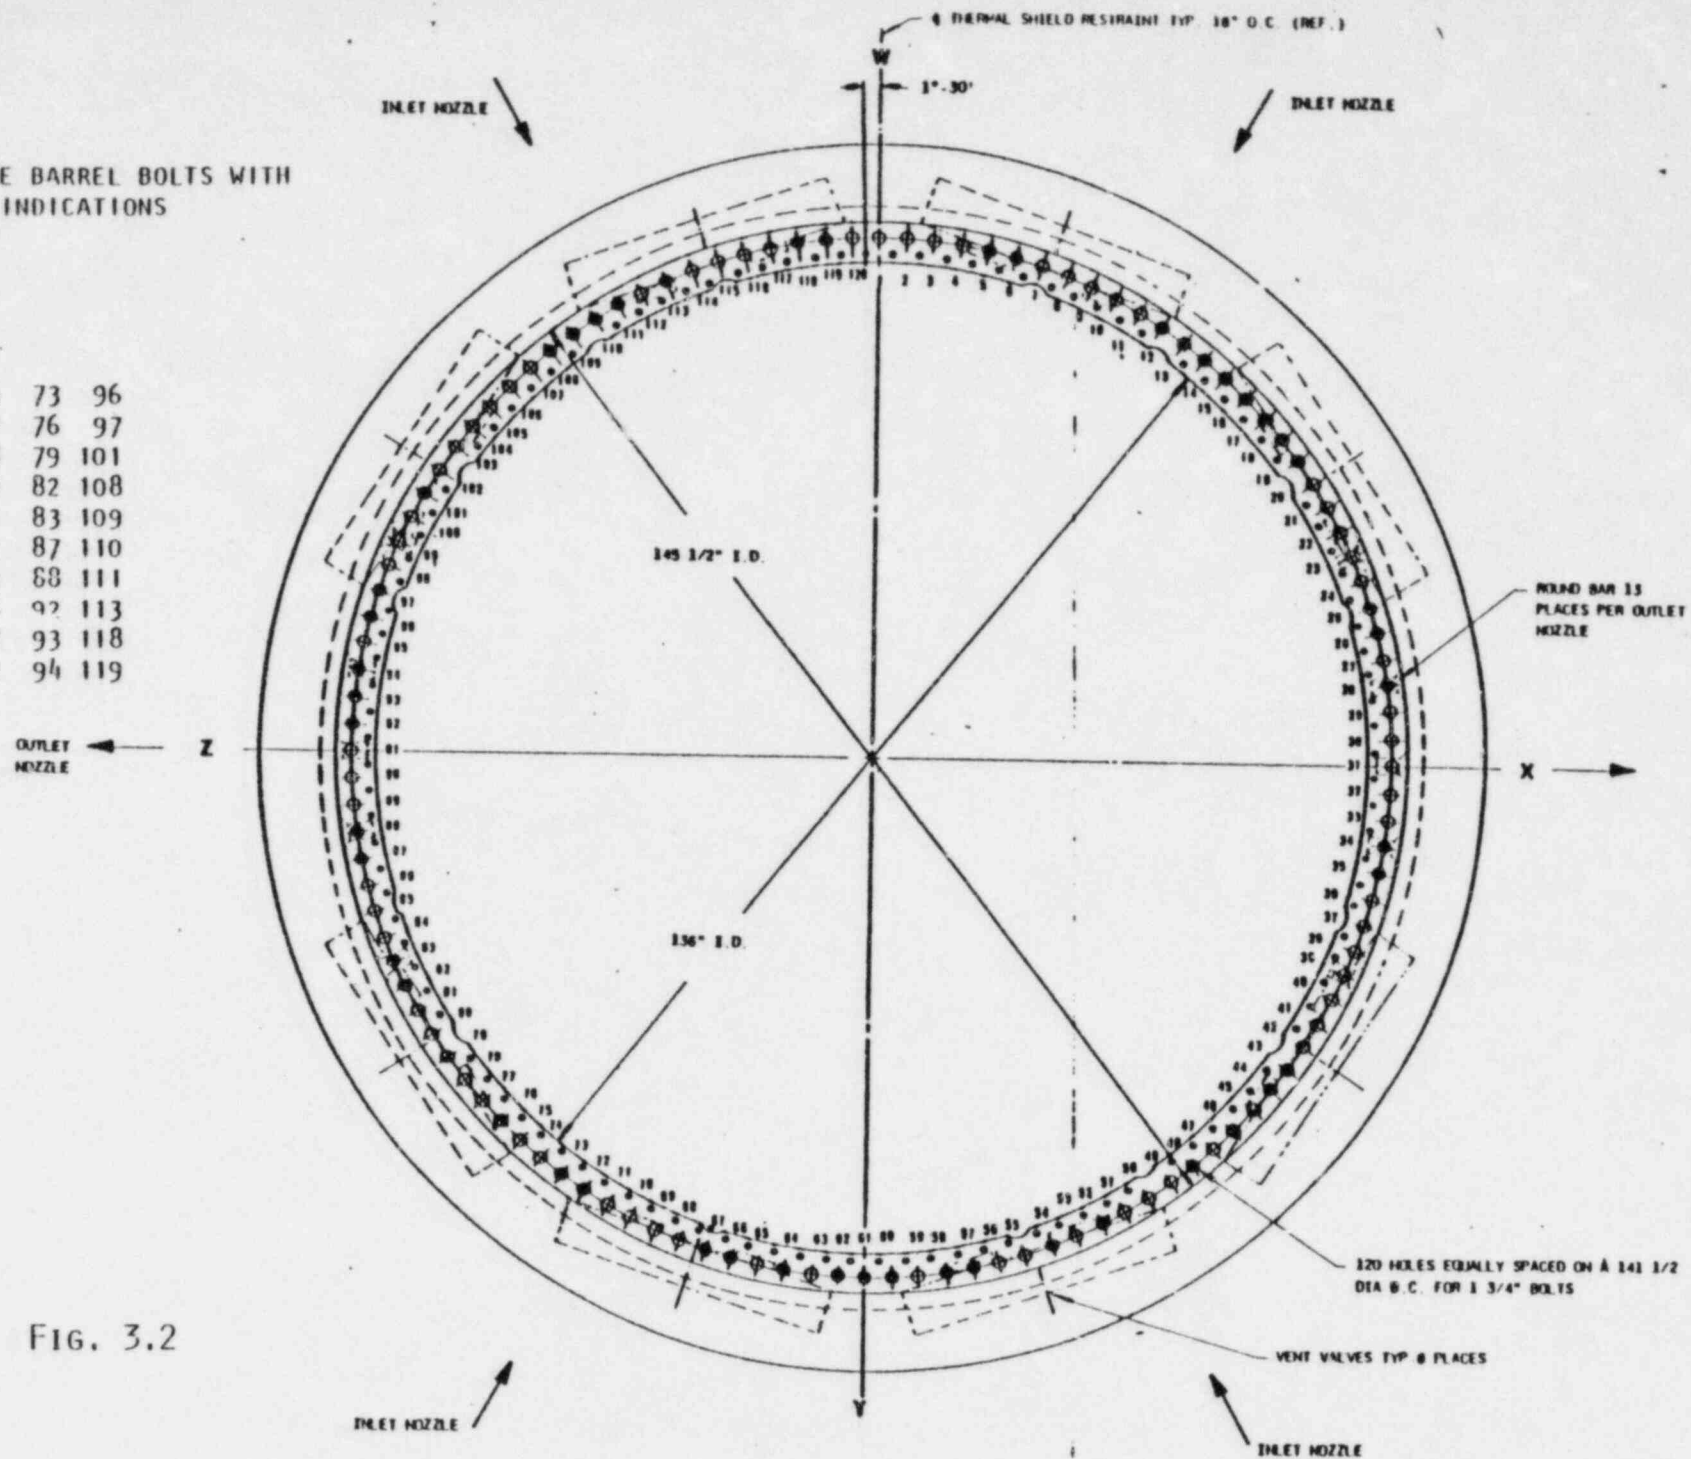
FIG. 3.2

5	25	54	73	96
6	26	57	76	97
12	28	58	79	101
13	34	60	82	108
14	35	61	83	109
15	43	62	87	110
16	44	64	88	111
17	46	66	92	113
18	48	67	93	118
19	52	72	94	119

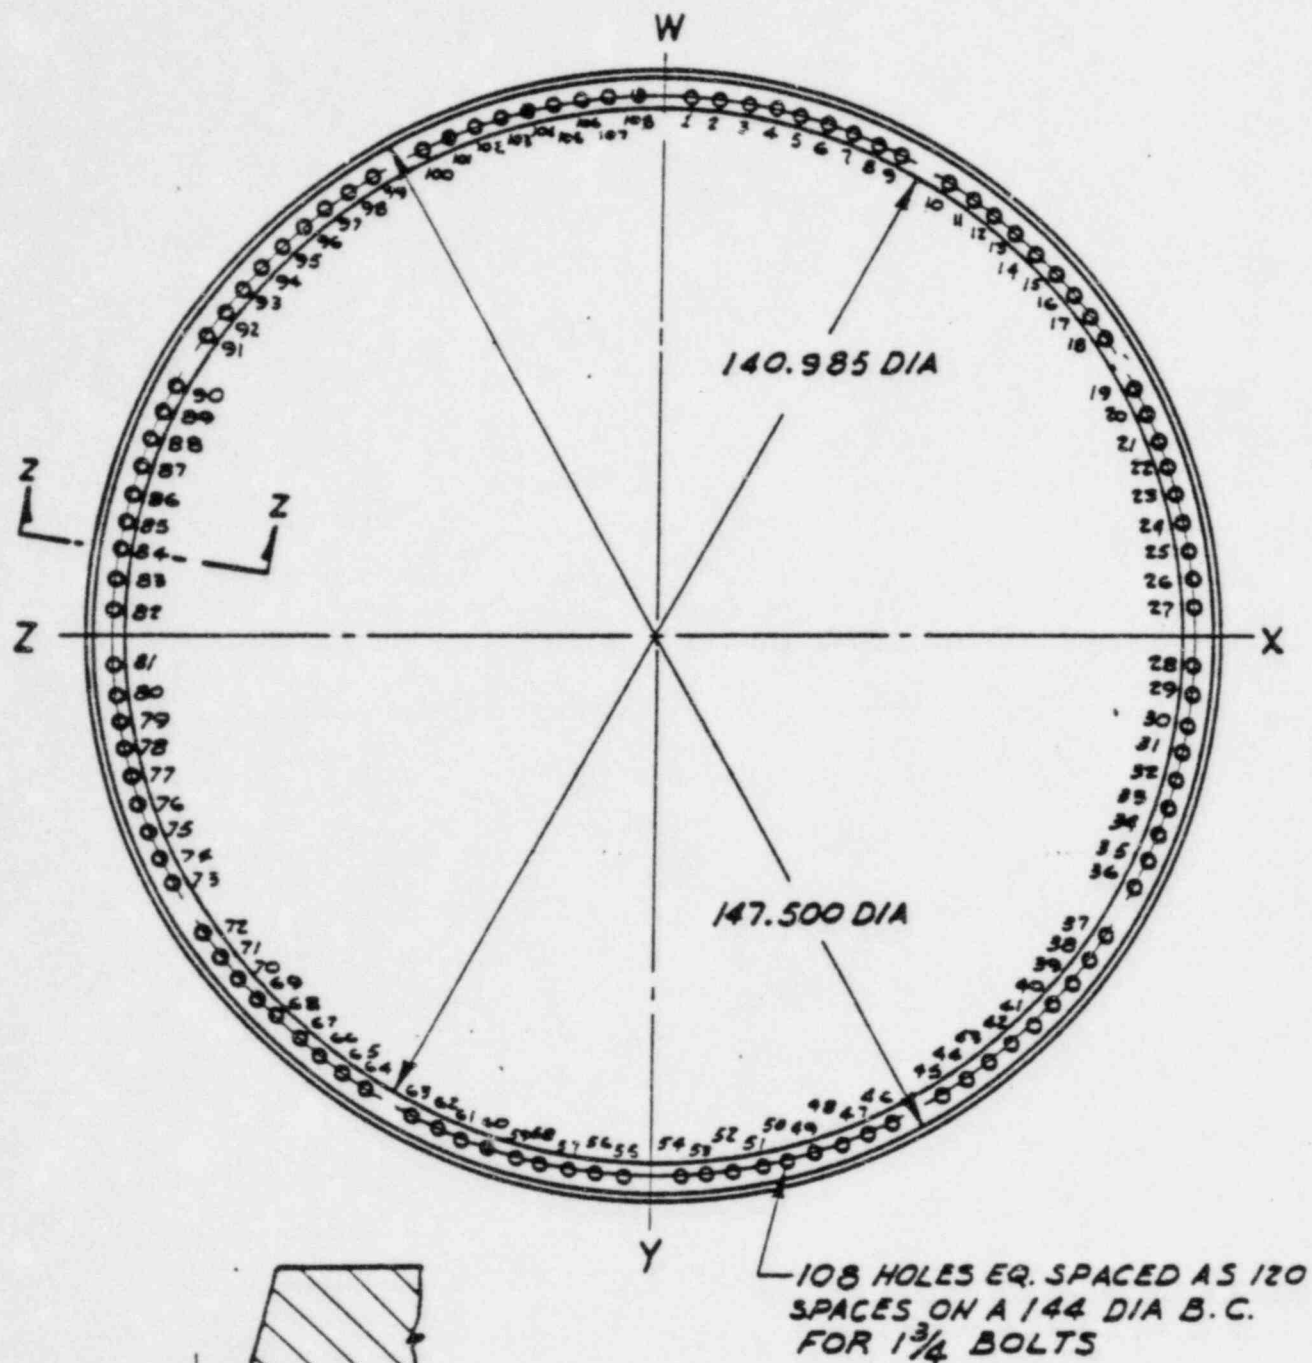
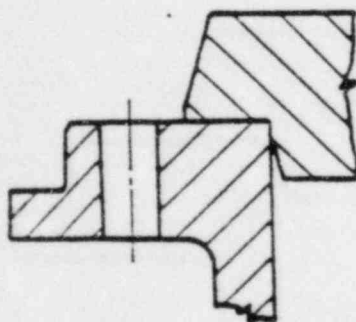
FIG. 3.3

**CORE BARREL/LOWER GRID BOLT LOCATIONS
CRYSTAL RIVER-3**

BOLTS WITH ABNORMAL INDICATIONS

60
101
104
108

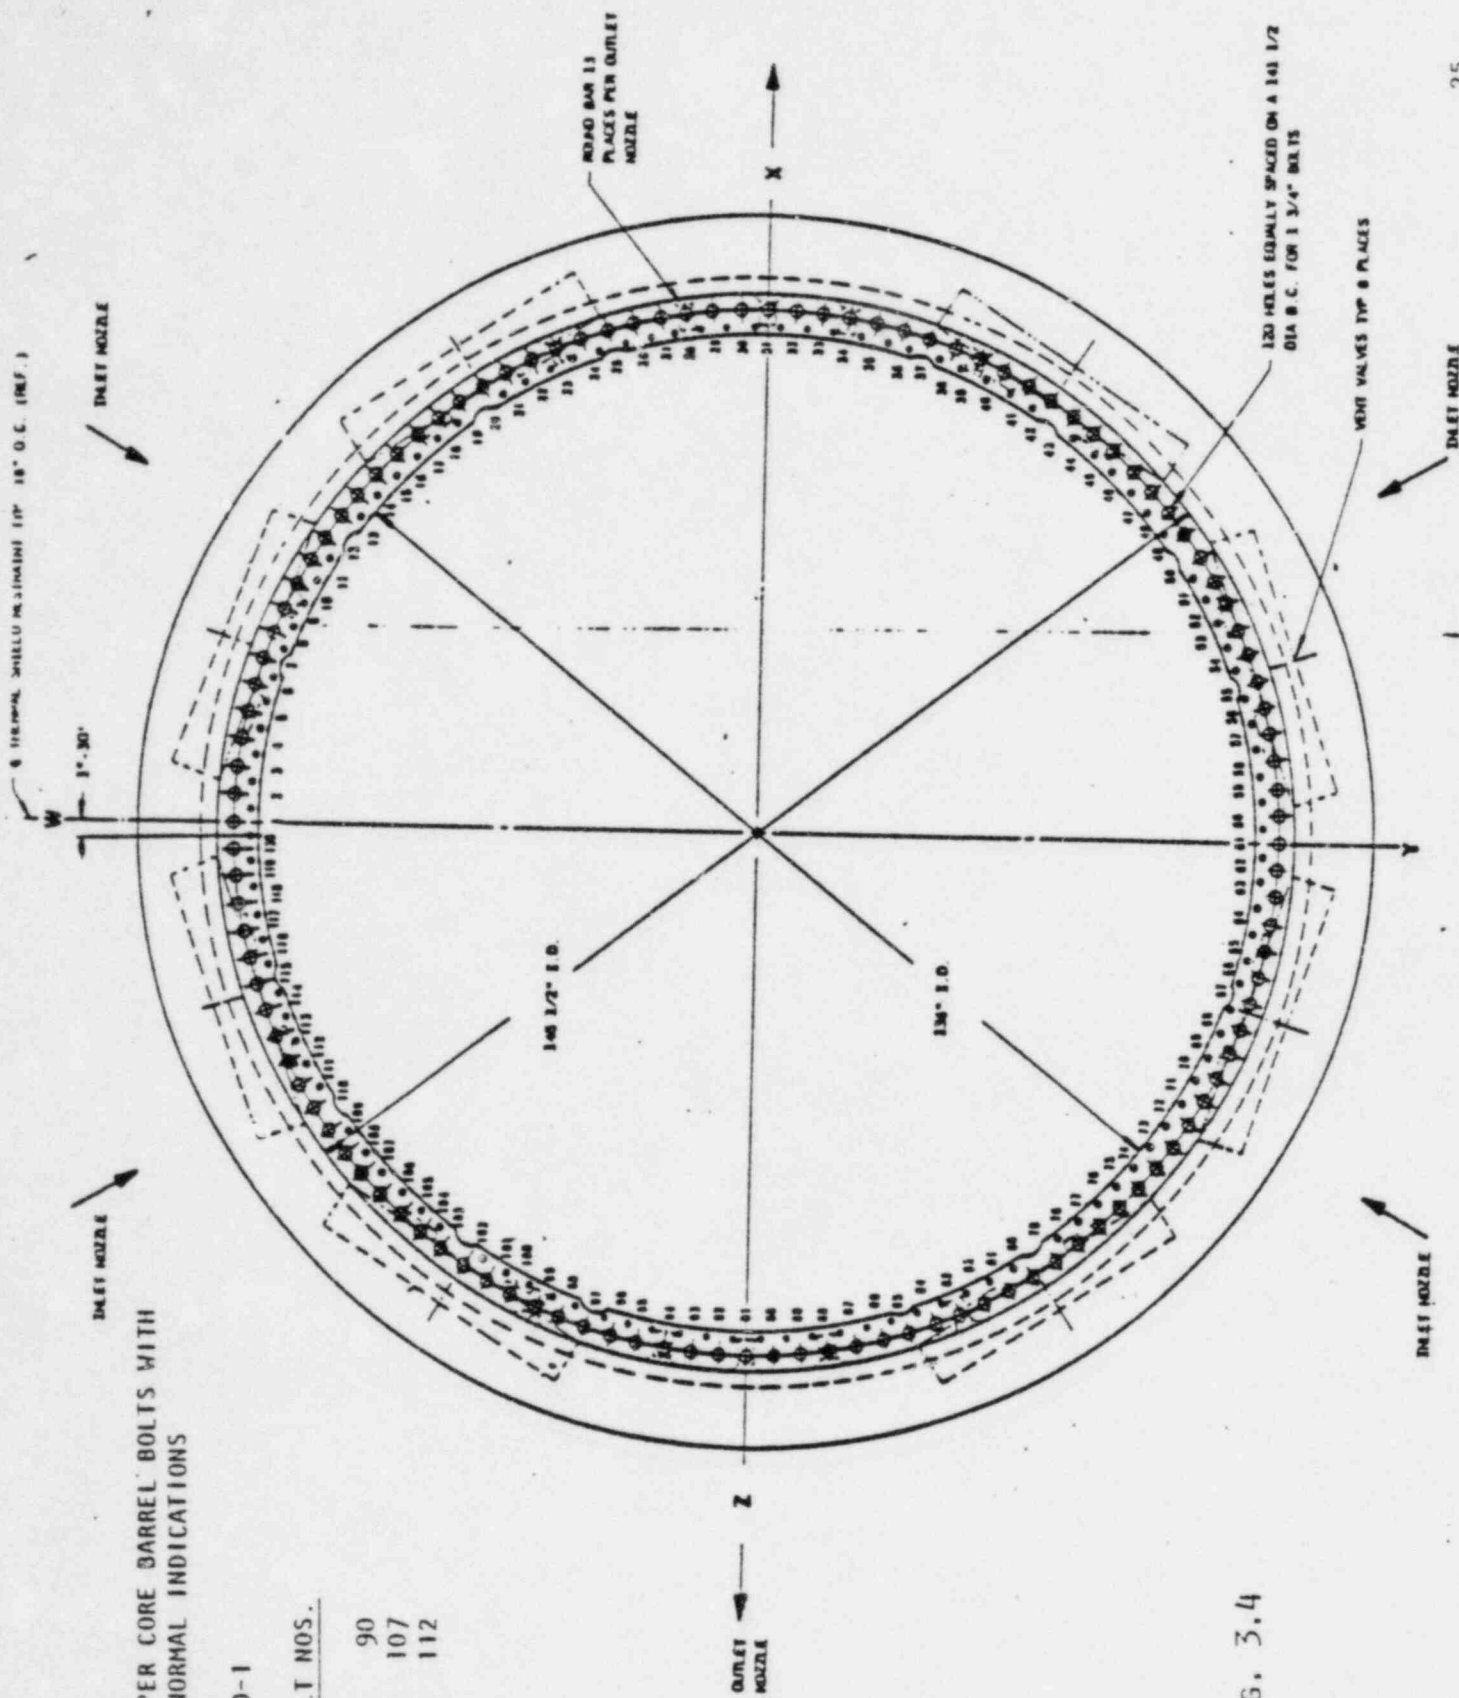
FIG. 3.4

ANO-1 prolonged their present refueling outage to UT inspect their upper core barrel bolts. Only 7 UT indications were noted. These favorable results together with the large structural margins in the UCB/LCB bolt rings justify restart without repair or further inspections. In addition, Arkansas is installing neutron noise analysis equipment and will periodically monitor the signature to insure satisfactory behavior. Also supporting this judgement will be the increasing data base for understanding the bolting failures that will be obtained from near term inspections performed for Davis Besse and the Oconee units.

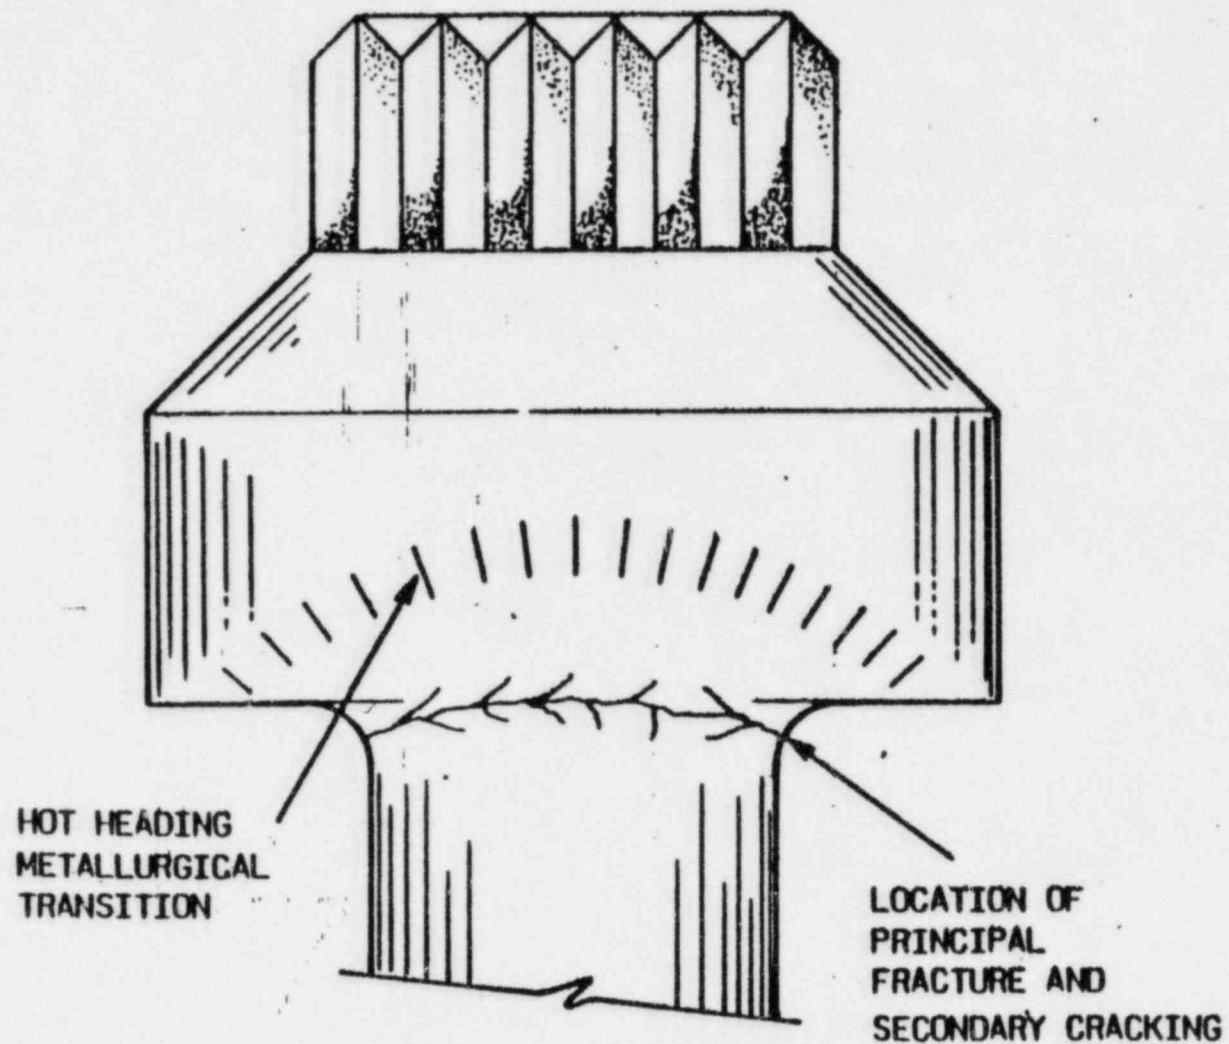
FIG. 3.5

The results of the examination of the two cracked bolts showed both bolts to have cracking initiated in the head to shank transition region similar to that found in the lower thermal shield bolts and that the cracking propagated through 95% of the shank area (see Figure 3.5) the cracking noted was typical of intergranular fracture and showed extensive secondary cracking.

These results led to the conclusion that Rancho Seco UCB failures are typical of previously noted LTS bolt failures. It was also judged that the flaw in the bolt that showed no indications by site UT was an anomaly not associated with the other bolt failures and is metallurgically inert showing no evidence of cracking or propagation and no significant loss of load carrying capability.

SKETCH OF UPPER CORE BARREL BOLT
SHOWING LOCATION OF FRACTURE

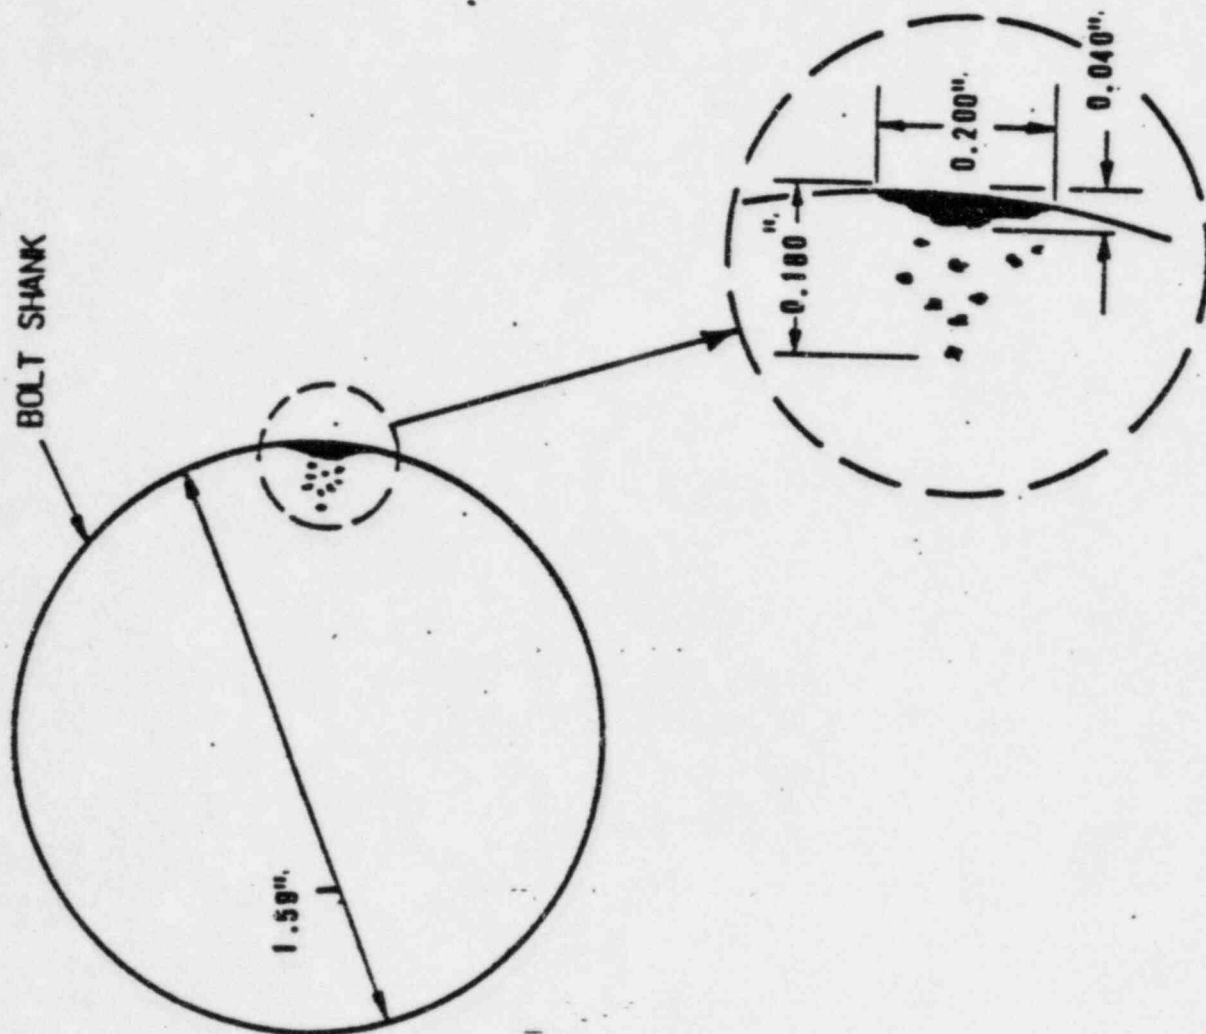
Fig. 3.6

Bolt 79, the bolt showing no indications by field UT, was fluorescent penetrant tested and SEM/EDX examined. Small flaws containing localized deposits were noted in the upper shank region, see Figure 3.6. The surfaces between the flaws opened by ductile rupture when pulled apart. The flaw was not intergranular in nature and showed no secondary cracking. The flaw size was well below the minimum 15% site UT calibration standard and, therefore, would not be expected to be noted by the field UT examination.

RANCHO SECO UPPER CORE BARREL
BOLT #79

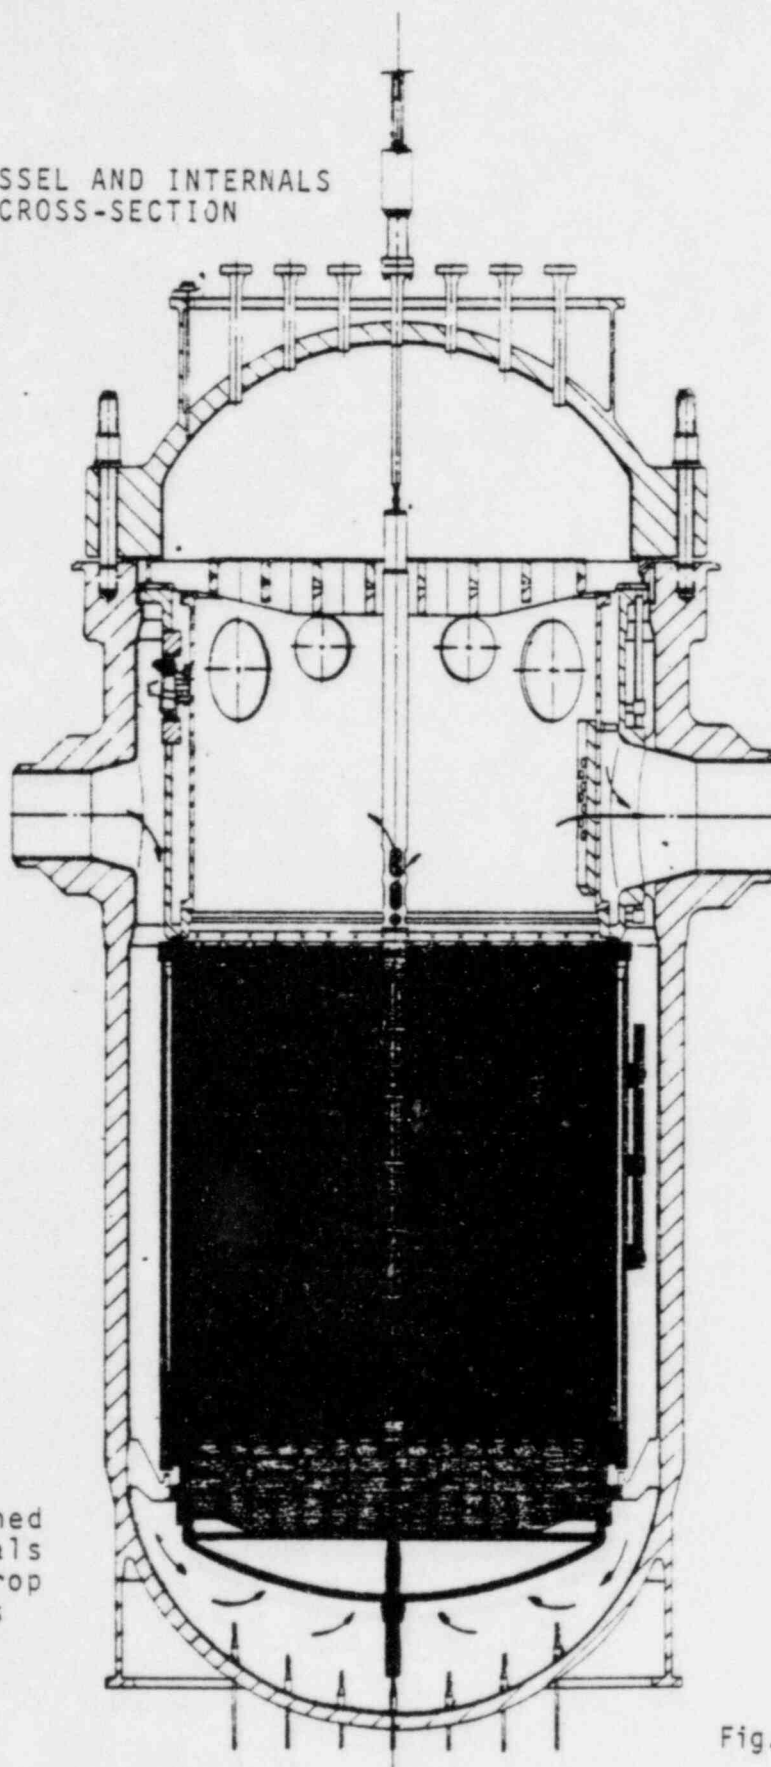
Fig. 4.1

With UCB Joint
failure blackened
part of internals
and the core drop
onto guide lugs

The consequences of both upper and lower core barrel joint failure have been assessed. Upper core barrel joint failure during normal operation will cause the core to drop .54" (the gap present at normal operating conditions) onto the reactor vessel guide lugs. Figure 4.1 shows a cross-section of the core and internals with the darkened portion representing components that would drop on UCB joint failure and Figure 4.2 shows the UCB bolt and joint detail in the failed condition.

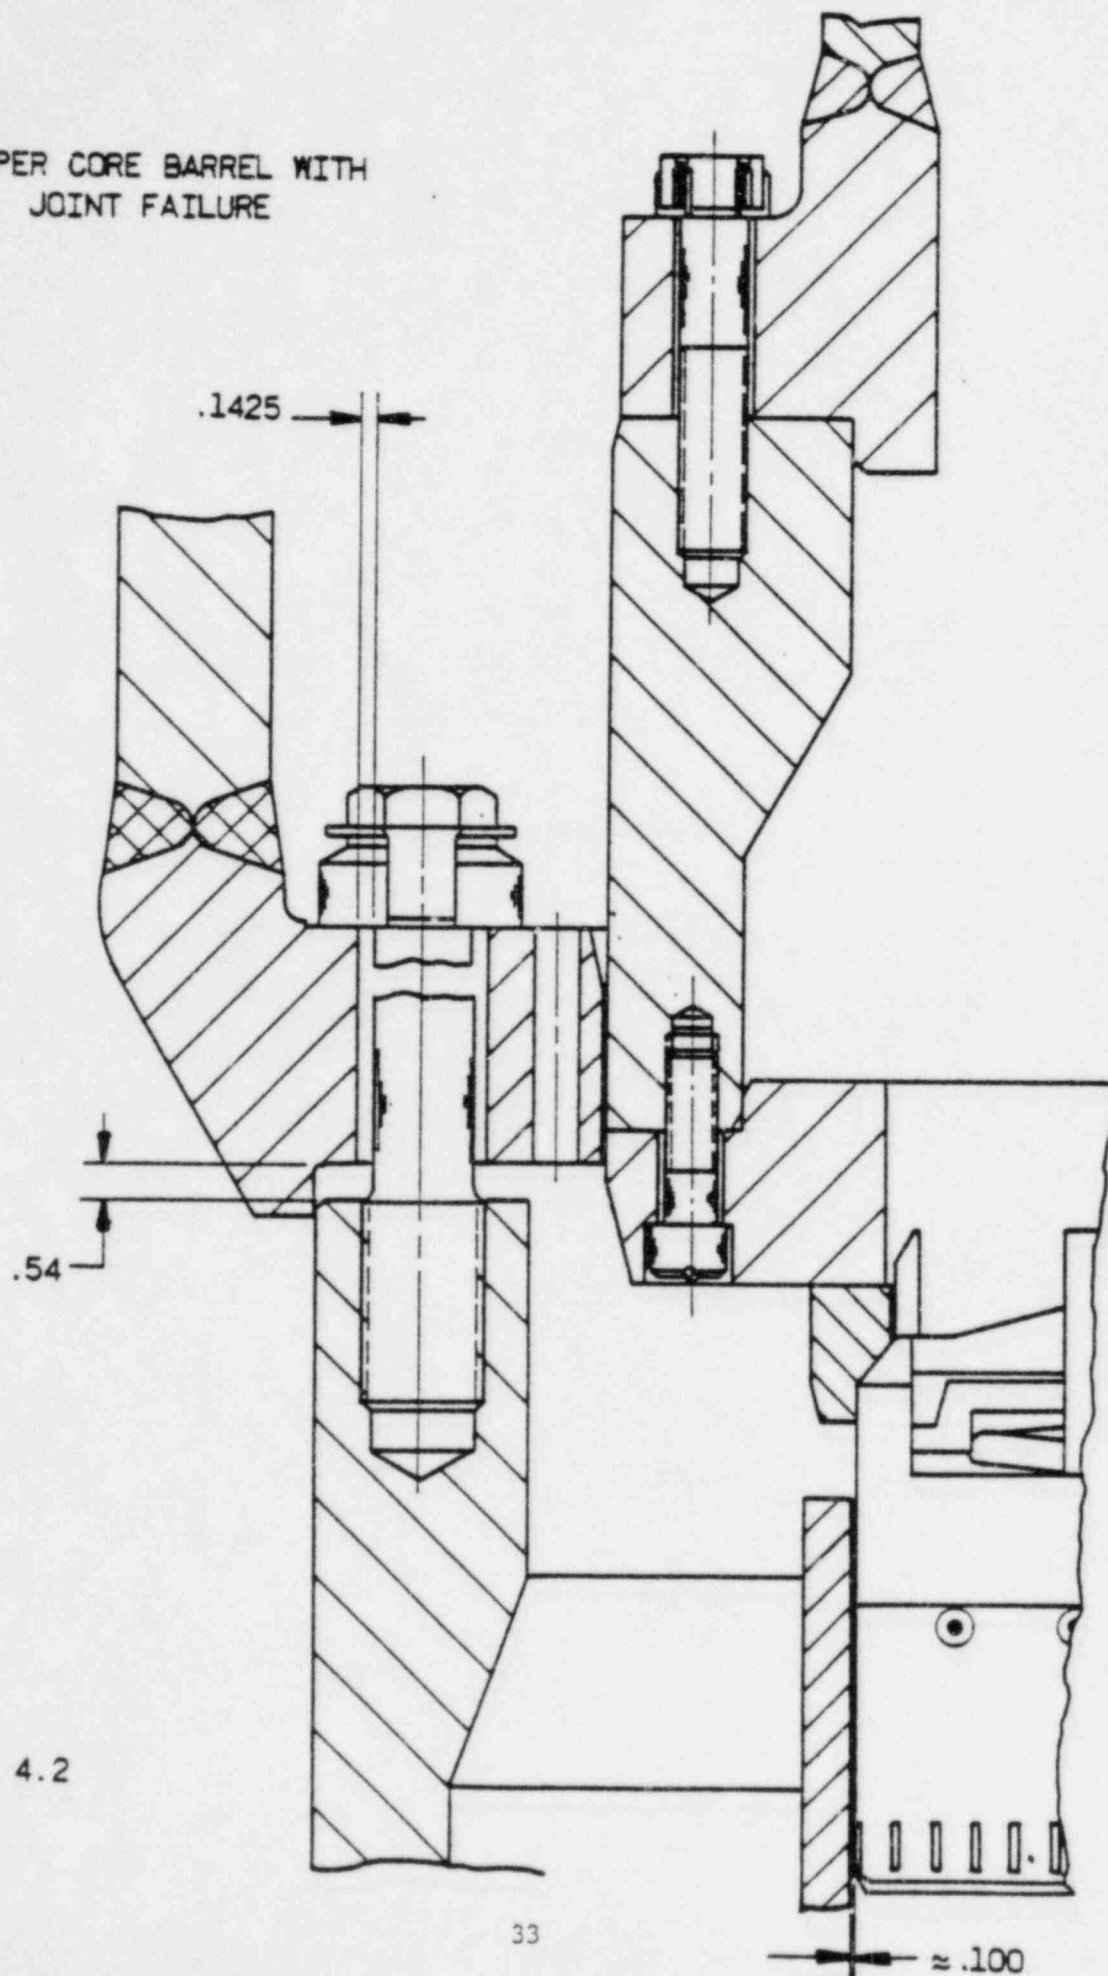
Fig. 4.2

UPPER CORE BARREL WITH
JOINT FAILURE

After core drop, the bolt heads would be held in place by the locking clips, thus precluding becoming loose parts and the bolt shanks would remain captured within the core support shield bolt holes. The nominal radial clearance between the bolt shank and the bolt hole is 0.142". While there may be some damage to peripheral fuel assemblies by contact between the baffle plate and upper end fitting of the fuel assemblies, both lateral and rotation motion of the upper core barrel and core would be restrained by the bolt shanks and coolable core geometry would be maintained. Likewise the guide lugs and guide blocks with a 25 mil maximum (range 0.20-0.25 mils) clearance would provide similar restraint at the bottom of the core (See Fig. 2.7). In addition, the combination of bolt shanks at the upper end of the core barrel and guide lugs and guide blocks at the lower end would prevent core tilt in the dropped condition.

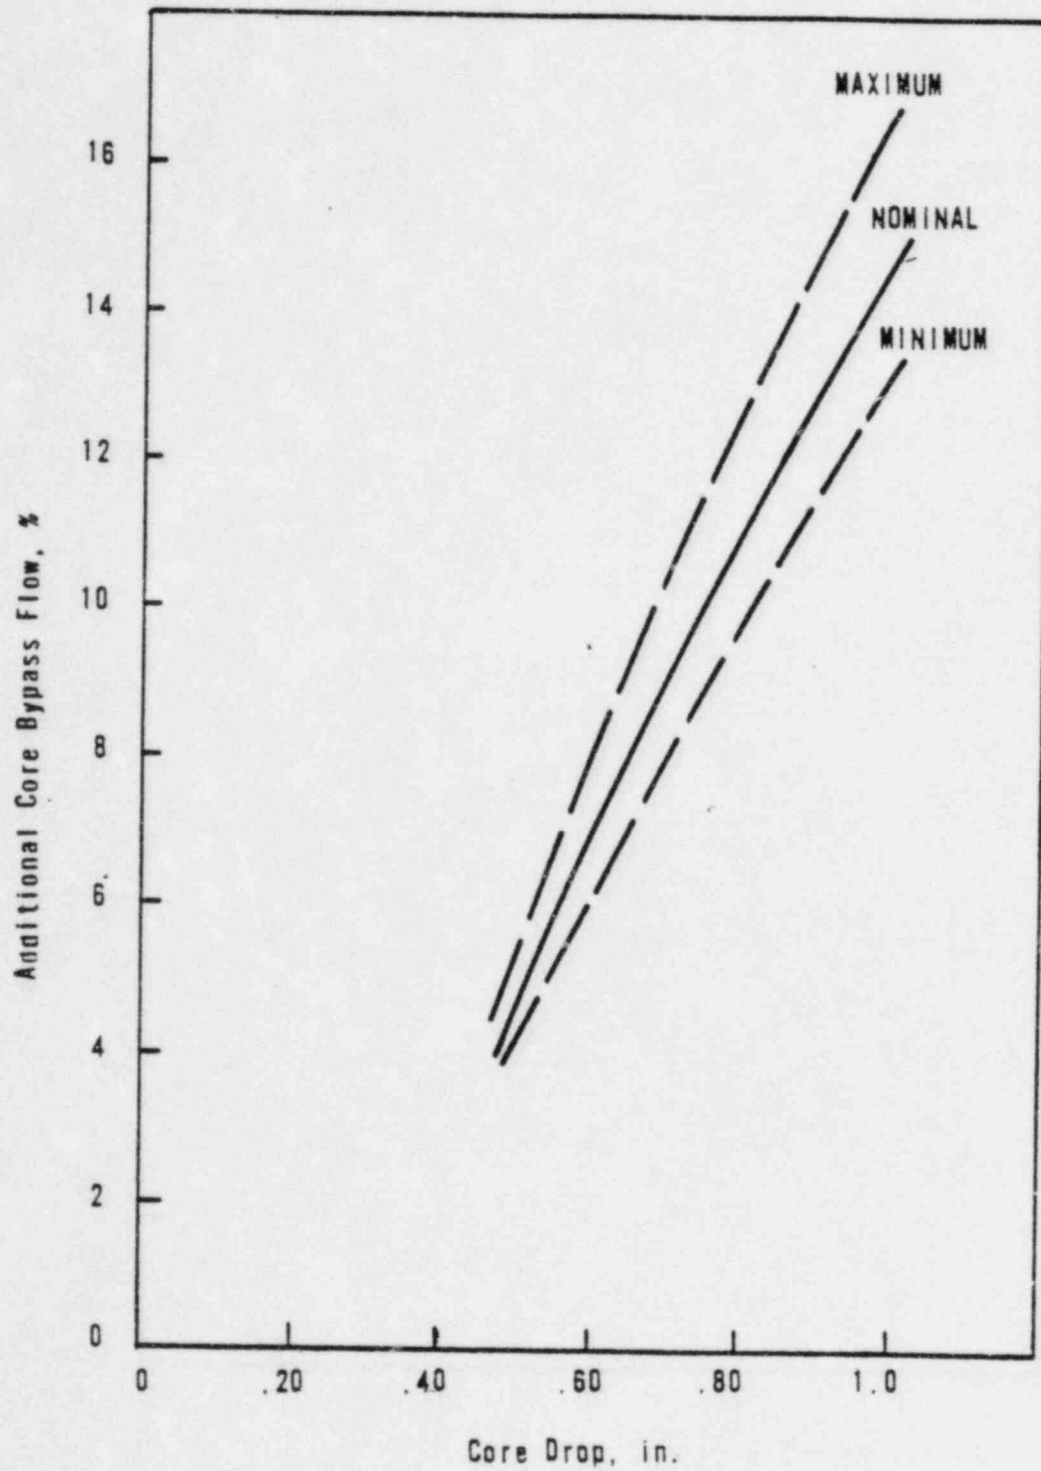
Fig. 4.3

With the core in the dropped condition, approximately 5% added bypass flow is predicted (see Figure 4.3) which is within existing thermal margins. The fuel assembly upper end fittings remain engaged in the upper grid assembly and since the control rods penetrate 6-1/2" into the fuel assembly guide tubes, control rod insertion would be possible.

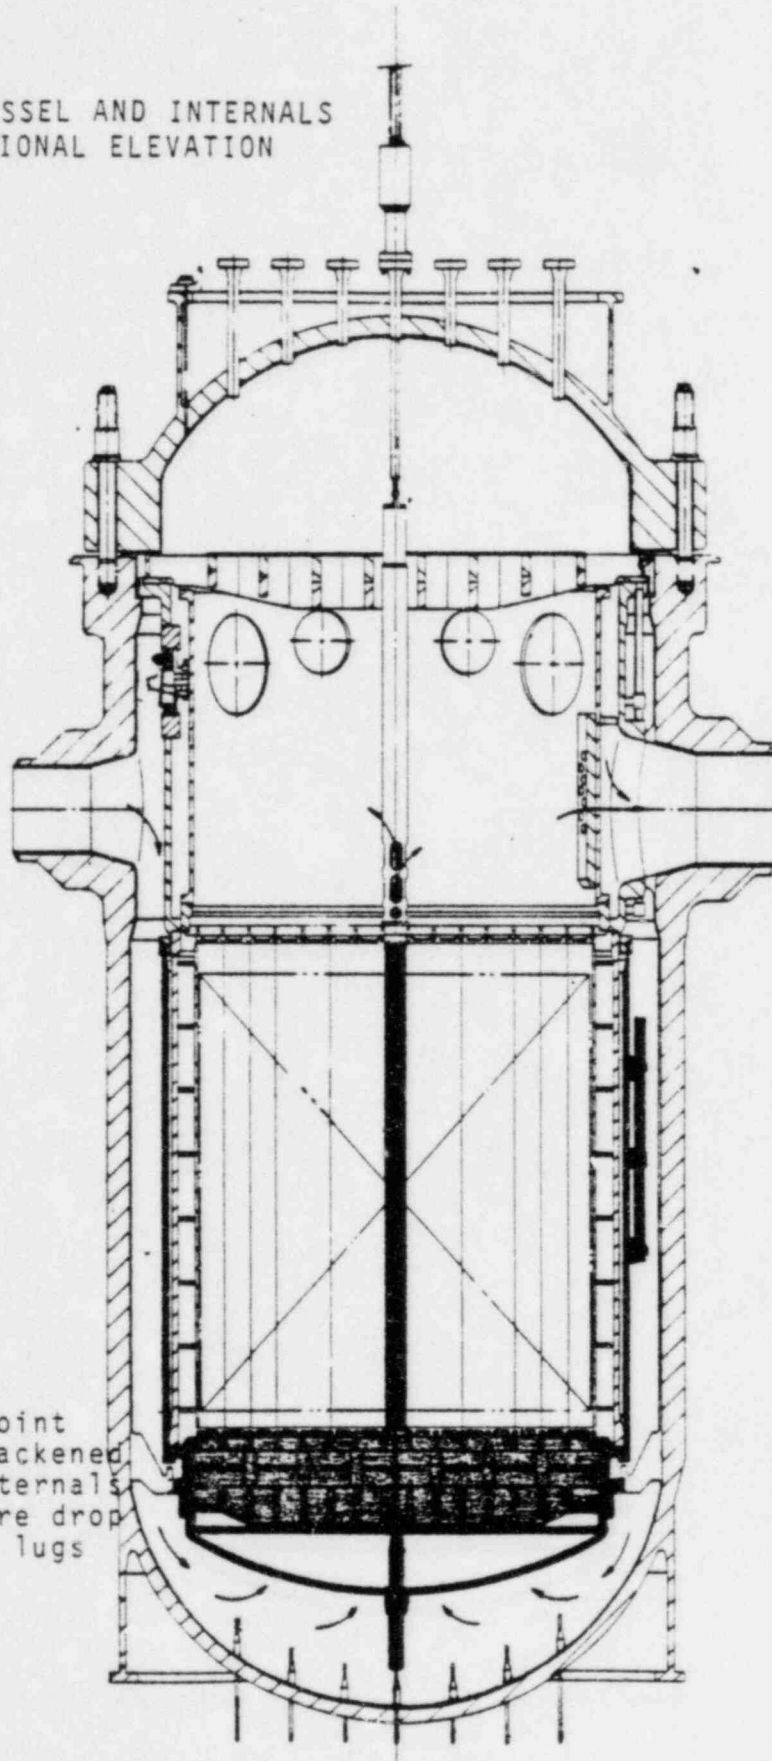
Fig. 4.4

Similar conclusions can be reached for failure of the lower core barrel joint since the considerations are the same for this failure mode as for the UCB joint failure, with only two exceptions. Since the core barrel to core support shield joint remains intact no core bypass flow is expected and the load on the guide lugs is reduced by the weight of the core barrel. Figures 4.4 and 4.5 depict the lower core barrel joint failure and in the core dropped condition.

With LCB Joint
failure blackened
part of internals
and the core drop
onto guide lugs

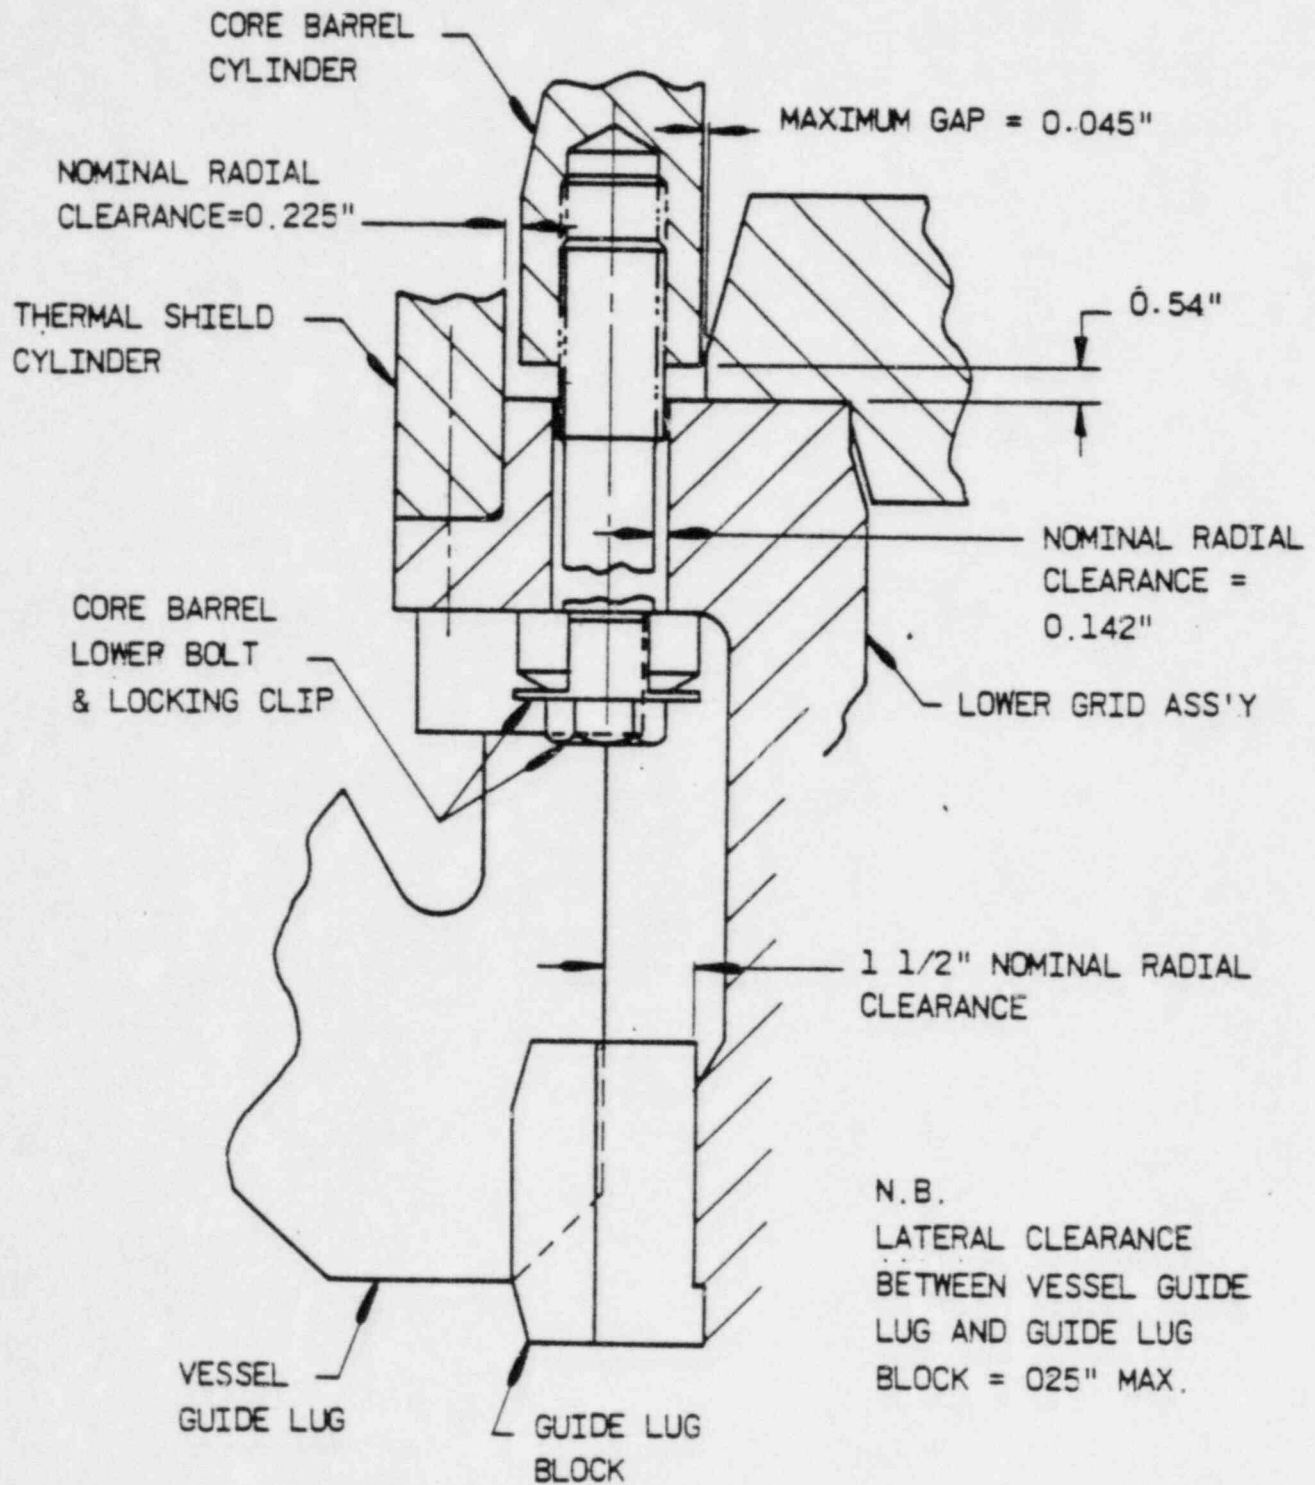
CORE AND INTERNALS IN DROPPED CONDITION
FROM
LOWER CORE BARREL JOINT FAILURE

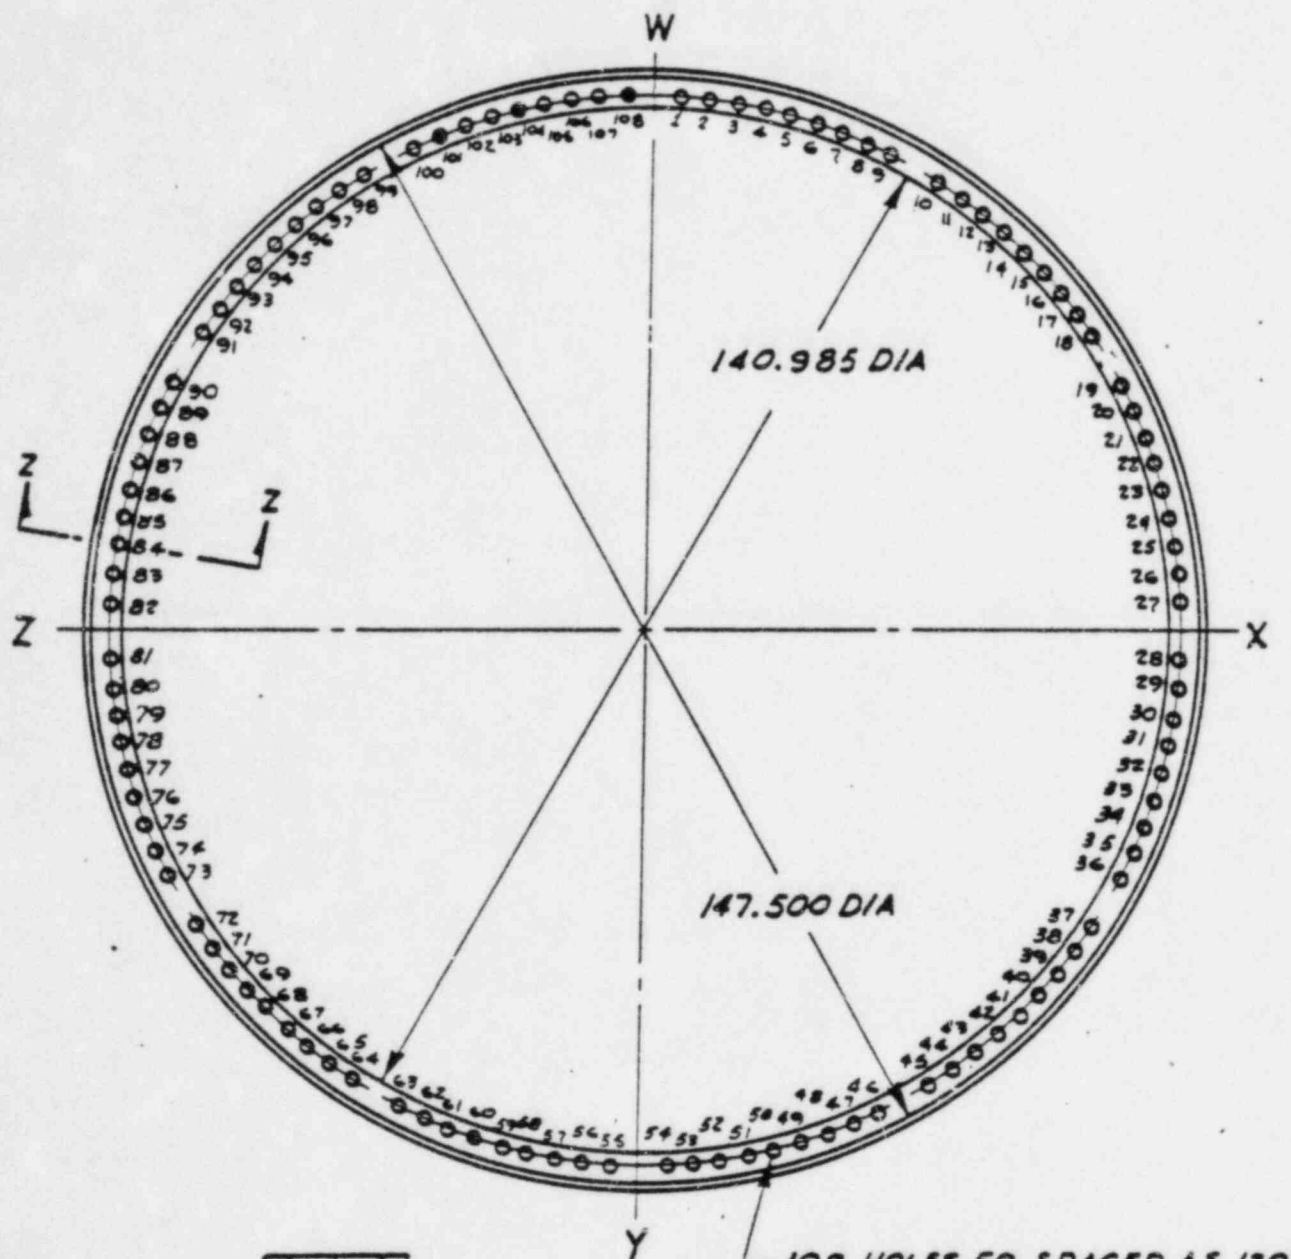
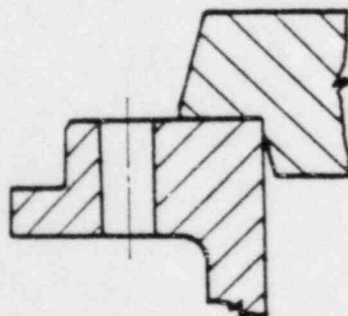
**CORE BARREL/LOWER GRID BOLT LOCATIONS
CRYSTAL RIVER-3**

BOLTS WITH ABNORMAL INDICATIONS
