B&W OWNERS GROUP

BOLTING TASK FORCE

SUMMARY REPORT OF
NUCLEAR REGULATORY COMMISSION/
BABCOCK & WILCOX OWNERS GROUP
MEETING ON
REACTOR VESSEL INTERNALS BOLTING
MAY 6, 1983

SUMMARY REPORT OF
NUCLEAR REGULATORY COMMISSION /
BABCOCK & WILCOX OWNERS GROUP
MEETING ON
REACTOR VESSEL INTERNALS BOLTING
MAY 6, 1983
BAW 1784

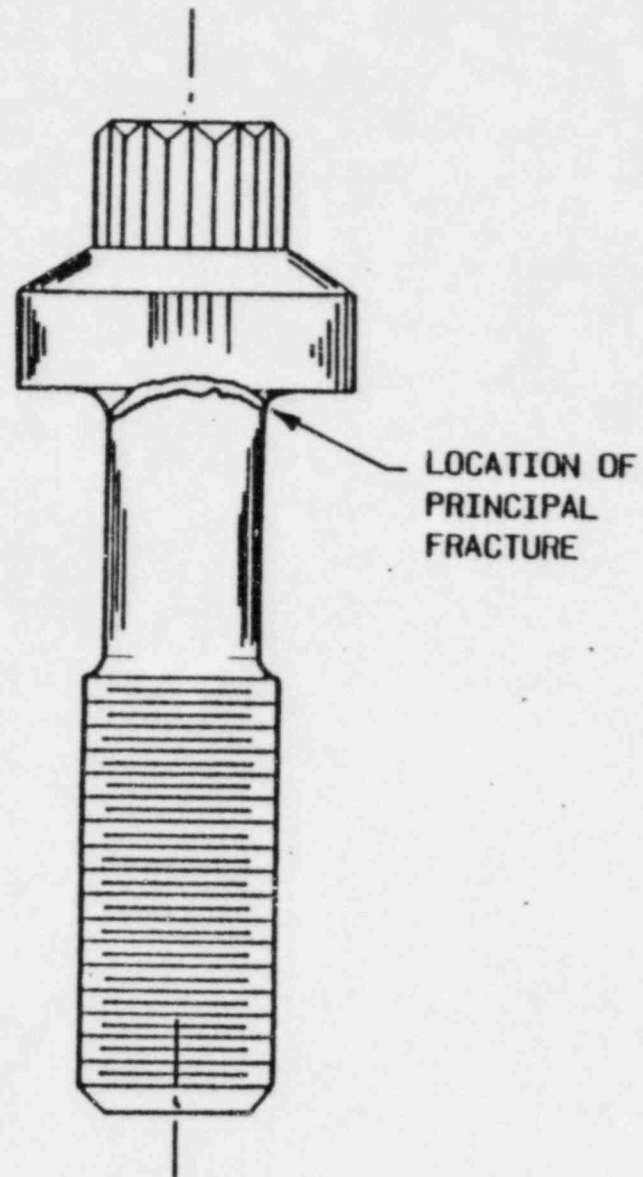
SKETCH OF LOWER THERMAL SHIELD BOLT
SHOWING LOCATION OF FRACTURE

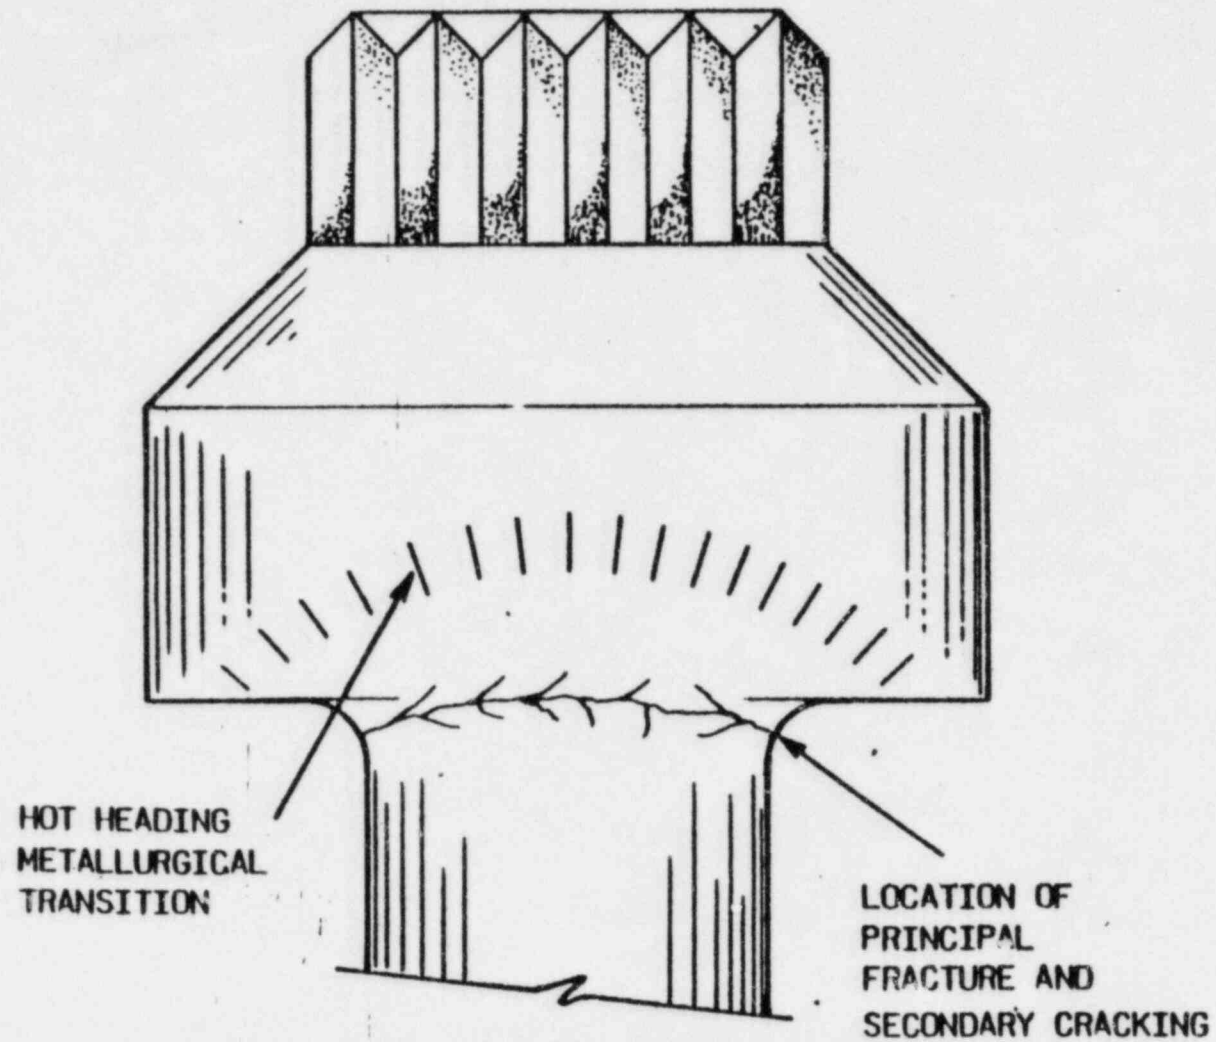
1. INTERGRANULAR FRACTURE WITH EXTENSIVE SECONDARY CRACKING (BRANCHING).
2. CRACKING INITIATED IN THE HEAD TO SHANK TRANSITION REGION.
3. CRACK PROPAGATION SIMILAR TO THAT FOUND IN THE LOWER THERMAL SHIELD BOLT, I.E., FOLLOWED HAZ CURVATURE.
4. THE HEADS OF BOTH BOLTS WERE ATTACHED BY SMALL LIGAMENTS FORMED BY THE SECONDARY CRACKING. (CRACKING PROPAGATED THROUGH ~ 95% OF BOLT SHANK.)

SKETCH OF UPPER CORE BARREL BOLT
SHOWING LOCATION OF FRACTURE

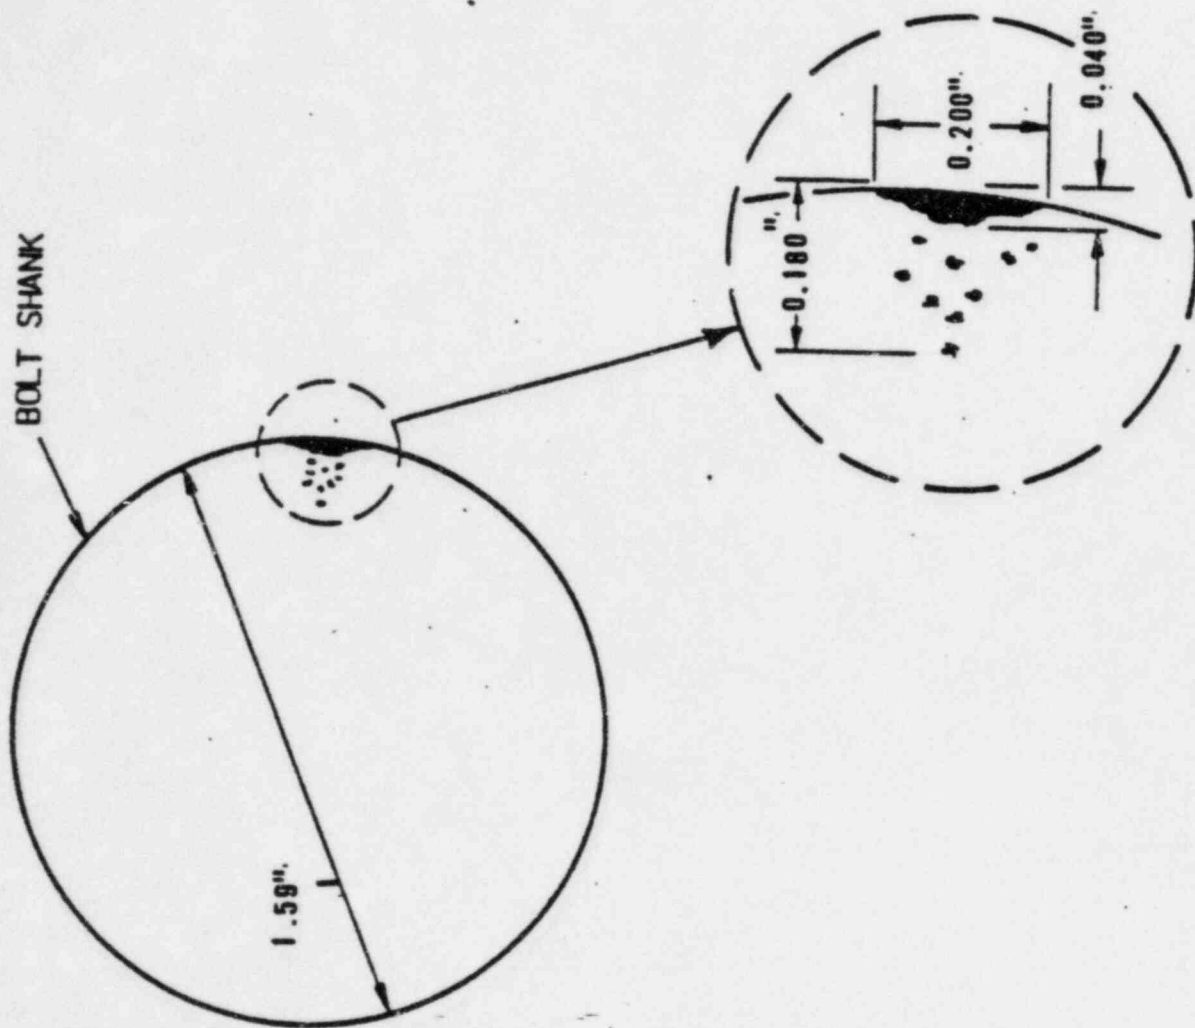
RANCHO SECO UPPER CORE BARREL
BOLT #79

BOLT #79 (CONTAINING NO SITE U/T INDICATIONS)

1. FLAW CONTAINS LOCALIZED DEPOSITS
2. FLAW IS NOT INTERGRANULAR IN NATURE.
3. NO SECONDARY INTERGRANULAR CRACKING WAS OBSERVED.
4. SURFACES BETWEEN FLAWS OPENED BY DUCTILE RUPTURE WHEN PULLED APART.
5. TOTAL FLAW SIZE MUCH LESS THAN 15% SITE U/T CALIBRATION STANDARD.

1. RANCHO SECO UPPER CORE BARREL BOLT FAILURES ARE TYPICAL OF PREVIOUS BOLT FAILURES.
2. BOLT #79 FLAW IS AN ANOMALLY AND NOT ASSOCIATED WITH BOLT FAILURES. THE FLAW IS METALLURGICALLY INERT SHOWING NO EVIDENCE OF PROPAGATION.
